SPARTAN HOME INSPECTION, LLC

# PROPERTY INSPECTION REPORT FORM

Neil Doran <i>Name of Client</i>	11/11/2022 5:00 pm <i>Date of Inspection</i>
15207 Lakewood Ave, Mont Belvieu, TX 77523 <i>Address of Inspected Property</i>	
Adam Wright <i>Name of Inspector</i>	TREC # 23898 <i>TREC License #</i>
<i>Name of Sponsor (if applicable)</i>	<i>TREC License #</i>

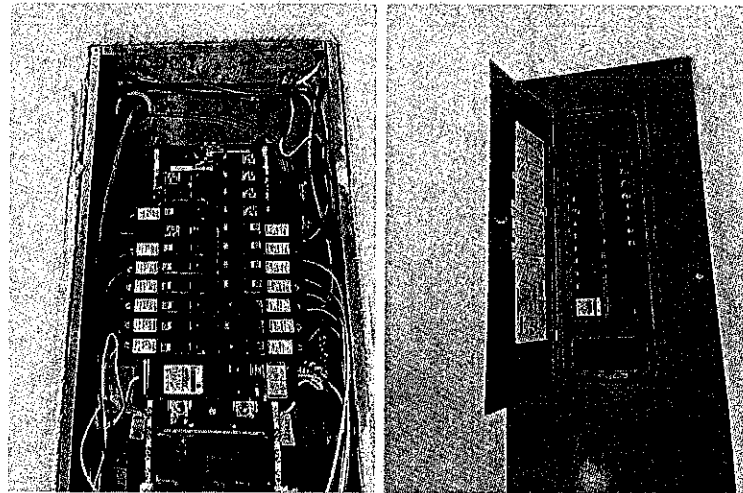
Panel cover

The service panel was 150 amp and located on the right interior wall of the garage. Power was supplied by aluminum wires coming into the equipment panel. The electrical supply utility wires were run underground.

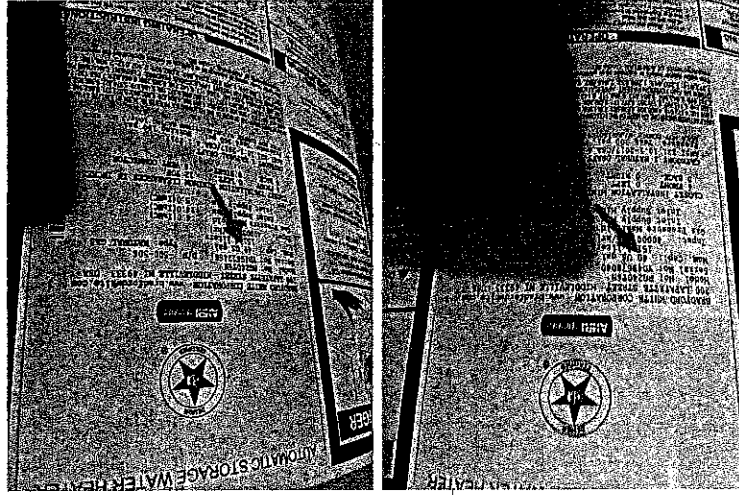
There are two 40 gallon water heaters in the attic for a total of 80 gallons of hot water.

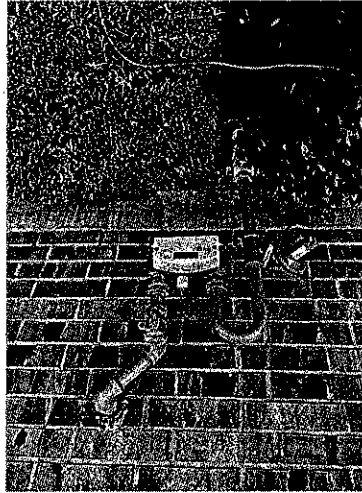
Gas meter located on right side of home.
