Prepared for Emerson Property Management

6/21/2024

711 Avenue A Unit 2

La Marque TX 77568

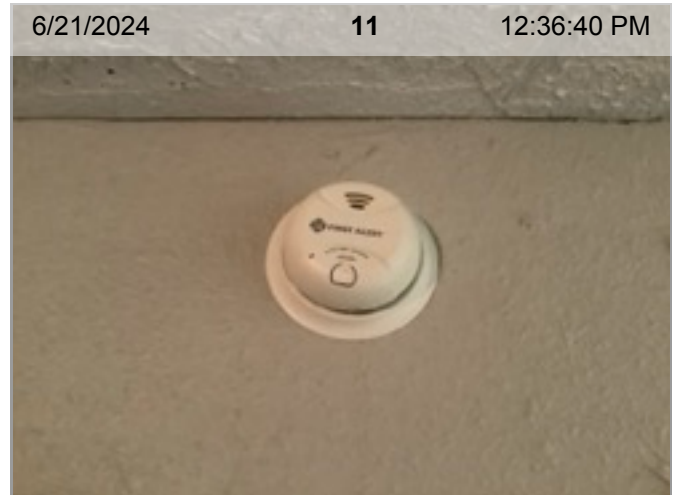
Wireless Smoke Alarm (mfd 3/2022) | Smoke test: Passed | Alarm in place

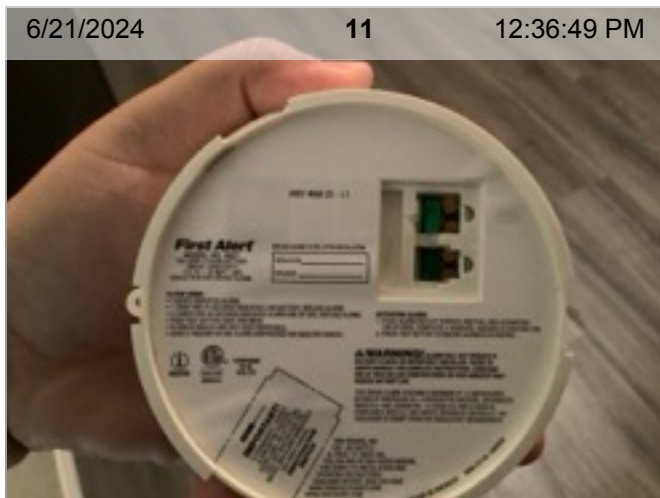
Wireless Smoke Alarm (mfd 3/2022) | Smoke test: Passed | Close-up of printed manufacture date | 2.3 years old

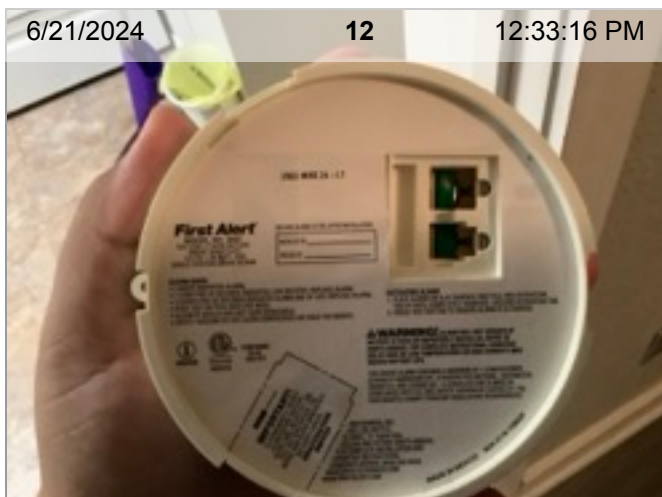
Wireless Smoke Alarm (mfd 5/2022) | Smoke test: Passed | Close-up of printed manufacture date | 2.1 years old

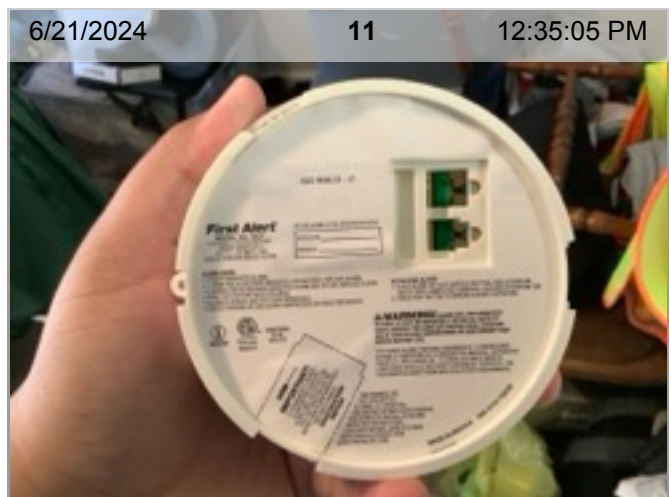
Wireless Smoke Alarm (mfd 3/2022) | Smoke test: Passed | Close-up of printed manufacture date | 2.3 years old

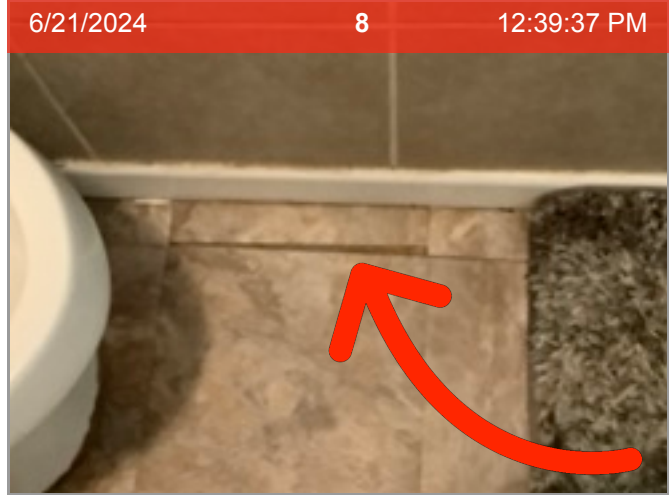
Bathroom 1
Floors
Gap in flooring.

Floors | Gap in flooring.
