HOME INSPECTION REPORT

Monica Perez and Orlando Urdeneta	6-14-2024
<i>Name of Client</i>	<i>Date of Inspection</i>
19147 Sprintwood Ct, Humble, TX 77346	
<i>Address of Inspected Property</i>	
Bob Wiesner (# 22223) Ronald Randle (# 26218)	22223
<i>Name of Inspector</i>	<i>TREC License #</i>
Bob Wiesner	22223
<i>Name of Sponsor (if applicable)</i>	<i>TREC License #</i>

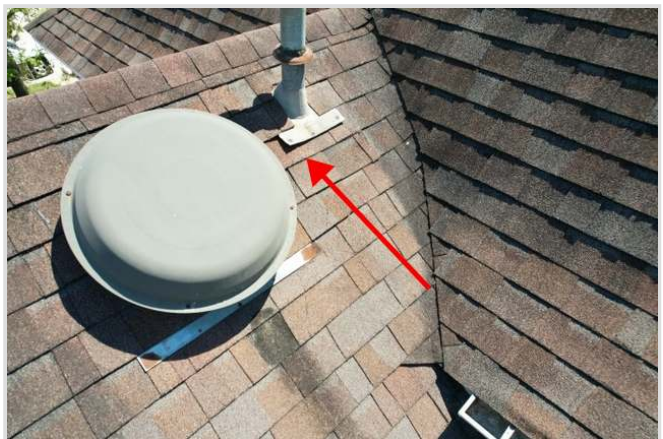
Lifted flashing - water heater flue

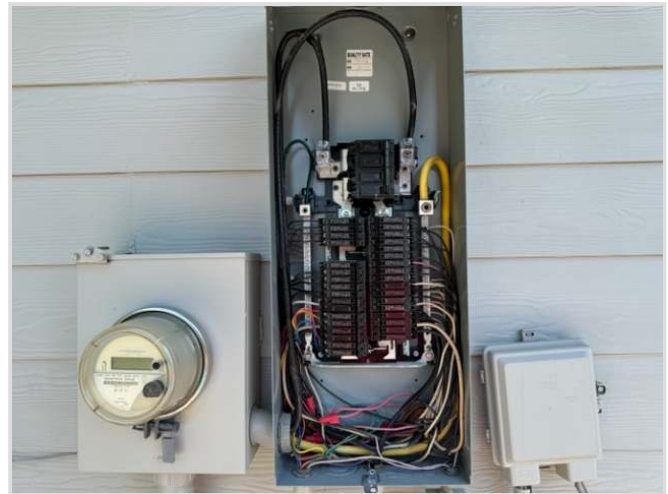
Knockouts were missing.

White wires were used as hot (ungrounded conductors) without being properly marked. It is recommended that they be marked with a black marker to designated the white wires are being used as hot wires and not neutral.

Cover removed for inspection

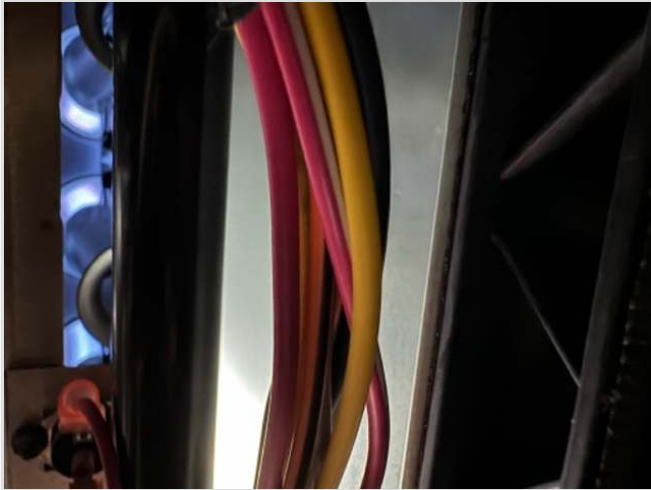
Unit #1: Furnace burners functioning

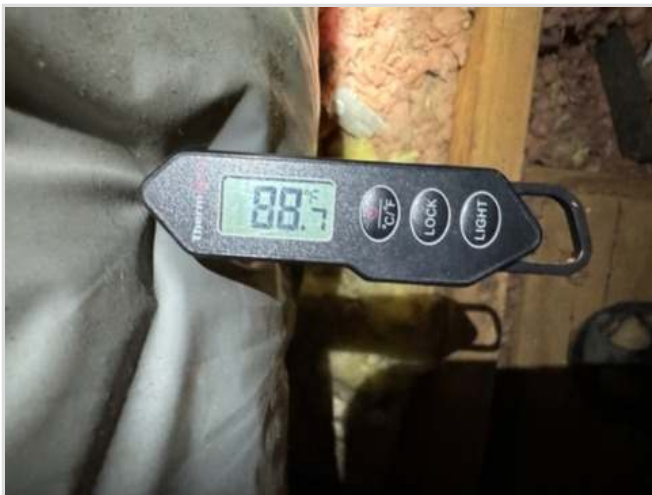
Unit #1: Return air temperature

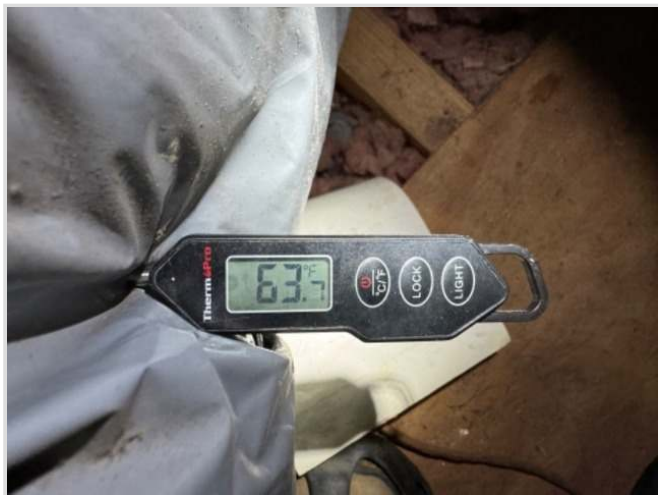
Unit #1: Supply air temperature

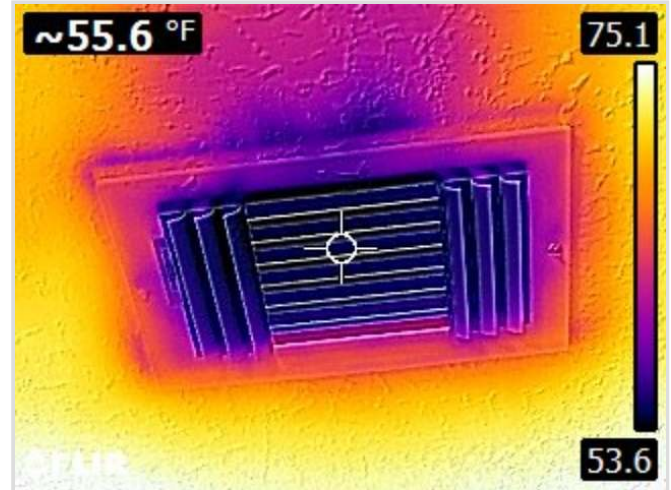
Unit #2: Supply air temperature

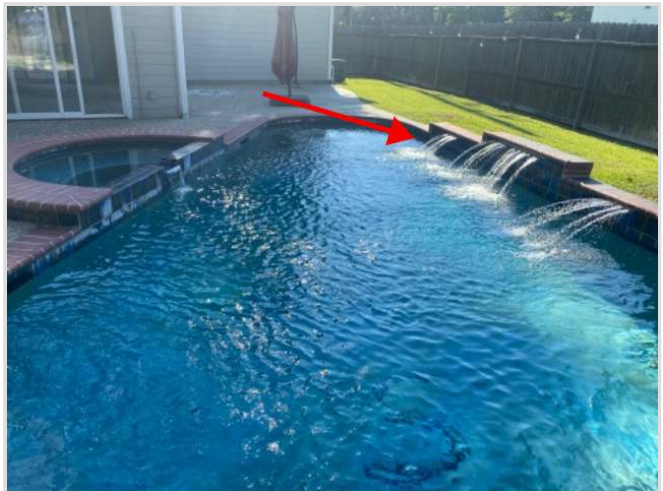
Water feature pump functioning

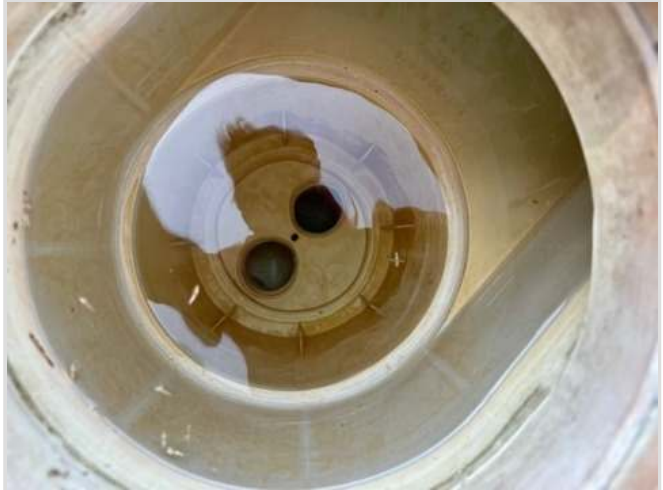
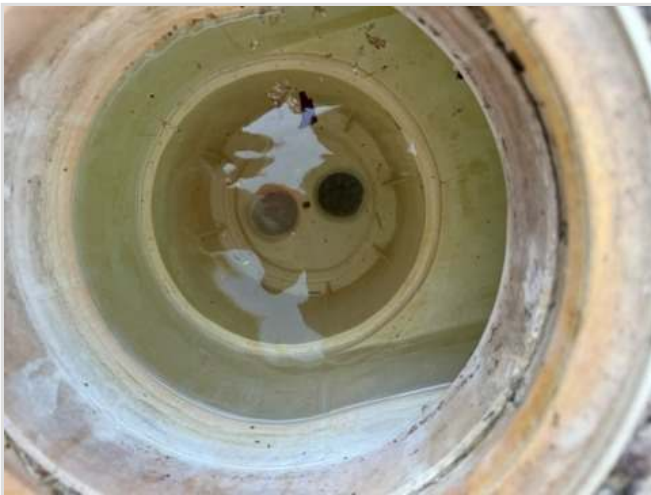
Skimmers were in good condition
