**7814-7816-7818 Glass St  
Houston, TX 77016**

**July 5, 2024**

# PROPERTY INSPECTION REPORT FORM

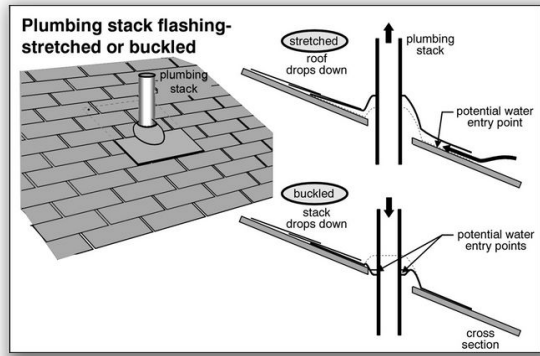
**Note:** Roof fasteners (nails and/or staples) were observed to be exposed and should be properly sealed at the ridge caps and flashing areas.

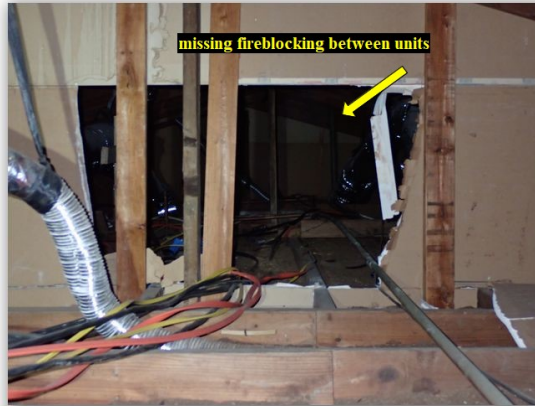
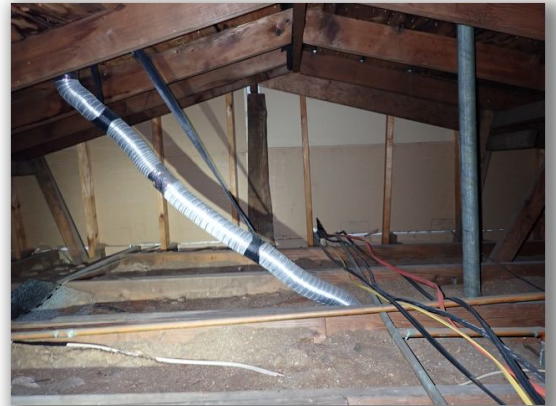
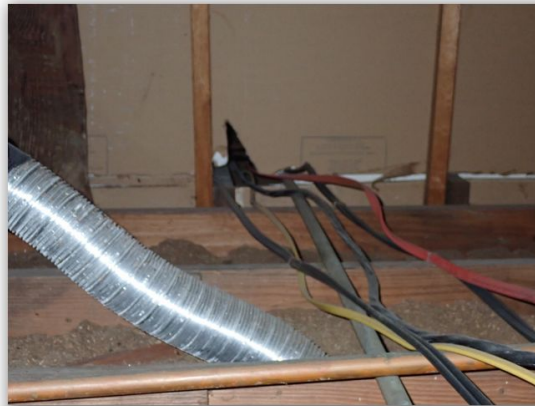
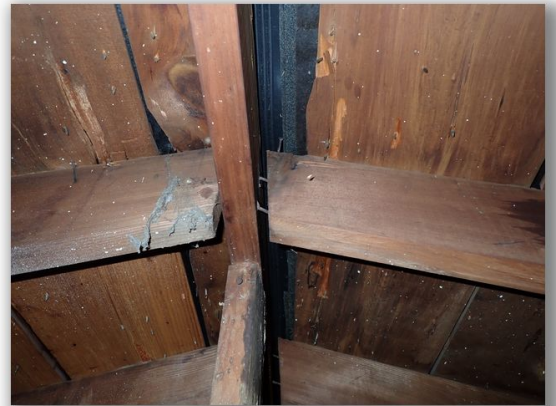
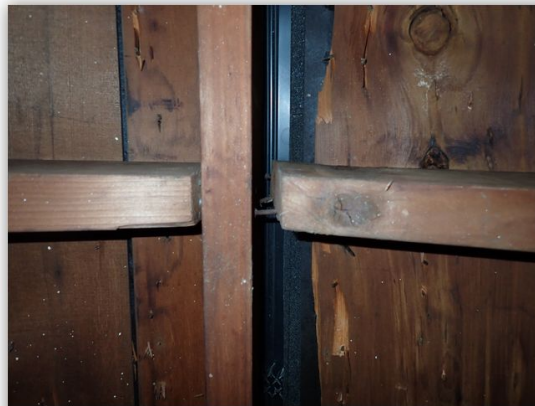
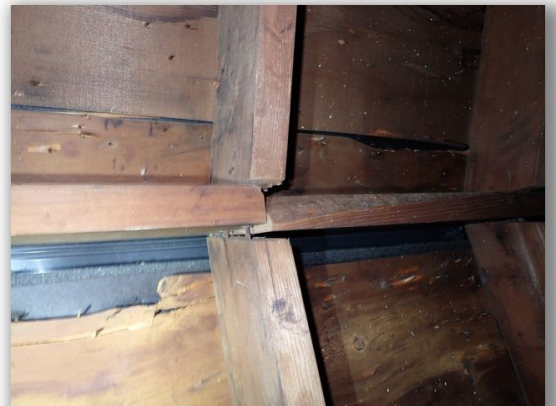
- The fireblock between the units is damaged and repairs are recommended.
- One or more of the roof structure rafters were observed to be pulling away from the top ridge board.

**Note:** There are visible water stains on the roof sheathing (decking) in one or more locations.

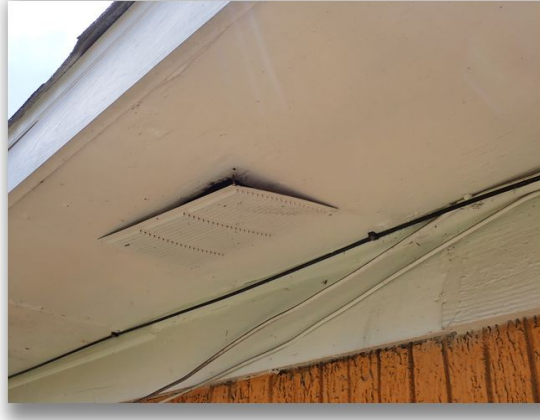
- One or more of the soffit vent screens were observed to be pulling loose on the north side of the roof structure.

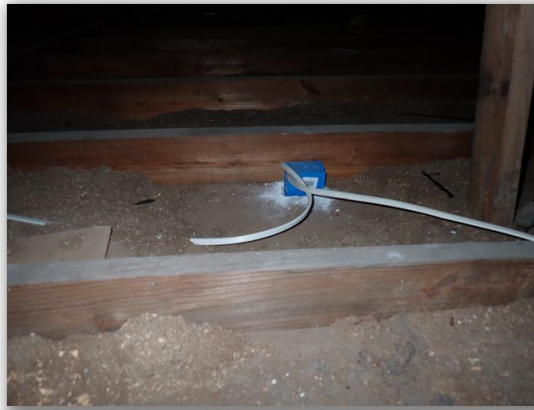
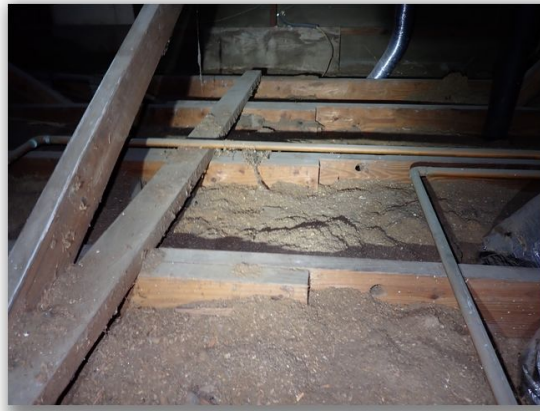
- The attic insulation is lower than typical and it is recommended to add additional insulation to achieve at least a R-38 rating.
- The attic floor insulation was observed to be missing over several locations throughout the house.

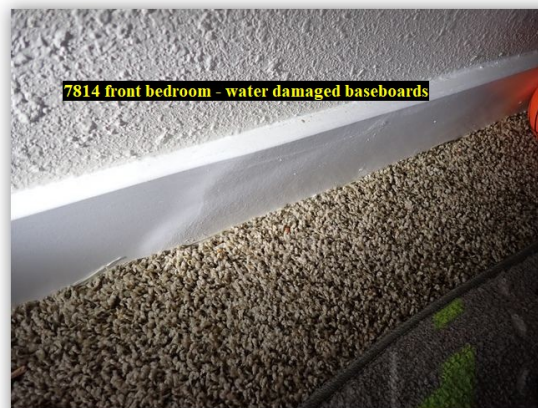
- The baseboards were observed to be water stained and/or damaged in the 7814 front corner bedroom. The cause and remedy should be further evaluated and corrected as necessary.

- Elevated moisture levels were detected in the wall finished surfaces in the 7814 front corner bedroom. The cause and remedy should be further evaluated and corrected as necessary. **Additional Note:** Due to the elevated moisture, other adverse conditions such as mold-like substance growth, wood rot/deterioration and wood destroying insects are possible.

- Wall surface damage was observed in 7818 several locations.
- There was an unknown mold like substance observed in 7818 hall bathroom. Evaluation of this substance is beyond the scope of this inspection. If any concerns exist on the type and/or nature of this substance, we recommend further evaluation by a professional in the Air Quality sampling field.

- Cabinet damage was observed in the 7818 kitchen.

**Note:** Visible evidence of rodent activity was observed in the interior of the home. It is recommended to have a Certified Pest Control Operator further evaluate this condition and make corrections as necessary.

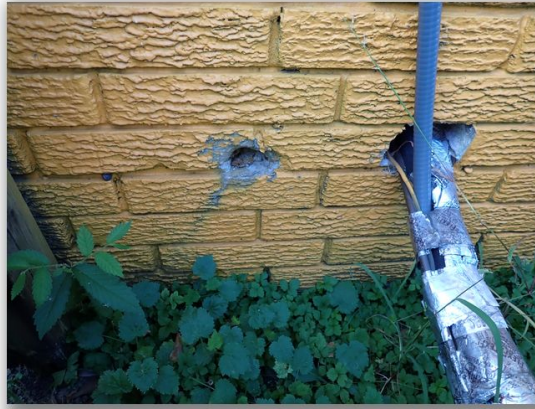
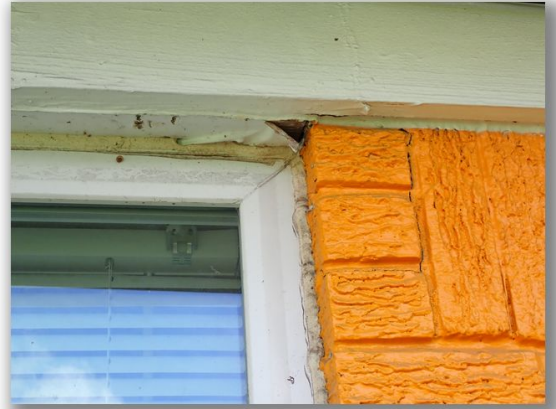
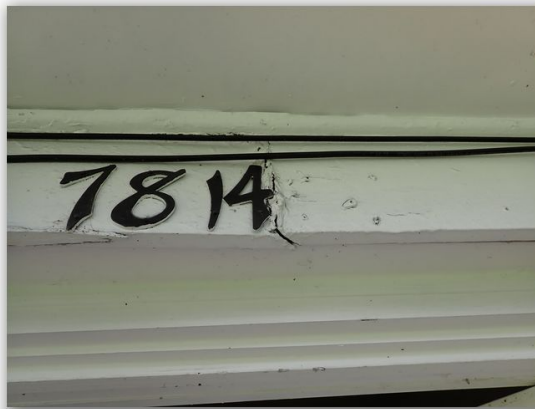
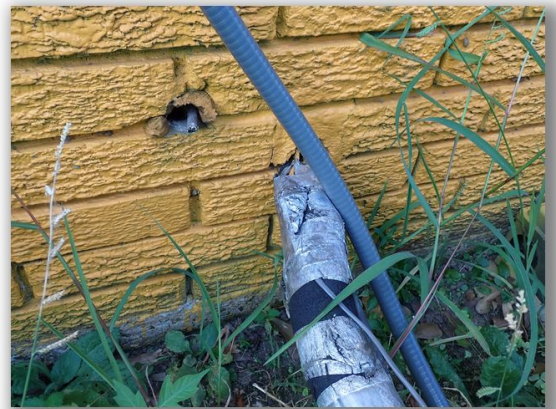
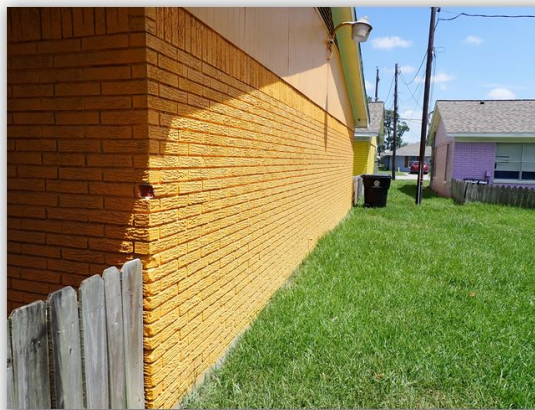
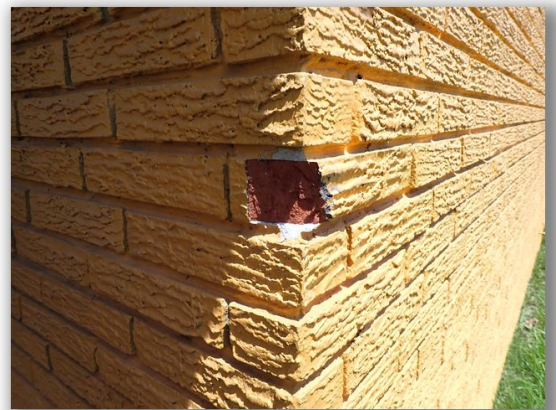
- All joints between two different types of siding should be properly sealed. It is recommended to use elastomeric sealant.
- Deflection cracks were observed in the exterior veneer on the west side of the structure.

- One or more of the exterior bricks were observed to be damaged on the east side of the structure.
- The weepholes in the lower course of the exterior masonry veneer were observed to be blocked and/or sealed. The weepholes should be reopened to help vent the wall voids and release any absorbed rain water from behind the exterior masonry veneer walls.

**Note:** Mortar and/or brick cracks were observed in the exterior veneer on the north, east, west and south sides of the structure.

- Caulking improvements are recommended for the area between the exterior veneer and the window frames. It is recommended to use an elastomeric sealant.

- The area between the exterior cladding / veneer and all of the wall penetrations / openings should be properly sealed. Areas such as utility connections, downspouts, hose bibbs, lighting fixtures, receptacles, vent termination covers, etc. It is recommended to use an elastomeric sealant.

- It is recommended to add a fresh coat of exterior paint where needed to the exterior veneer.

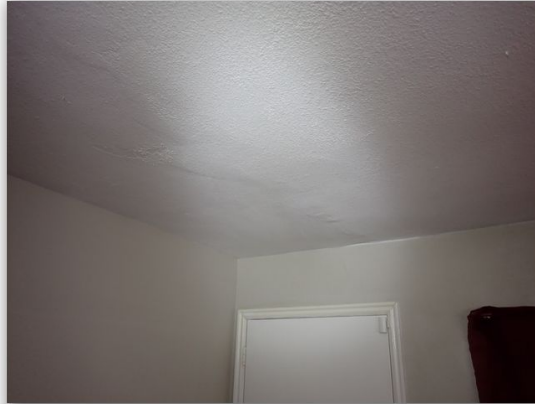
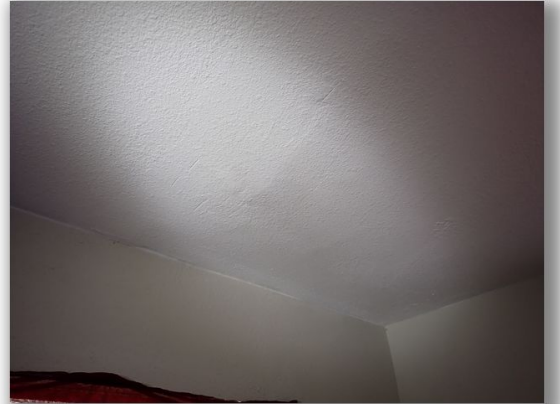
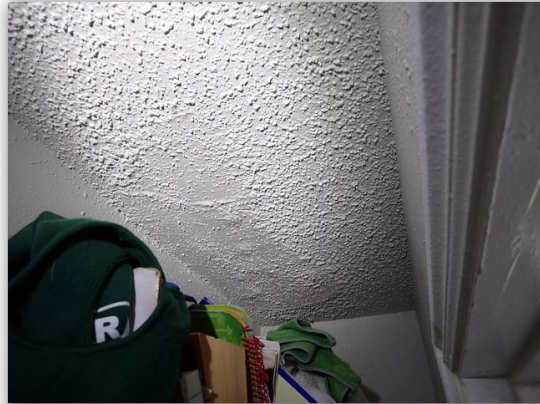
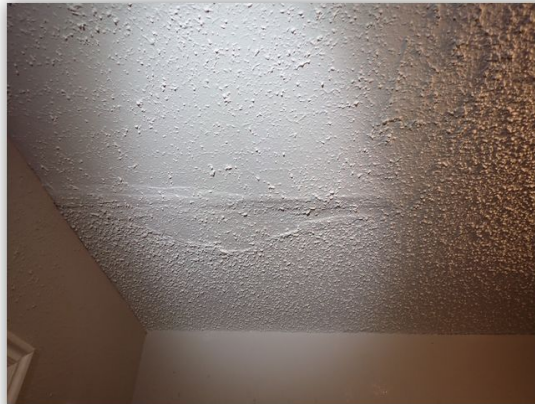
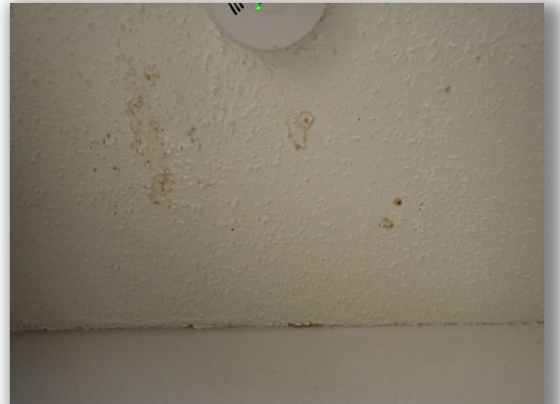
- The ceiling texture has some deterioration and/or damage in several locations throughout 7814, 7818.
- Some of the ceiling finishing material was observed to be sagging in several locations throughout 7814, 7818.
- The ceiling was observed to be water damaged in the 7818 rear corner bedroom.
- Water stains were observed on the ceiling finish in the 7818 rear corner bedroom. The cause and remedy should be further evaluated and corrected as necessary.

**Note:** Nail heads were observed to be pushing through the interior finish in one or more locations.

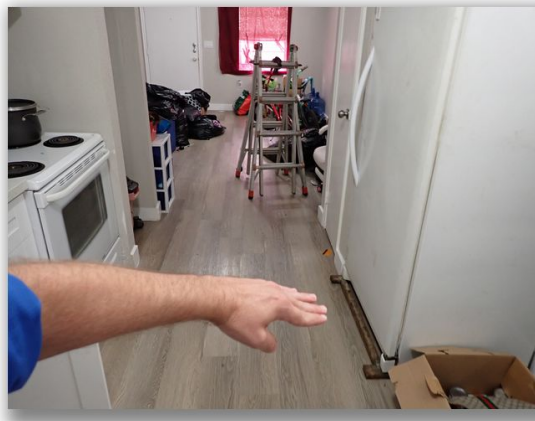
- The floors were observed to be out-of-level in some areas of the structure.
- The floor covering is stained in one or more locations of the home.

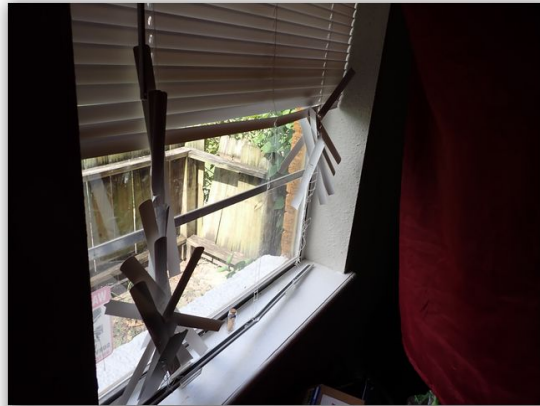
- One or more of the window screens were observed to be damaged.
- One or more of the window screens were observed to be missing.

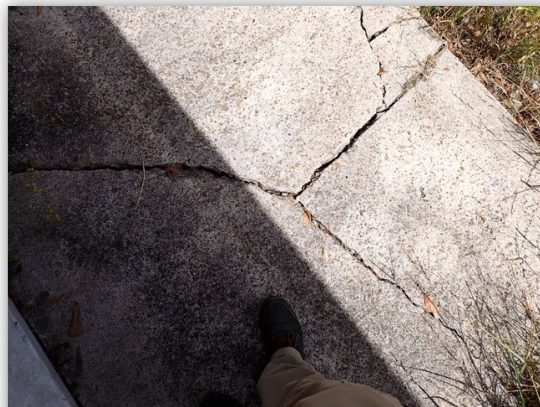
**Porches / Patio**

- Minor cracks and/or deficiencies were observed in the patio.
- Larger than typical cracks and/or deficiencies were observed in the patio.

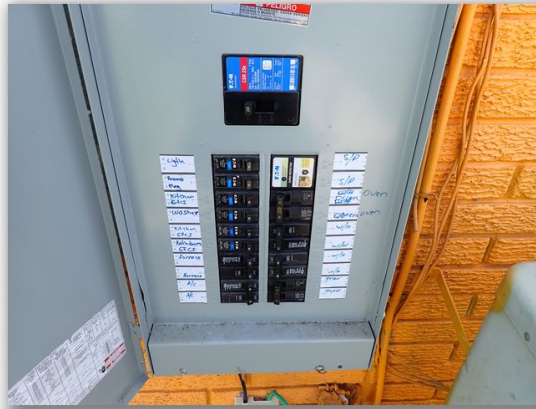
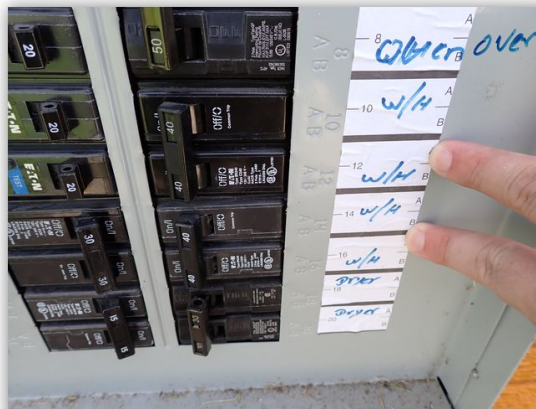
- There is no ground fault circuit interrupter type breaker for the dryer outlet installed at the panel box. This does not meet current building standards.
- There was no anti-oxidant gel observed on the exposed aluminum conductor terminations.

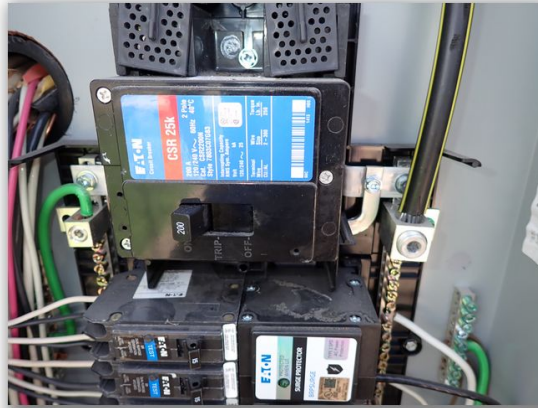
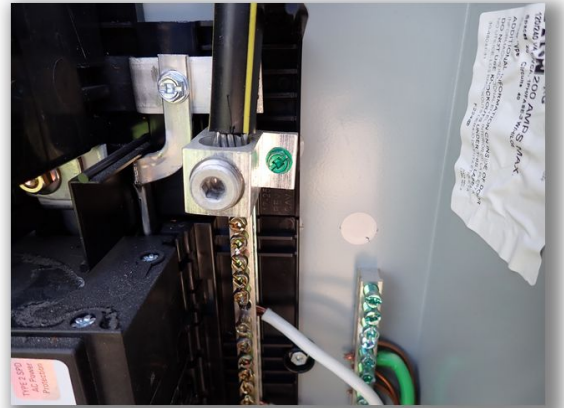
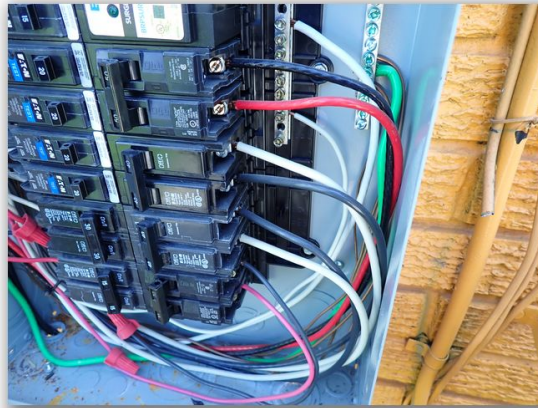
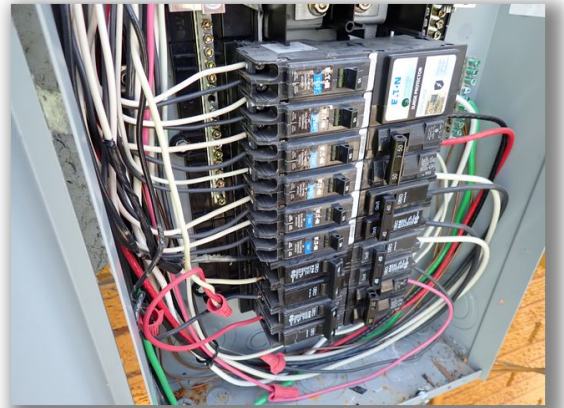
**7816 Panel Box**

- There is no ground fault circuit interrupter type breaker for the dryer outlet installed at the panel box. This does not meet current building standards.
- There was no anti-oxidant gel observed on the exposed aluminum conductor terminations.

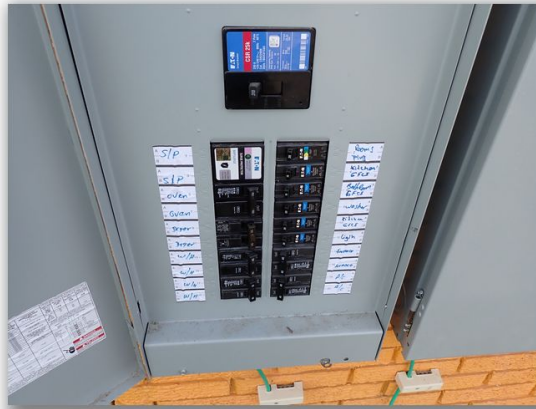
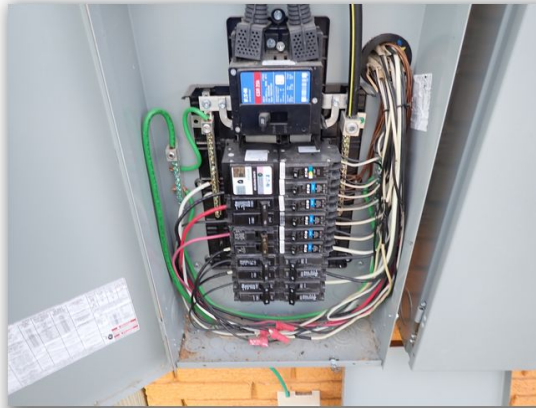
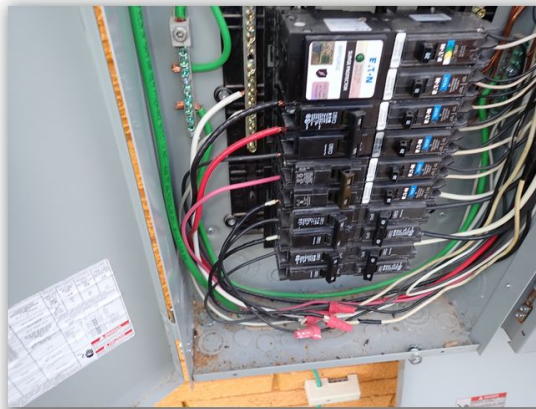
- There was no anti-oxidant gel observed on the exposed aluminum conductor terminations.

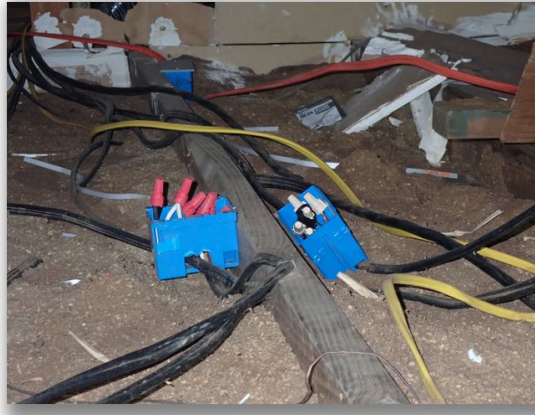
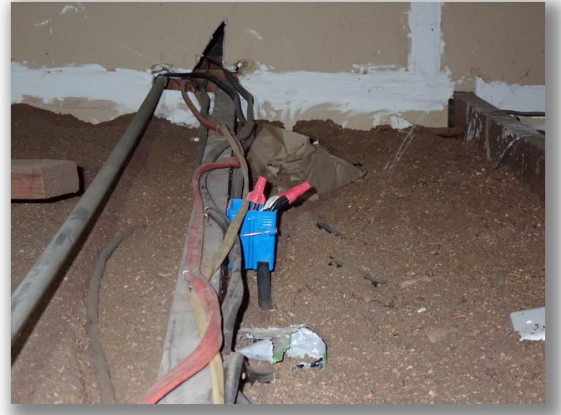
- Open electrical junction box(es) were observed in the attic area. All open junction box(es) should be properly enclosed for reasons of safety.

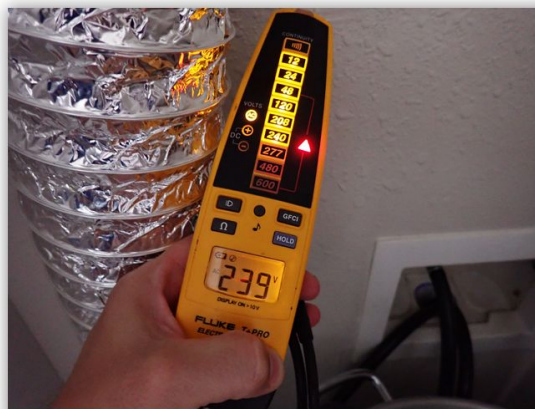
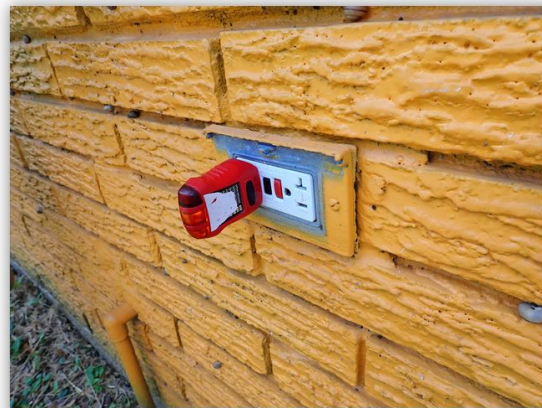
- There is no receptacle installed at the AC outside condenser. Under current building standards, there should be a receptacle installed within 25 feet and on the same level as the condenser.
- One or more of the receptacle cover plates are damaged in the 7814 rear corner bedroom.
- All exterior receptacles should have weather tight covers. The receptacle weather cover plate is damaged and/or missing on the north exterior wall.

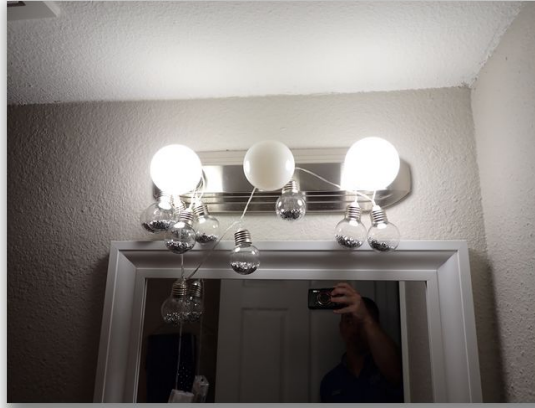
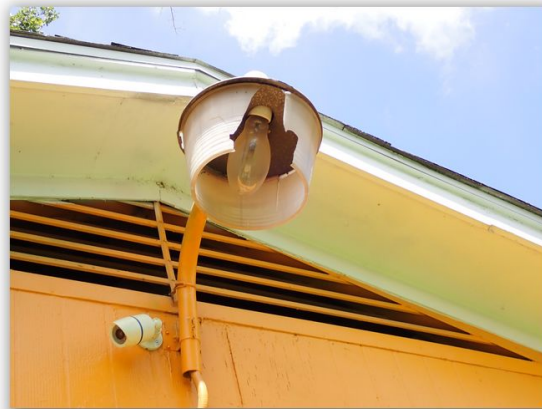
This may be due to a bad bulb or some other unknown condition. This condition should be further evaluated and corrected as necessary.

- One or more of the exterior light fixtures were observed to be damaged on the east soffit.

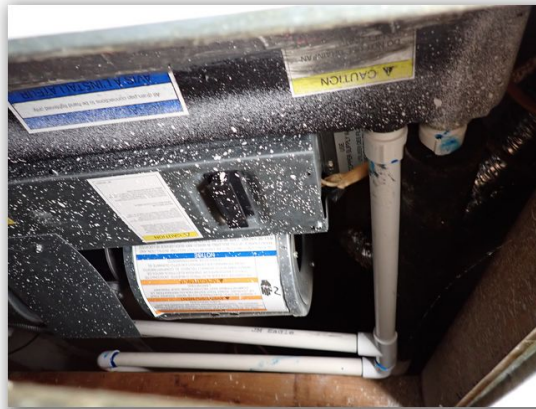
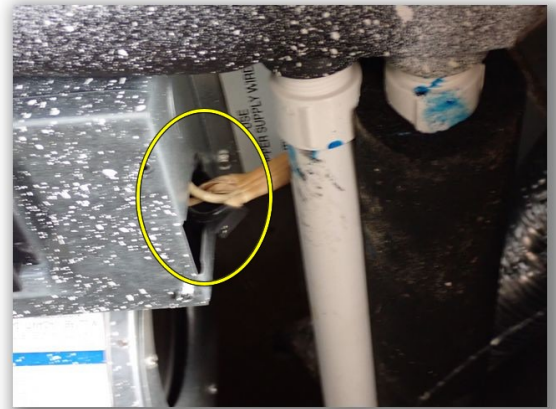
**7816 Central Heating System** – Energy Source: Electric

- The exposed electrical service wires to the heating equipment should be enclosed in conduit.

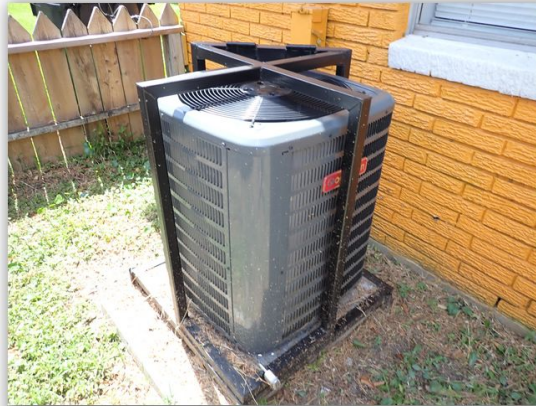
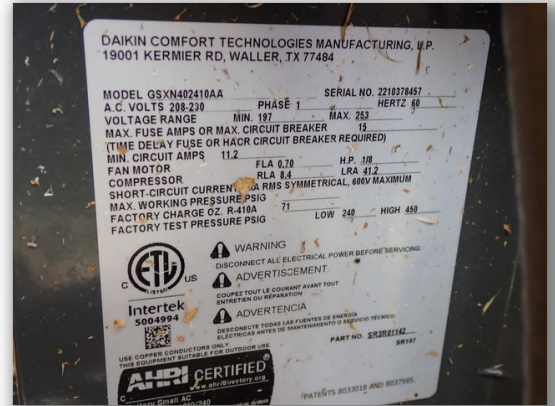
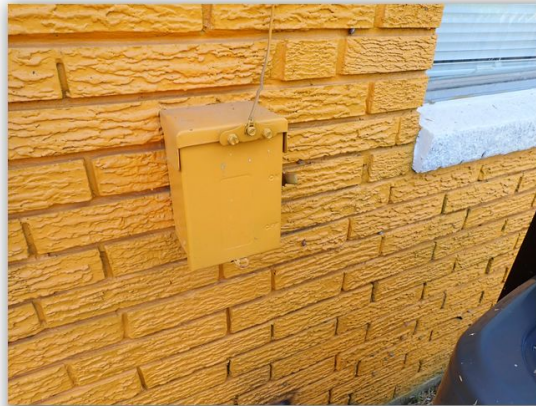
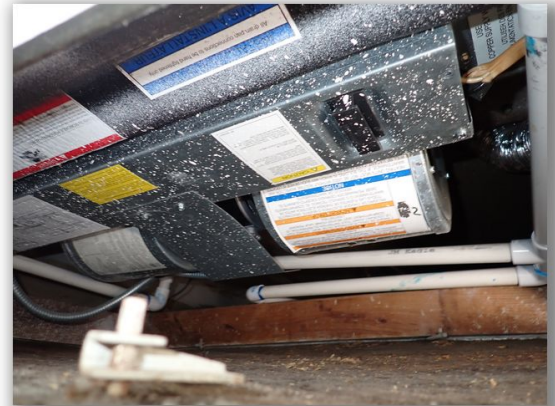
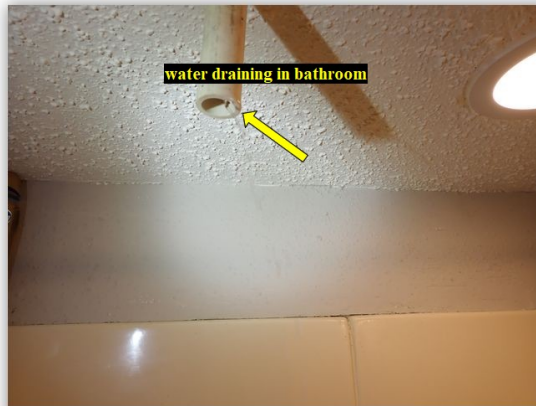
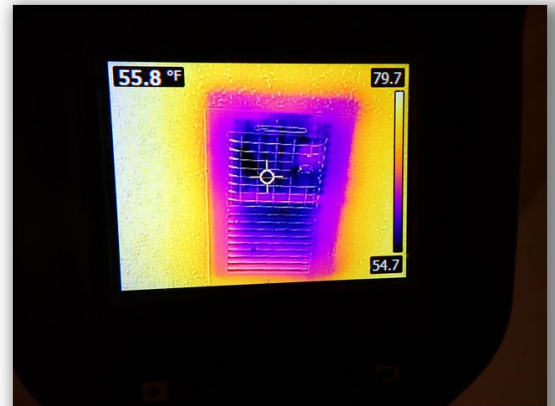
**7818 Central Cooling System**

- The secondary condensate drain line is leaking water, indicating the primary drain line is being bypassed. This indicates that servicing may be necessary.

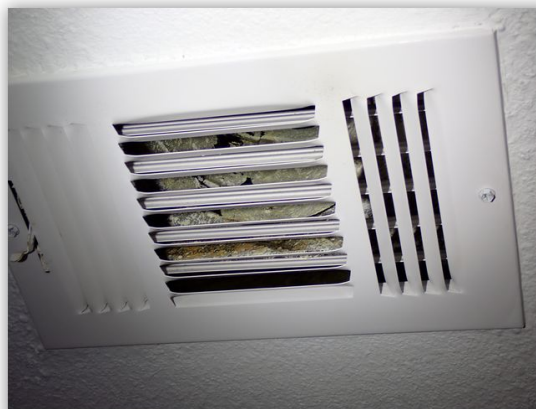
- The duct work in the attic area has sags between the supports. This condition can cause pressure loss and affect the airflow through the duct system.
- There is rust on the air registers in several locations throughout the house.
- The register box is damaged in the 7814 front corner bedroom.
- The air register has poor air flow in the 7816 rear corner bedroom.

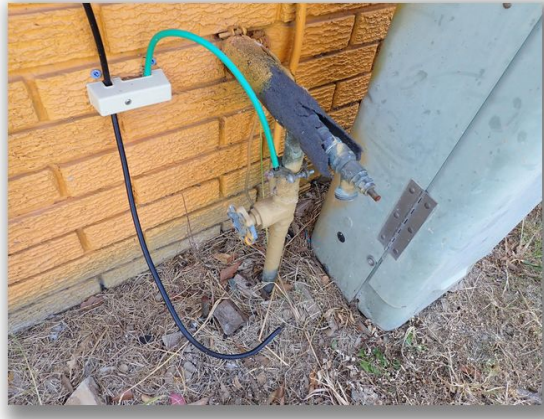
**Exterior Faucets/Fixtures**

- The exterior water hose bib (faucet) handle is missing on the west side of the structure.

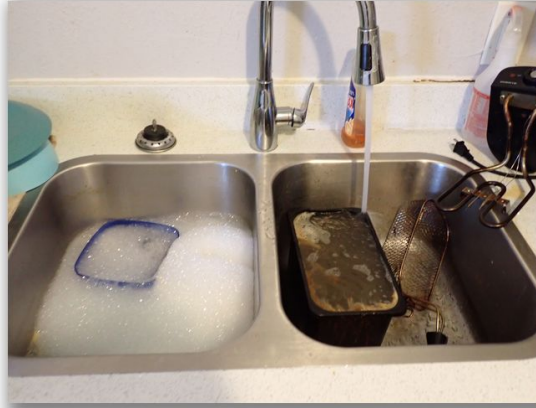
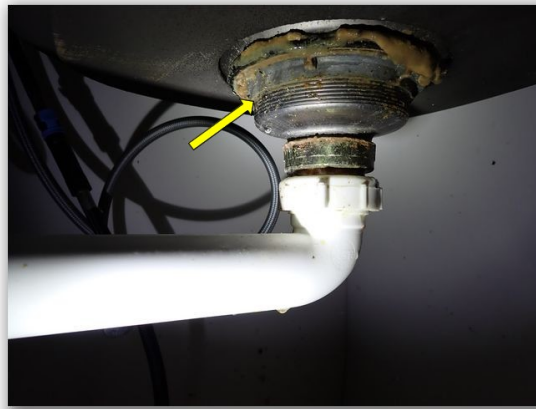
**7818 Kitchen Sink**

- The drain leaks water into the cabinet.

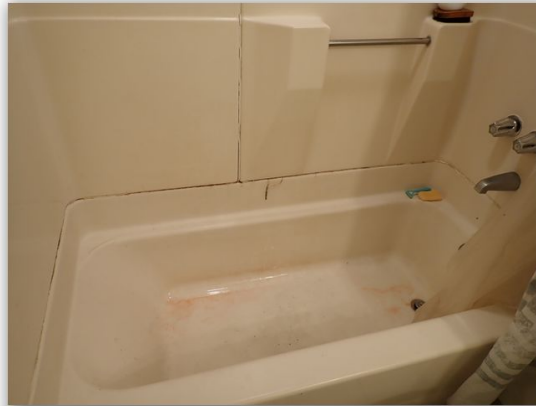
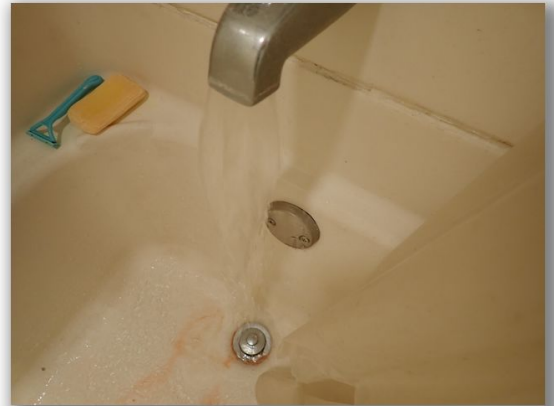
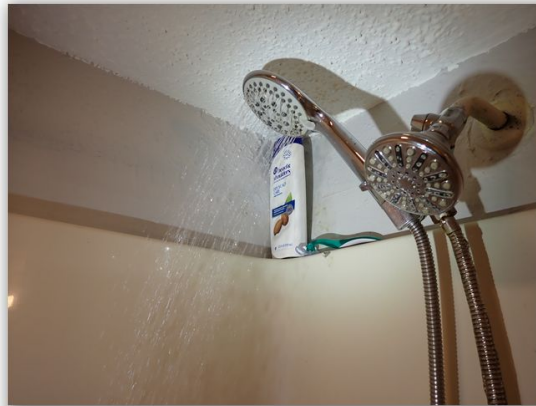
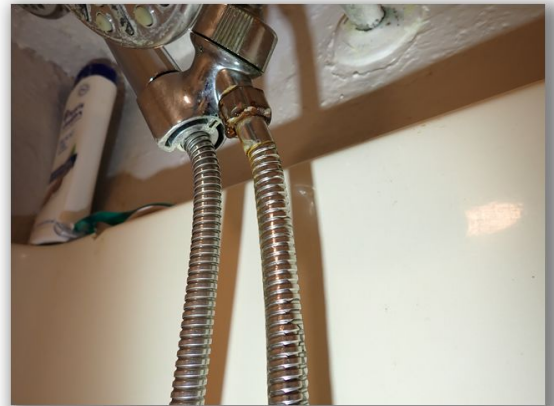
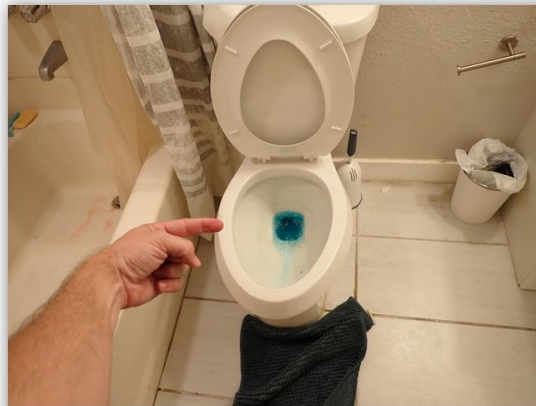
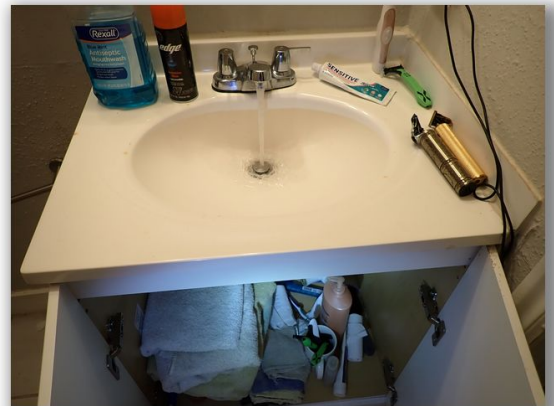
**7818 Hall Bathroom**

*Lavatory / Sink*

- The drain line is made of corrugated material. It is recommended to use smooth wall/PVC type material to prevent blockage/poor drainage.

- Cracked, deteriorated and/or missing grout and/or caulking should be repaired or replaced as necessary.
- The shower spout is leaking at the neck connection.

- The commode is loose at the floor mount.

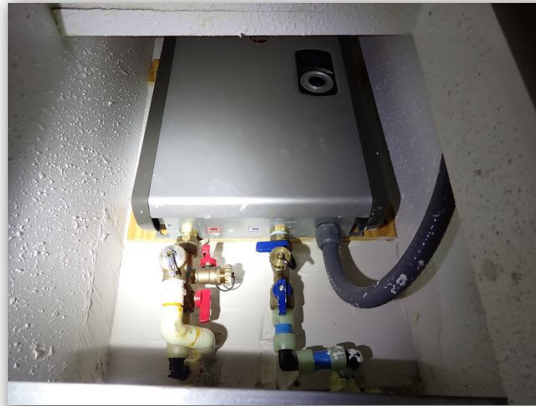
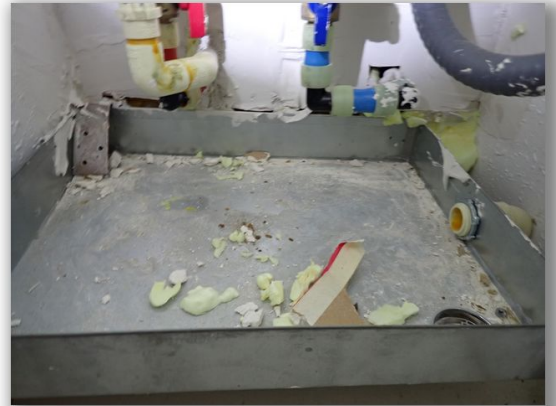
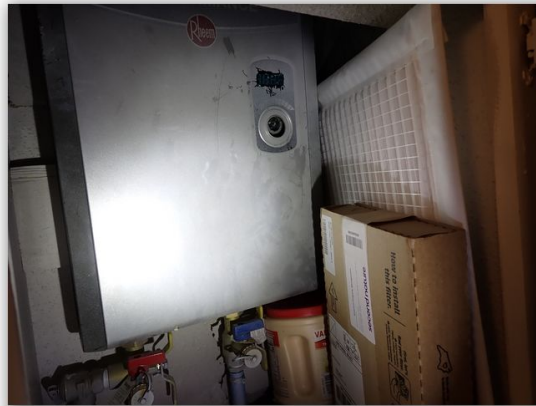
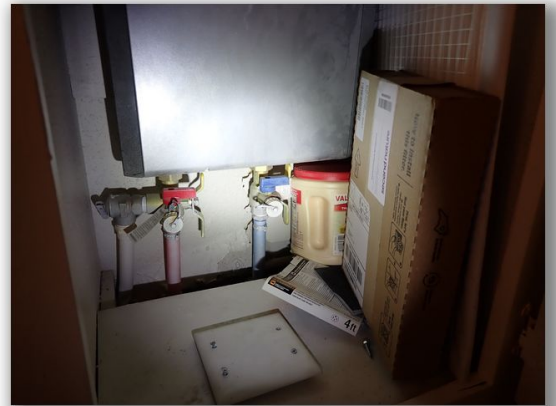
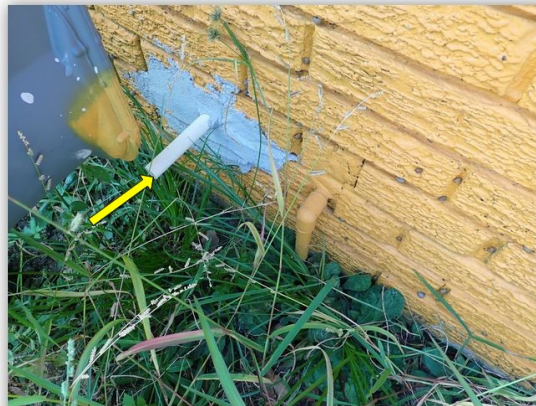
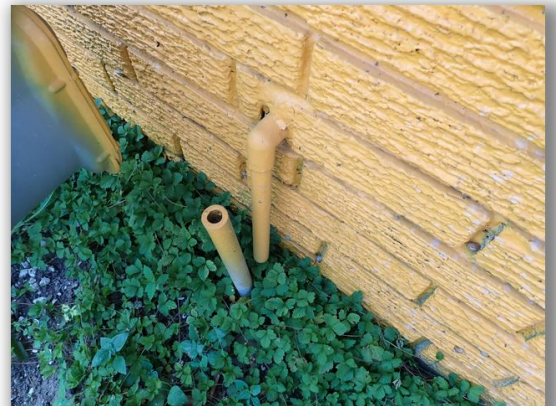
- There is no pan installed under the 7818 water heater.
- The exterior termination point of the temperature and pressure relief (TPR) valve discharge pipe is missing its 90-degree elbow. The TPR discharge pipe should turn 90-degrees downward and terminate within 6-inches of the ground.
- The exterior temperature and pressure relief (TPR) discharge pipe does not terminate at the proper height over the finished grade (ground). The TPR discharge pipe should terminate a minimum of 6-inch above the ground.

**Note:** The 7816 water temperature was observed to be over 140 degrees Fahrenheit when running the hot water. This high temperature could cause scalding/burning of the skin. It is recommended to adjust the temperature on the water heater to a lower setting. The general recommended setting for water heaters is between 120-130 degrees Fahrenheit.

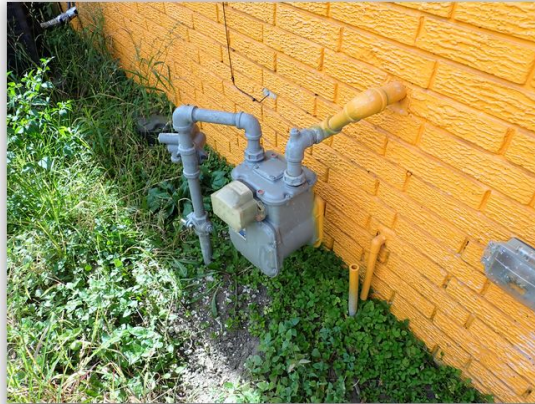
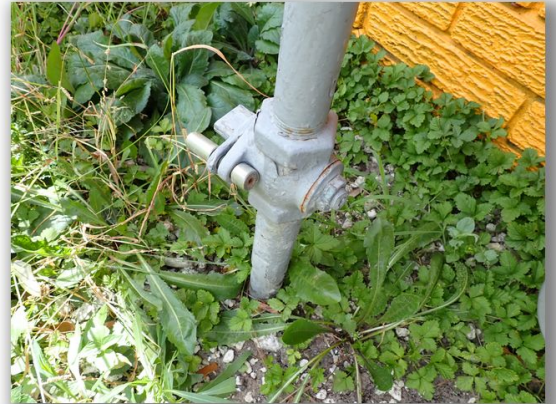
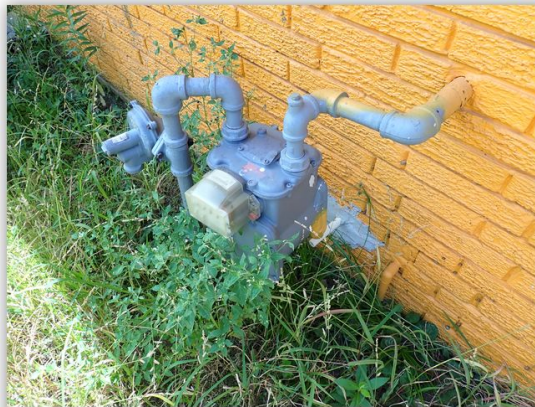
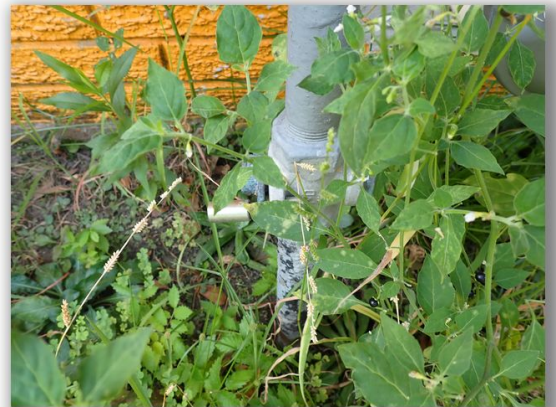
**Note:** There is no gas service to the property. There are gas meters present, but all gas appliances have been converted to electric appliances.

**Note:** The gas service was turned off to the structure at the time of this inspection. I was unable to check the gas operation of any of the gas components at this time. A limited visual survey will be performed and if any deficiencies are found they will be listed within this section.

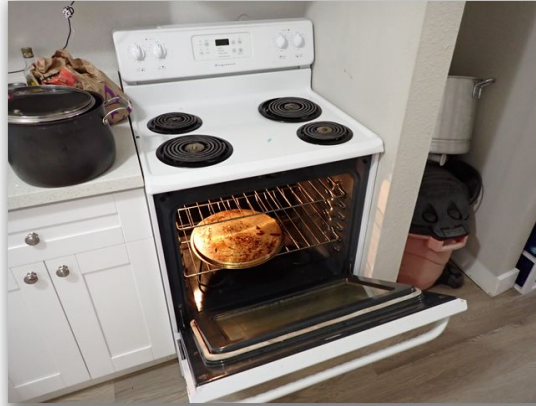
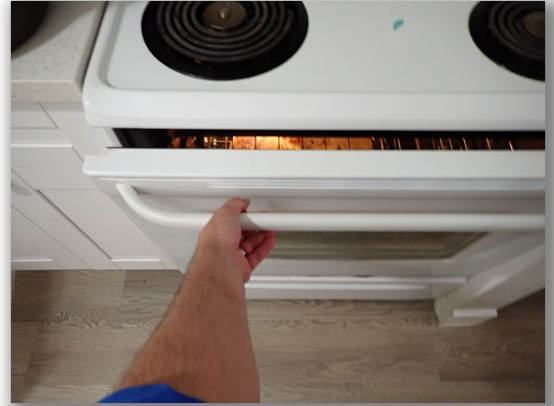
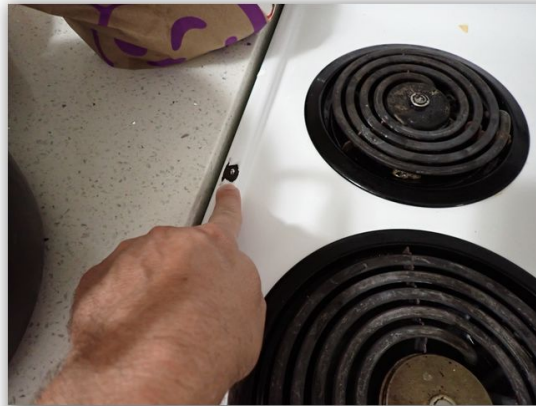
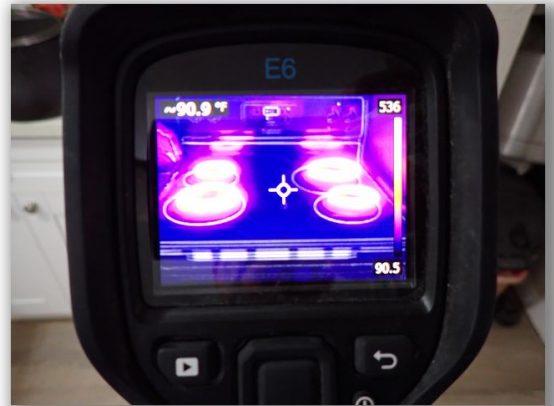
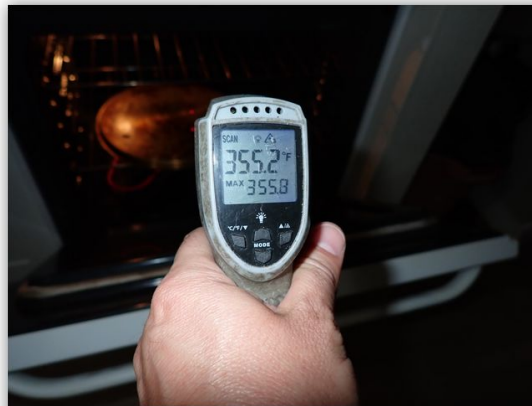
- The cooktop surface was observed to be damaged.
- The oven door hits the wall when opened.
- The range can be easily tipped over and should be equipped with an anti-tip device, for safety.

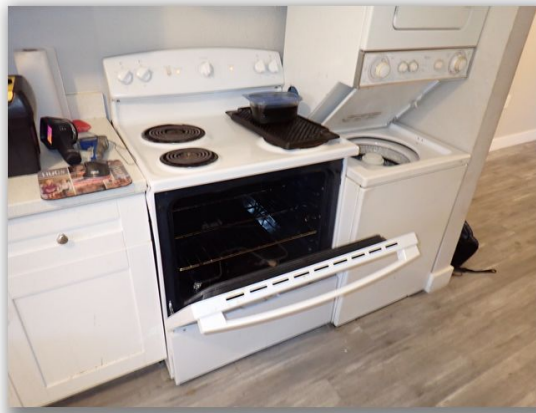
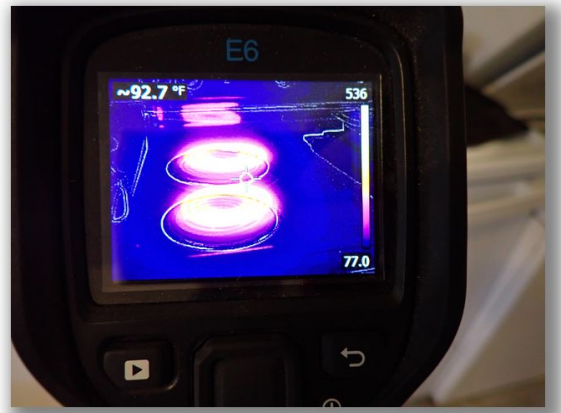
**7818 Kitchen Range**

- The range can be easily tipped over and should be equipped with an anti-tip device, for safety.

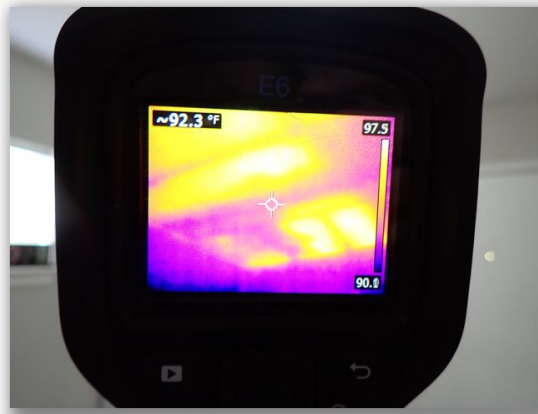
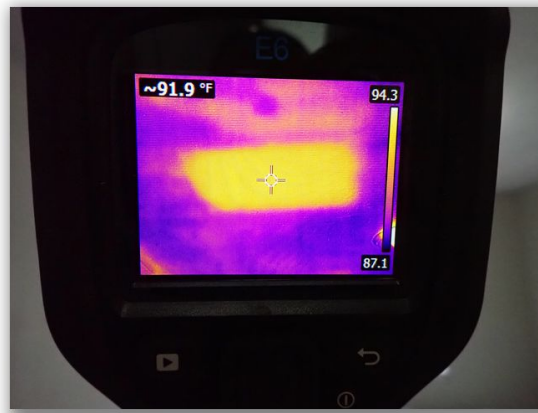
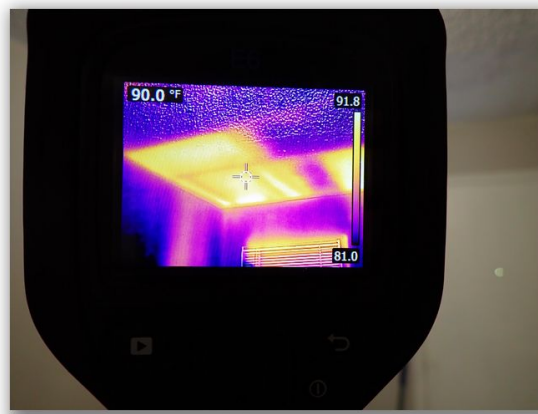
- Missing insulation was observed at the ceiling in several locations throughout the house.

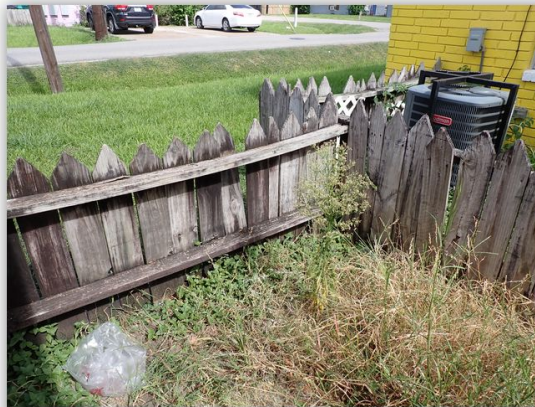
**B. Fences**

- One or more of the fence boards are pulling loose.
- One or more of the fence boards are damaged / deteriorated and repairs are recommended.

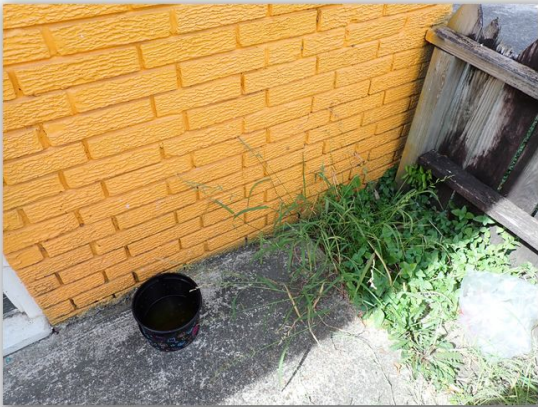
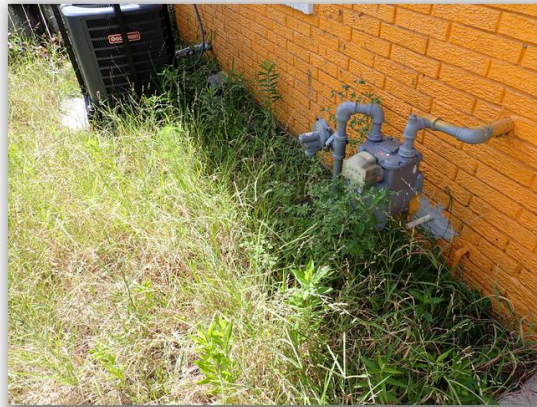
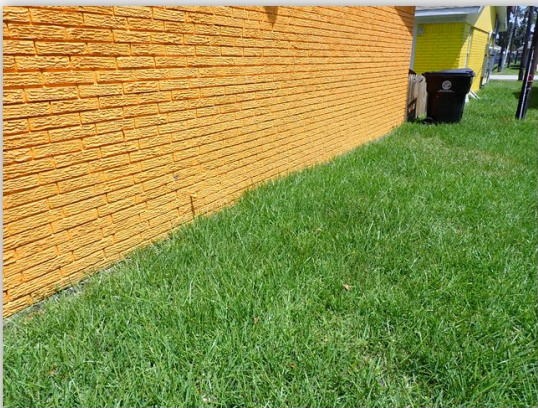
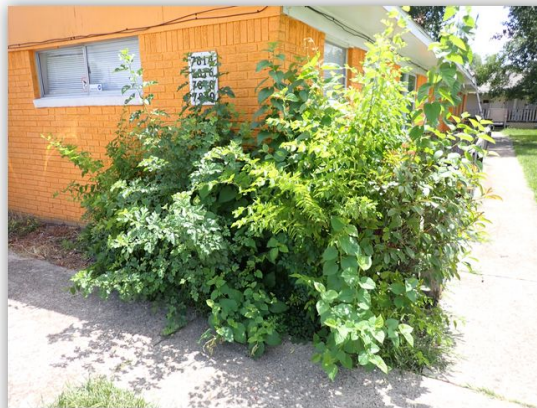
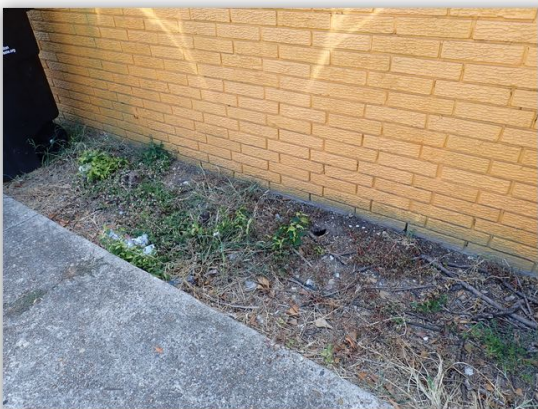
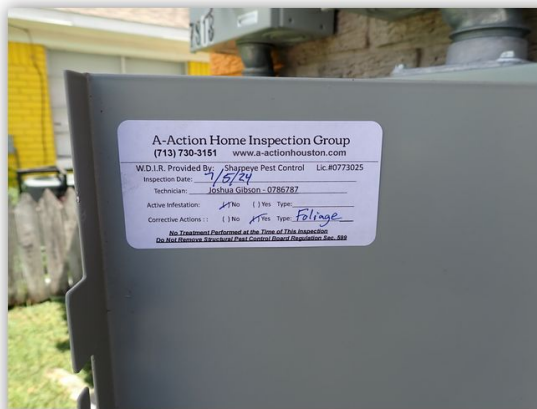
The digital pictures within this report are a representative sample of active/previous wood destroying insects, locations of active/previous infestations, inaccessible areas, conducive conditions, deficiencies or damages in place and should not be considered to show all. There will be active/previous wood destroying insects, locations of active/previous infestations, inaccessible areas, conducive conditions, deficiencies or damages not represented with digital imaging.

W.D.I.R. Provided By: Shupeye Pest Control Lic #0773025  
 Inspection Date: 7/6/24  
 Technician: Joshua Gibson - 0786787  
 Active Infestation: Yes (1) No ( ) Yes ( ) No ( )  
 Corrective Action: (1) No ( ) Yes ( ) No ( )  
 Type: Foliage
