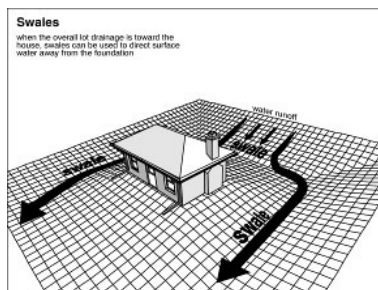
Perimeter Grading/Drainage: Appeared Adequate

The perimeter drainage around the property appeared to generally be adequate. It could not be determined with certainty if water would pool at any localized low areas around the property. Further investigation with the homeowner is recommended to determine if there are any drainage problems or water that ponds on the property after a rain.

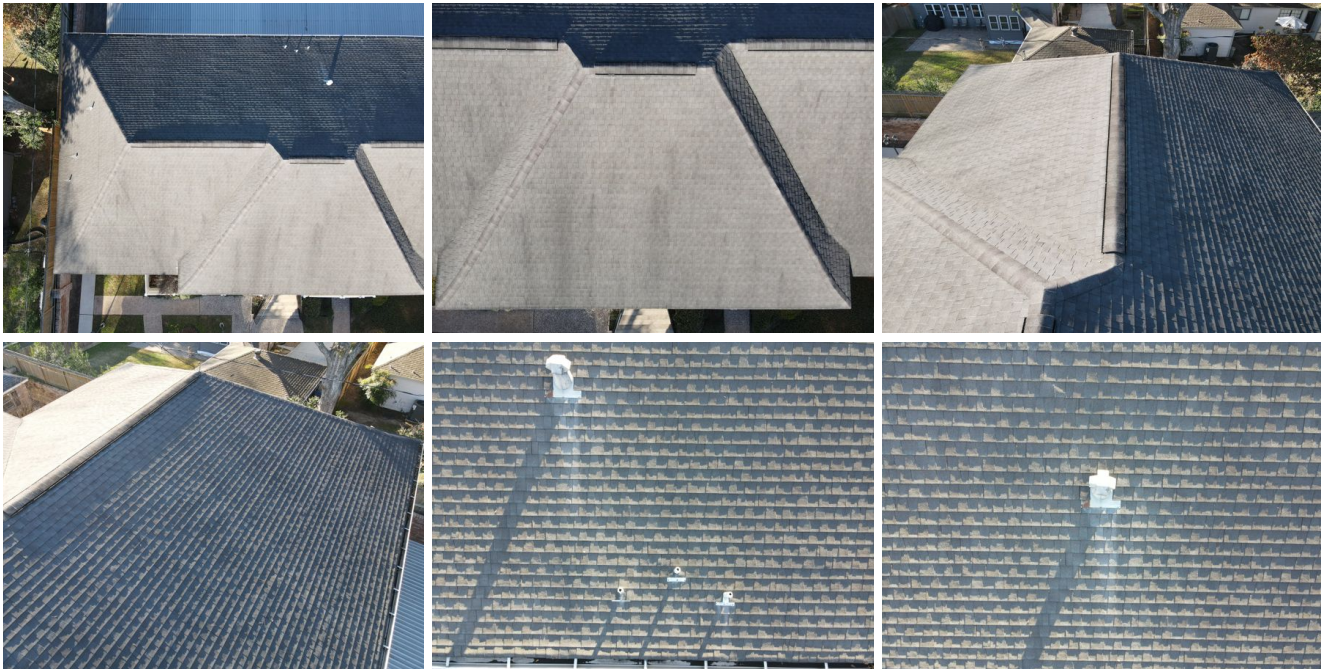
Roof Description: Composition Shingles

The pitched roof surface was constructed of composition shingles. The life expectancy of a composition shingle roof has been observed to vary from 15 to 20 years, with most requiring replacement at about 17-20 years.

Age of Roof-Estimated by Inspector: Age of Roof: 7-8 years

The seller's disclosure statement was not available at the time of the inspection, and the age of the roof was unknown to the inspector at the time of the inspection. The roof appeared to the inspector to be approximately 7-8 years old.

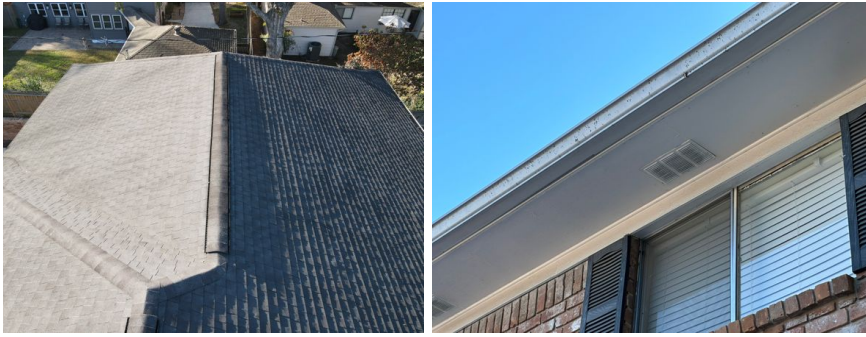
Roof Ventilation: Continuous ridge vents/Soffit screens

The ventilation for the attic included continuous ridge vents at the top of the roof and screens in the soffits.

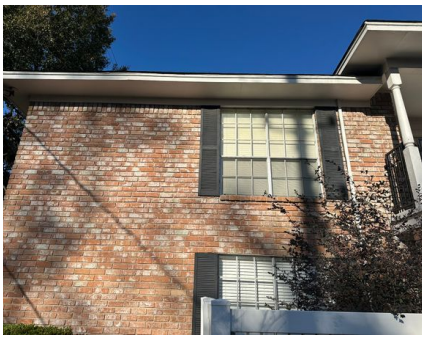
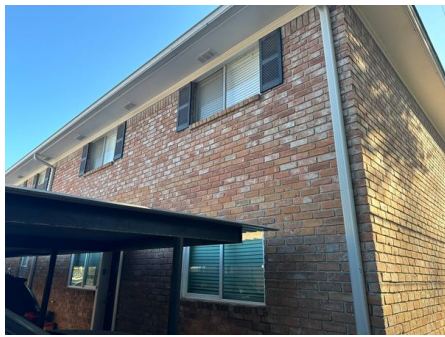
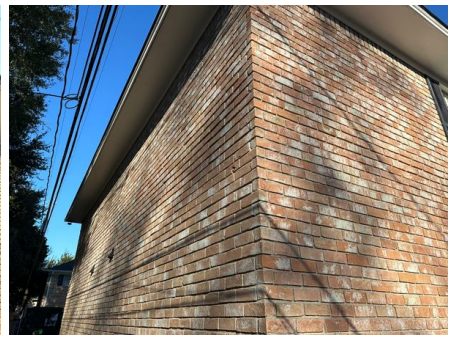
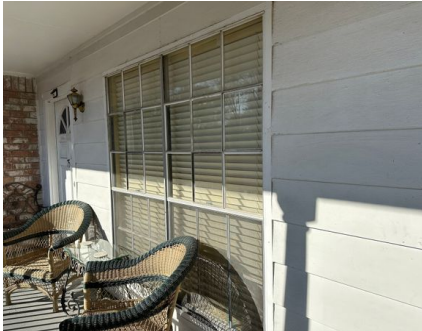
Cladding Material: Cladding Material

Brick Veneer, Wood
