HOUSTON INSPECTIONS

September 1, 2021

PROPERTY INSPECTION REPORT

Concerning: 3001 Murworth Dr, Houston, TX 77025
(Address or Other Identification of Inspected Property)

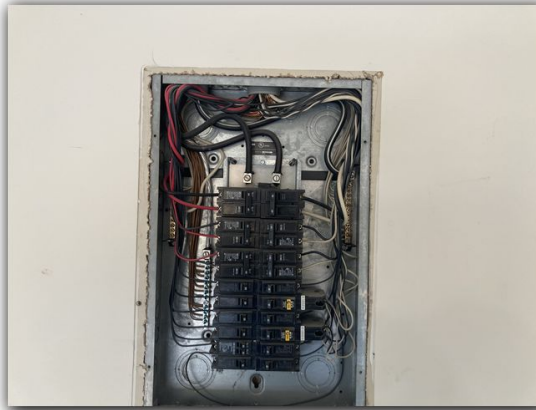
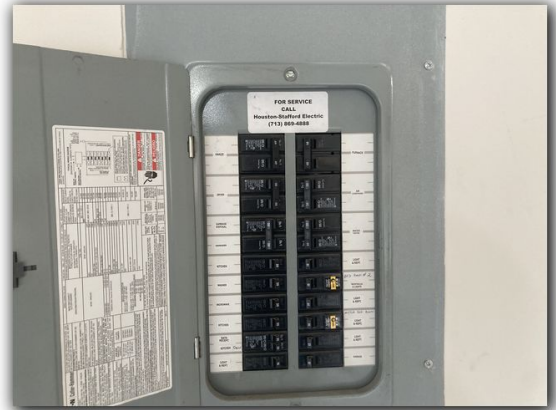
Location of Main Electrical Panel: Garage

Service Conductors Size: Unable to Identify

Type of Visible Grounding / Bonding: Ground Rod Connection Not Visible

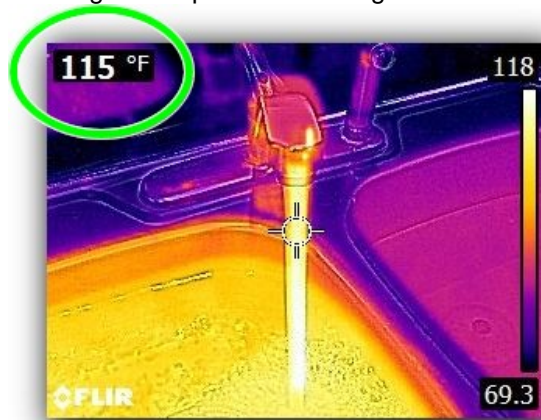
The hot water heater was functional at the time of inspection. The unit should be drained and flushed periodically to eliminate chemical deposit buildup. Adjust temperature to a maximum of 120 degrees to prevent scalding.

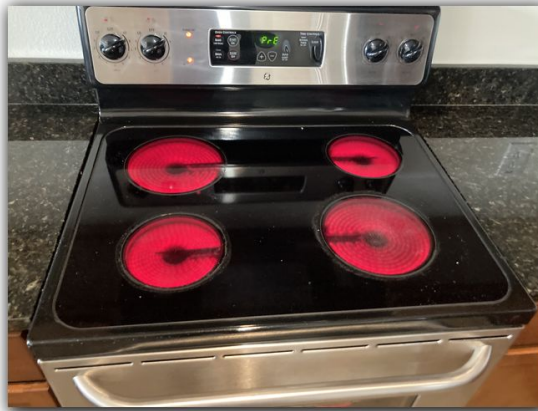
- D. Ranges, Cooktops, and Ovens
Comments:
Type of Range: Electric

Type of Oven: Electric

Oven Temperature Measured When Set at 350 Degrees F = 340

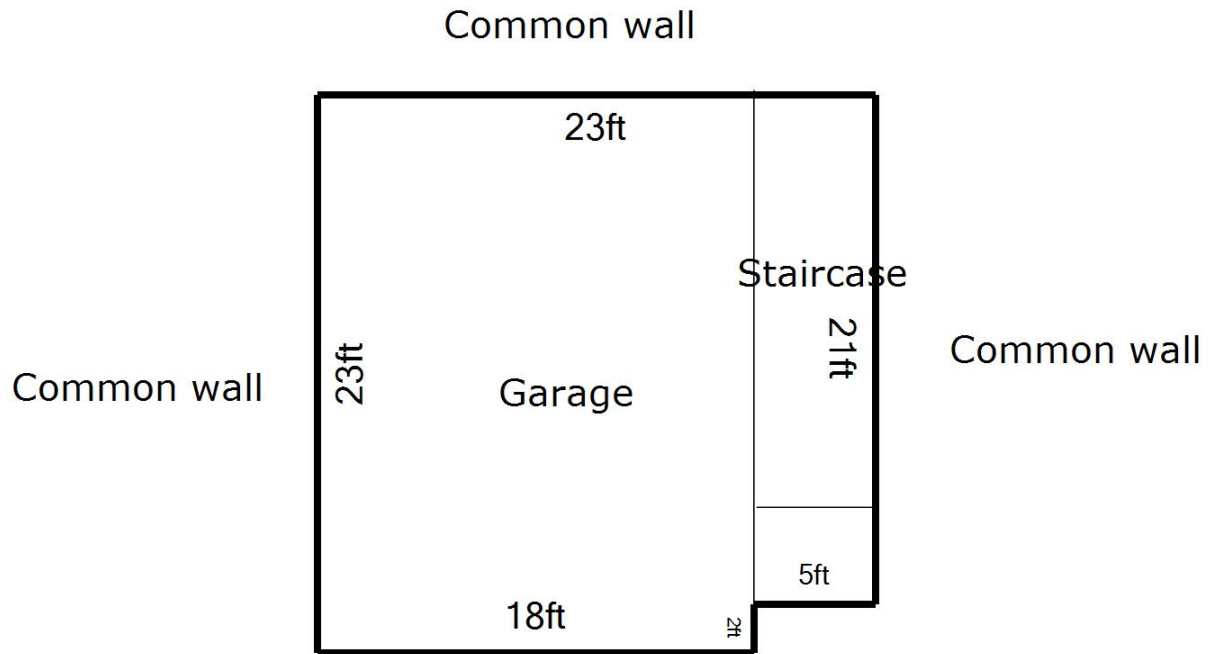
Diagram of Structure(s) Inspected

Additional Comments Notice to Client(s): There is always a possibility of the presence of undetectable activity of wood destroying insects. If evidence of active or previous infestation(s) of listed wood destroying insects is reported, it should be assumed that some degree of damage is present, wether visible or non-visible.
