Lone Star Stucco, LLC

Moisture Assessment Report

4102 Roseland Street

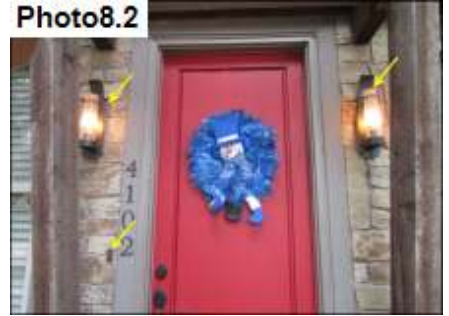
Photo8.2

- The penetration sealants are aged or missing in these locations. The inspector suggests to have a qualified waterproofing contractor seal these areas with a low modulus sealant in an effort to prevent moisture intrusion. These types of sealants are of high quality and compatible with stucco and other termination points. Please refer to photos #8.2, #8.3, #8.4, #8.5 and #8.6 for more detail.

Penetration Sealants / Seal

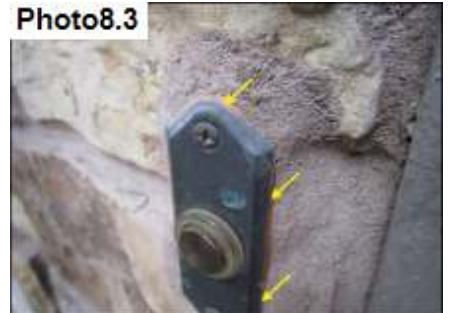
Photo8.3

Penetration Sealants / Seal

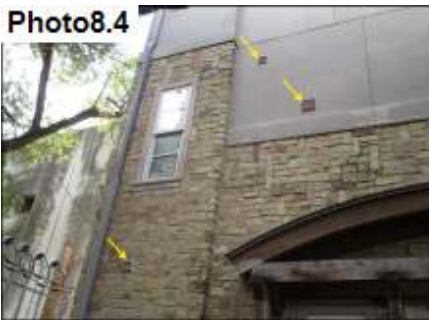
Photo8.4

Penetration Sealants / Seal

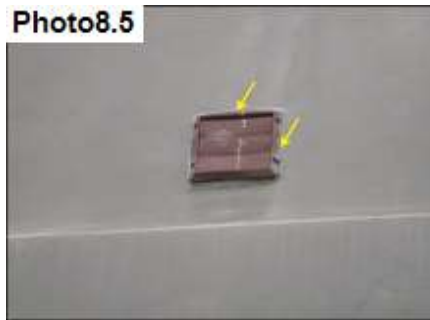
Photo8.5

Penetration Sealants / Seal

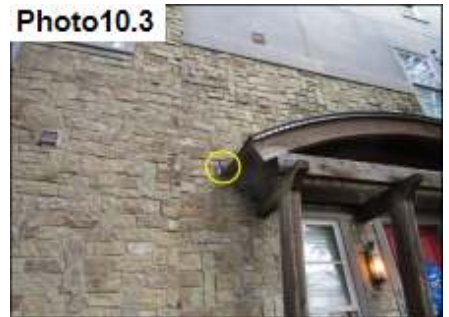
Kickout Flashing / Seal

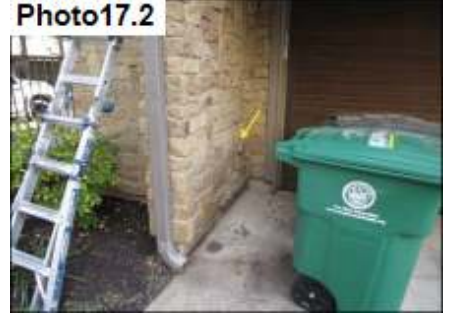
Photo17.2

Penetration Sealants / Seal

Grid Location	Item Description	Moisture Readings	Substrate Condition	Observations
Yellow Arrows	Penetrations			The penetration sealants are aged, separated or missing in these locations. The inspector suggests to have a qualified waterproofing contractor seal these areas with a low modulus sealant in an effort to prevent moisture intrusion. These types of sealants are of high quality and compatible with stucco and other termination points. Please refer to photos #17.2, #17.3, #17.4 and #17.5 for more detail.

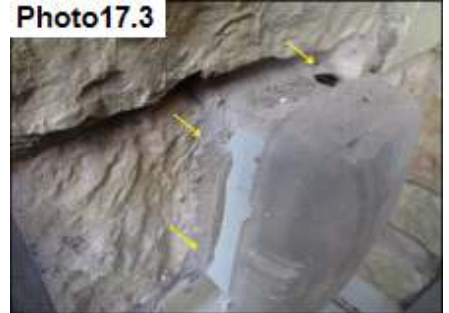
Photo17.3

Penetration Sealants / Seal

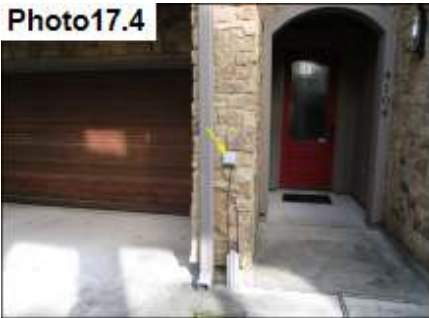
Photo17.4

Penetration Sealants / Seal

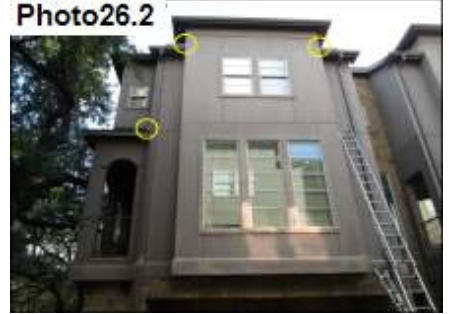
Photo26.2

Kickout Flashing / Seal

Grid Location	Item Description	Moisture Readings	Substrate Condition	Observations
Yellow Circles	Kickout			The kickout flashing sealants are aged or separated at these locations. The inspector suggests to have a qualified waterproofing contractor further assess and seal these areas with a low modulus sealant in an effort to prevent moisture intrusion. These types of sealants are of high quality and compatible with stucco and other termination points. Please refer to photos #26.2, #26.3 #26.4, #26.5 and #26.6 for more detail.

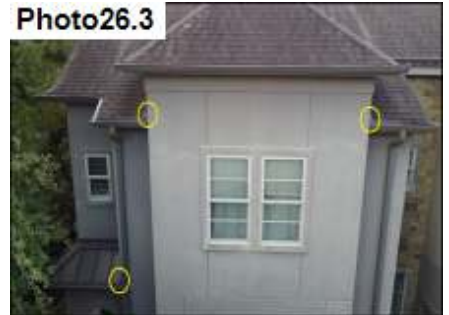
Photo26.3

Kickout Flashing / Seal

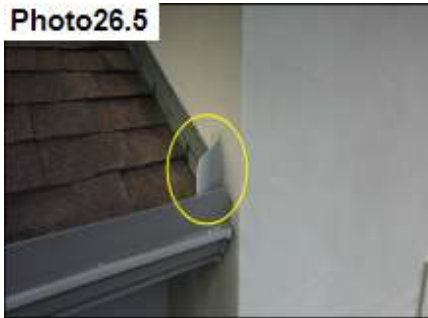
Photo26.5

Kickout Flashing / Seal

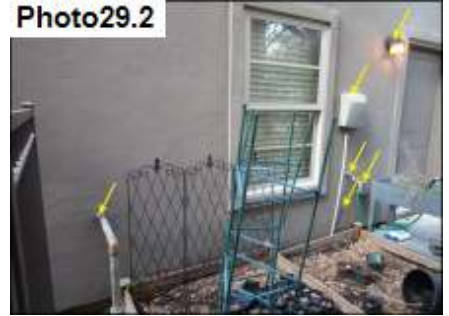
Photo29.2

Penetration Sealants / Seal

Grid Location	Item Description	Moisture Readings	Substrate Condition	Observations
Yellow Arrows	Penetrations			The penetration sealants are aged, separated or missing in these locations. The inspector suggests to have a qualified waterproofing contractor seal these areas with a low modulus sealant in an effort to prevent moisture intrusion. These types of sealants are of high quality and compatible with stucco and other termination points. Please refer to photos #29.2, #29.3, #29.4, #29.5 and #29.6 for more detail.

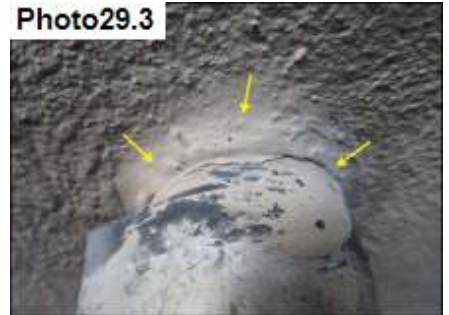
Photo29.3

Penetration Sealants / Seal

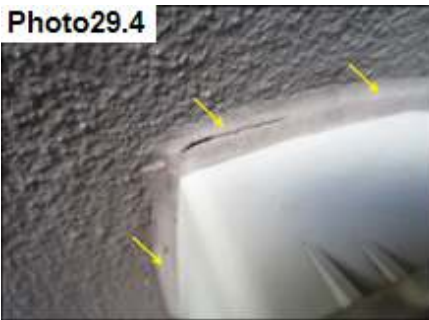
Photo29.4

Penetration Sealants / Seal

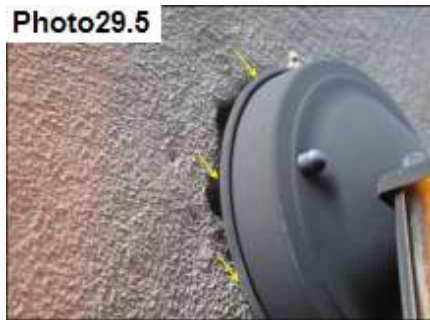
Photo29.5

Penetration Sealants / Seal

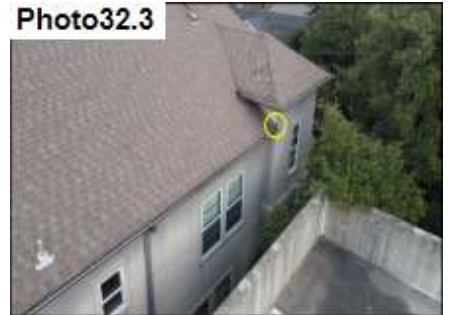
Photo32.3

- The kickout flashing sealants are aged or separated at this location. The inspector suggests to have a qualified waterproofing contractor further assess and seal this area with a low modulus sealant in an effort to prevent moisture intrusion. These types of sealants are of high quality and compatible with stucco and other termination points. Please refer to photos #32.2, #32.3, #32.4 and #32.5 for more detail.

Kickout Flashing / Seal

Grid Location	Item Description	Moisture Readings	Substrate Condition	Observations
Yellow Circle	Kickout			The kickout flashing sealants are aged or separated at this location. The inspector suggests to have a qualified waterproofing contractor further assess and seal this area with a low modulus sealant in an effort to prevent moisture intrusion. These types of sealants are of high quality and compatible with stucco and other termination points. Please refer to photos #32.2, #32.3, #32.4 and #32.5 for more detail.

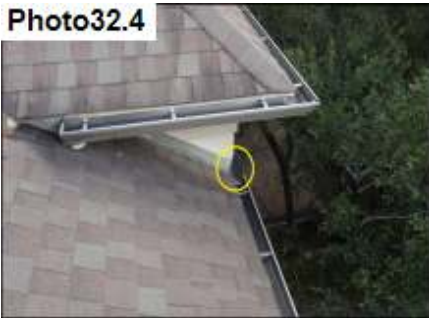
Photo32.4

Kickout Flashing / Seal
