Property Inspection Report

**Stan and Sandee Davis
1003 Sable Drive
Friendswood, TX 77546
Sablewood
Galveston County**

Wednesday, September 6, 2023

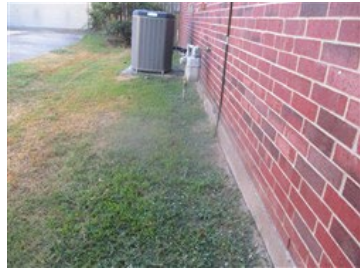
The soil levels were high against isolated areas of the foundation grade beam. When soil levels and vegetation are high against the face of the foundation it promotes water penetration, wood rot and insect infestation. Brick veneer wall cladding should have about 4" of clearance between the soil and the first course of bricks, and other materials should have 6" of clearance between other materials and the soil.

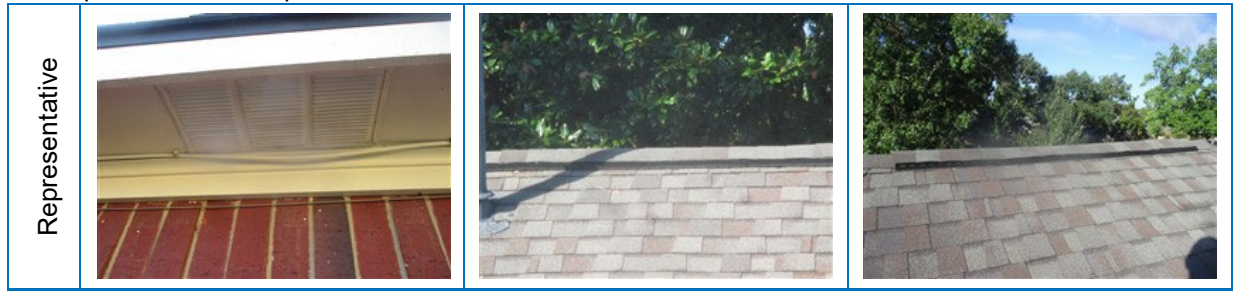
Garage attic space did not appear to be adequately ventilated. There was a ridge vent, but there were not soffit vents.

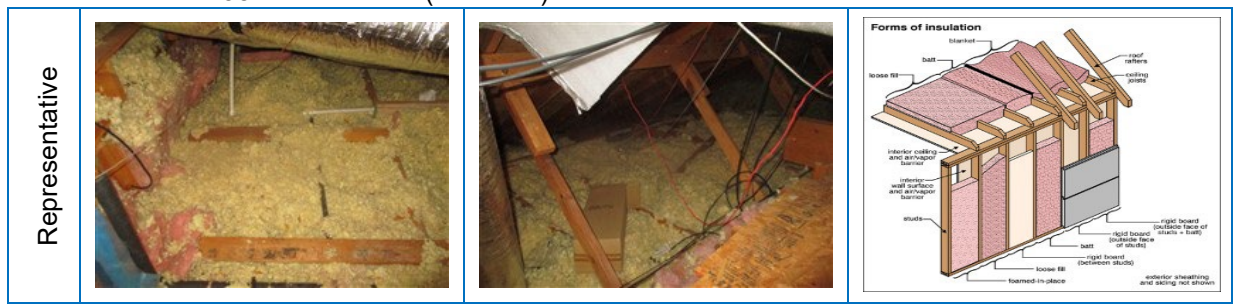
Safety: Stairway was insulated with batt insulation, creating a trip hazard. Recommend that only rigid insulation be used for personal safety.

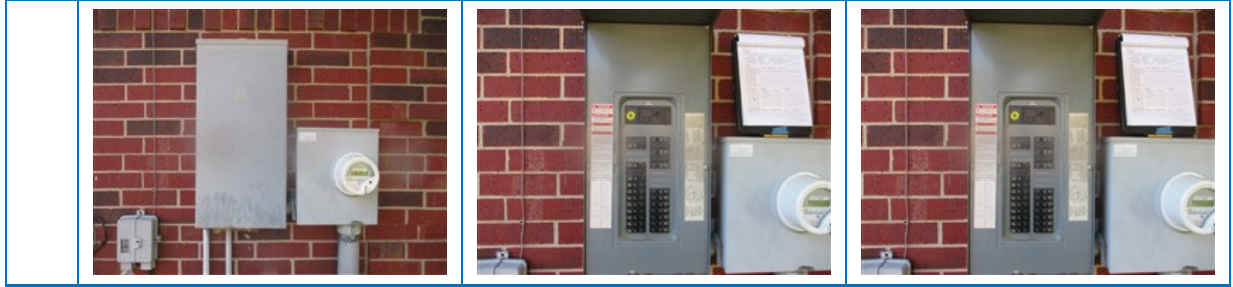
Overcurrent devices were not all accurately or adequately identified as to **use, purpose, and location** (Lights and Receptacles, or variations thereof, are not specific enough). I may not be able to comply with the minimum inspection standards of practice requiring evaluation of breaker sizes against manufacturer specifications. [NEC - Circuit Directory or Circuit Identification. "Every circuit and circuit modification shall be legibly identified as to its clear, evident and specific purpose or use. The identification shall include sufficient detail to allow each circuit to be distinguished from all others. Determining the accuracy of device labeling is outside the scope of this inspection.

Amperage rating of the overcurrent protection device (aka circuit breaker) protecting the HVAC condenser was greater than that specified by the manufacturer of this appliance. The actual breaker size was 60 amps but should be 30 amps per the manufacturer's specifications (**Breaker type:** Heating, Air Conditioning Refrigeration "HACR"). The ampacity of the conductors supplying multi-motor and combination load equipment shall not be less than the minimum circuit ampacity, or more than the maximum breaker ampacity marked on the equipment. The branch-circuit overcurrent protection device rating shall be the size and type marked on the appliance. §535.229 (a)(1)(g)(iv)

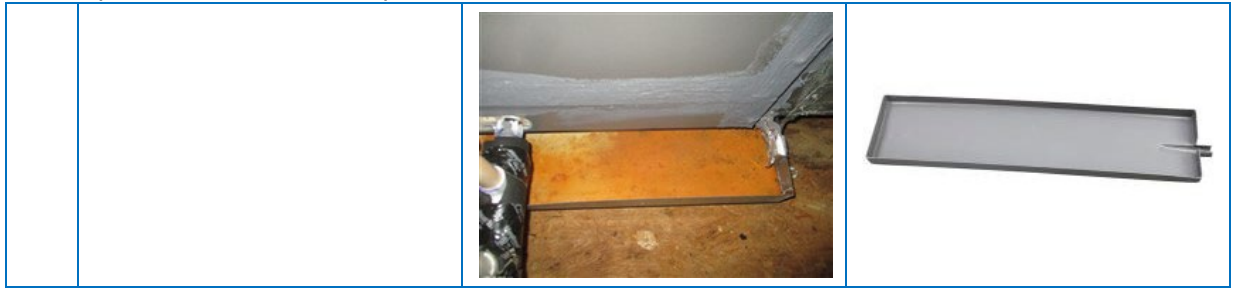
Information: Scaling and corrosion in the secondary drain pan beneath the evaporator in the attic space was indicative of condensate bypassing the primary drain system. While there was no standing water in the pan at the time of this inspection, the common recommendation is that the system be monitored and that the primary drain be cleaned periodically. I could not positively determine whether the pan had been compromised and my test was limited to visual examination. I cannot warrant that the pan will not fail at some point in time.

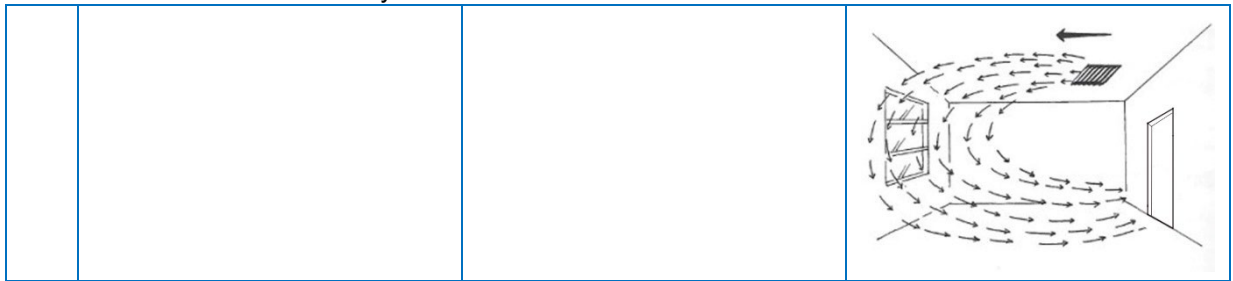
Supply registers in one or more rooms were installed backwards and should be turned to face the outside walls (casual dining room). Supply register placement along an interior wall with supply throw toward the outside walls is the proper orientation in a cooling climate such as Texas. Manual T (Air Distribution Basics) from ACCA supports this air pattern. Air conditioning supply registers are intended to wash the outside walls; that is, to direct air against the outside walls and windows and to return that warm air to the system for removal of that heat.

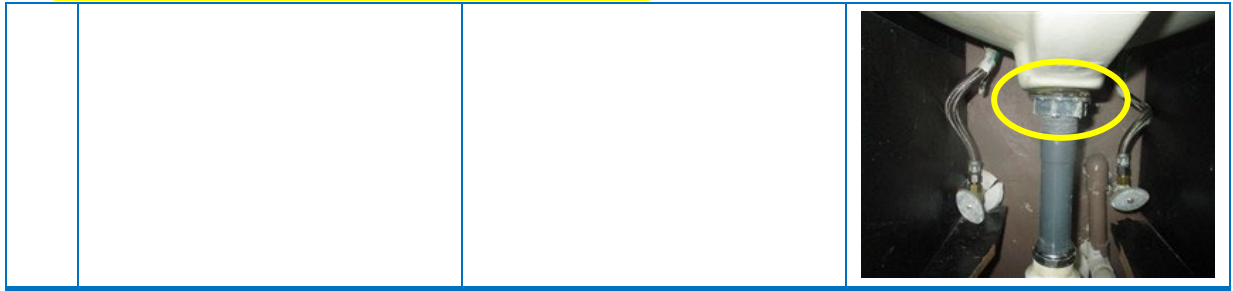
Hall bathroom sink leaked at connection the basin.

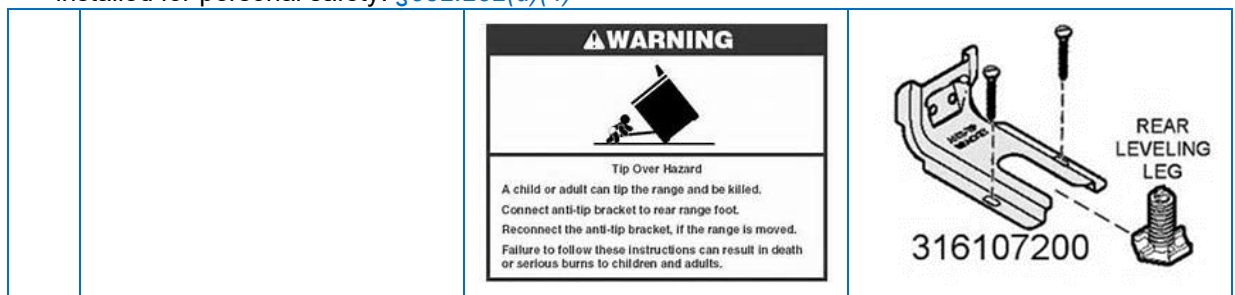
There was no anti-tip device installed on the range. Anti-tip devices are intended to protect persons, typically children, who use the door as a step from personal injury. An anti-tip bracket should be installed for personal safety. [§532.232\(d\)\(4\)](#)

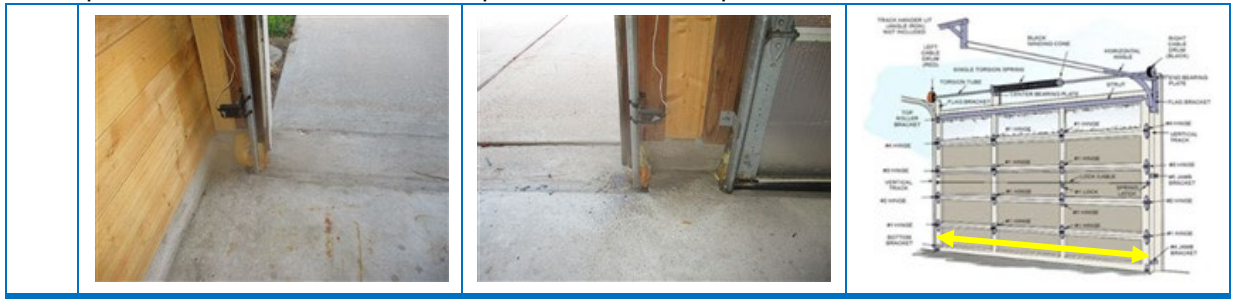
The door lock, or locks, was not disabled on overhead doors with operators present. Locks, on garage doors controlled by a garage door opener, should be disabled or removed. Attempting to open a locked door may result in damage to the door, or the unit may be pulled from its mounting causing property damage or personal injury.

The sensors (electric eyes) were improperly installed on one, or more, overhead doors; they were more than 6" above ground level. These sensors, in conjunction with the auto-reverse feature, are protection against personal injury to small children and animals. These sensors should be set to a height of no more than 6" above ground level for personal safety. If the operator pre-dates the requirement for these sensors, the operator should be replaced.

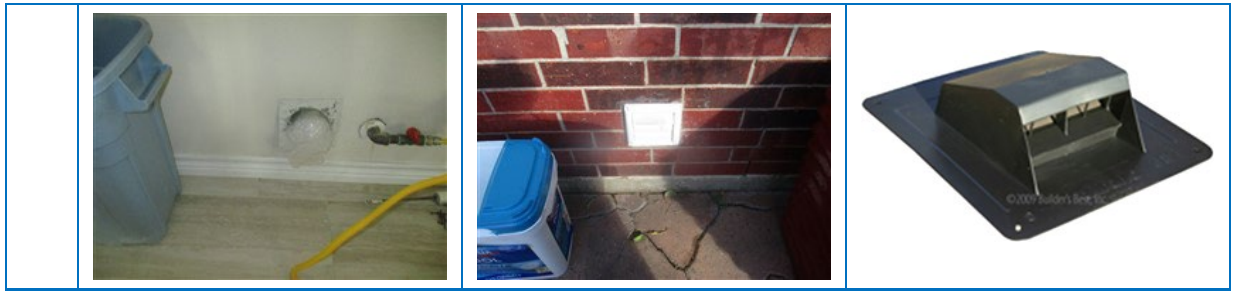
No adverse and material deficiencies requiring immediate repair.

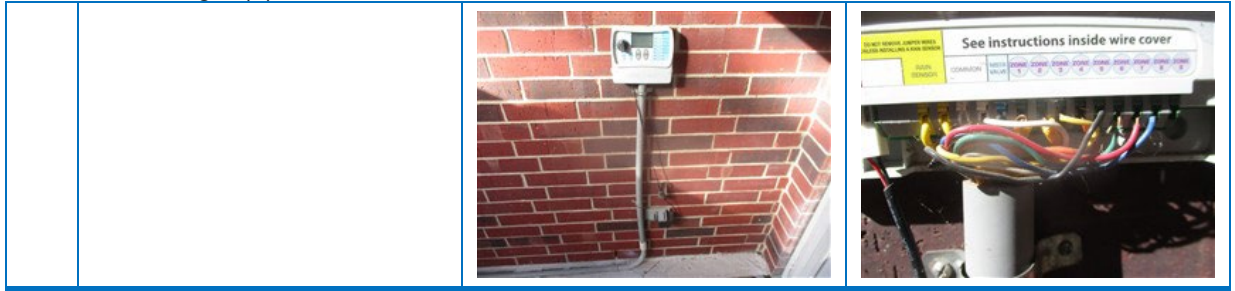
Zone 6, apparently located along the left side fence in the back yard, was not functional.

The Landscape Irrigation System did not have a rain or moisture sensor; a jumper was installed across the sensor terminals. §532.233(1)(B)(i)

No backflow protection was observed.

Maintenance: Recommend that sprinkler heads be monitored during operation to ensure that the water is not directed upon the structure.

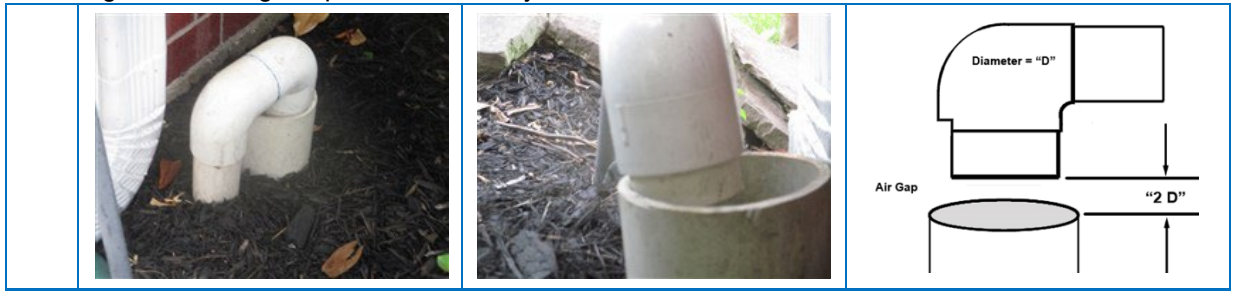
The pool's backwash drain did not have an air gap; the discharge pipe (the "candy cane" pipe) was set down into the drain line. There should be a space between the two pipes to prevent water from rising and entering the pool circulation system.
