Inspection Report

Property Address: 2623 Oakcliff Street Houston TX 77023

PROPERTY INSPECTION REPORT FORM

Chris Hale	7/26/2024	
Name of Client	Date of Inspection	
2623 Oakcliff Street, Houston, TX 77023		
Address of Inspected Property		
Pat McInturff	23279	
Name of Inspector	TREC License #	
Name of Sponsor (if applicable)	TREC License #

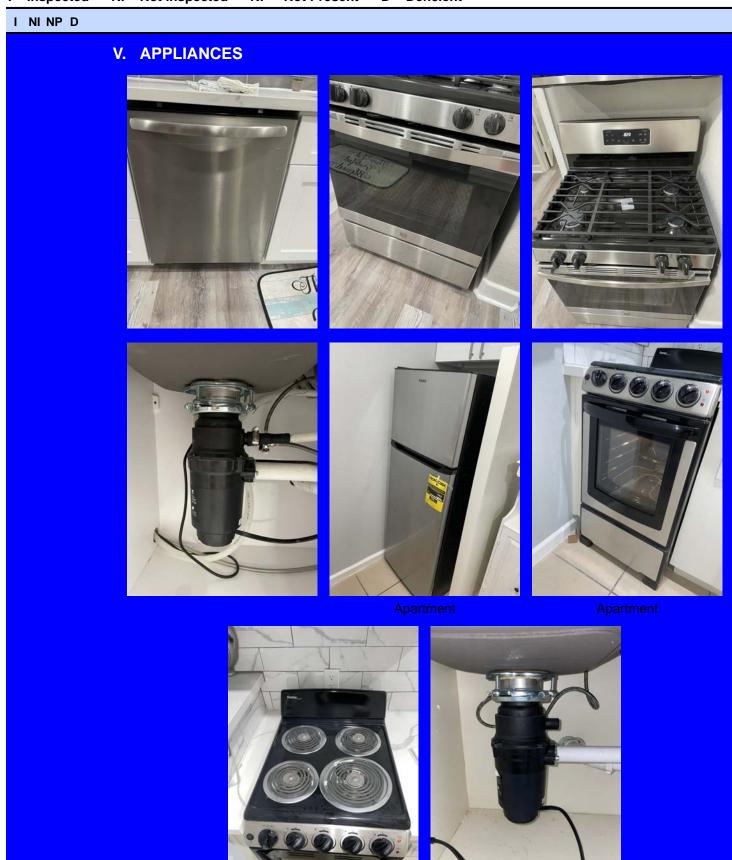
There was a slight odor of gas after I turned on the gas supply valve to the main house cooktop/oven. Not sure whether it was from the burners or not. /After testing I turned the valve back off.
