# Inspection Report

**Property Address:**  
2623 Oakcliff Street  
Houston TX 77023

# PROPERTY INSPECTION REPORT FORM

| Chris Hale | 7/26/2024 |

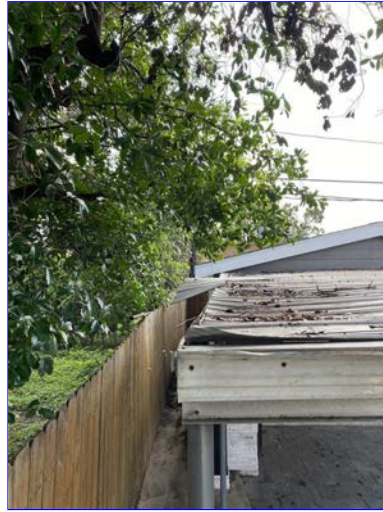
C. Item 2(Picture) Corrected

- (1) Tree limbs that are in contact with roof or hanging near roof should be trimmed back 3-5'. Areas damaged by limb contact should be repaired. There were damaged areas observed. A roofer should evaluate areas beneath tree limbs for need of repair. (photos are for representation only, and may not depict all areas observed)

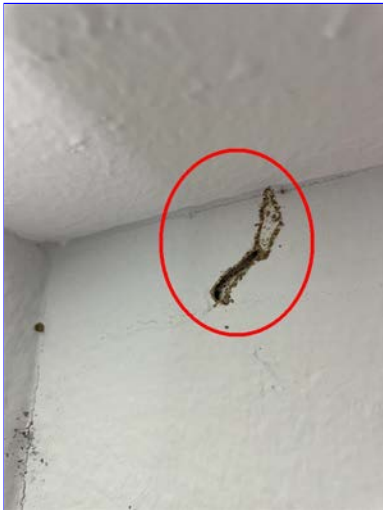
E. Item 24(Picture)

● (7) Possible termite activity in apartment.

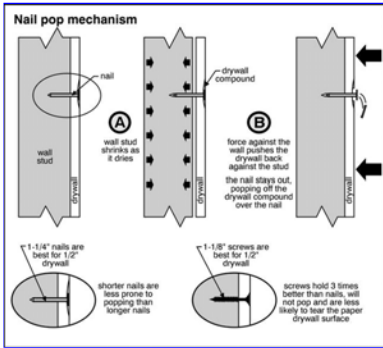
F. Item 1(Picture)

● (2) Nail pops observed in sheetrock. This is common and usually due to settling of structure. Reset nails and seal/paint.

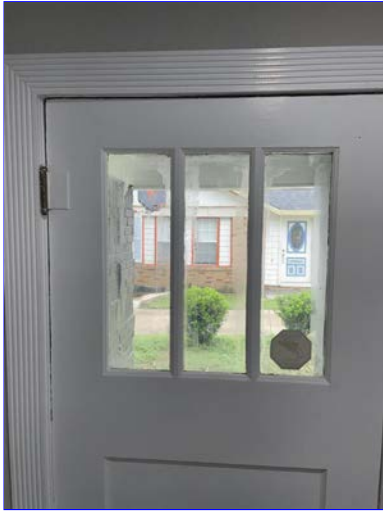
G. Item 6(Picture)

● (2) Doors in various areas are missing working door-stops. This is a maintenance issue and is for your information. A qualified person should repair or replace as needed.

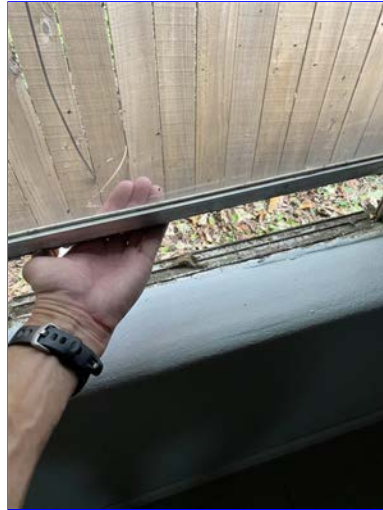
● (2) Window sash springs need adjustment or repair to allow windows to remain completely open, most notably in the apartment bedroom.

H. Item 4(Picture) Not corrected

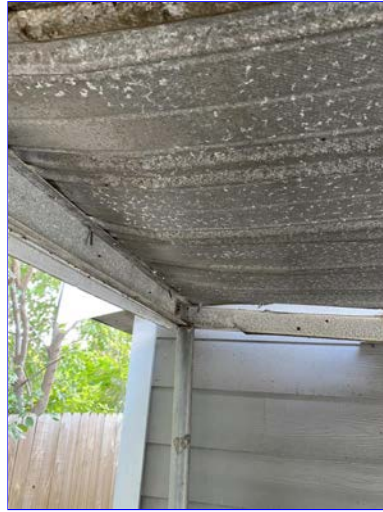
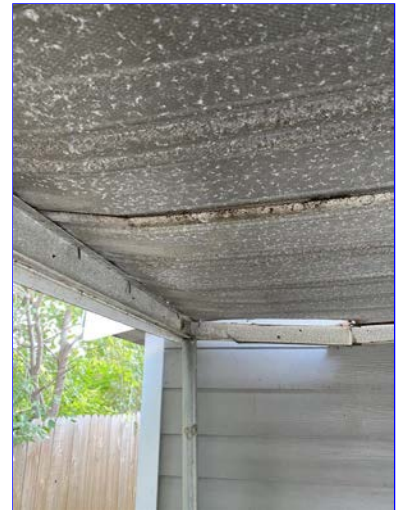
Carport roof has sags where water pools and won't drain. Tin has rusted and is leaking. Recommend repair to plug leak and add support to eliminate the water ponding.

K. Item 2(Picture) Sag not corrected

K. Item 6(Picture) Sag not corrected

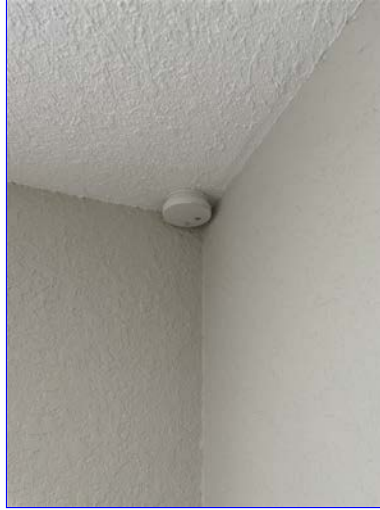
B. Item 2(Picture)

(1) Smoke alarms were functional. Recommend moving smoke detectors to the ceiling just inside the entry door.

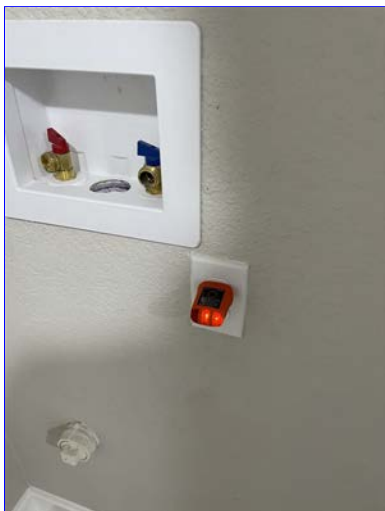
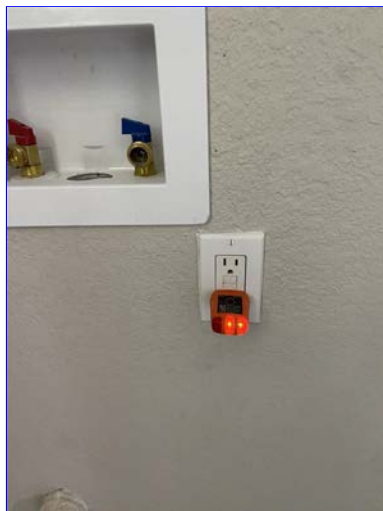
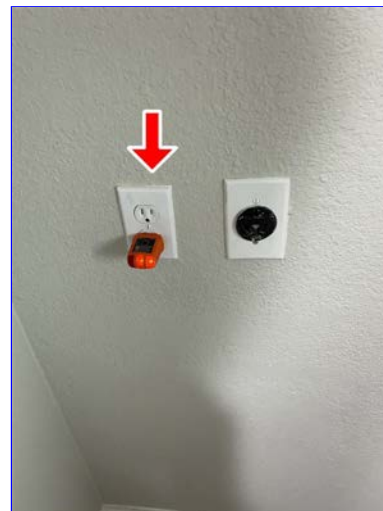
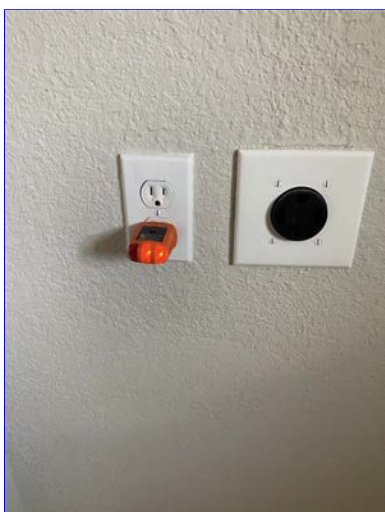
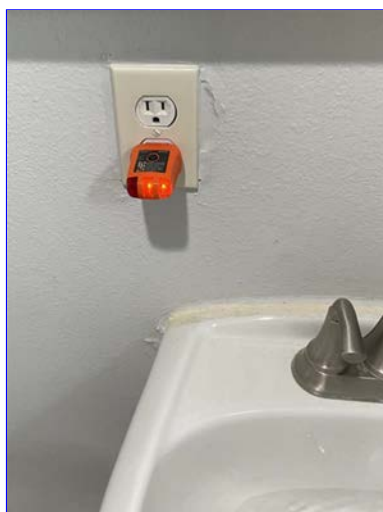
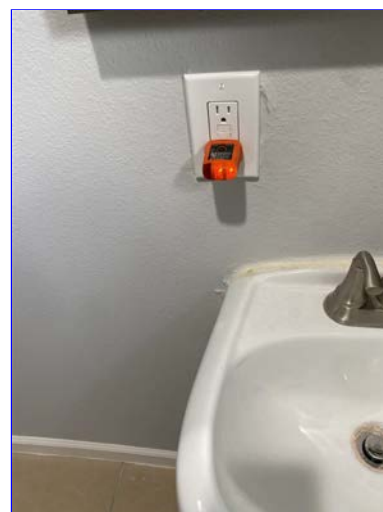
- (2) There are no GFCI (Ground Fault Circuit Interrupt) protected outlets in locations called for by today's standards (all kitchen, baths, non dedicated garage below 6', laundry, and exterior outlets)

B. Item 4(Picture) Corrected

B. Item 6(Picture) Corrected

B. Item 7(Picture) Apartment

B. Item 8(Picture) Corrected

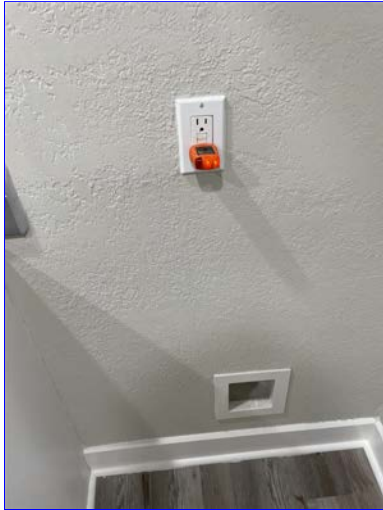
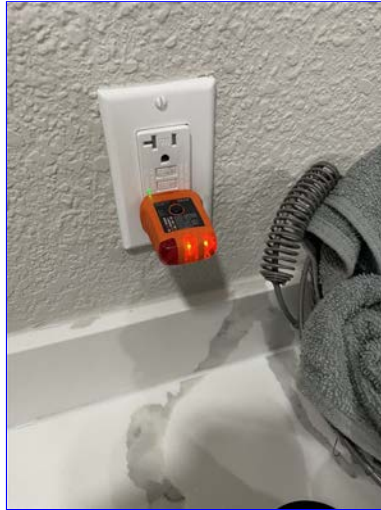
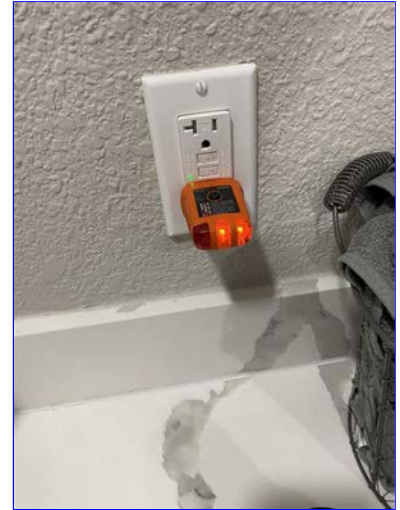
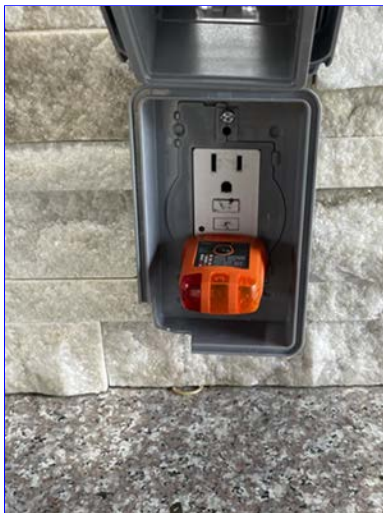
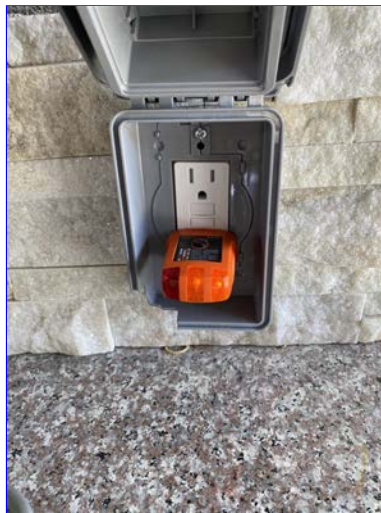
- (3) GFCI not functioning in Utility Rooms and apartment kitchen counter, will need to be corrected.

B. Item 10(Picture) Apartment

B. Item 11(Picture) Corrected

B. Item 12(Picture) Outdoor cooking area

B. Item 13(Picture) Corrected

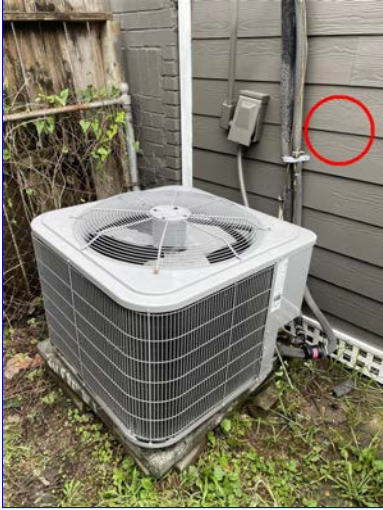
B. Item 14(Picture)

- (4) There is no electrical service outlet near HVAC unit, according to current standards.

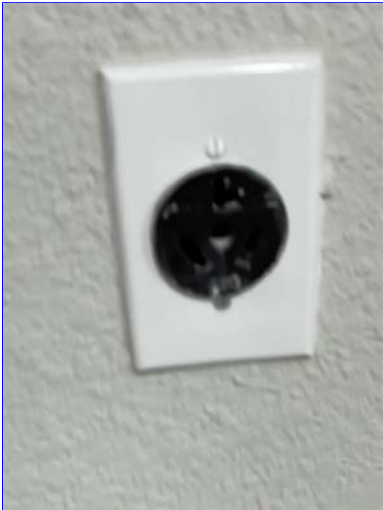
B. Item 15(Picture)

● (5) The utility 220 electric dryer outlet is a 3 prong type. Electric dryers today are now sold with a 4-prong plug. It may be necessary to swap out the 4-prong plug on newer units

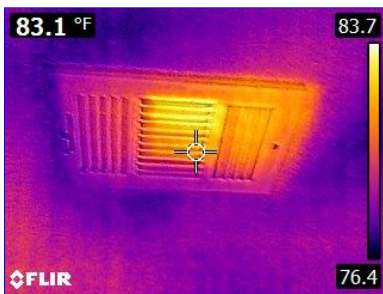
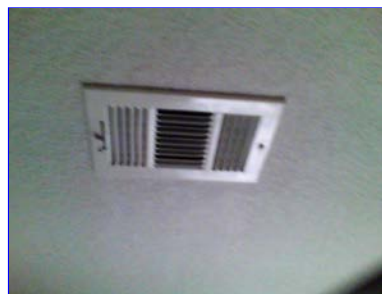
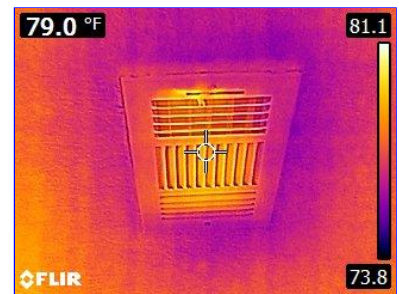
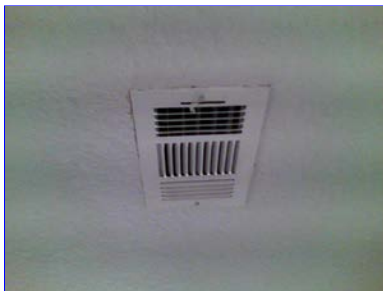
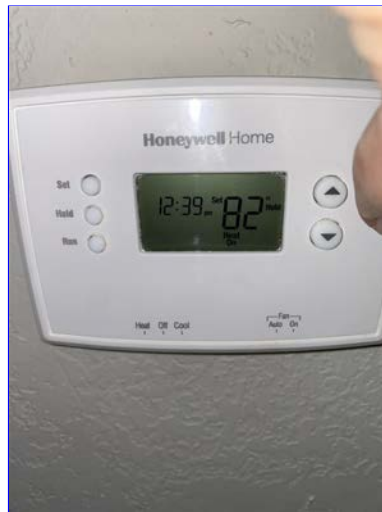
- (1) Unit did not seem to function properly at time of inspection. Could not hear the blower running while thermostat was set on heat at 80 degrees. Recommend checkup by a qualified HVAC specialist.

**Item not corrected**

A. Item 5(Picture) Not corrected

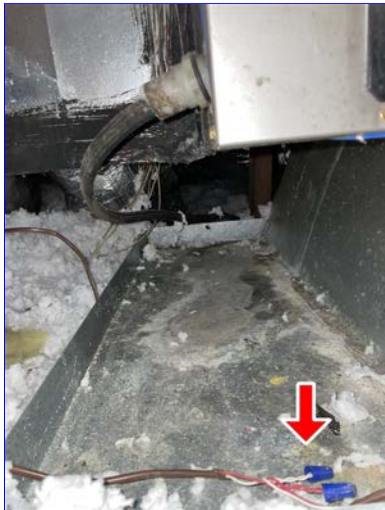
A. Item 6(Picture)

- (2) Low voltage cables should be secured at unit, or protected with grommet from metal cabinet.

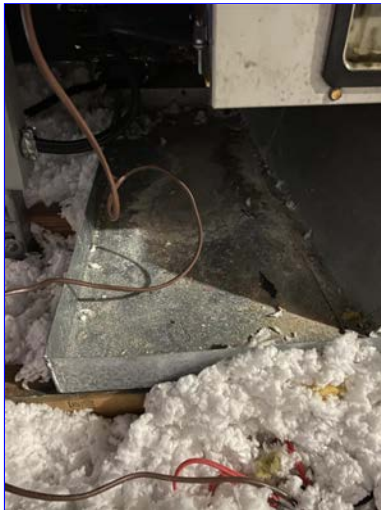
A. Item 7(Picture) Corrected

**●** (3) There was not a service disconnect observed on or around the unit. Unit inside breakers are not considers main service disconcert. Under current building standards, there should be a service disconnect within fifty feet (50 ft.) and within sight of the unit.

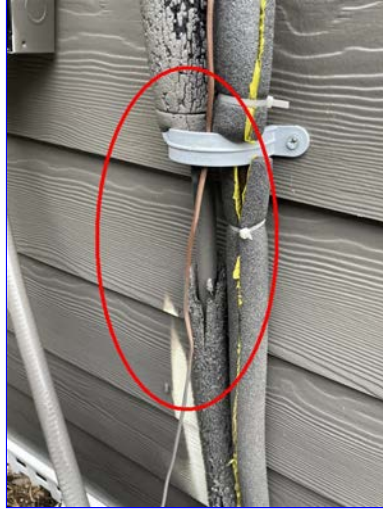
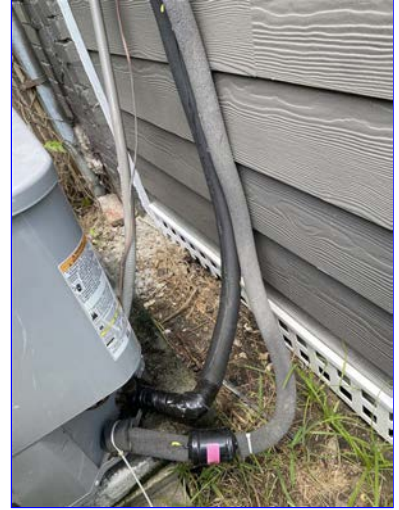
- (2) Repair/replace insulation on refrigerant lines between house and condenser.

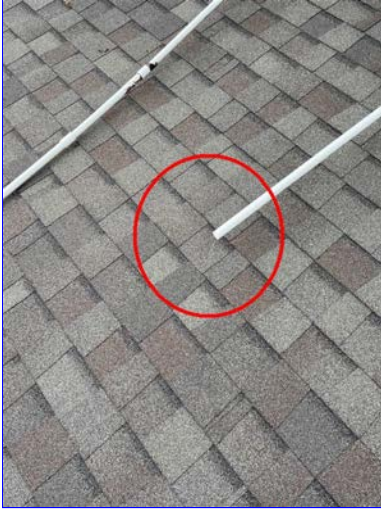
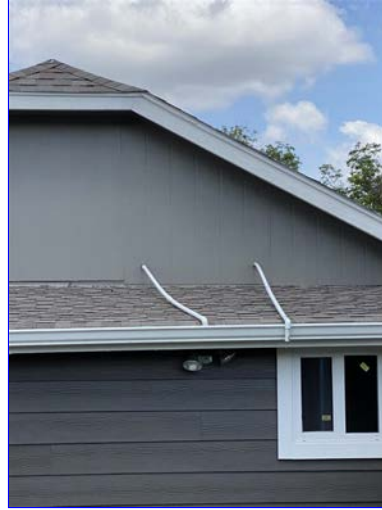
B. Item 11(Picture) Corrected

● (6) The cooling system exterior condensation drain line needs to be extended so that it terminates a minimum of 3' away from the foundation perimeter

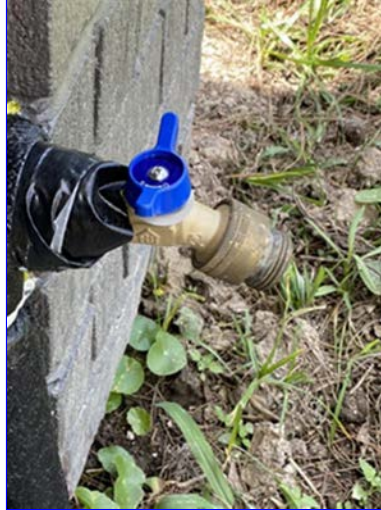
A. Item 2(Picture) Corrected

- (1) There is a leak at the hose bib turn valve. Recommend repair.

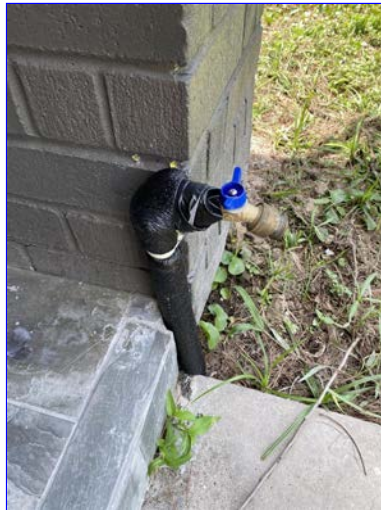
A. Item 4(Picture) Corrected

(2) Recommend installing a clamp around the water line to support the PVC riser from breakage.

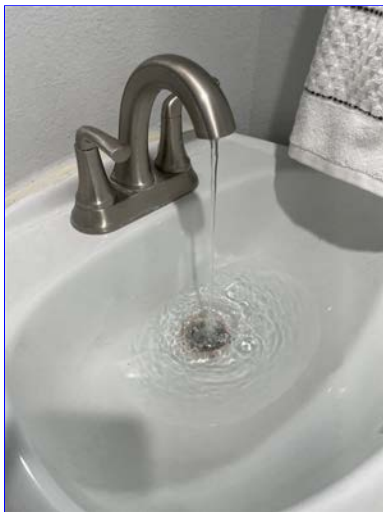
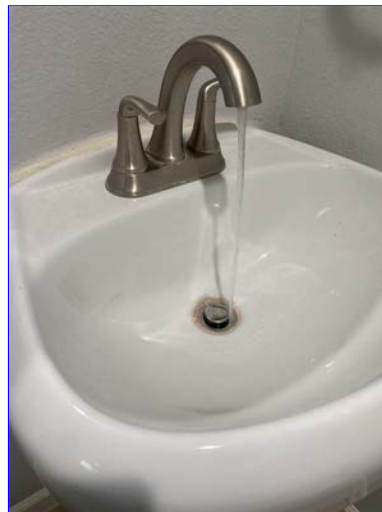
A. Item 9(Picture) No change

● (4) The hot water pressure did not pass a "functional flow" test. This low rate is without the shower running or toilet flushed. Shower pressure did drop to a non-acceptable level.

**No change**

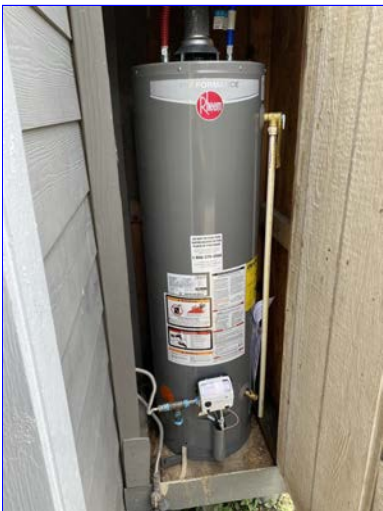
C. Item 1(Picture)

Unit did not deliver hot water at time of inspection.

**All items corrected, new unit was installed (could not get hot water in main house)**

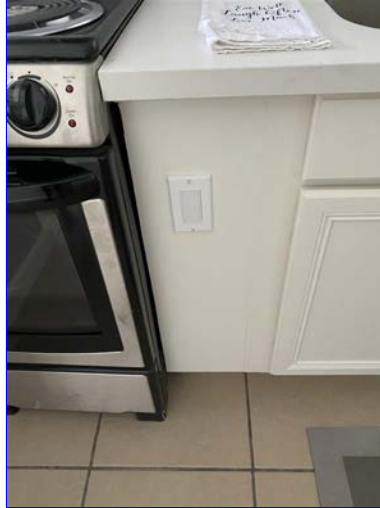
B. Item 2(Picture)

The food disposer power switch is too low, and does not prevent children from operating. I recommend repair as needed.
