Prepared for Emerson Property Management

5/30/2024

8202 Furray Road A

Items that Need Attention Summary

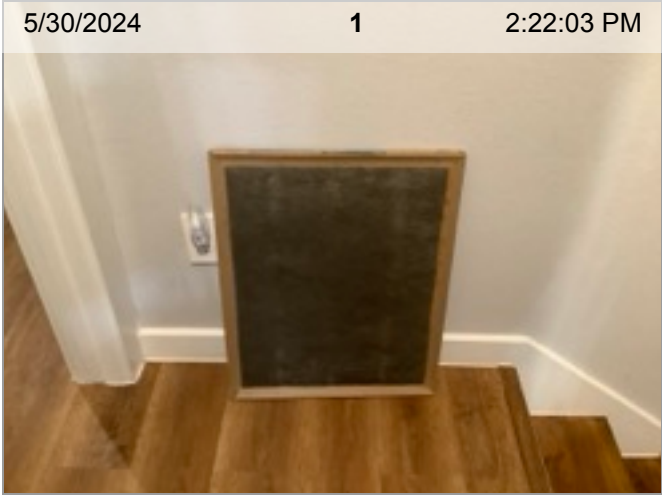
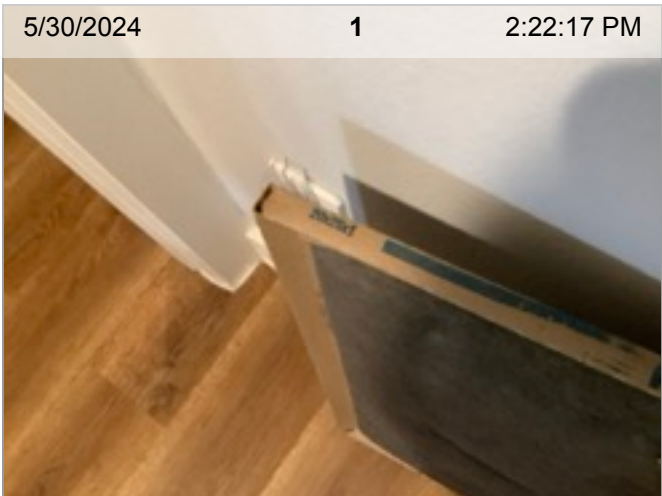
20 x 25 x 1 Air Filter Removed | Front

20 x 25 x 1 Air Filter Removed | Back

20 x 25 x 1 Air Filter Removed | Close-up of size/initials/date

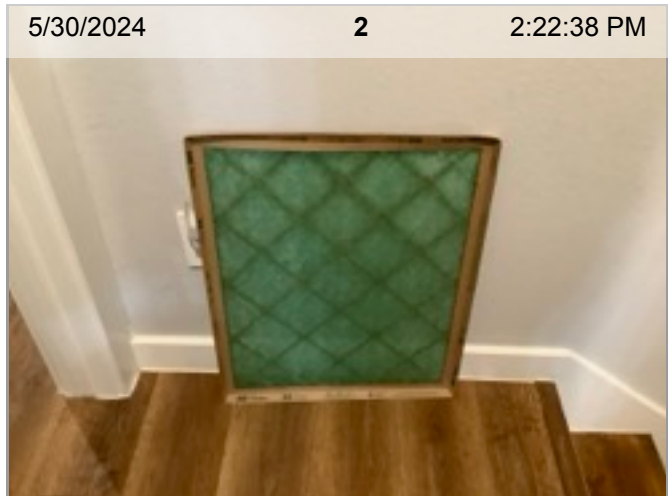
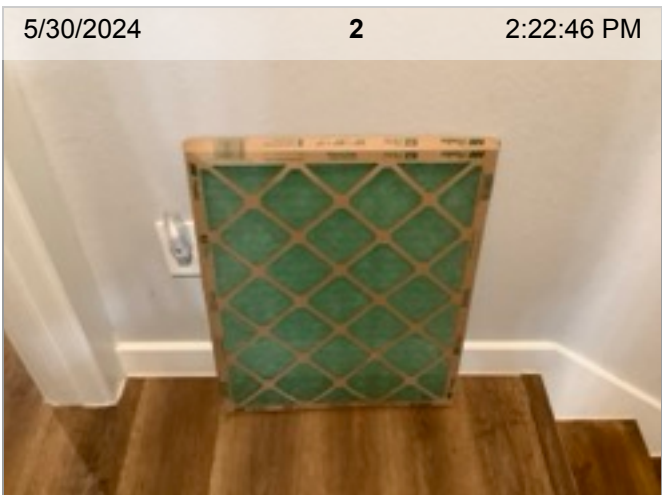
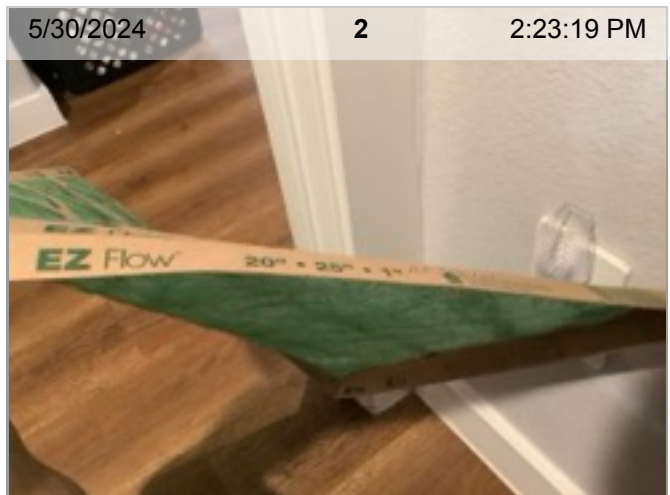
20 x 25 x 1 Air Filter Installed | Front

20 x 25 x 1 Air Filter Installed | Back

20 x 25 x 1 Air Filter Installed | Close-up of size/initials/date

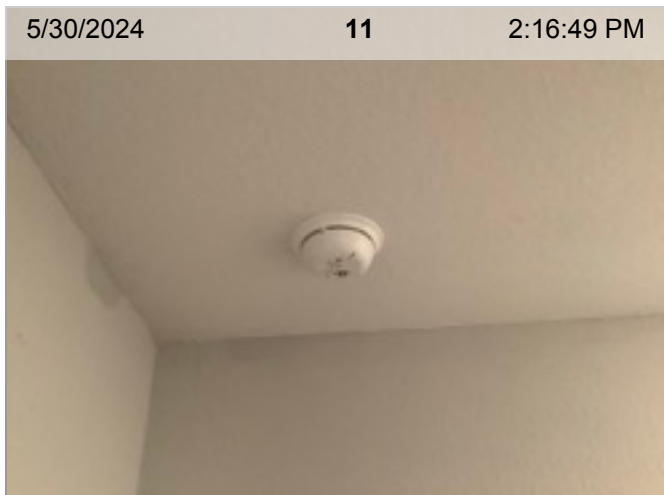
Wired Smoke/CO Combo Smoke Alarm | Smoke test: Not tested | Alarm in place | Alarms with no date are over 10 years old.

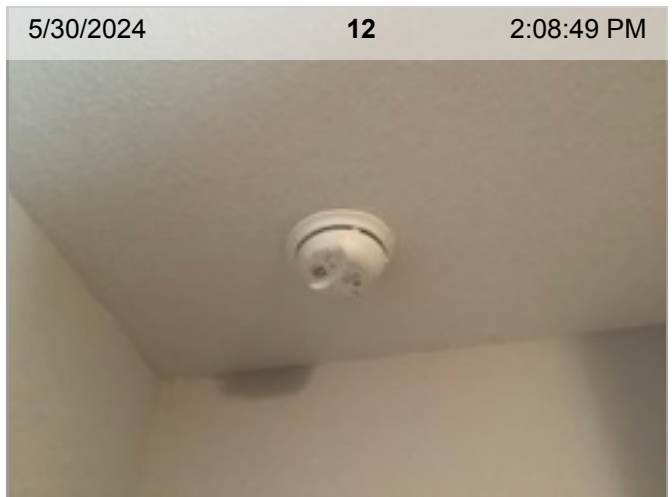
Wired Smoke/CO Combo Smoke Alarm (mfd 3/2022)

| Smoke test: Passed | Alarm in place

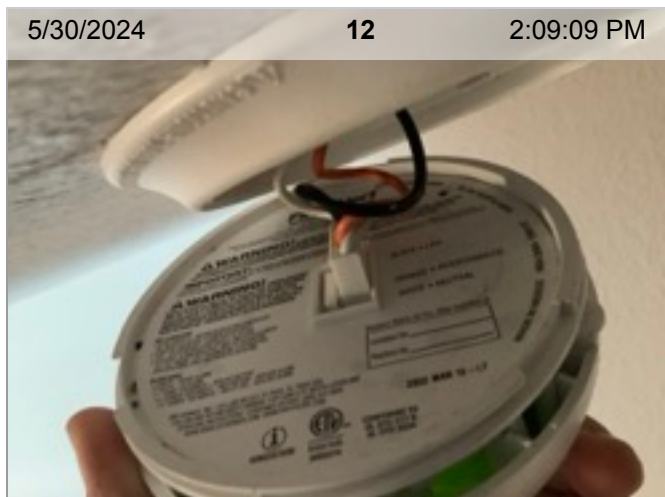
Wired Smoke/CO Combo Smoke Alarm (mfd 3/2022) | Smoke test:
Passed | Close-up of printed manufacture date | 2.2 years old

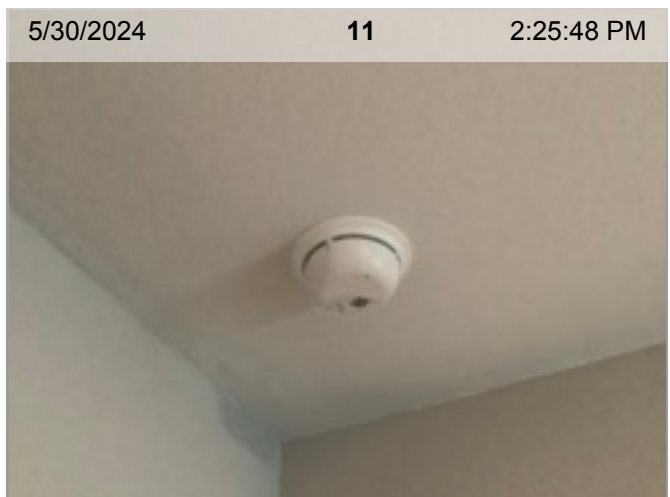
Wired Smoke Alarm (mfd 9/2022) | Smoke test: Passed | Alarm in place

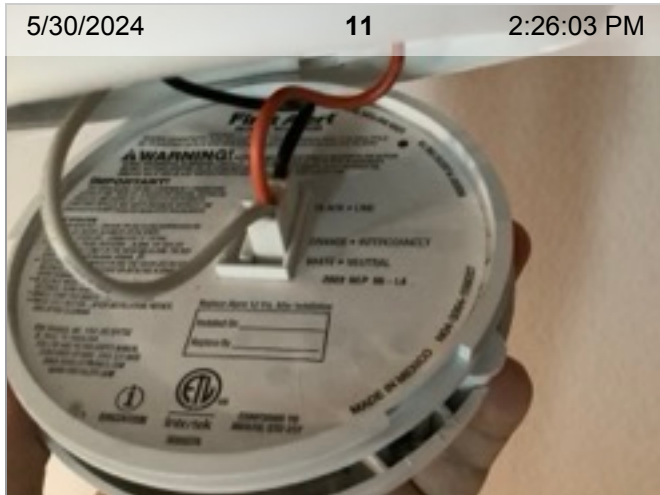
Wired Smoke Alarm (mfd 9/2022) | Smoke test: Passed | Close-up of printed manufacture date | 1.7 years old
