Prepared for Emerson Property Management

6/22/2024

8202 Furray Road #B

Houston TX 77028

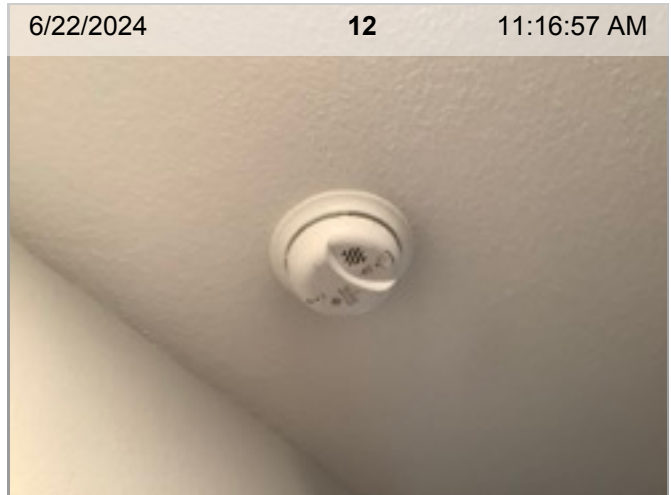
Wired Smoke/CO Combo Smoke Alarm (mfd 5/2022) | Smoke test: Passed | Alarm in place

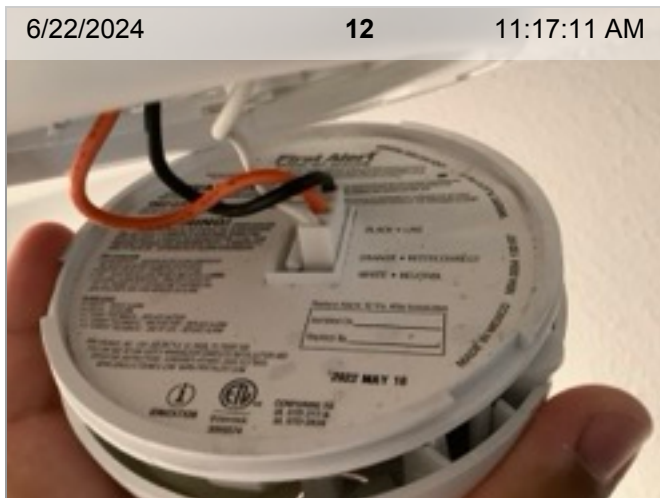
Wired Smoke/CO Combo Smoke Alarm (mfd 5/2022) | Smoke test: Passed | Close-up of printed manufacture date | 2.1 years old

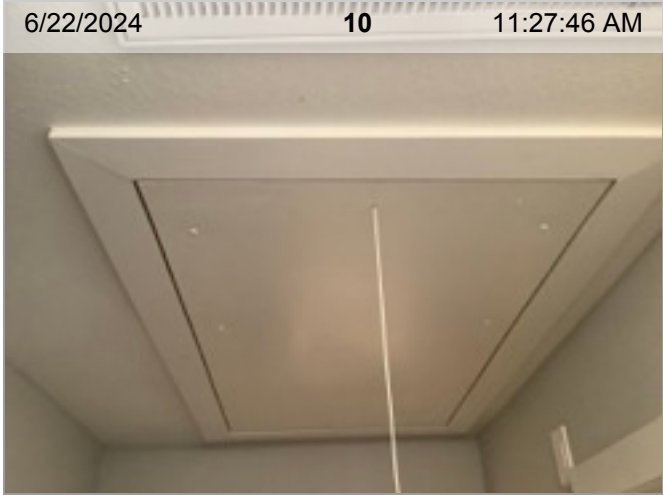
Inaccessible Water Heater | NA | Water heater (with expansion tank if present) | Water heater is in the attic

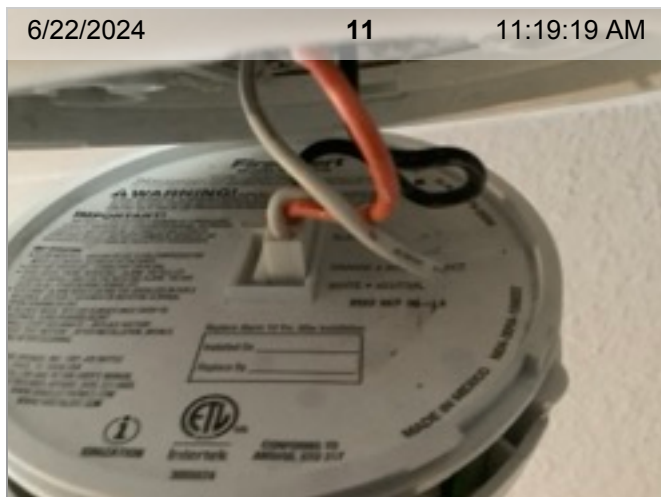
Wired Smoke Alarm (mfd 9/2022) | Smoke test: Passed | Close-up of printed manufacture date | 1.8 years old

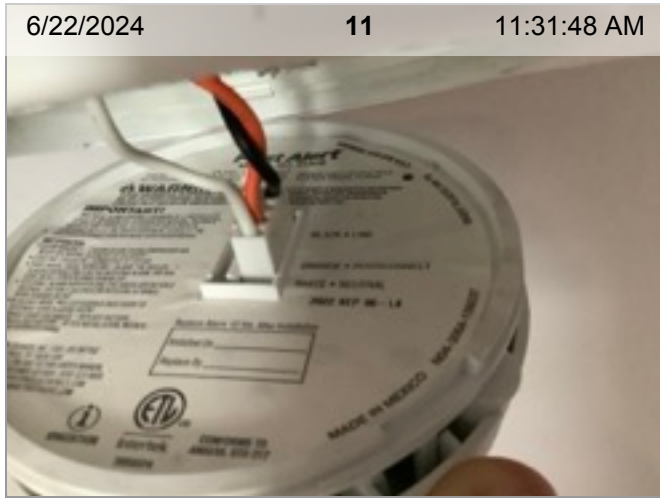
Wired Smoke Alarm (mfd 9/2022) | Smoke test: Passed | Close-up of printed manufacture date | 1.8 years old
