Prepared for Emerson Property Management

5/24/2024

7813 Glass Street #7813

Houston TX 77016

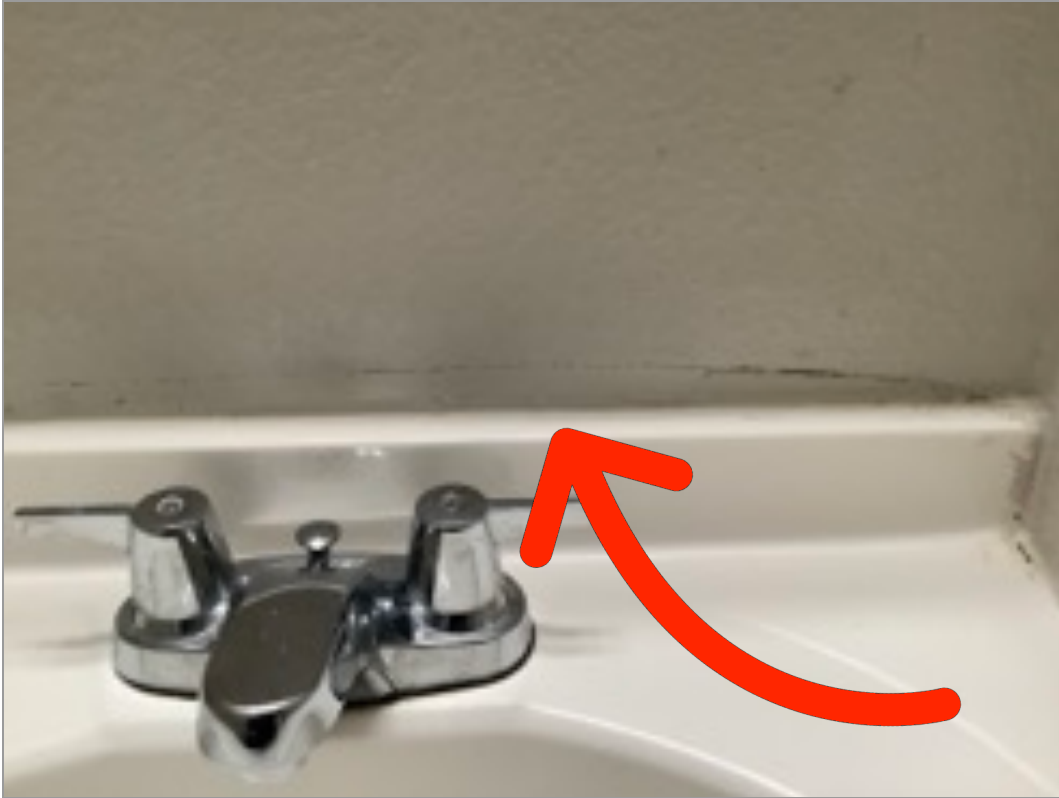
Bathroom 1
Walls/Paint
The wall is discolored

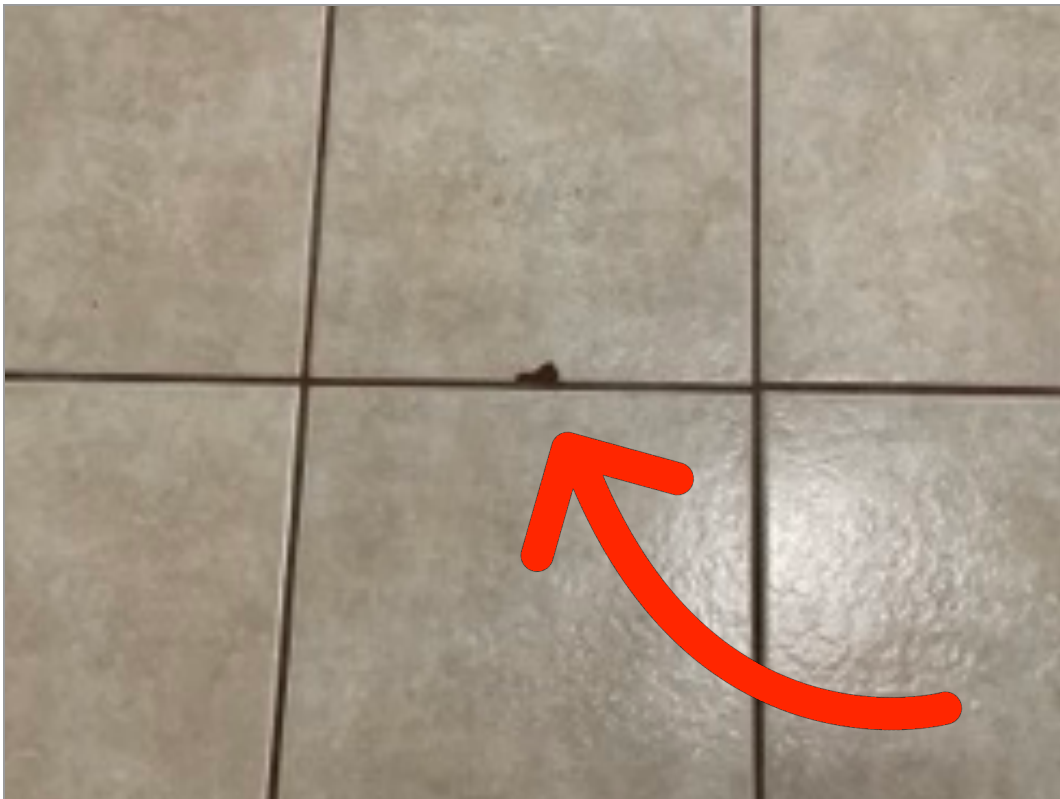
Bathroom 1
Tub/Fixture
The floor is discolored around the base of the tub.

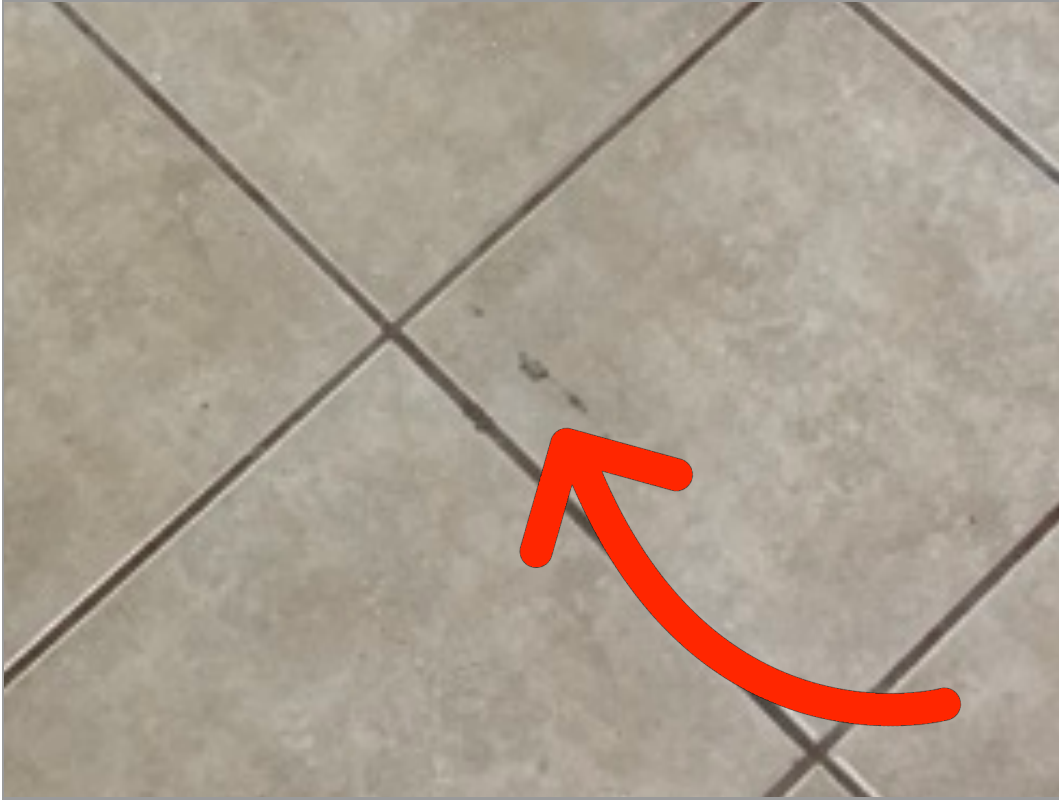
Bedroom 1
Floors
Gap in flooring.

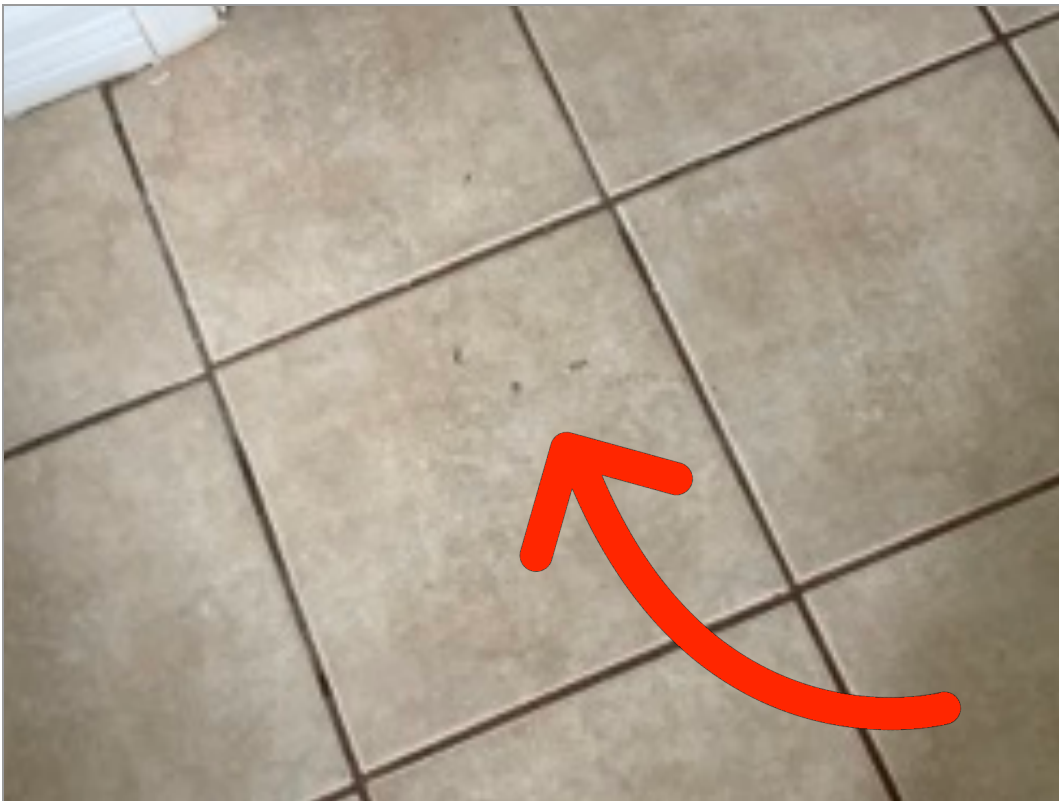
Bedroom 1
Floors
Flooring is scratched.

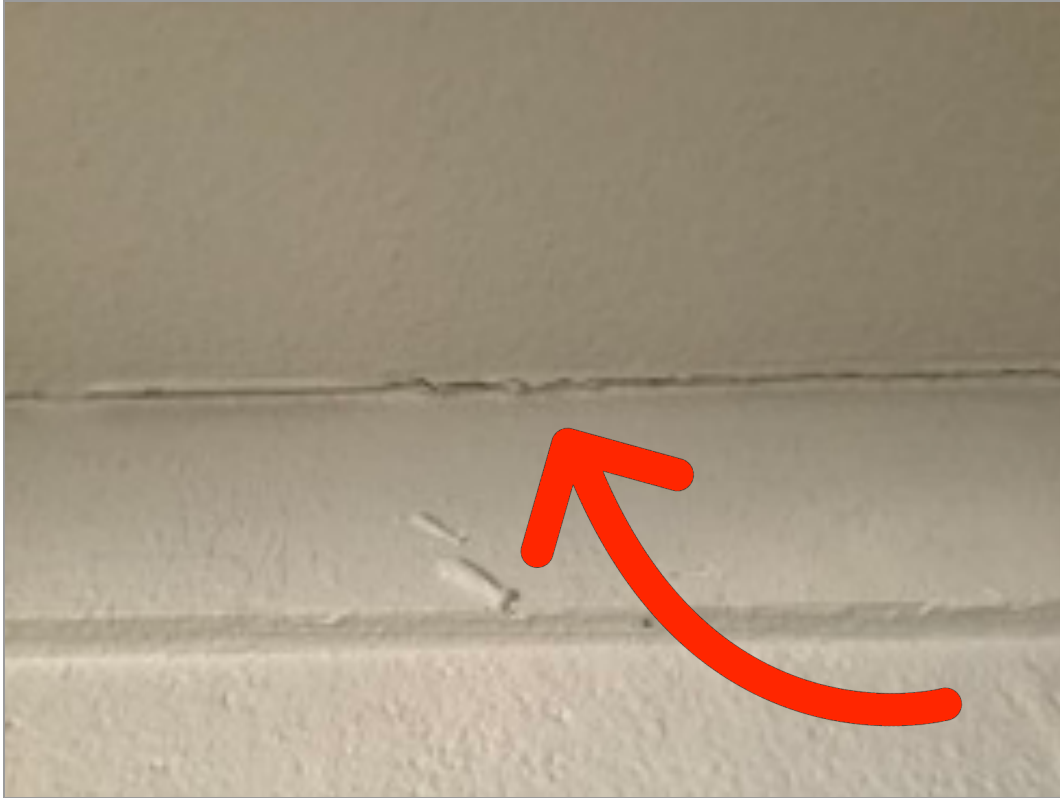
Bedroom 1
Closets
Cracks in ceiling

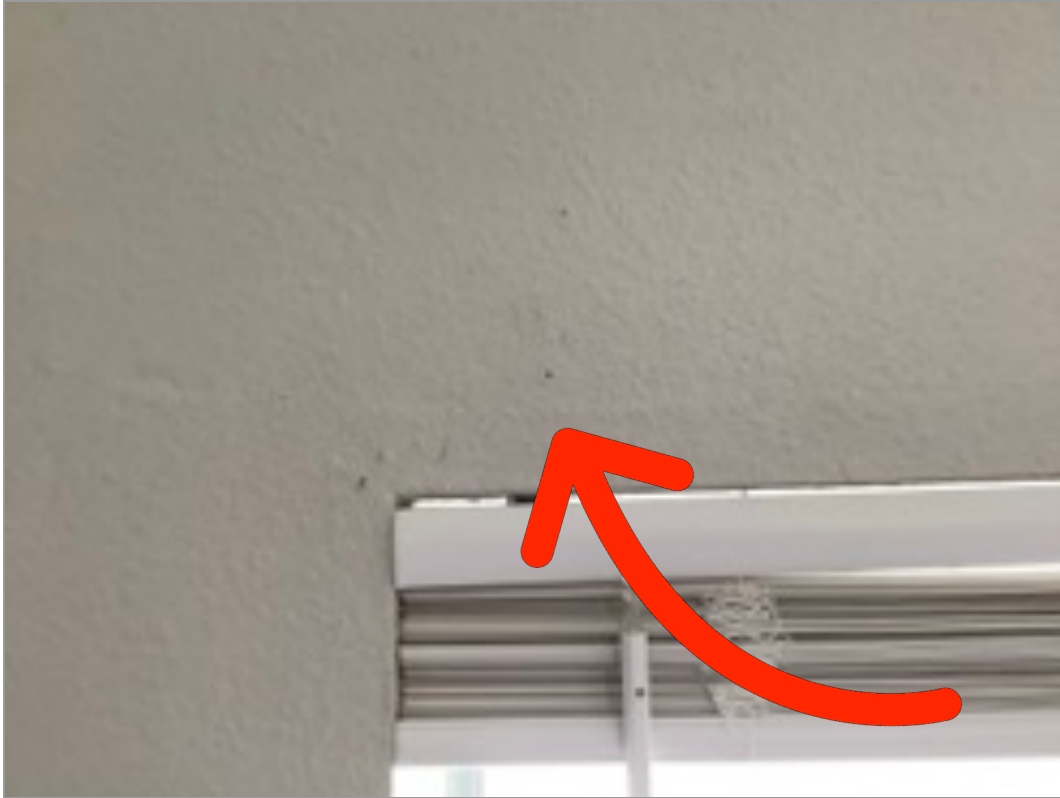
Bedroom 2
Walls/Paint
Holes in wall.

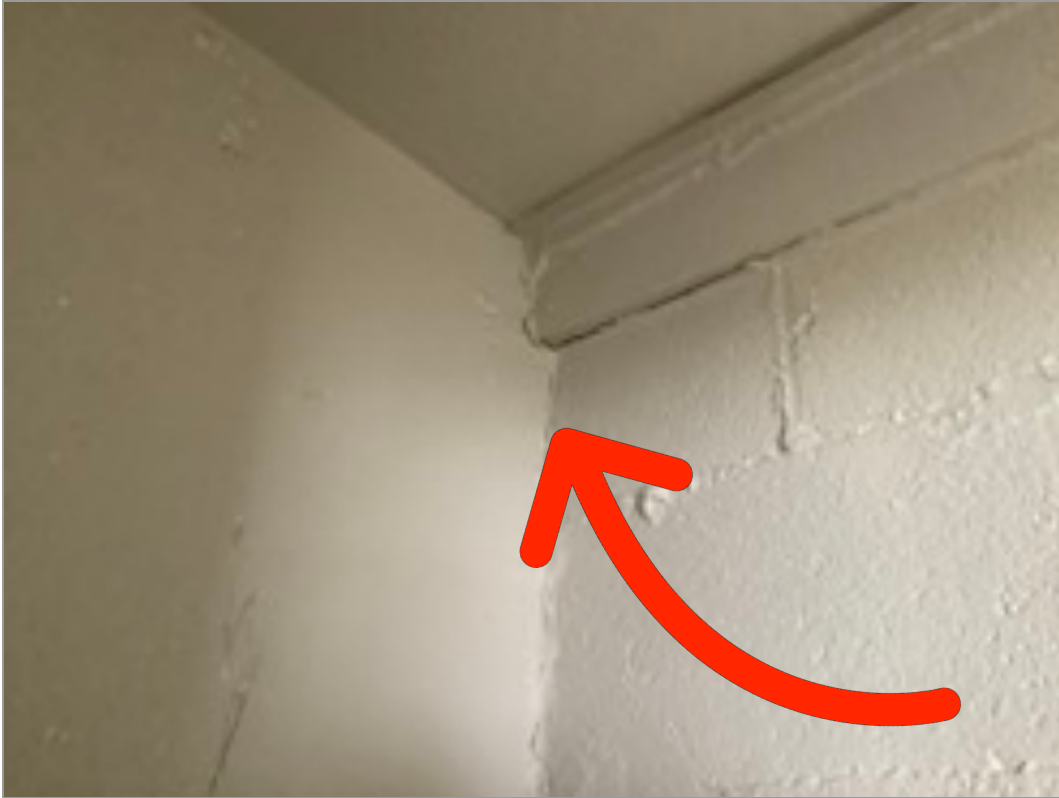
Bedroom 2
Closets
Cracks in texture

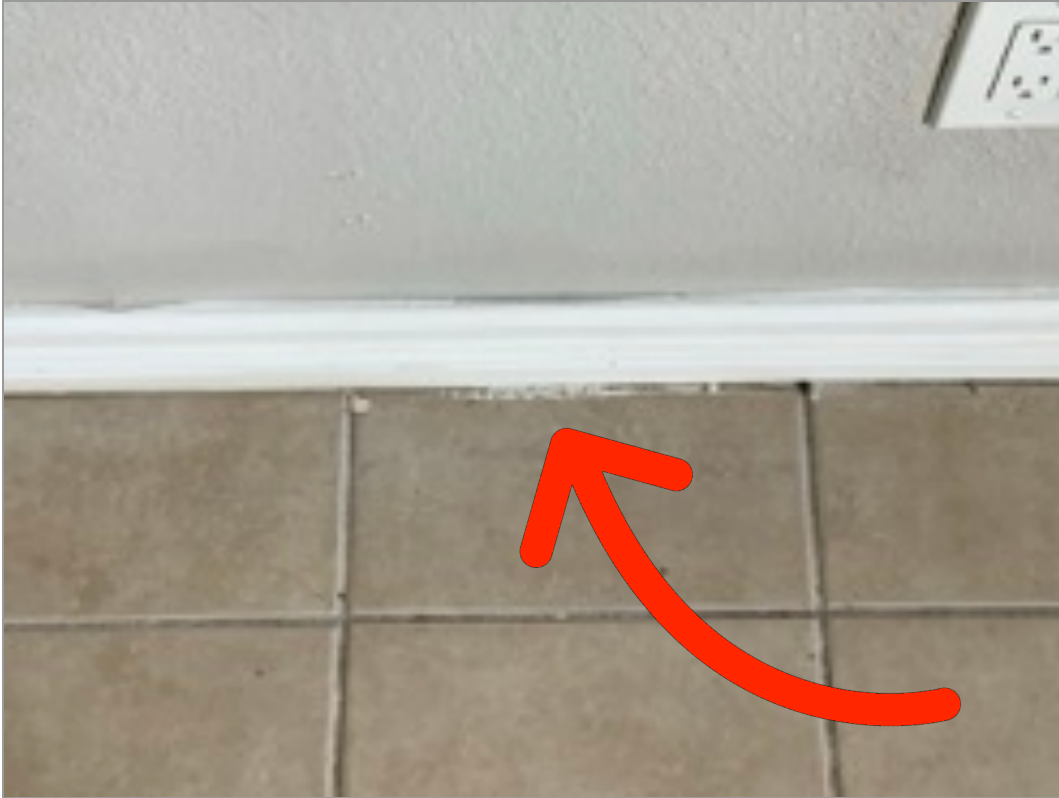
Entry
Floors
Flooring is stained.

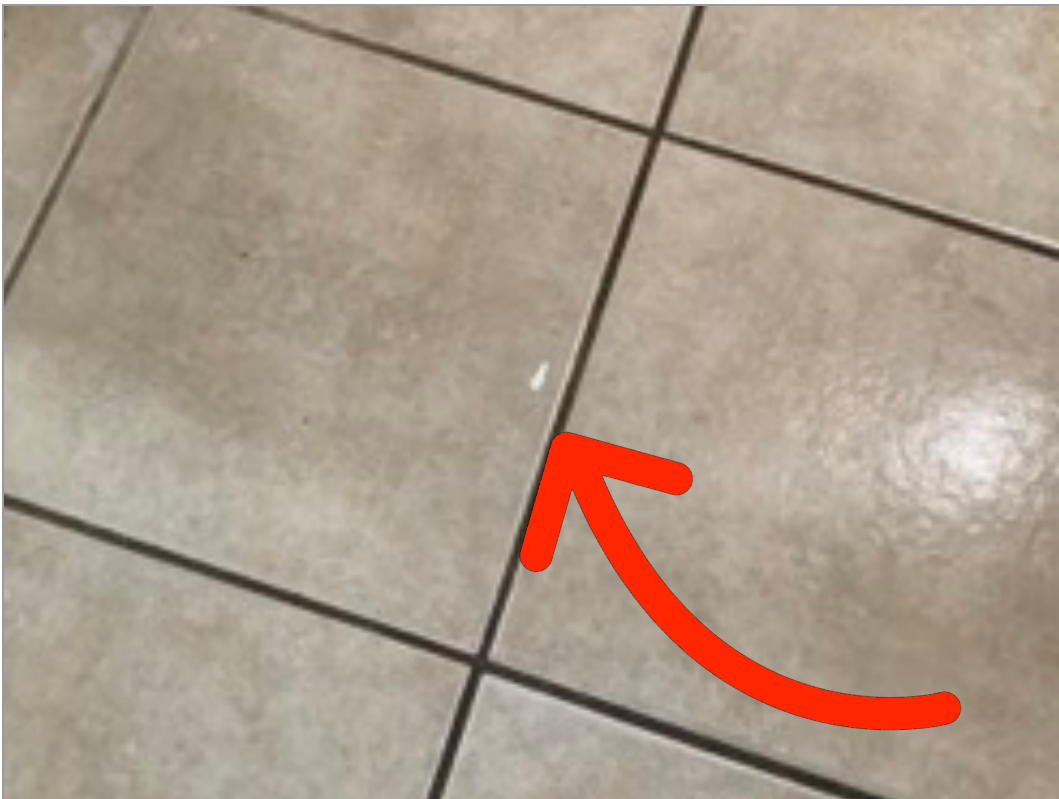
Hallway/Stairway
Floors
Gap in flooring.

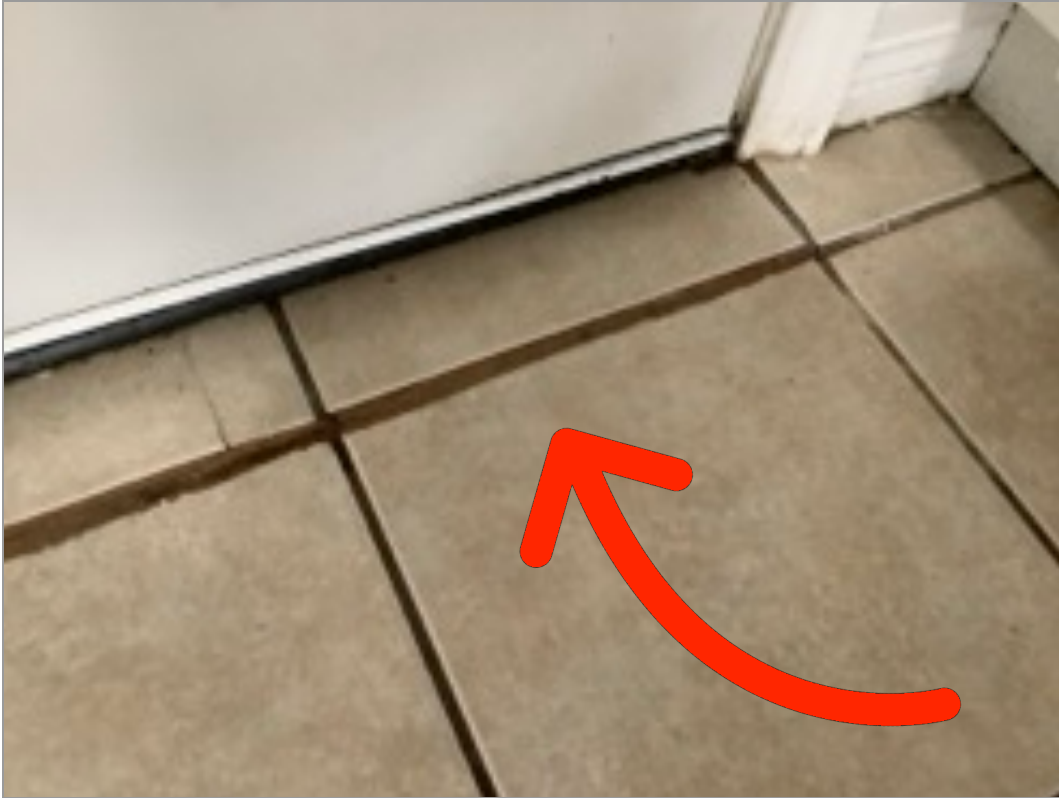
Kitchen
Floors
Gap in flooring.

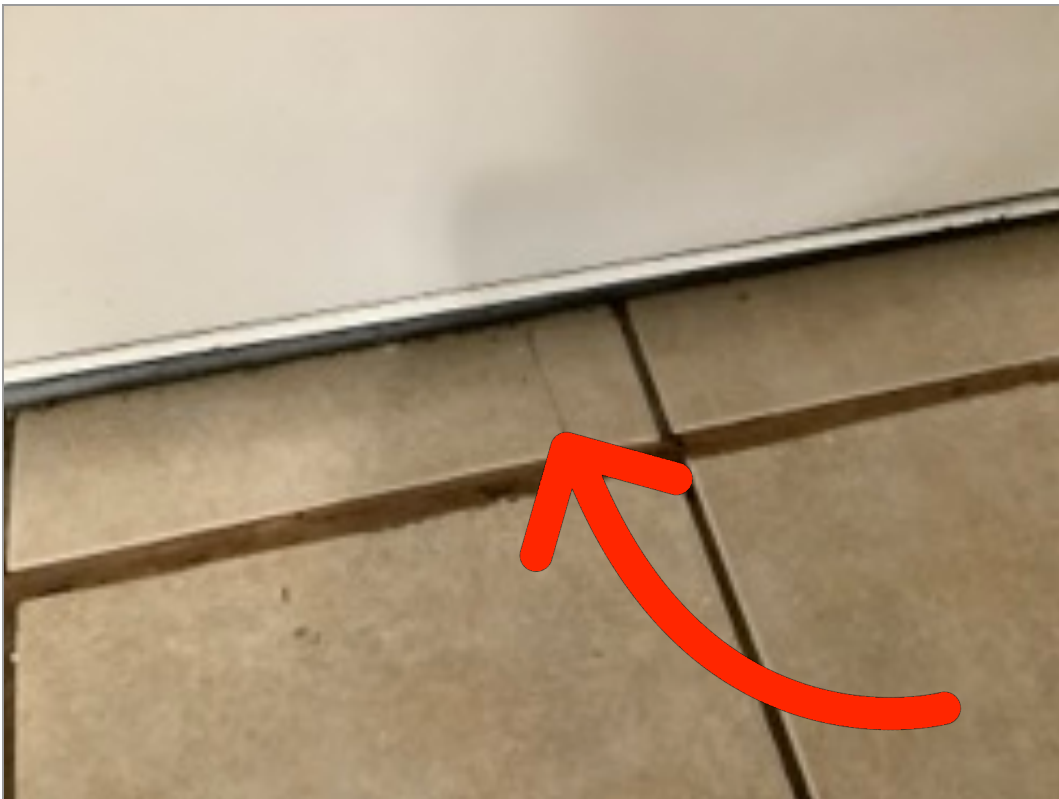
Kitchen
Floors
Gap in flooring.

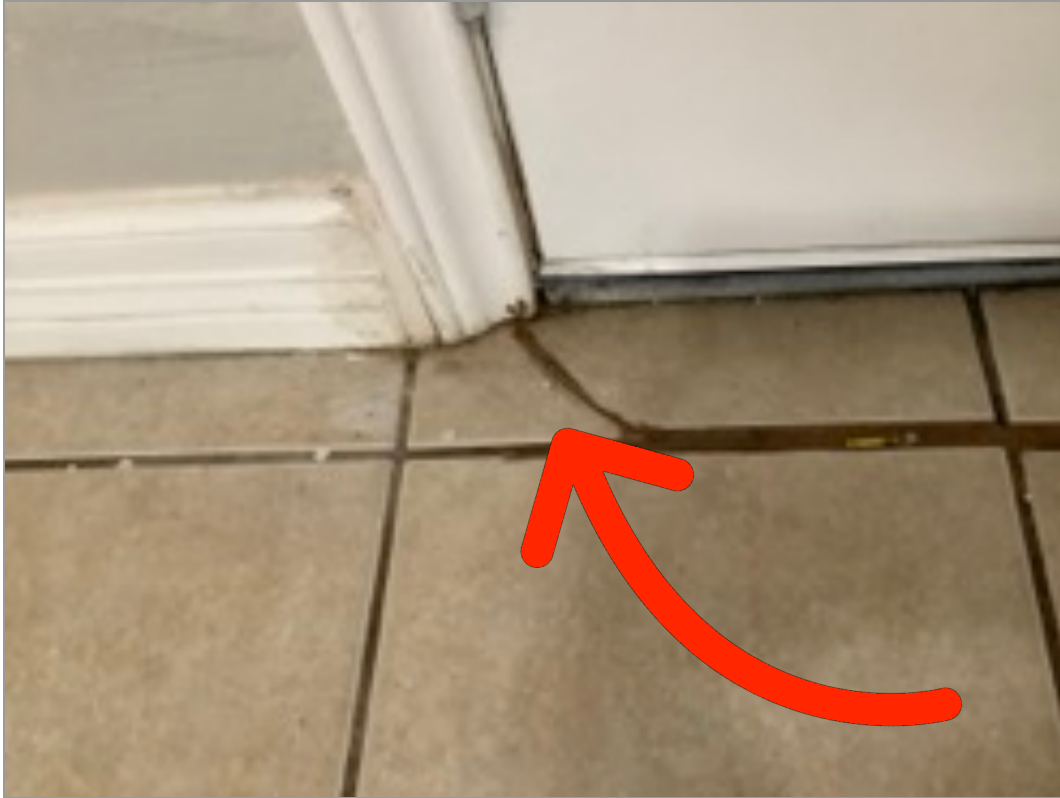
Kitchen
Floors
Crack in flooring.

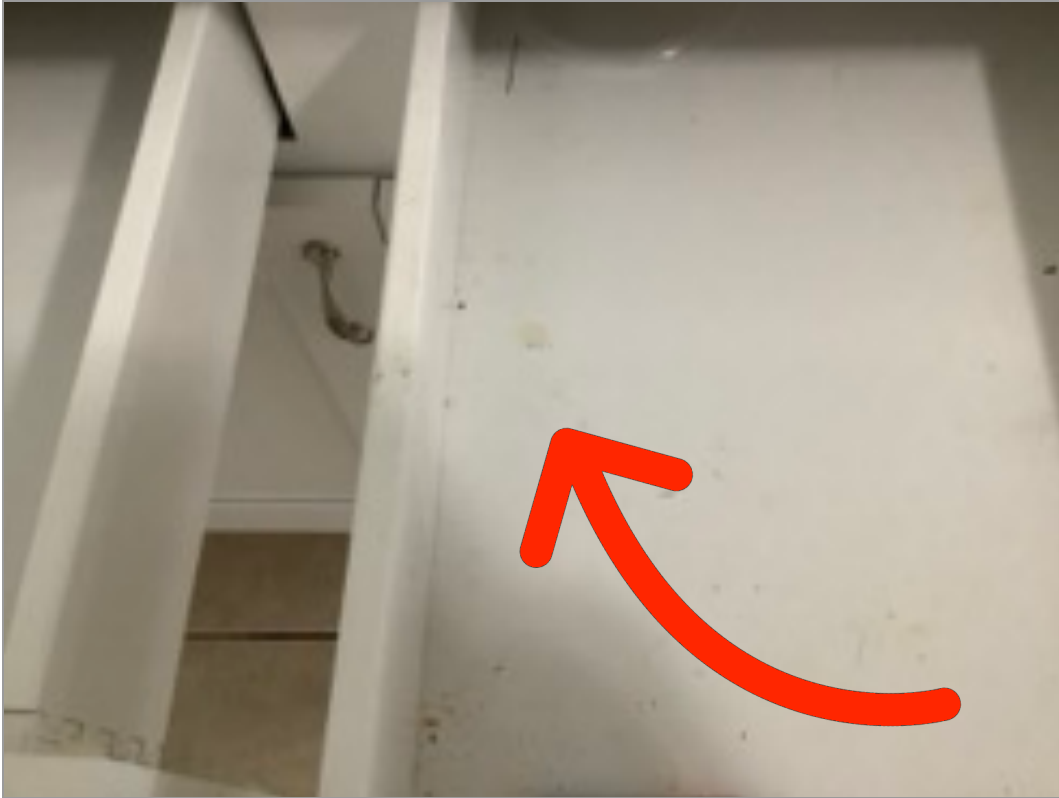
Kitchen
Cabinet Under Sink
The base of the cabinet is discolored.

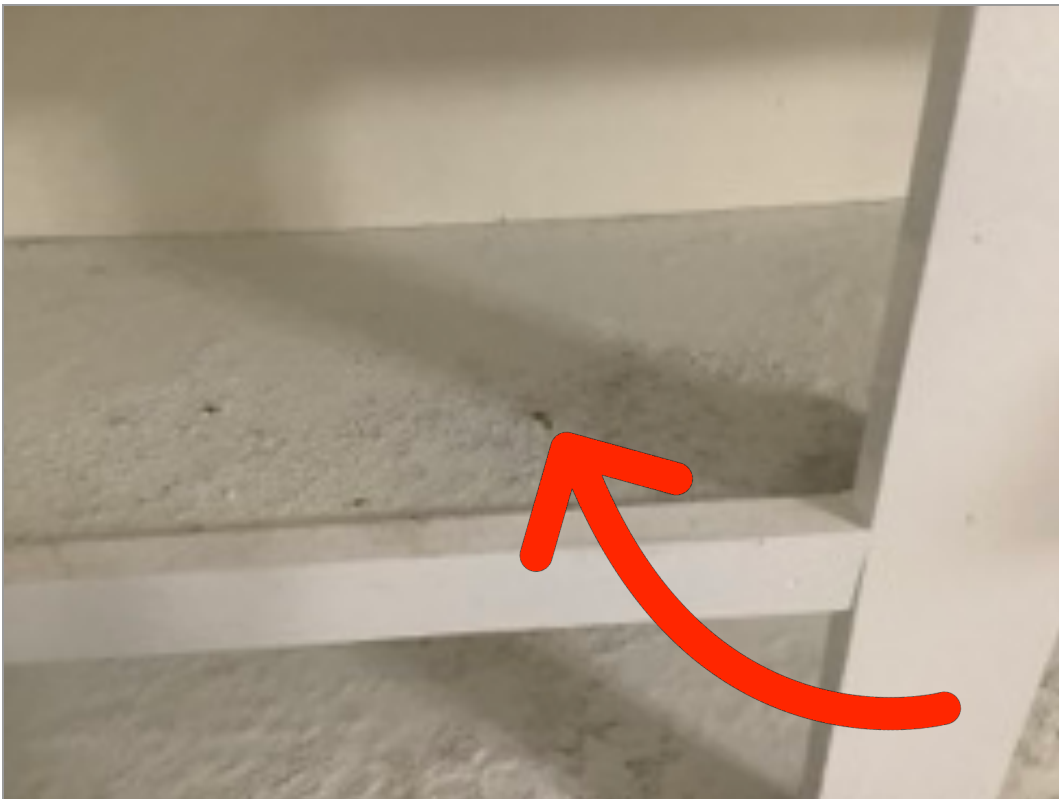
Kitchen
Lower Cabinets - Interior
Base of the cabinet is discolored

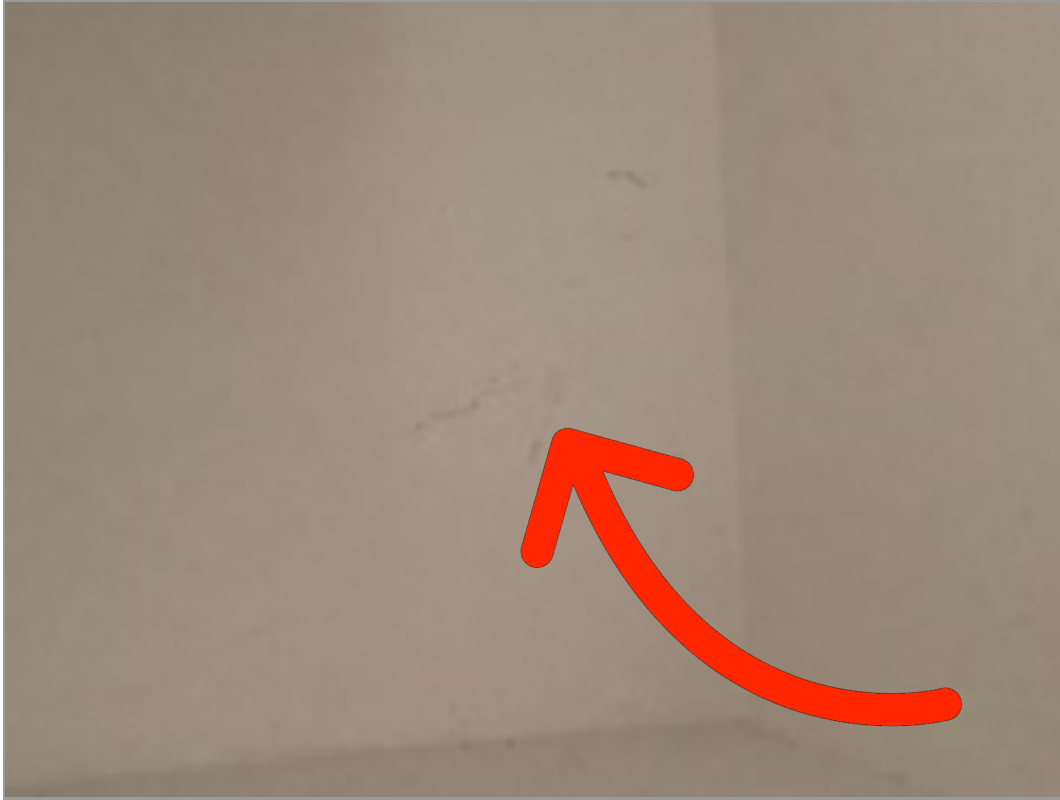
Kitchen
Upper Cabinets - Interior
Base of the cabinet is discolored

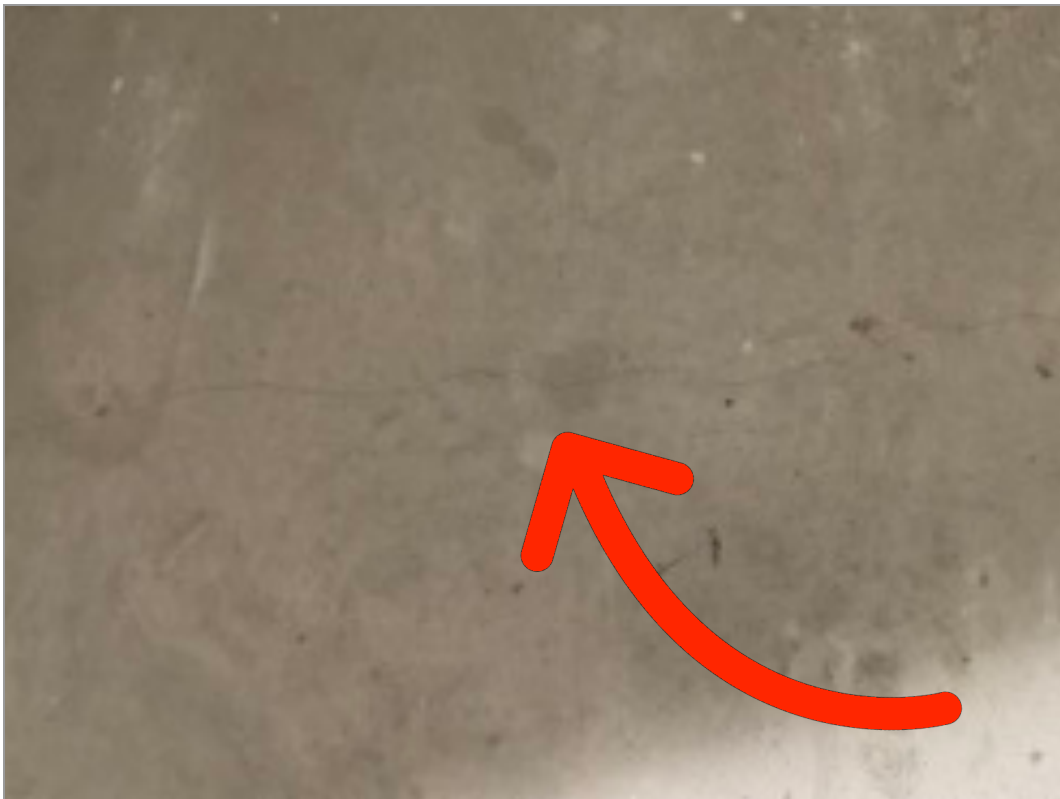
Laundry Room
Floors
Flooring is stained.

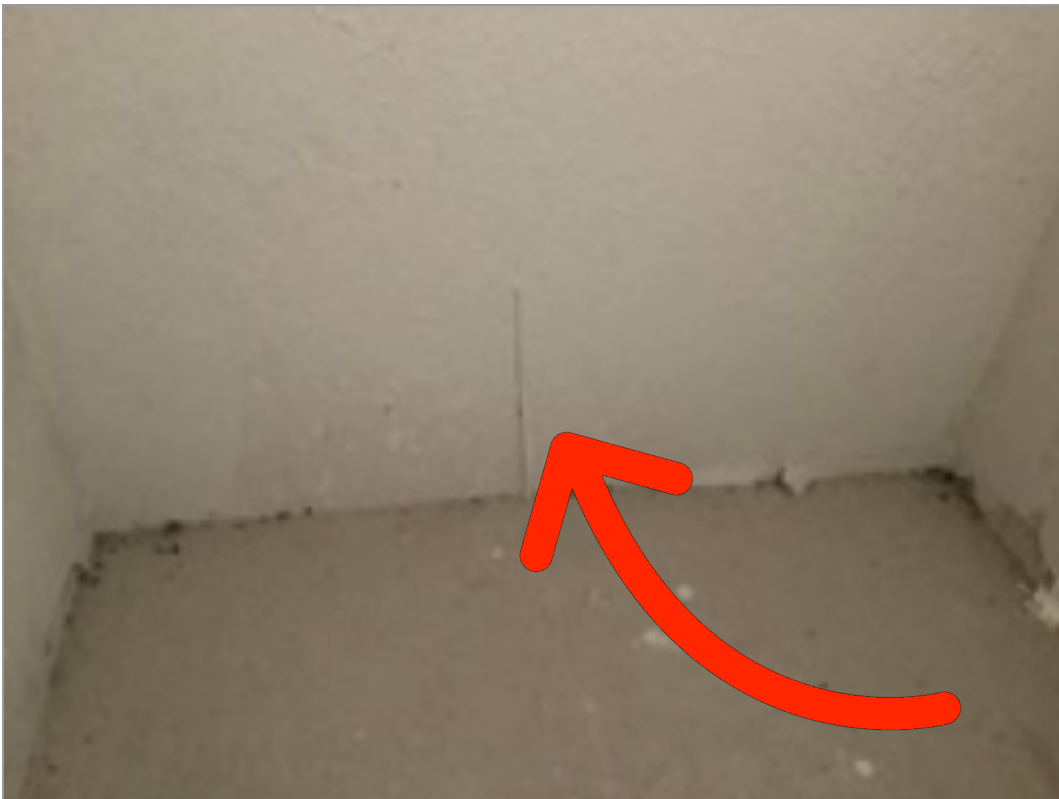
Laundry Room
Walls/Paint
Holes in wall.

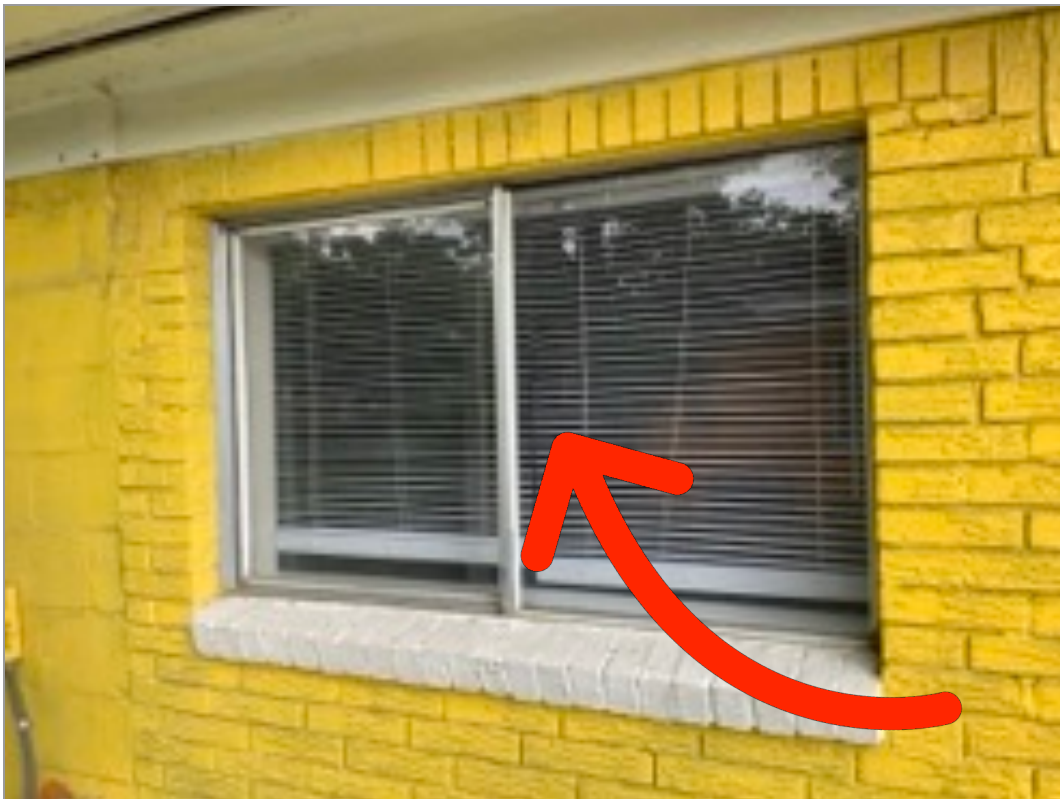
Rear Exterior
Walls/Siding/Trim
Siding is discolored

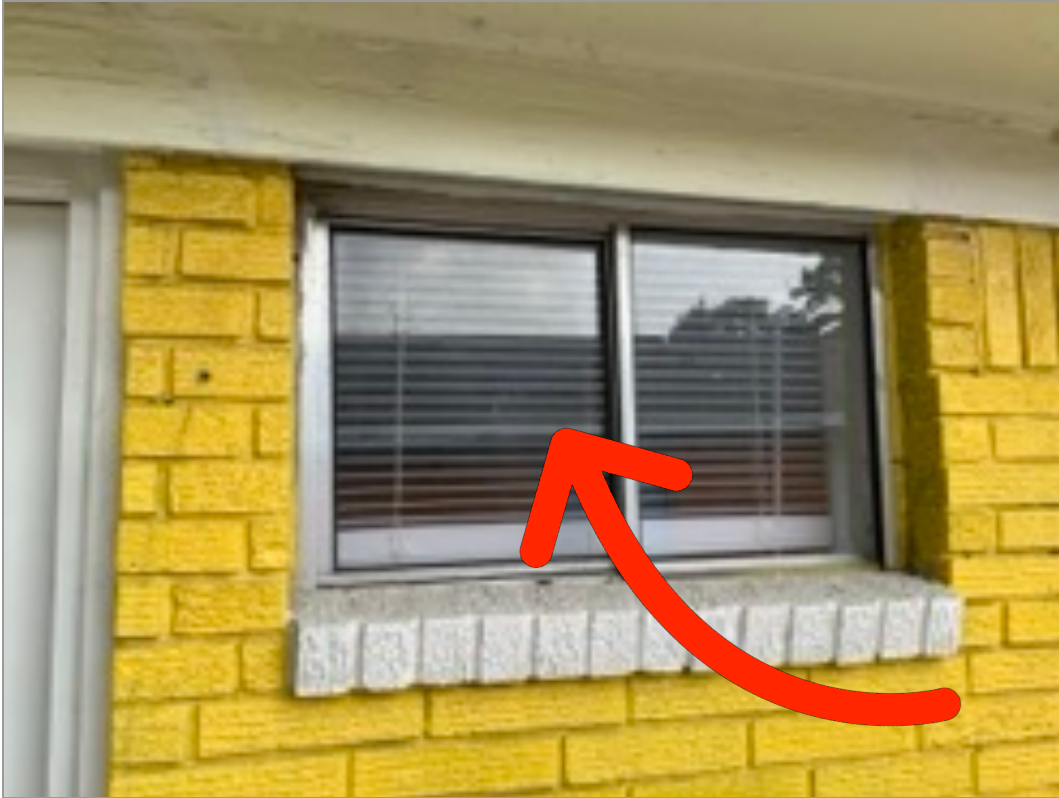
Rear Exterior
Window Screens
Screen(s) are missing

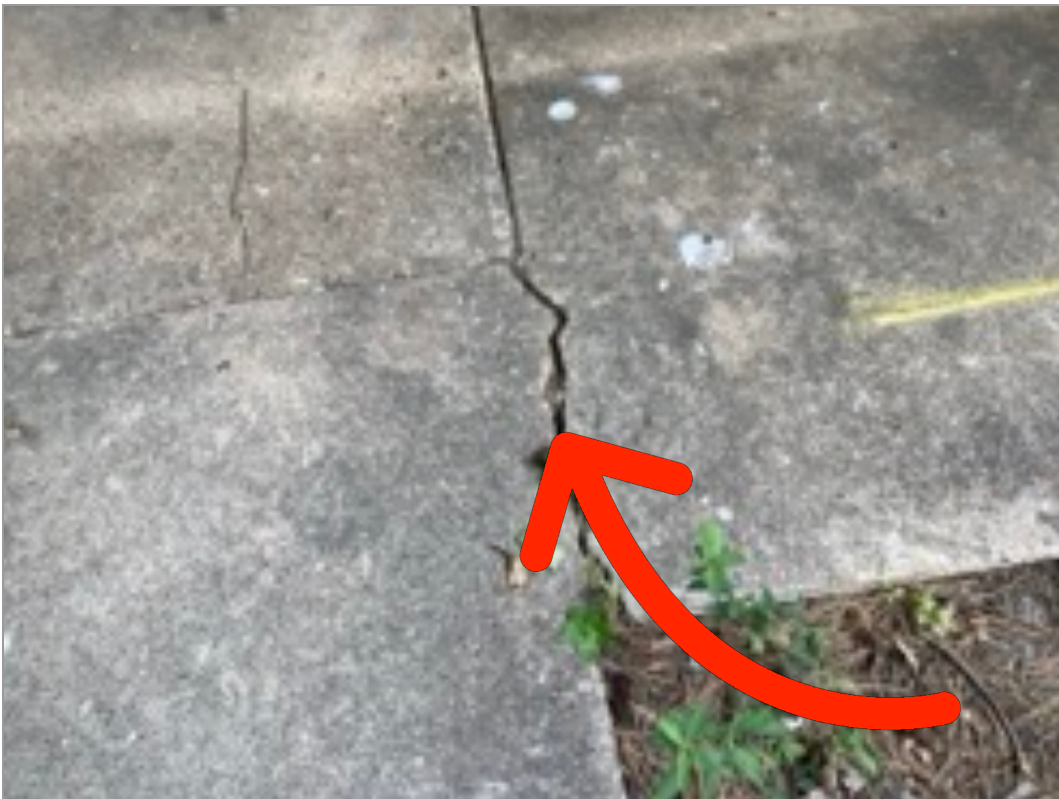
**Rear Exterior
Porch/Patio/Deck**
Cracked concrete

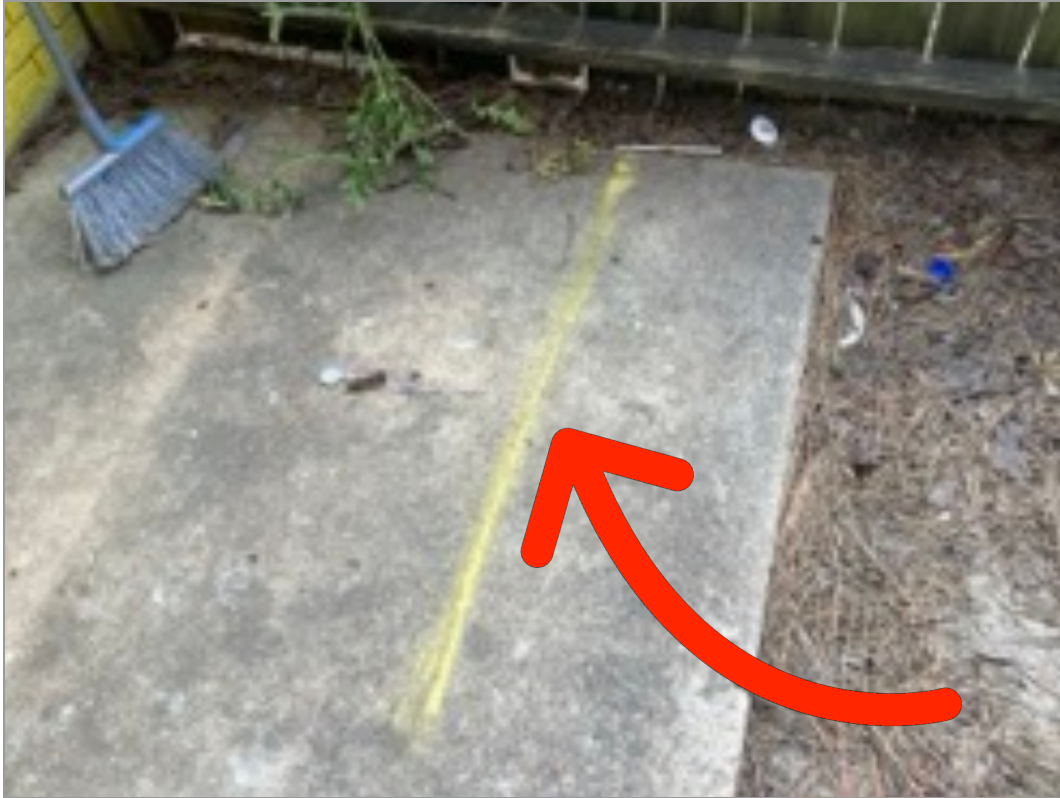
Rear Exterior
Porch/Patio/Deck
Discoloration

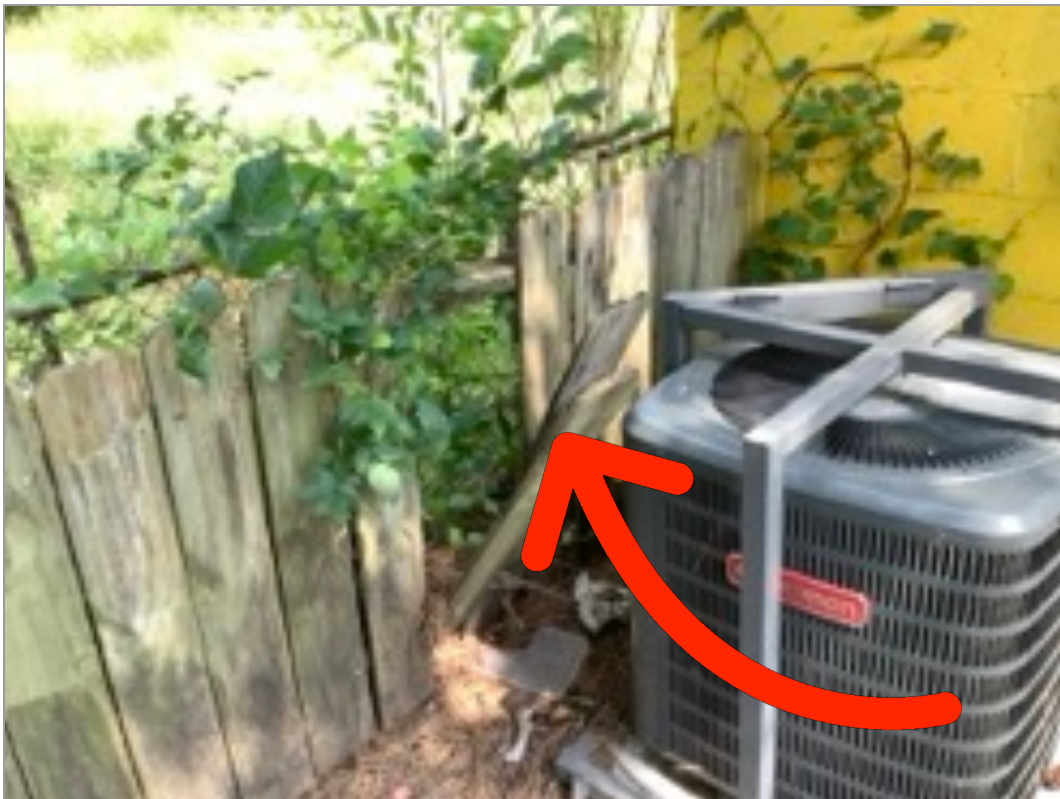
Rear Exterior
Fence
Fence is leaning
and needs
attention.

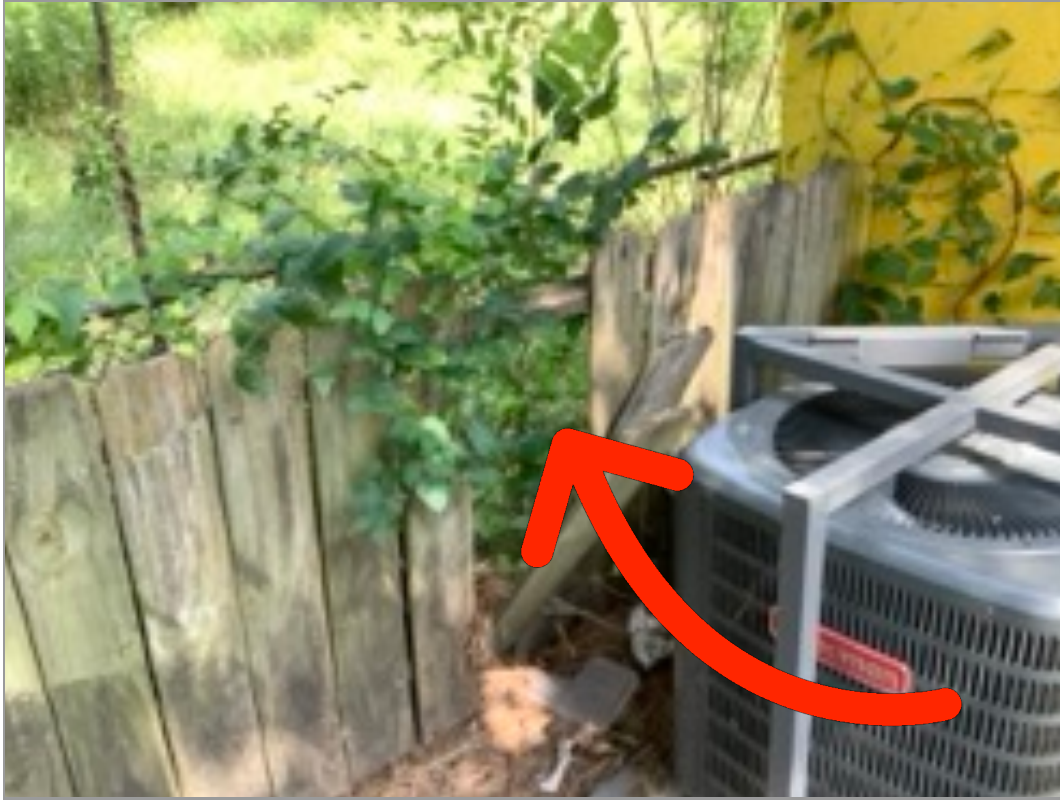
Rear Exterior Fence
Damaged, rotten, or chipping fence materials; holes/gaps in fence; damaged clasps; gates that don't close securely

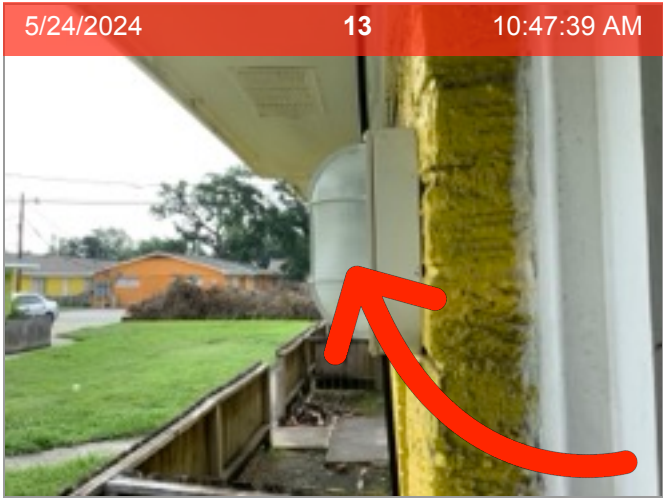
Light Fixtures | Bulb is out

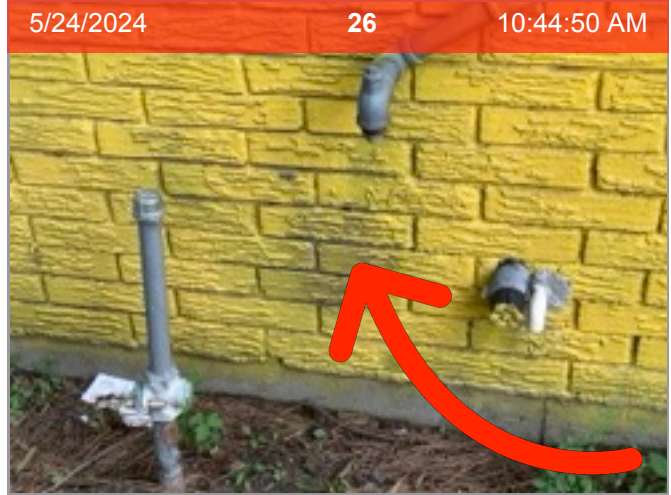
Walls/Siding/Trim | Siding is discolored

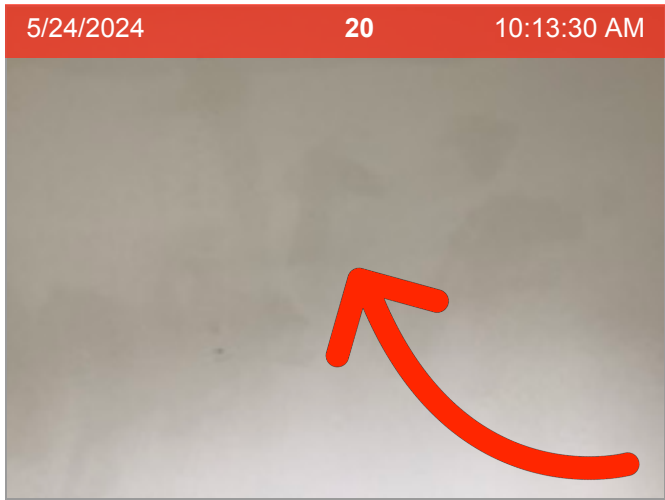
Walls/Paint | The wall is discolored

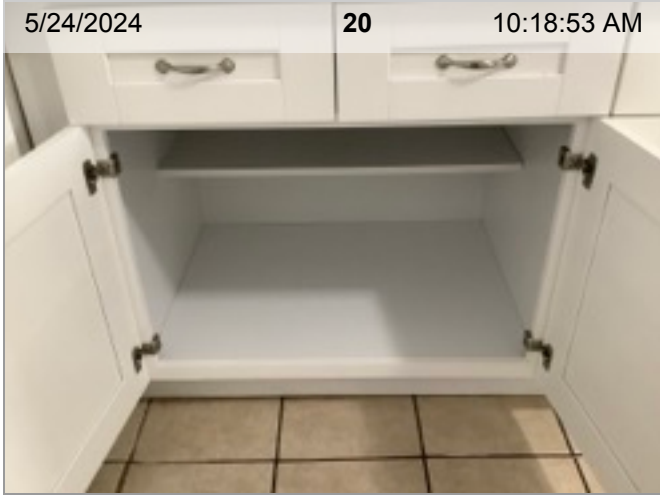
Lower Cabinets - Interior | Base of the cabinet is discolored

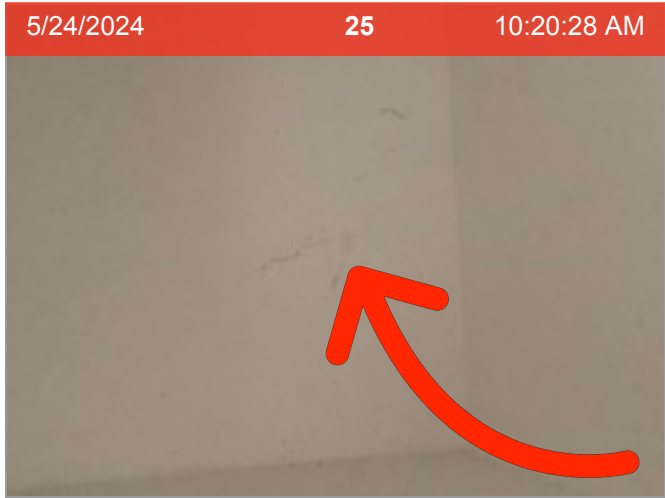
Pantry | The walls are marked up.

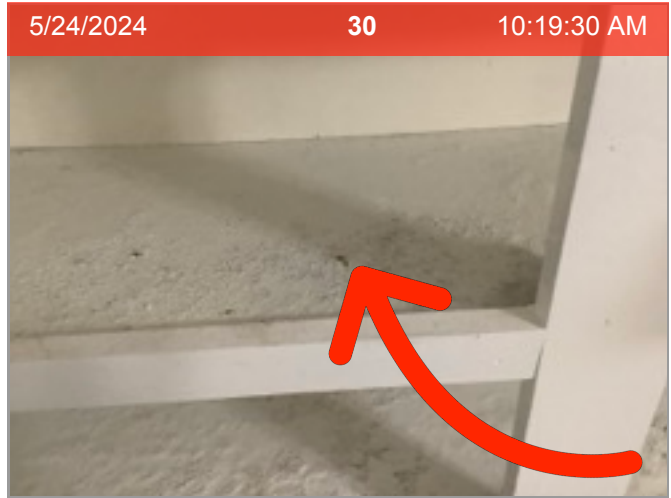
Upper Cabinets - Interior | Base of the cabinet is discolored

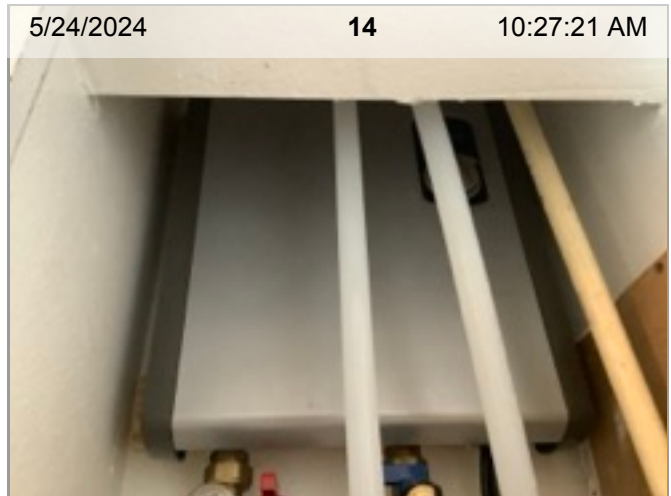
Inaccessible Water Heater | NA | Water heater (with expansion tank if present) | Cannot access full water heater

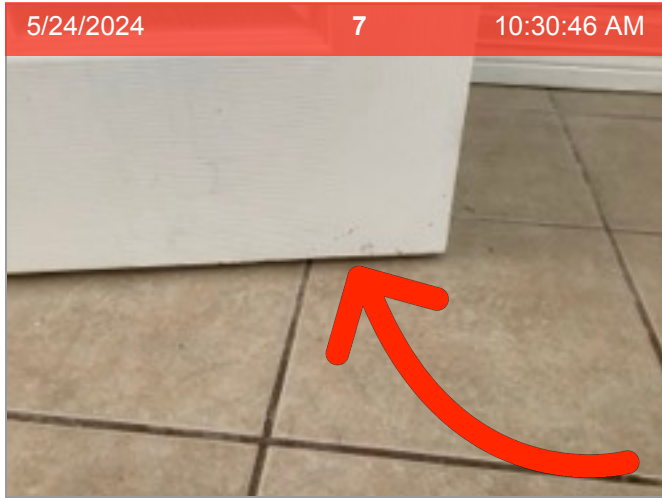
Door | Scuffs on door.

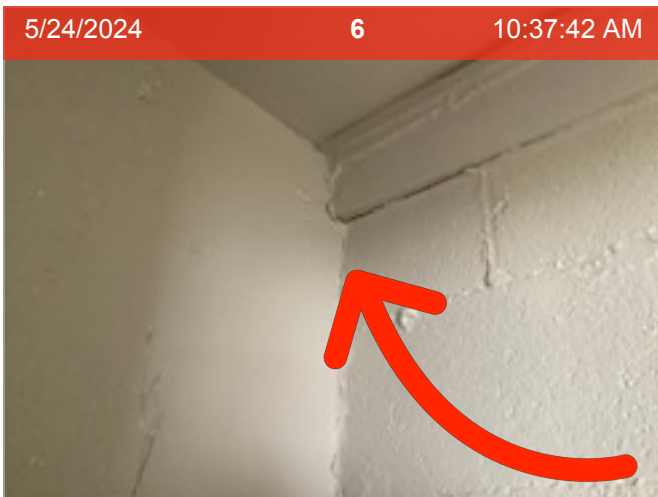
Closets | Cracks in texture

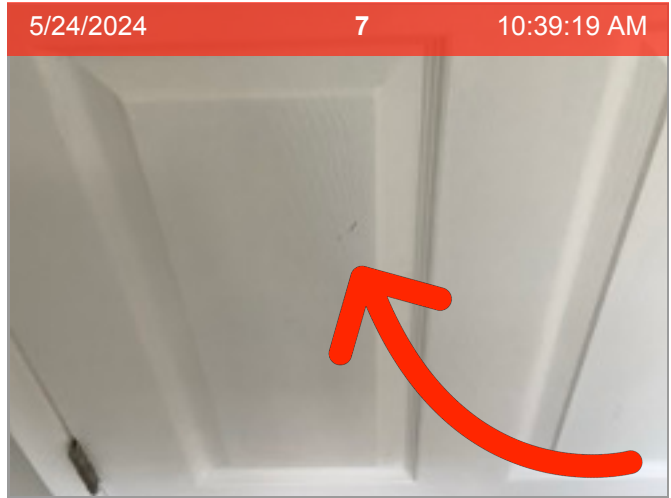
Door | Scuffs on door.
