Prepared for Emerson Property Management

5/24/2024

7813 Glass Street #7813

Houston TX 77016

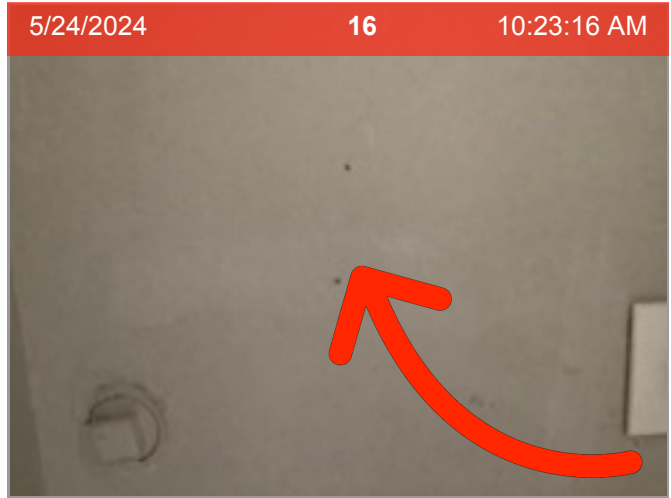
5/24/2024 16 10:23:16 AM
Walls/Paint | Holes in wall.

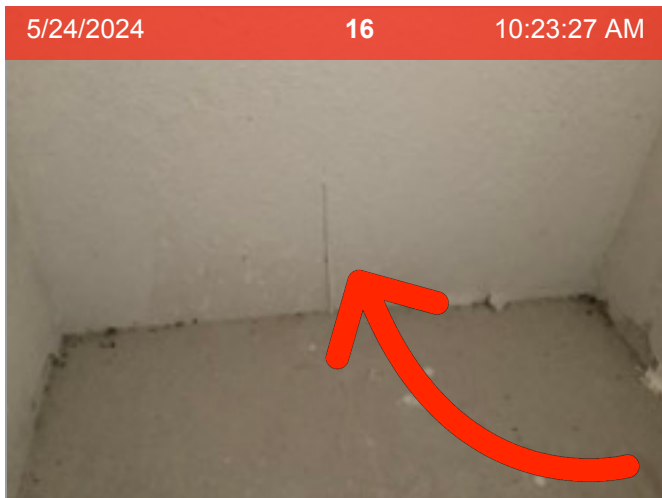
5/24/2024 16 10:23:27 AM
Walls/Paint | Scratches on the wall
