# Your Inspection Report

5603 Armillary Dr  
Katy, TX 77449

**INSPECTION DATE:**  
Tuesday, June 25, 2024

# PROPERTY INSPECTION REPORT FORM

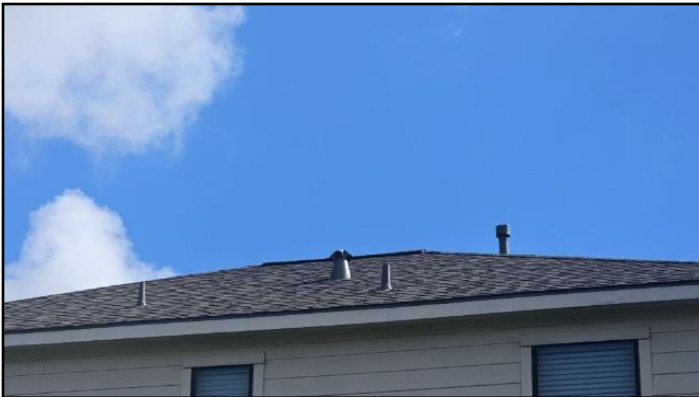
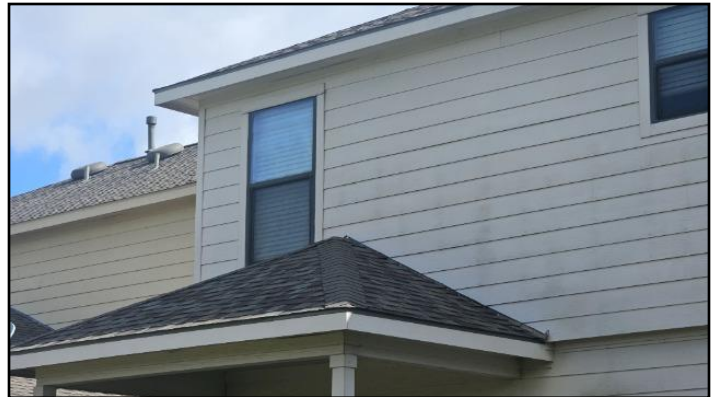
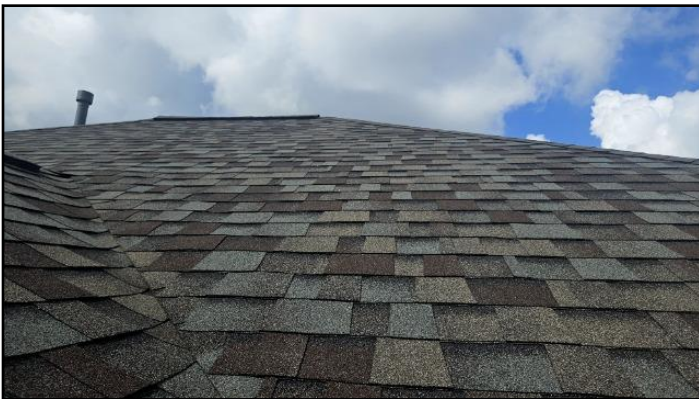
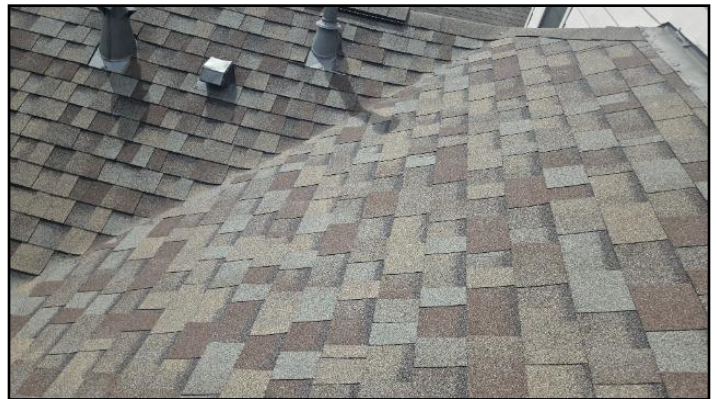
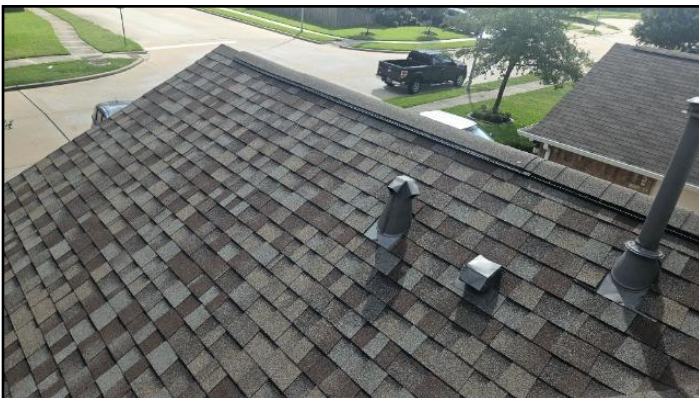
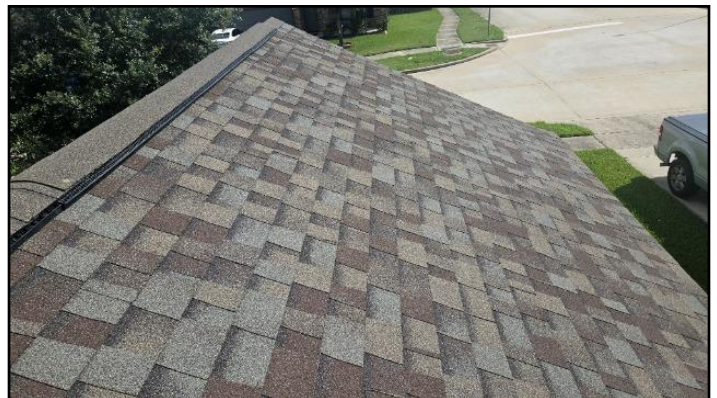
1. **Condition:** • The inspector has checked for visible signs of damage or issues at the time of inspection. If your roof is more than 10 years old comprehensive roof inspection should be completed by a roofing professional

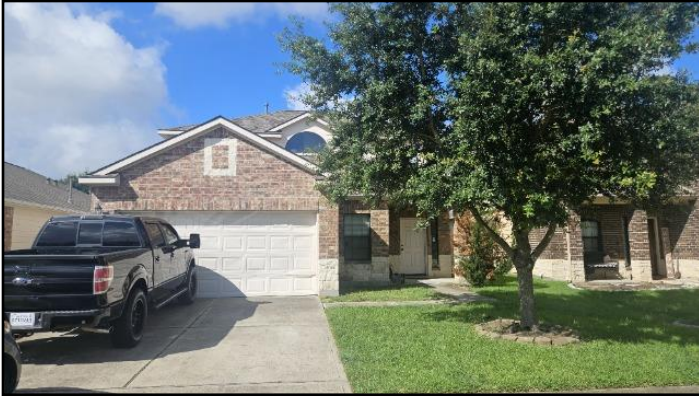
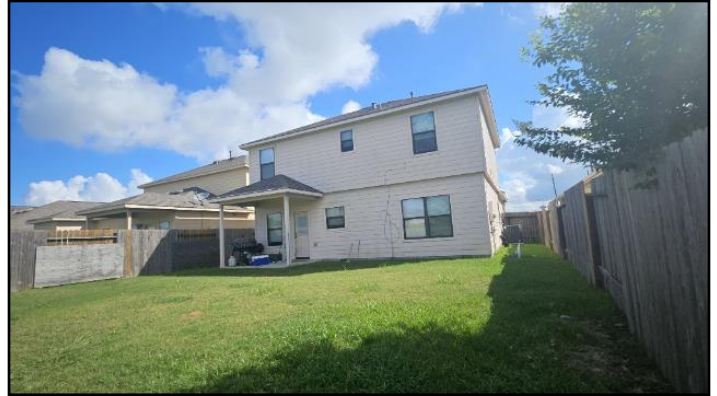
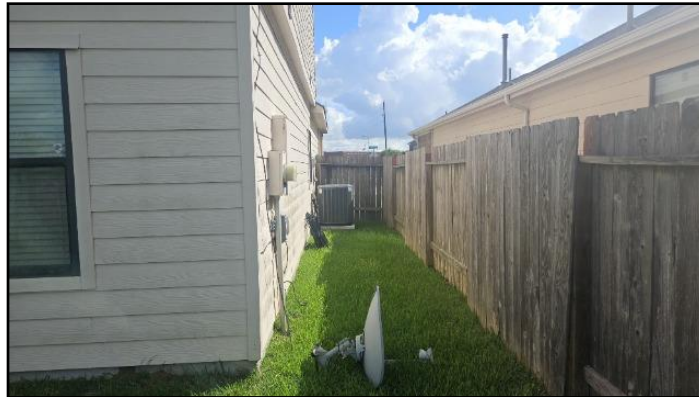
3. **Condition:** • Exterior view of the house

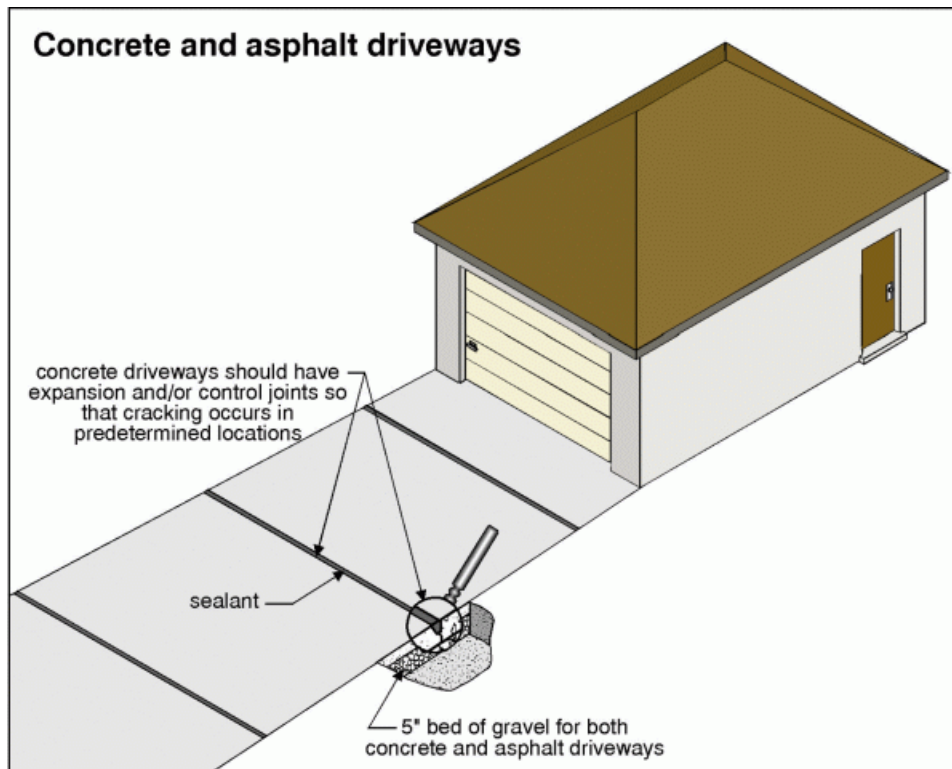
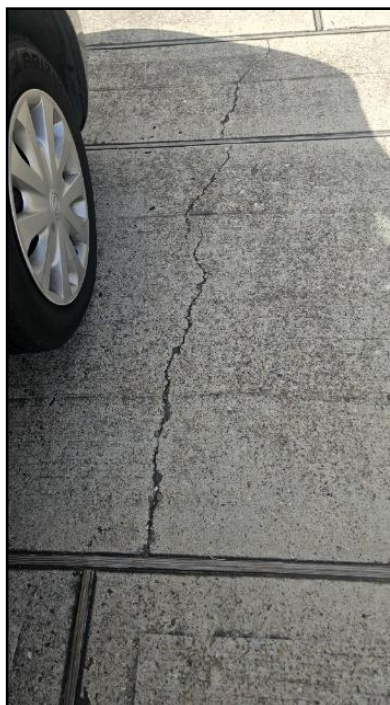
42.

**12. Condition:** • Driveway cracks are a common issue that can occur over time due to various factors such as weather conditions, heavy traffic, or poor installation. While some cracks may be purely cosmetic, others can compromise the integrity and functionality of the driveway.

Small cracks that are less than a quarter inch in width are generally not a cause for concern and can be filled with a crack filler or sealant to prevent water penetration and further damage. However, larger cracks or those that are wider than a quarter inch may require more extensive repairs such as resurfacing or patching.

It is recommended that you consult with a qualified contractor to assess the severity of the issue and recommend appropriate repairs.

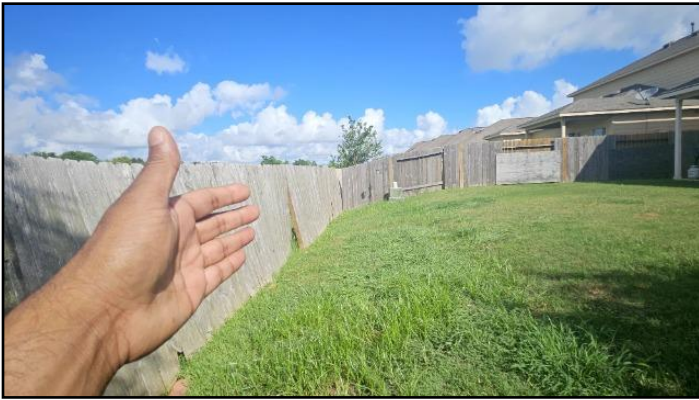
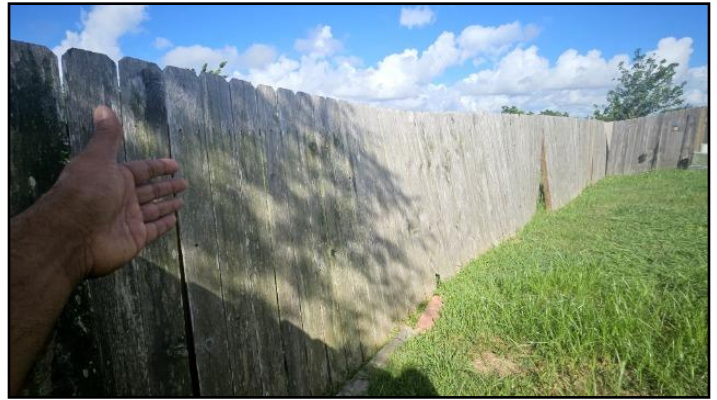
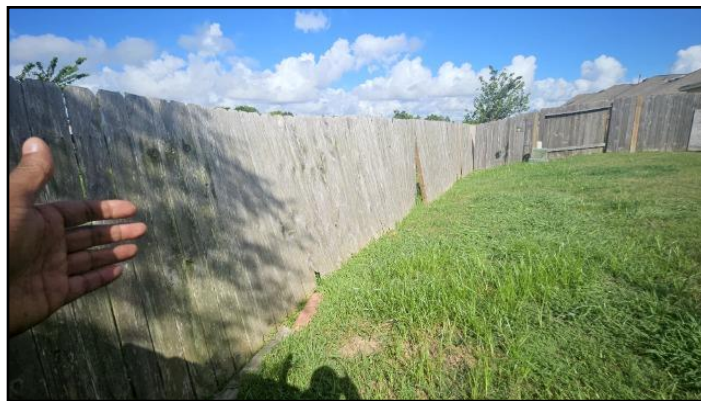
**13. Condition:** • At the time of inspection, the inspector noted that the wood fence post was loose and shaking when pushed. This is a sign of incorrect post installation and can be further weakened by heavy wind and storms. It is recommended that this issue be corrected to prevent further damage.

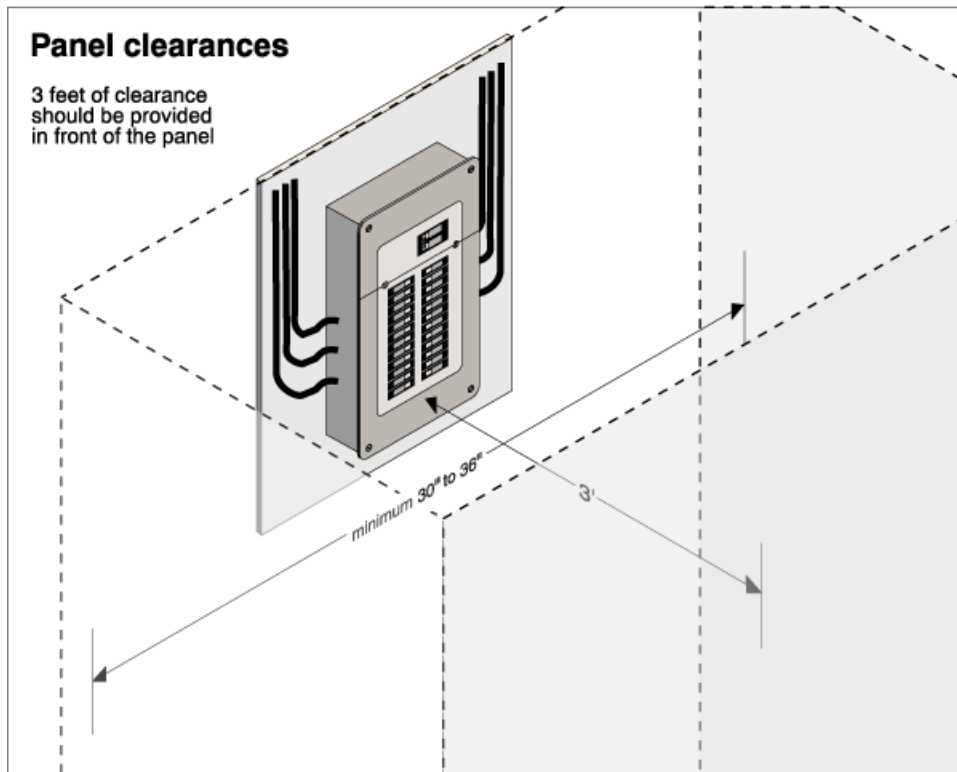
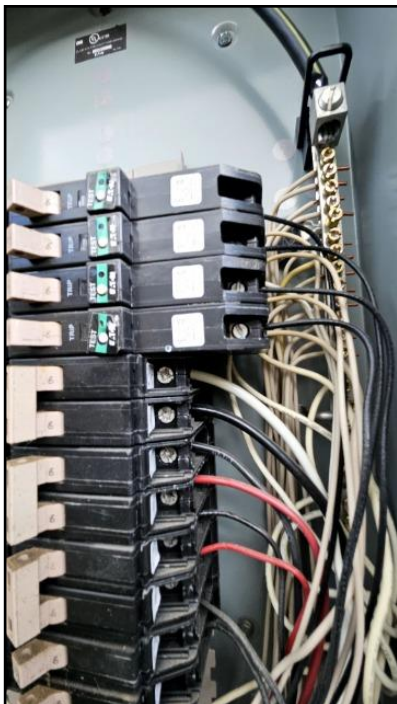
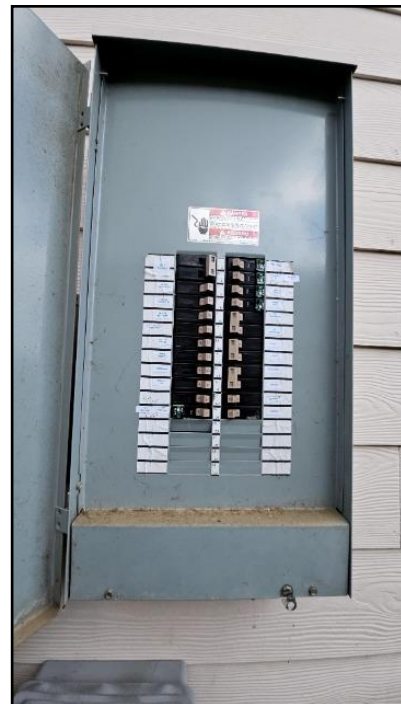
**14. Condition:** • Electrical outlets and breaker panels were inspected, however if the home is 40 years or older, and or new an appliance has been added, and or the home had any renovation. In any situation, a licensed electrician must perform the electrical inspection.

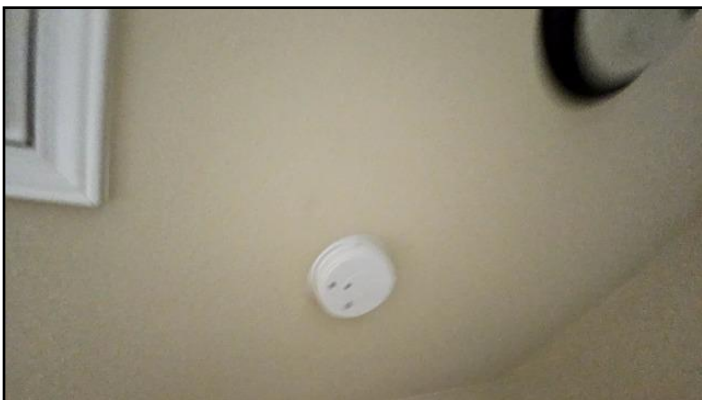
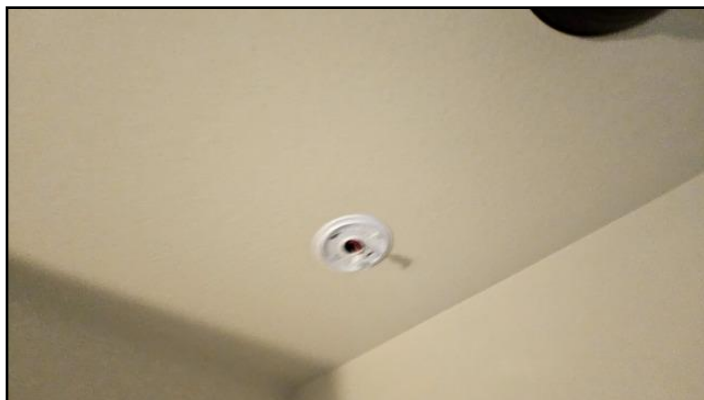
**15. Condition:** • Inspector is unable verify if the CO2 or smoke detectors are installed or working properly, Inspector recommends having it verified and tested prior to occupancy.

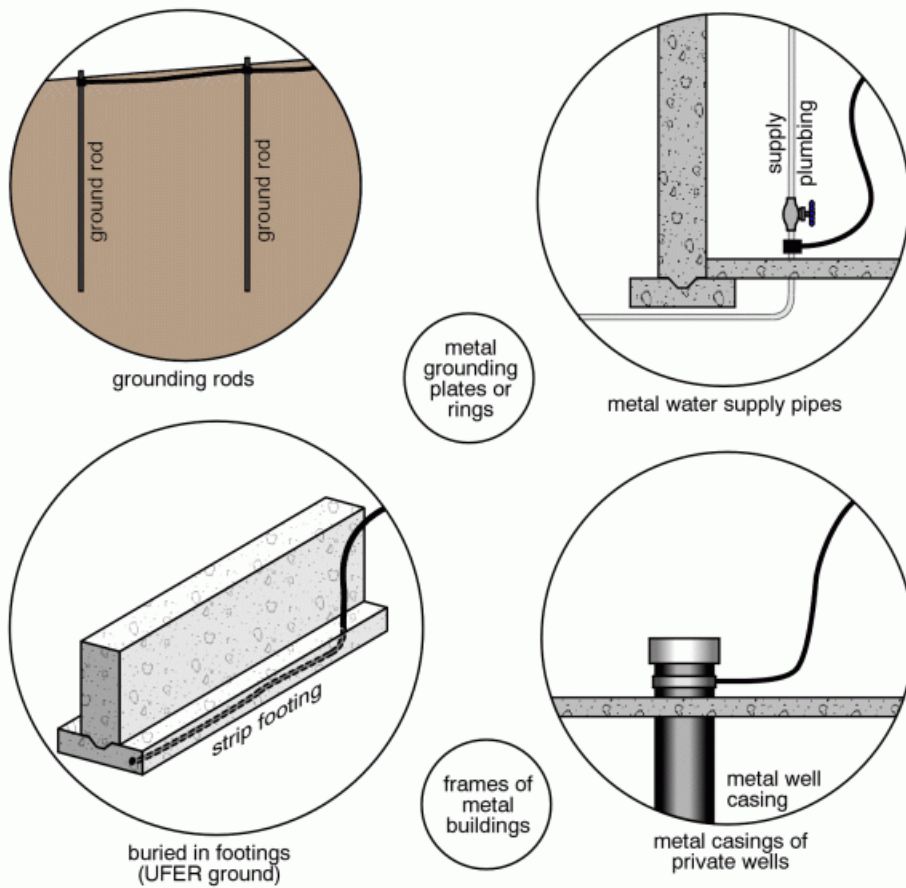
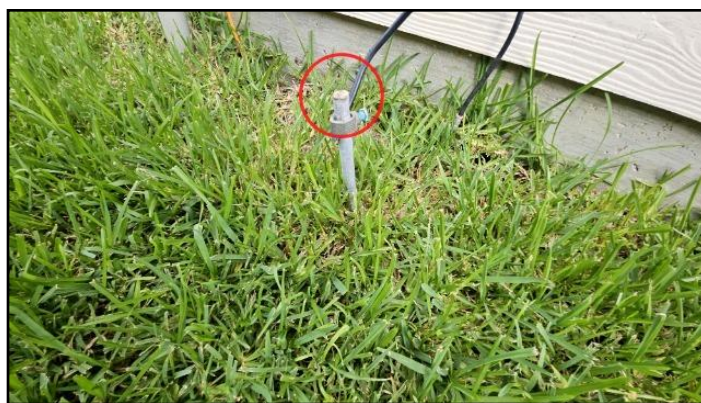
51.

**17. Condition:** • Ground Rod should be flush with the grade, recommend to have it corrected. As per code

Inspector recommends having it corrected and service the electricals systems for the house by a licensed electrician

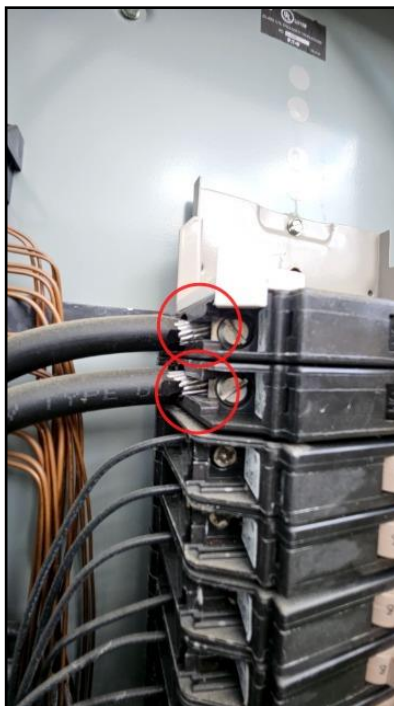
52.

**18. Condition:** • Anti-oxidant missing - At the time of inspection, it was noted that the aluminum main service wires were missing anti-oxidant gel. Aluminum service wires can become very hot and also corrode over time. It is crucial to apply an anti-oxidant gel to the wires where they meet the main lugs of the service panel. Recommend to have it serviced by licensed electrician.

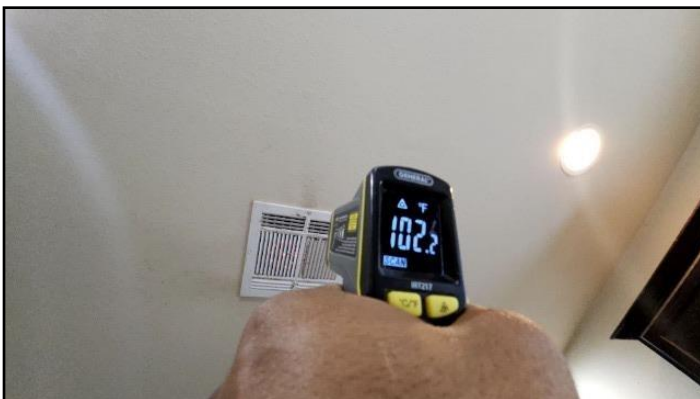
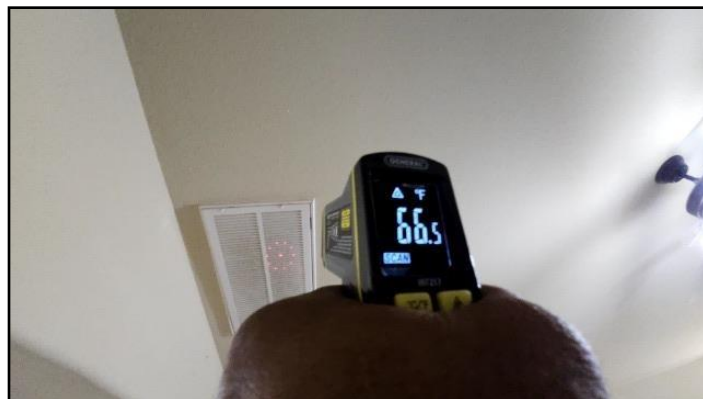
**19. Condition:** • The heating system was tested was working at the time of inspection. It is recommended that all furnace units especially those more than 10 years of age be further evaluated by licensed HVAC technician. Inspector is not a licensed to open up the units to check its components. Heating system consist of the heating equipment, operating and safety controls, venting and the means of distribution. These items are visually examined for proper function, excessive or unusual wear and general state of repair. This is a non-evasive, basic function review only. We do not dismantle, uncover or calculate efficiency of any system. Regular servicing of the Heating system is encouraged by a licensed HVAC technician.

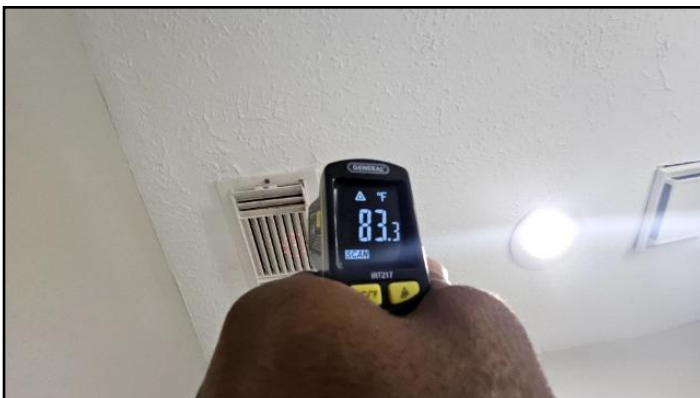
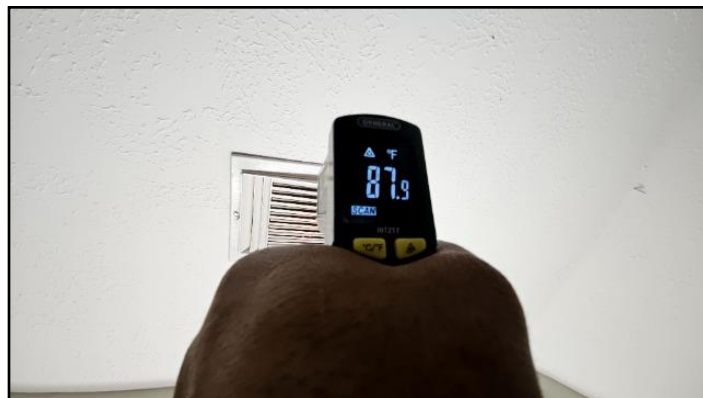
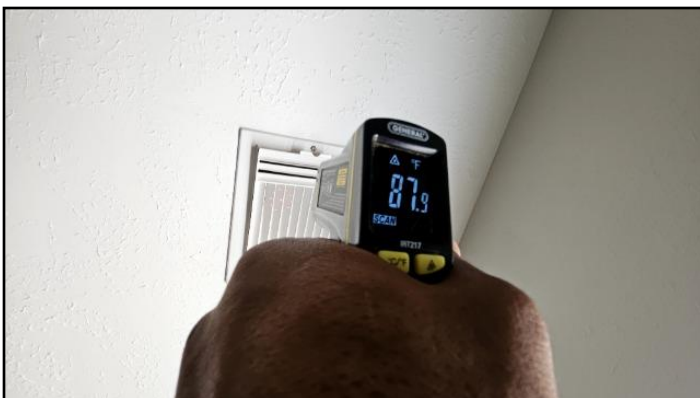
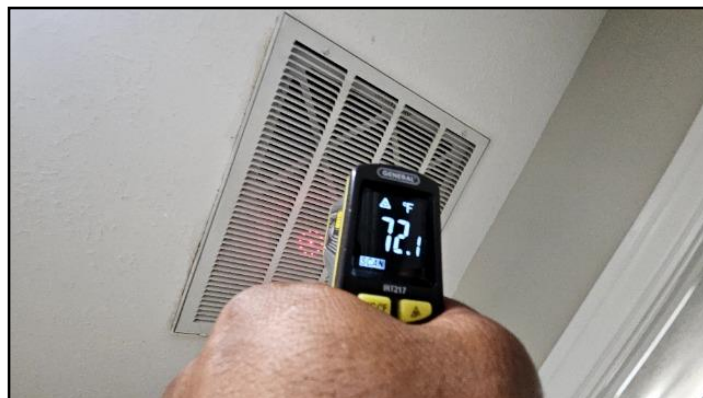
**20. Condition:** • The heating system was tested was working at the time of inspection. It is recommended that all furnace units especially those more than 10 years of age be further evaluated by licensed HVAC technician. Inspector is not a licensed to open up the units to check its components. Heating system consist of the heating equipment, operating and safety controls, venting and the means of distribution. These items are visually examined for proper function, excessive or unusual wear and general state of repair. This is a non-evasive, basic function review only. We do not dismantle, uncover or calculate efficiency of any system. Regular servicing of the Heating system is encouraged by a licensed HVAC technician.

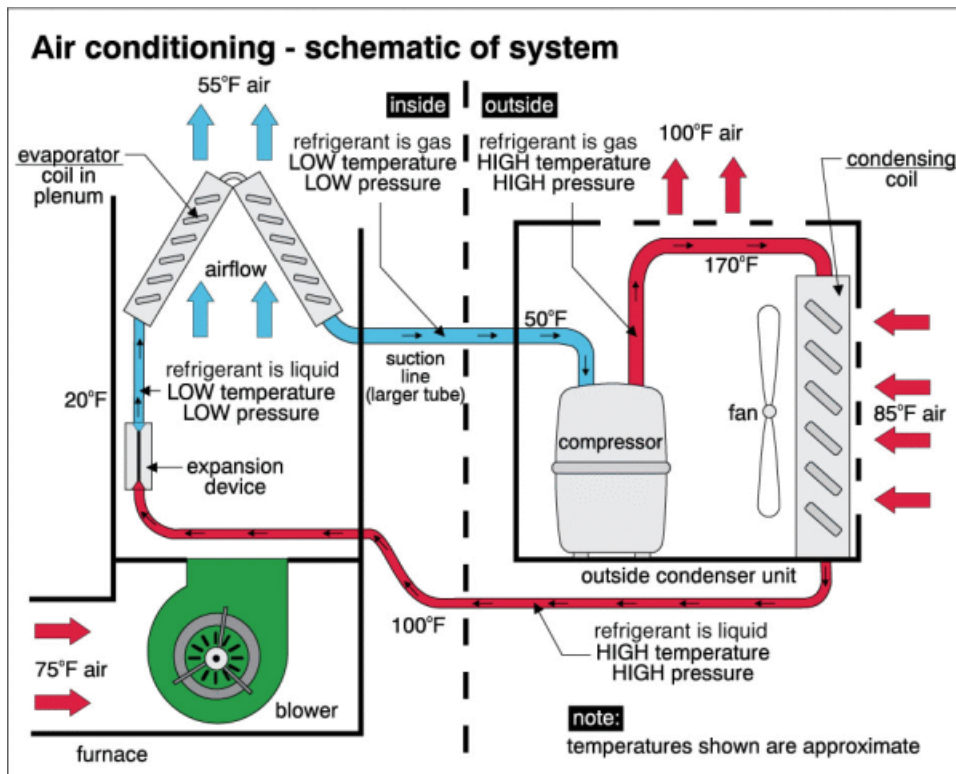
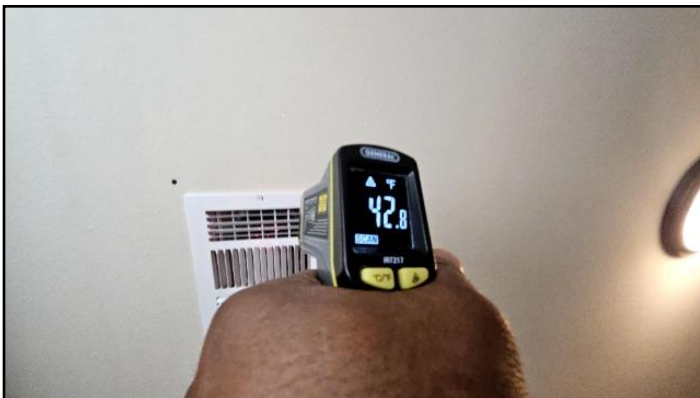
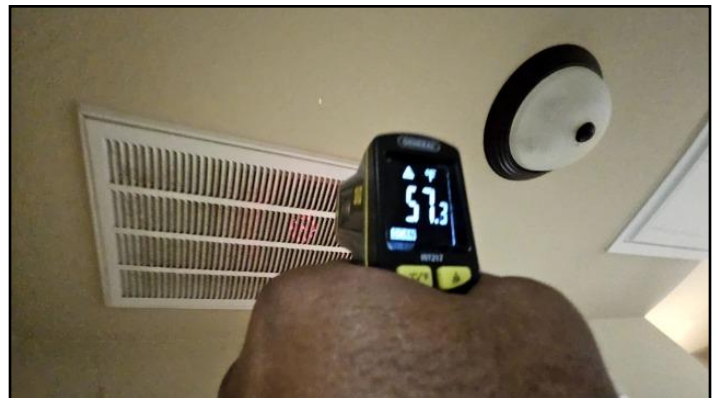
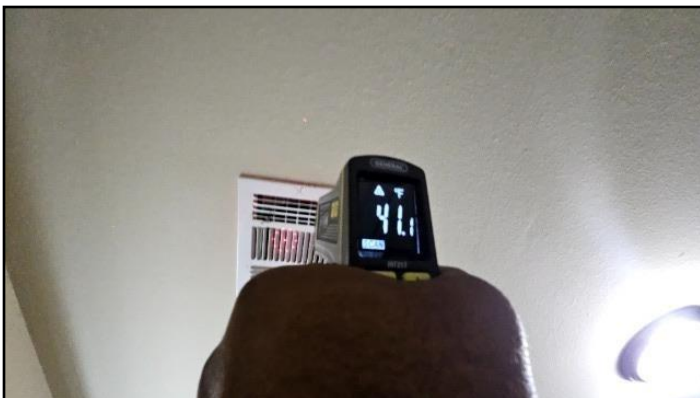
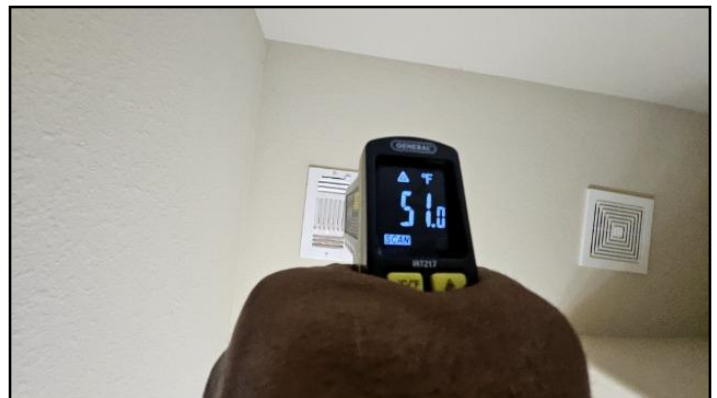
**21. Condition:** • Visual inspection was performed on Evaporator coil and the compressor. Although everything is functioning as expected at the time of inspection. It is recommended to have License HVAC person service the unit(s) prior to the option period expires. [Visual inspection HVAC]

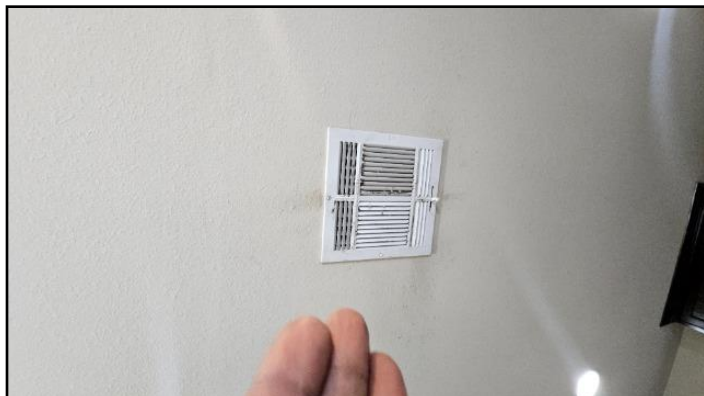
81.

**23. Condition:** • Mold / mildew like substance noted on the HVAC registers.

Recommended have it further evaluated repair and replace a needed.

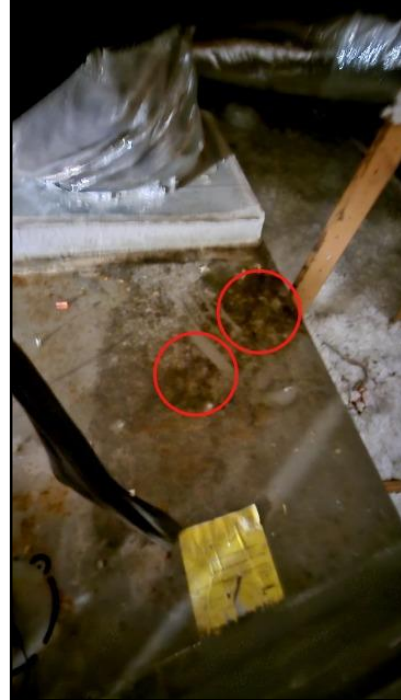
83.

**24. Condition:** • The inspector observed condensation on the HVAC plenum in the attic during the inspection. This condensation can be a sign of potential issues such as inadequate insulation, improper ventilation, or a malfunctioning HVAC system. Excess moisture can lead to mold growth, water damage, and decreased efficiency of the HVAC system. It is recommended to have a qualified HVAC technician evaluate the situation to determine the underlying cause of the condensation

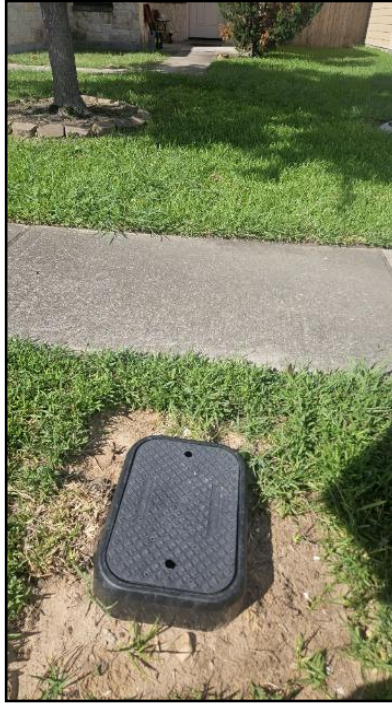
90.

26. **Condition:** • Main water shut off location. Please note this area in the case of emergency

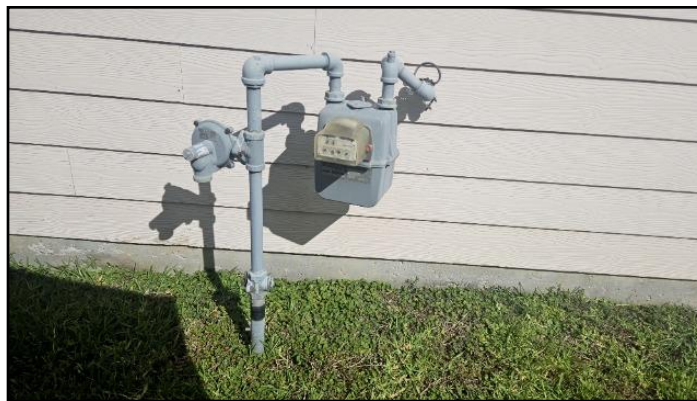
91.

27. **Condition:** • Gas shut off location on the exterior side of the house.

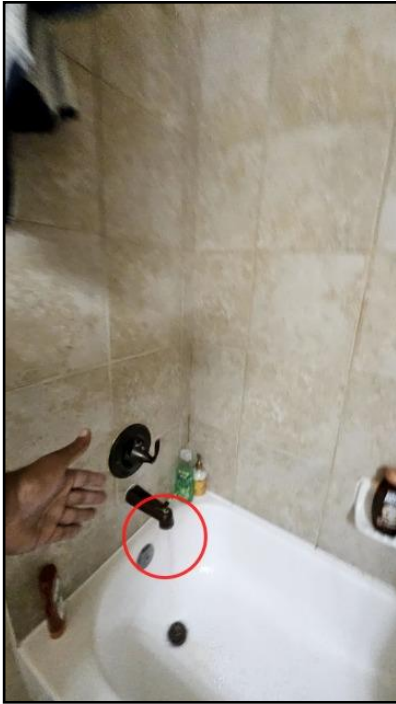
100.

**31. Condition:** • Shower diverter issue noted.

Worn rubber washers, seals or gaskets in the valve assembly cause most leaks.

Inspector recommends licensed plumber service the house repair and replace all plumbing issues.

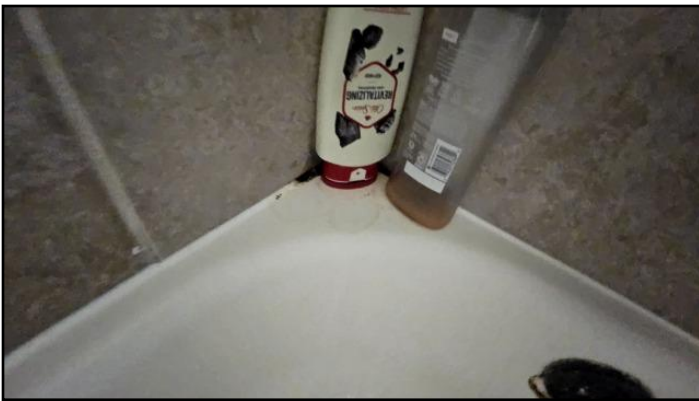
107.

### 35. Condition: • Caulking loose, missing or deteriorated

Caulking line failure/breaks down over time in a bathroom and kitchen between various plumbing fixtures and floor joints in a bathroom, especially around sinks, bathtubs, and showers.

The inspector noted at the time of inspection existing caulking has deteriorated/missing. The Inspector recommends that this

sealant be removed and replaced to help prevent the development of unhealthy conditions.

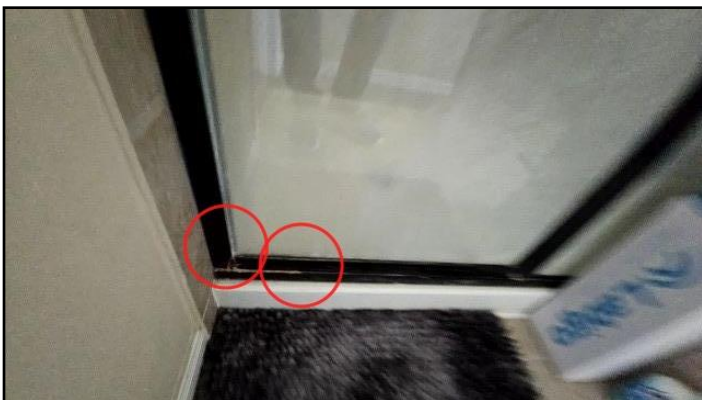
113.

**36. Condition:** • Shower stall issues noted at the time of inspection. shower door does not keep water inside the stall. Inspector recommends having the door tightly sealed and having door frames close properly.

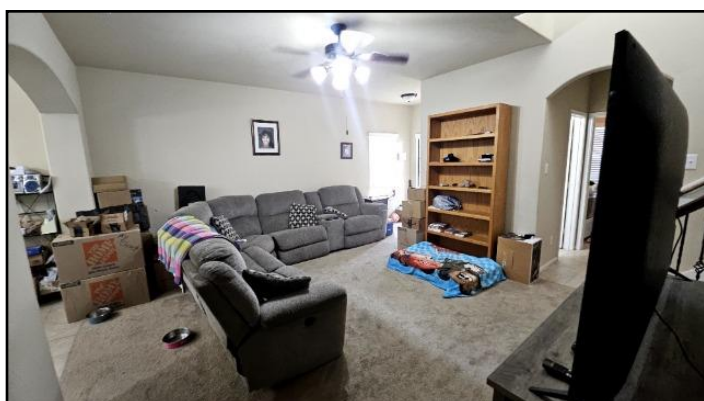
125.

**38. Condition:** • During the inspection, it was noted that the property was occupied, and as a result, the inspector's

visibility was limited due to storage, furniture, and materials. This means that cracks and damages that may be concealed behind furniture or other items may not have been visible or inspected.

It is important to note that items may be moved and appliances may be turned off or not working. Therefore, it is recommended that all appliances, plumbing, walls, and floors be checked prior to closing the property that they are in good working condition and free from any damage.

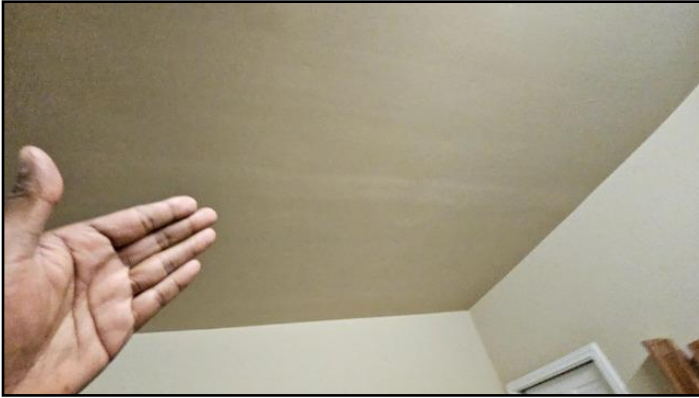
128.

**39. Condition:** • Poorly jointed Sheetrock can cause gaps, bulges, and uneven surfaces that detract from the look of the finished product. It can also lead to cracks in the Sheetrock, which can lead to further problems down the line. To prevent this, make sure to use a good joint compound and to apply it evenly and carefully. Use tape to reinforce the joints, and smooth out any ridges or bulges with a putty knife.

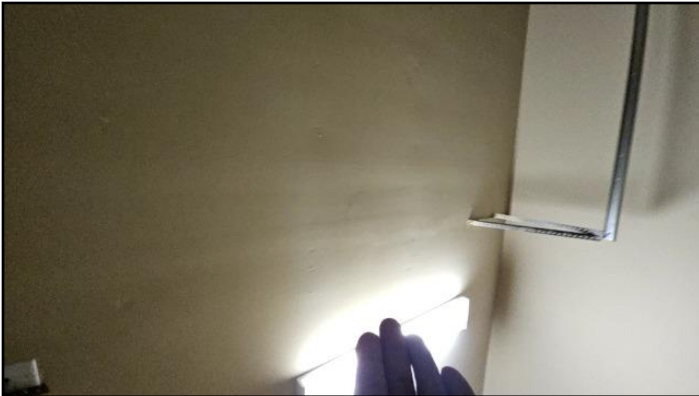
130.

**40. Condition:** • drywall damage noted at one more location the time of the inspection. Before the expiration of your Inspection Objection Deadline you may wish to consult with a qualified contractor to discuss options and costs for repairs.

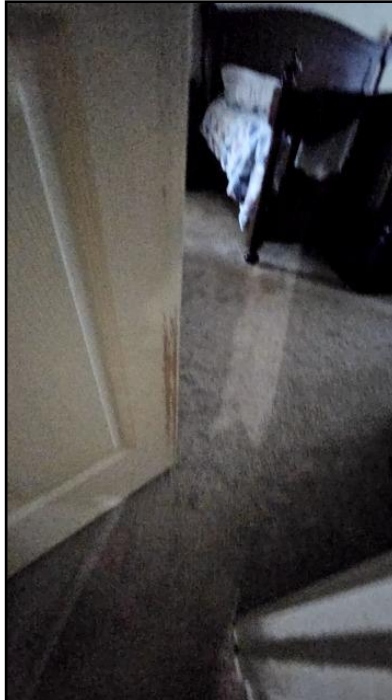
137.

**42. Condition:** • The Inspector observed that the door on the inside of the house was damaged and suggested that it be replaced.

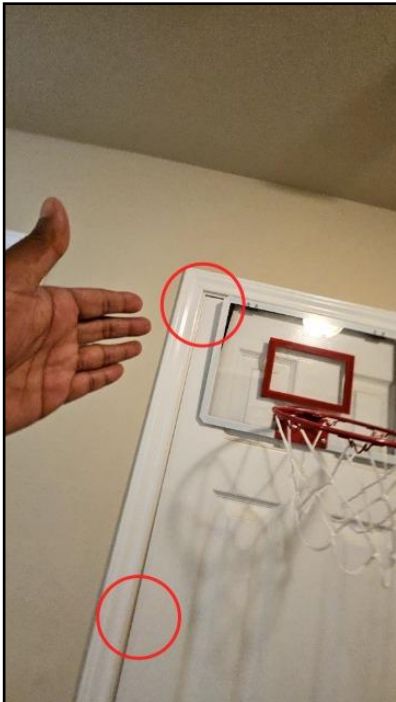
139.

**44. Condition:** • Inspector noted the door may not close properly due to the misalignment and may need to be adjusted

or replaced.

2. There may be gaps in the doorway that allow air or insects to enter the home.
3. The door may not be secure if the hinges are loose.
4. The door may be difficult to open and close if it is not properly aligned.

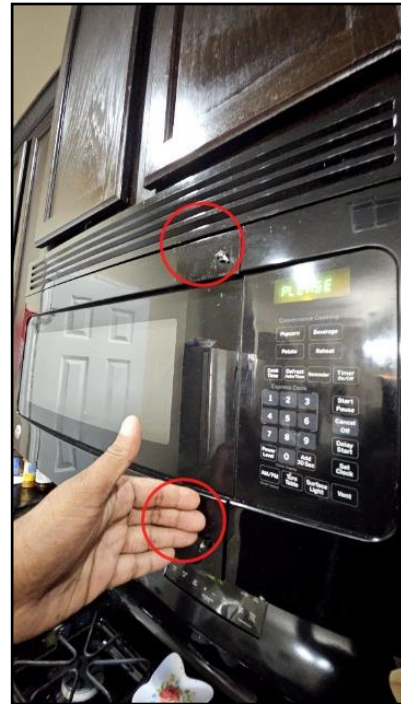
145.

**46. Condition:** • The microwave handle is broken/missing and needs to be repaired or replaced. The handle is essential for opening and closing the microwave door. Recommend having it corrected.
