September 10, 2024

PROPERTY INSPECTION REPORT FORM

310 Terminal St. A,B,C, Houston, TX 77020

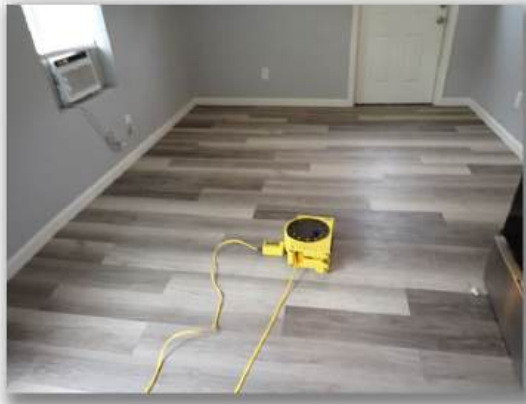
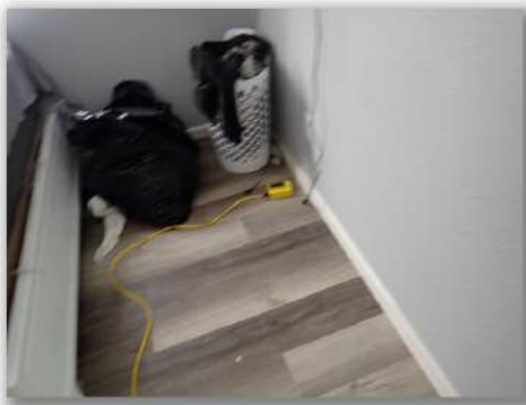
The foundation appears to have had movement that may be beyond normal. A Professional Engineer licensed by the State of Texas should be consulted on the current integrity of the foundation and any repairs that may be necessary (If Any). The observations made to support the rendering of this opinion are listed but not limited to the following:

- In my opinion, this foundation is showing signs of movement that exceeds normal tolerances. The changes in the floor elevation of the house were greater than what would normally be expected.
- Floor slopes and/or unlevelness were observed.

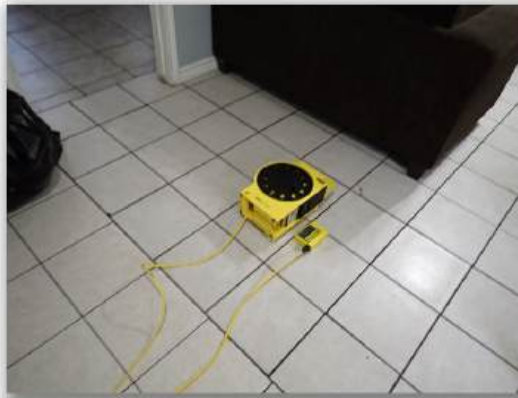
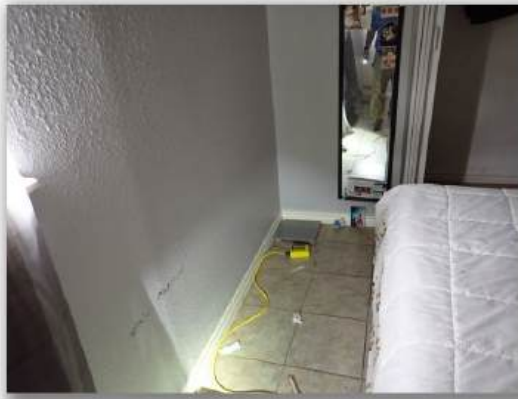
The foundation appears to have had movement that may be beyond normal. A Professional Engineer licensed by the State of Texas should be consulted on the current integrity of the foundation and any repairs that may be necessary (If Any). The observations made to support the rendering of this opinion are listed but not limited to the following:

- In my opinion, this foundation is showing signs of movement that exceeds normal tolerances. The changes in the floor elevation of the house were greater than what would normally be expected.
- Floor slopes and/or unlevelness were observed.

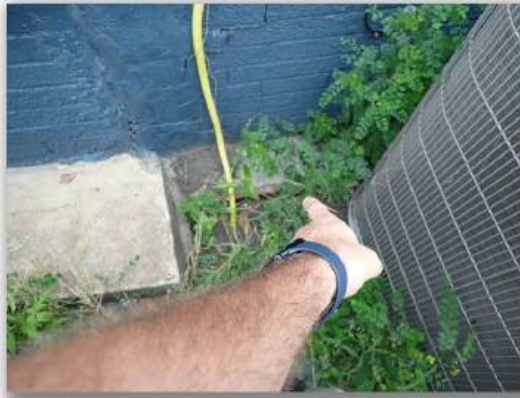
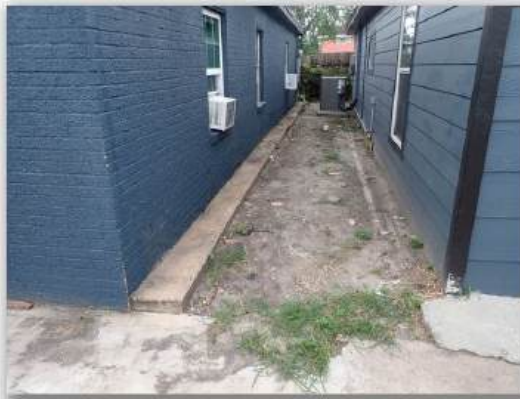
Grading & Drainage

- Fill dirt is needed against the foundation perimeter wall where the soil line is too low to help support the foundation beam footer properly on the south side of the structure.
- **Poor to negative site drainage** was observed on the north, east, west and south sides of the structure. Proper drainage is needed to help prevent water from standing and/or pooling next to the foundation beam. Corrective measures may be needed if the water stands within 10-feet of the foundation perimeter beam for more than 24-hours.

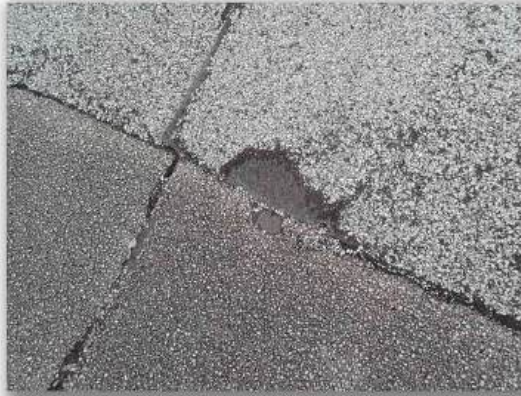
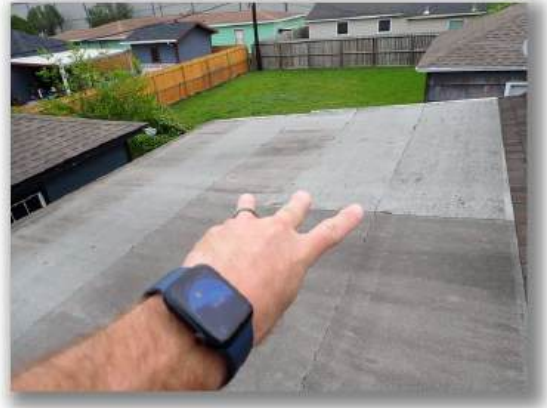
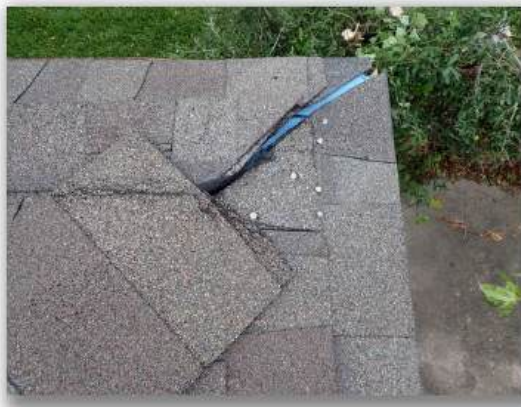
Roof Covering, Unit C

You are strongly encouraged to have a properly certified roofing contractor to physically inspect the roof, prior to the expiration of any time limitations such as option or warranty periods, to fully evaluate the condition of the roofing material. The observation made to support the rendering of this opinion are listed but not limited to the following:

- Damaged shingles were observed on the west side of the roof structure.
- The tree branches are too close to the roof and should be trimmed.
- The inspector identified soft decking in one or more locations of the roof structure. It is recommended to add additional support in this area.

- Exposed fasteners were observed at the shingles in one or more locations.
- The felt paper was observed to be installed under the lower metal drip edge flashing detail. The manufacturer installation requires the felt paper to be installed over the top of the metal drip edge flashing, in shingle like fashion, to help prevent water intrusion and/or damage to occur behind the fascia board and soffit/eave areas.

- One or more of the shingles were observed to be lifting on the east and west sides of the roof structure.
- Shingle fasteners (staples and/or nails) were observed to be pushing through the roofing material.

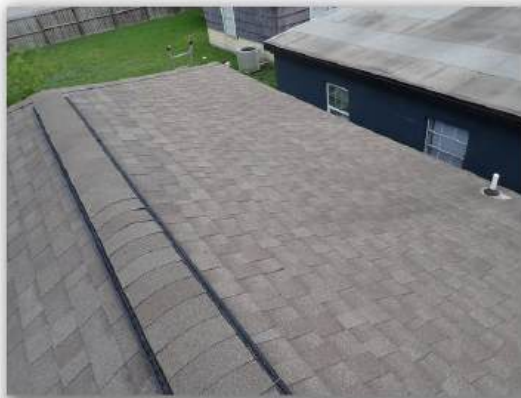
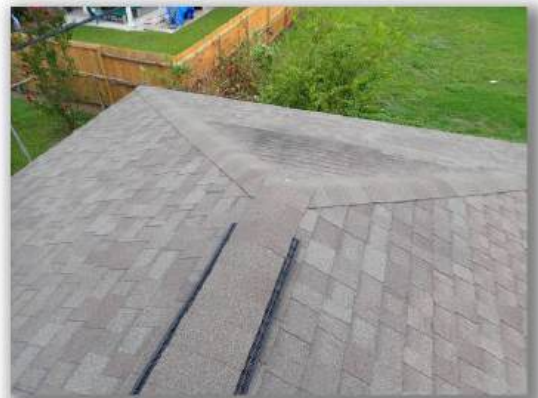
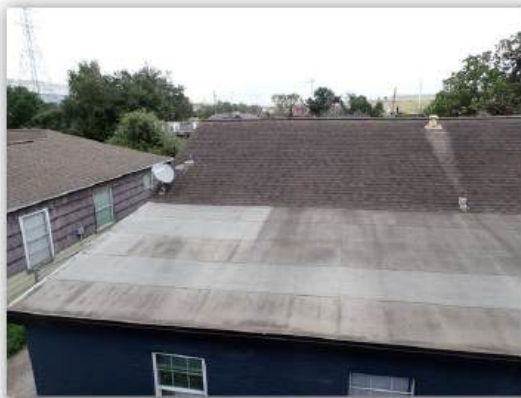
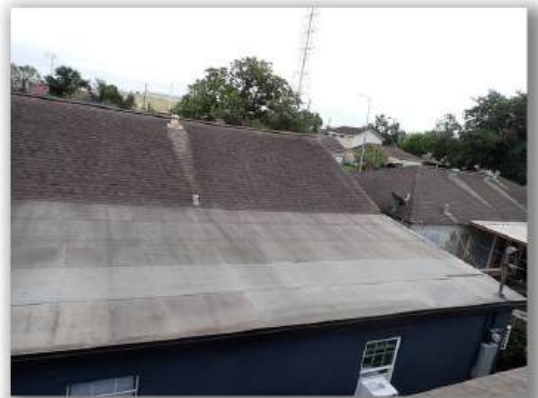
Flashing Details

The flashing details should be checked, reset or repaired as necessary. The observations made to support the rendering of this opinion are listed but may not be limited to:

- Roof fasteners (nails and/or staples) were observed to be exposed and should be properly sealed at the flashing areas.
- It is recommended to paint the flashing details to prevent rust and/or UV damage.

- Caulking improvements are recommended at the roof flashing areas. Damaged, deteriorated or missing caulking was observed at the time of inspection.
- The flashing is lifting and/or pulling loose on the west side of the roof structure. This condition could allow water intrusion at this location.

- It is recommended to properly seal the storm collar(s) at the roof level gas equipment vent pipe(s) to help prevent water intrusion into the structure.

- Some of the metal flashing details were observed to be rusted.
- The gas appliance flue was observed to be terminated at the roof level into a bonnet type vent. This configuration is susceptible to back drafting which could emit Carbon Monoxide into the attic area, which is a known safety hazard.

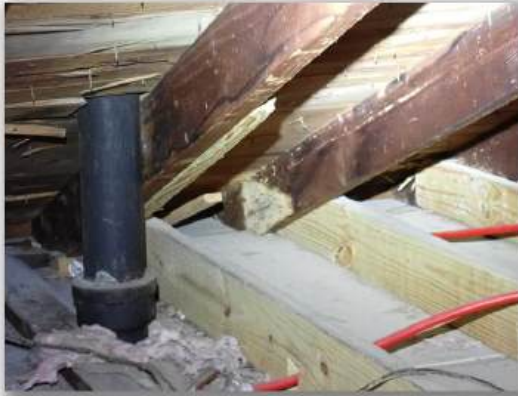
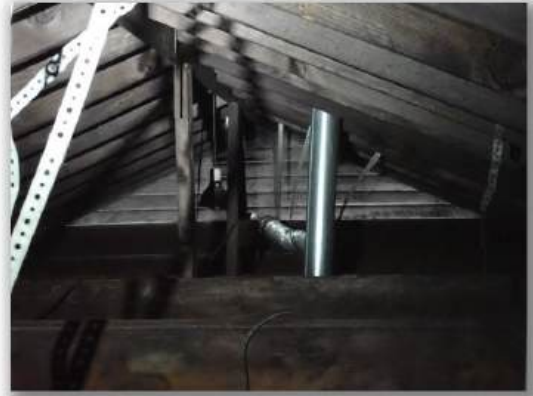
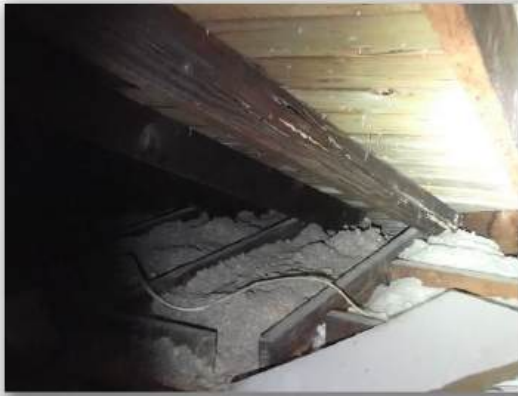
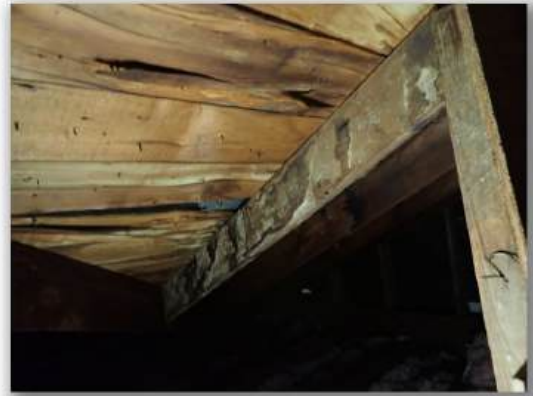
Note: There are visible water stains on the roof sheathing (decking) in one or more locations.

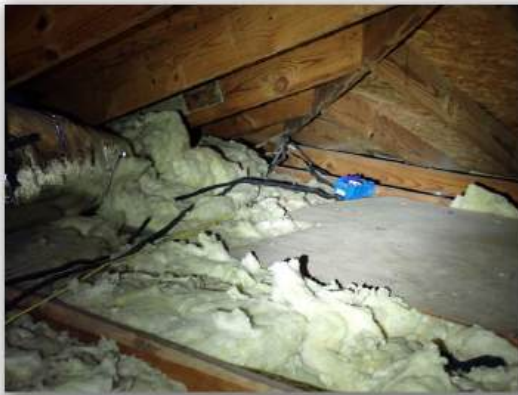
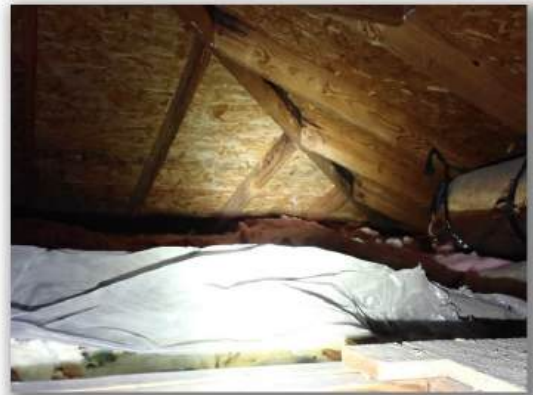
Roof Structure Unit B

- **Note:** There are visible water stains on the roof sheathing (decking) in one or more locations.

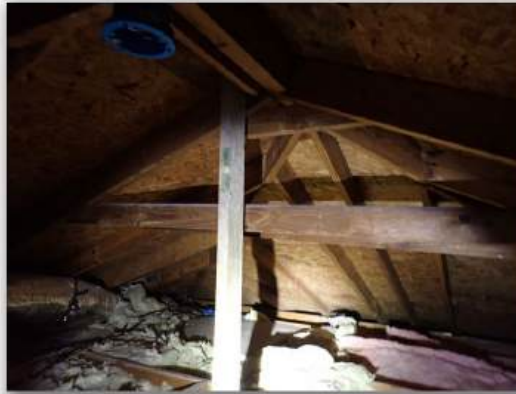
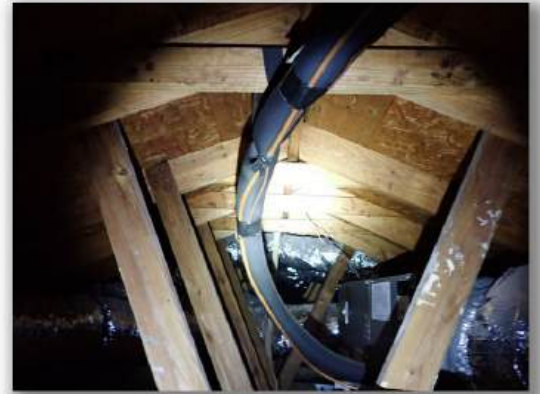
- The roof structure attic space does not appear to be adequately ventilated. It is recommended to increase the amount of lower and upper ventilation to help prevent heat buildup in the attic space area.
- The attic gable vent screen(s) were observed to be damaged and/or missing.

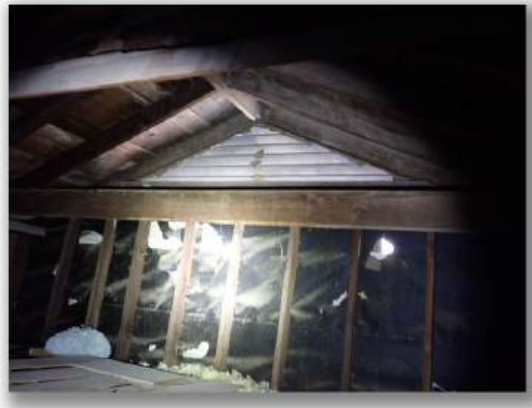
Attic Ventilation Unit C

- The roof structure attic space does not appear to be adequately ventilated. It is recommended to increase the amount of lower and upper ventilation to help prevent heat buildup in the attic space area.

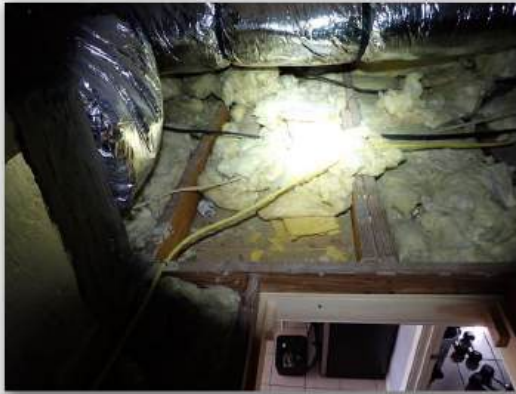
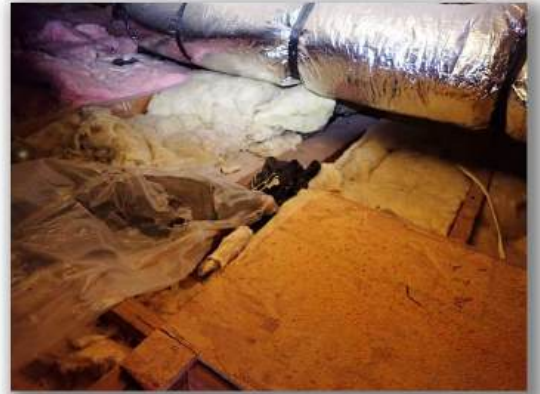
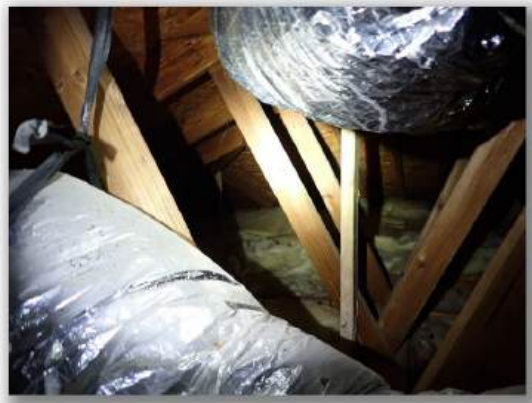
Attic Insulation Unit C

- The attic floor insulation was observed to be missing over the several locations throughout the house.
- The attic insulation is lower than typical and it is recommended to add additional insulation to achieve at least a R-38 rating.

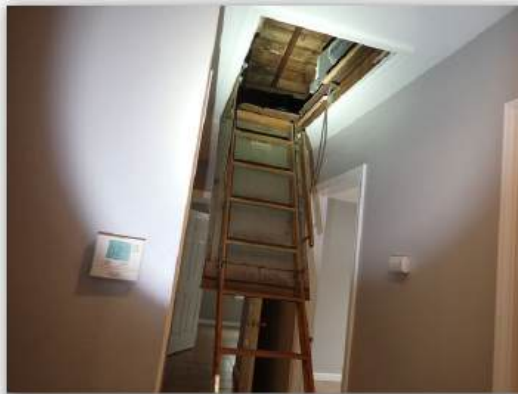
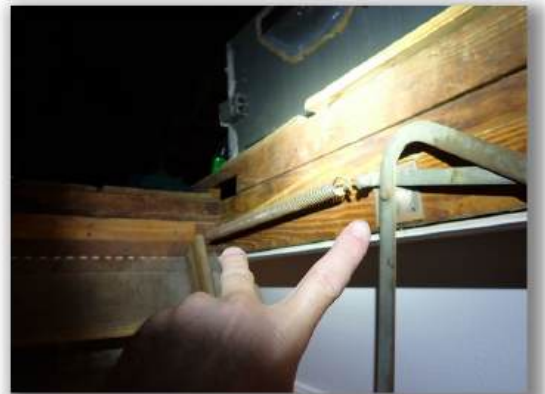
- The attic ladder was observed to be installed with improper fasteners. The attic ladder should be secured in place with 16d nails or 3-inch lag bolts. This condition should be further evaluated and corrected as necessary.

Note: The attic ladder/hatch door is not insulated at this time. This is an "As Built" condition that does not meet current energy standards. It is recommended to insulate the ladder/hatch door.

Note: There was no weather-stripping observed around the attic ladder/hatch opening. This is an "As Built" condition that does not meet current energy standards. It is recommended to weather-strip the ladder/hatch opening.

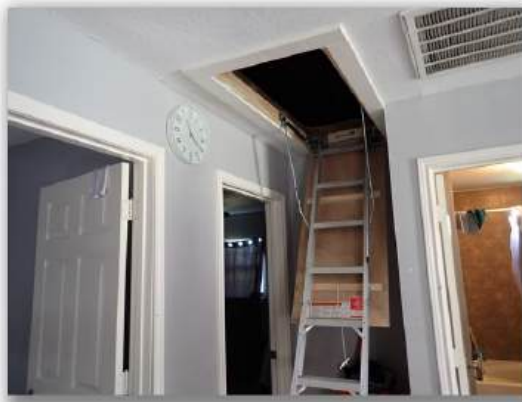
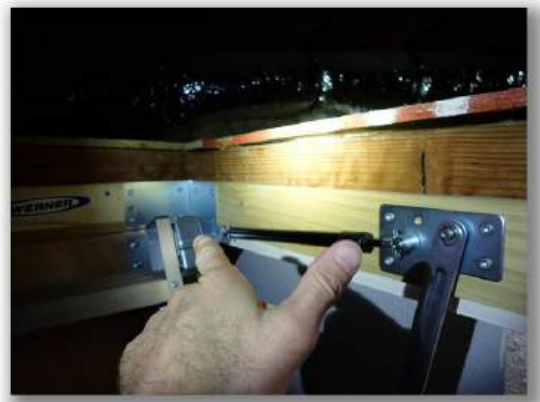
- The attic ladder was observed to be installed with improper fasteners. The attic ladder should be secured in place with 16d nails or 3-inch lag bolts. This condition should be further evaluated and corrected as necessary.

Note: The attic ladder/hatch door is not insulated at this time. This is an "As Built" condition that does not meet current energy standards. It is recommended to insulate the ladder/hatch door.

Note: There was no weather-stripping observed around the attic ladder/hatch opening. This is an "As Built" condition that does not meet current energy standards. It is recommended to weather-strip the ladder/hatch opening.

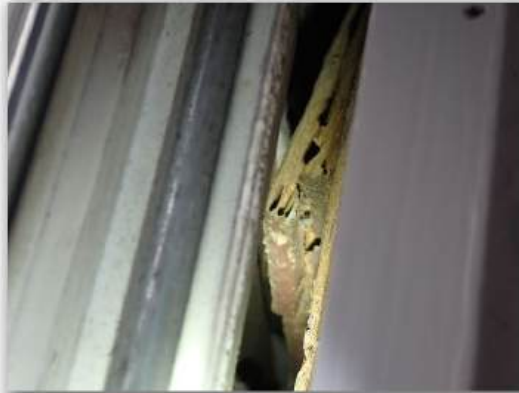
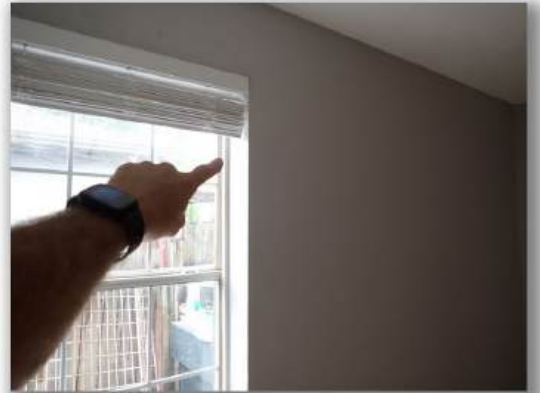
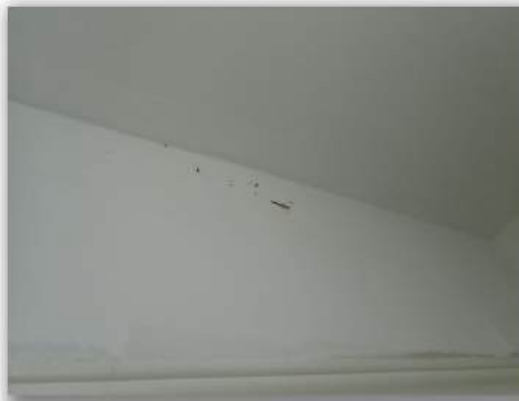
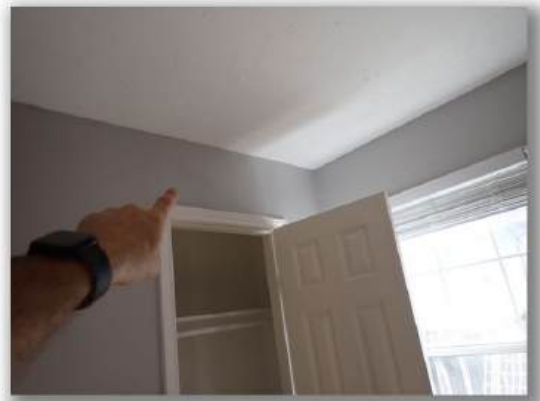
- Interior wall finishes were observed to have termite damage in the rear corner bedroom.
- Water stains were observed on the walls in the rear corner bedroom closet. The cause and remedy should be further evaluated and corrected as necessary.

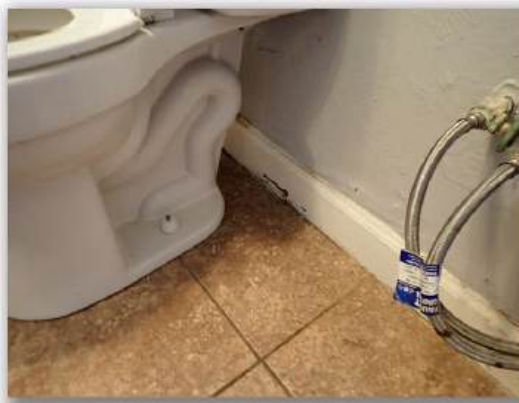
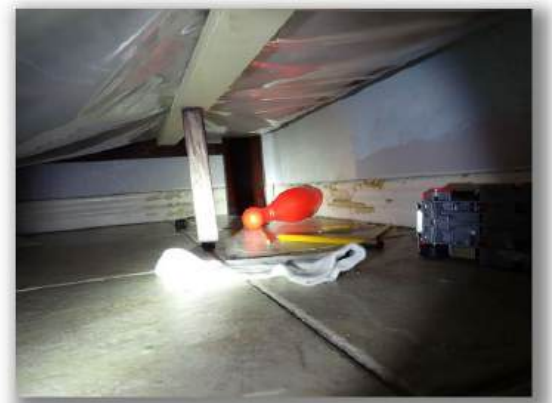
- The cabinet door is loose at the hinges in the kitchen.
- The baseboards were observed to be water stained and/or damaged in the hall bathroom, rear corner bedroom. The cause and remedy should be further evaluated and corrected as necessary.
- Interior wall finishes were observed to have termite damage in the rear corner bedroom, hall bathroom.
- Wall surface damage was observed in the several locations throughout the house.
- The cabinet doors are not operating properly in the kitchen.

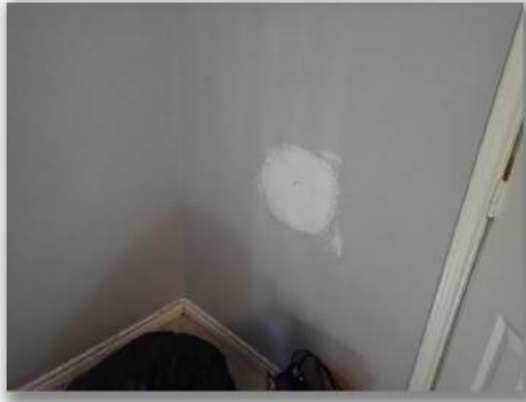
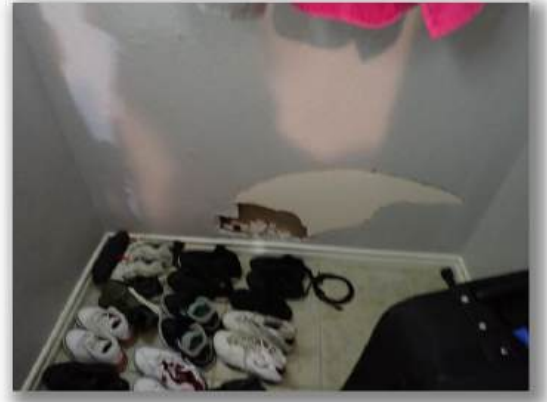
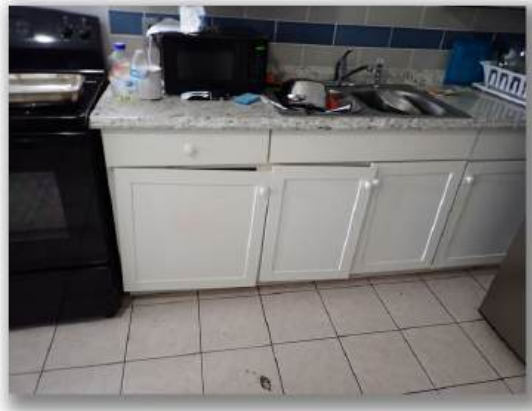
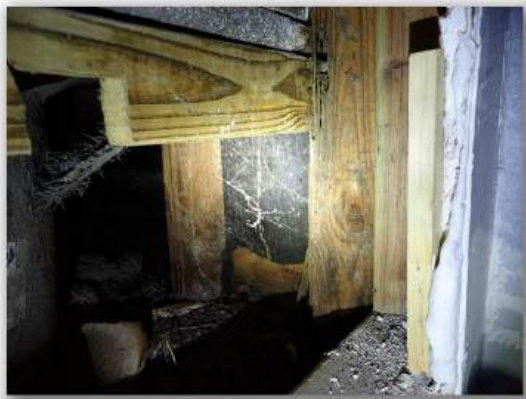
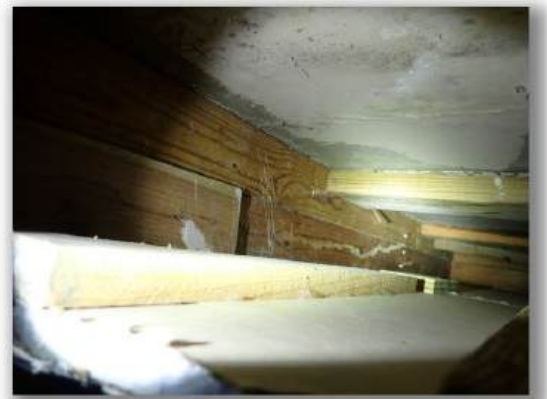
Wood Destroying Insect Information

Evidence of active and/or previous activity of a wood-destroying insect was detected at the time of this inspection. Full evaluation of the amount of damage caused by the insects cannot be detected within the wall voids or other hidden areas without defacing the property and cannot be addressed in this inspection report. With the detection of active and/or previous activity of a wood destroying insect, it should be assumed that some degree of damage is present.

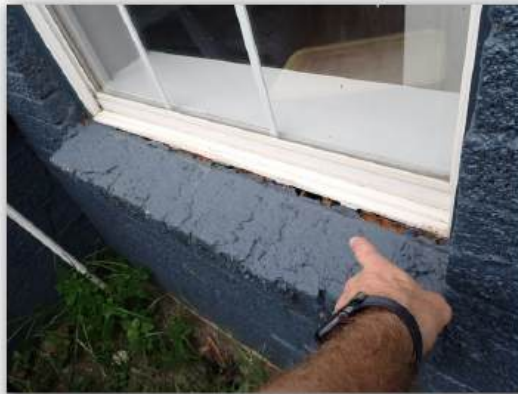
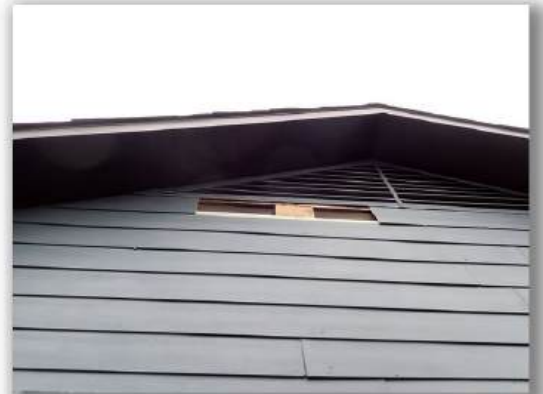
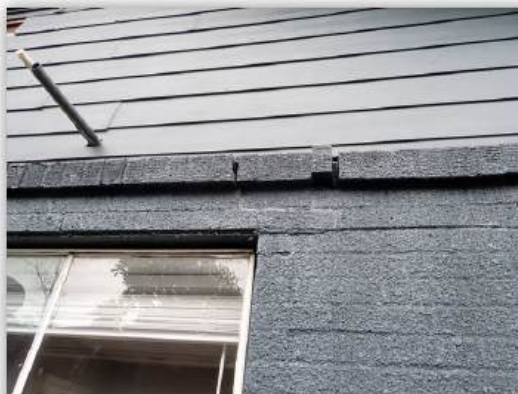
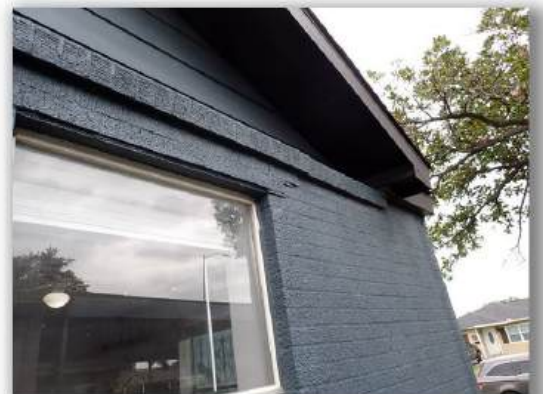
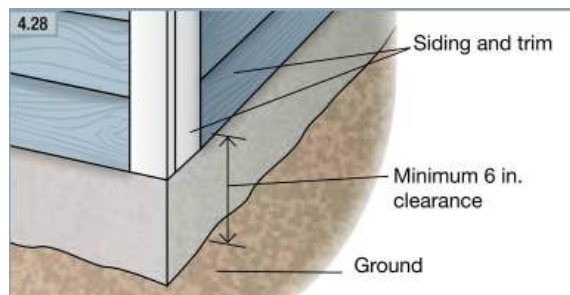
Exterior Walls & Surfaces, Unit C

- The exterior veneer / cladding has some deterioration and/or damage on the north, east, west and south sides of the structure.
- The fiber cement siding has poor clearance to the ground. Under current installation standards, there should be a minimum 6" clearance from the bottom of the fiber cement siding to the ground.
- Caulking improvements are recommended for the area between the exterior veneer and the window frames. It is recommended to use an elastomeric sealant.

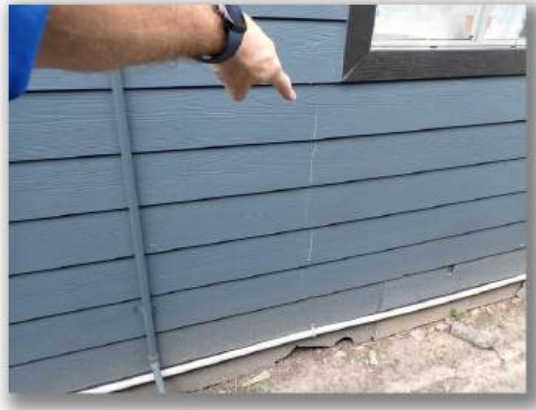
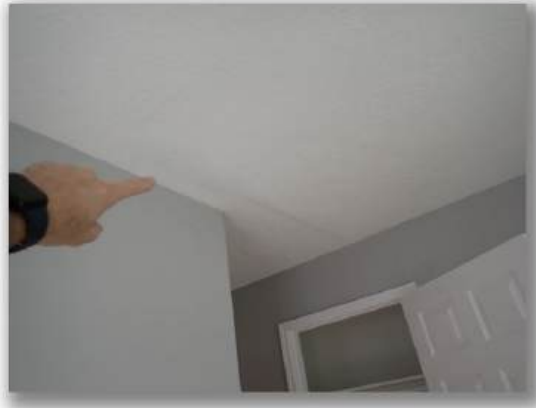
- The ceiling was observed to be damaged in the several locations throughout the house.

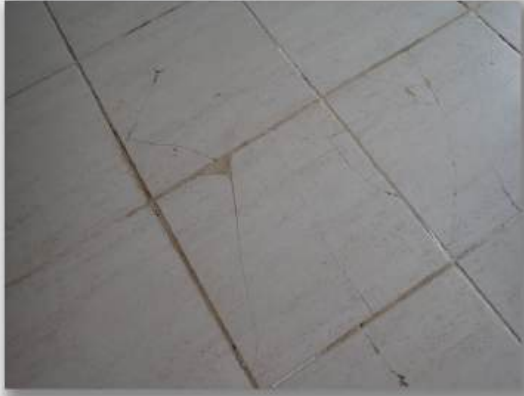
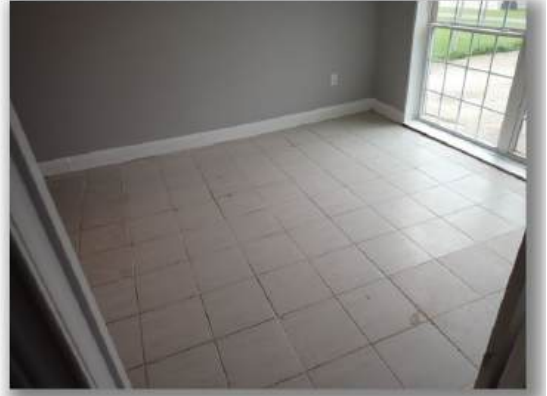
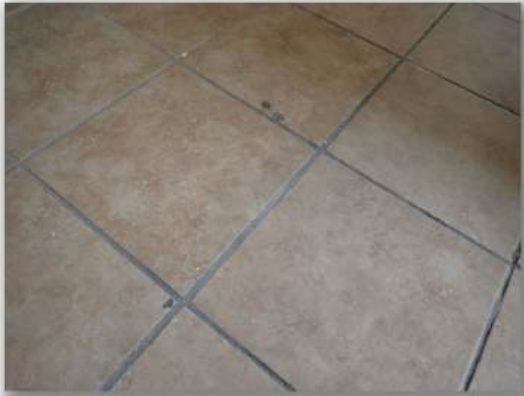
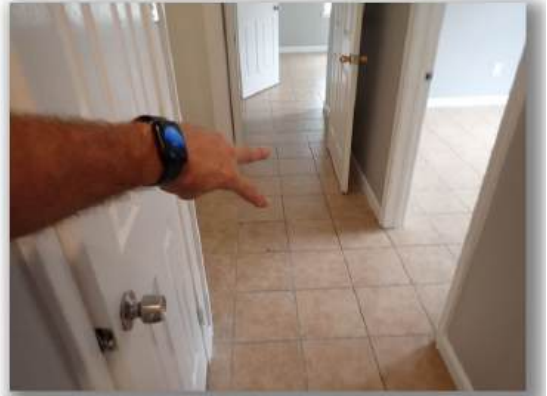
Floors Unit A

- The floor tile(s) were observed to be cracked and/or damaged in the several locations throughout the house.

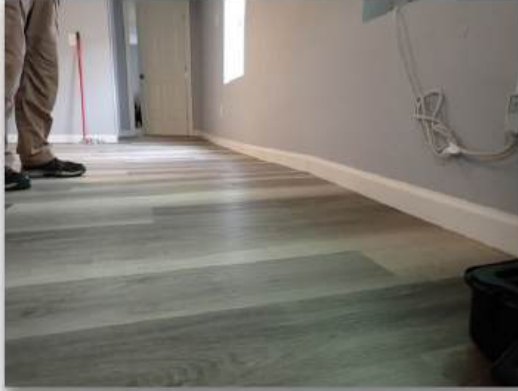
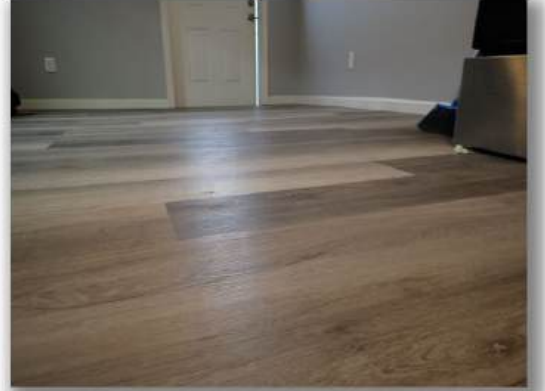
Floors Unit B

- The floors were observed to be out-of-level in some areas of the house.

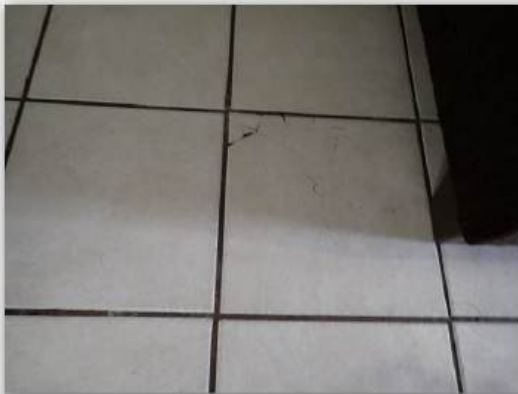
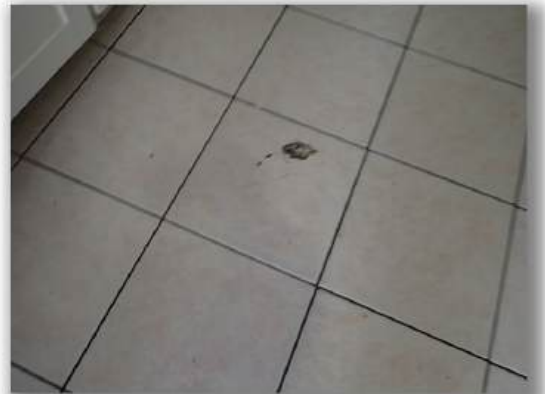
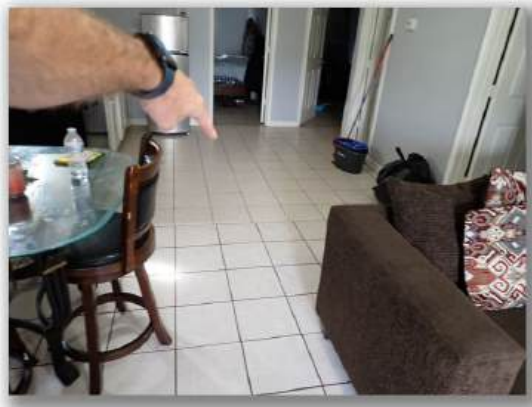
Floors Unit C

- The floor tile(s) were observed to be cracked and/or damaged in the several locations throughout the house.
- The floors were observed to be out-of-level in some areas of the house.

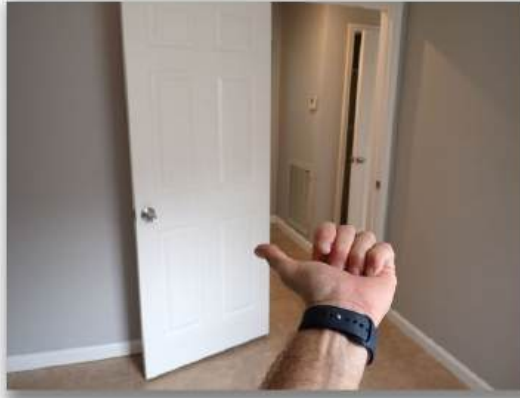
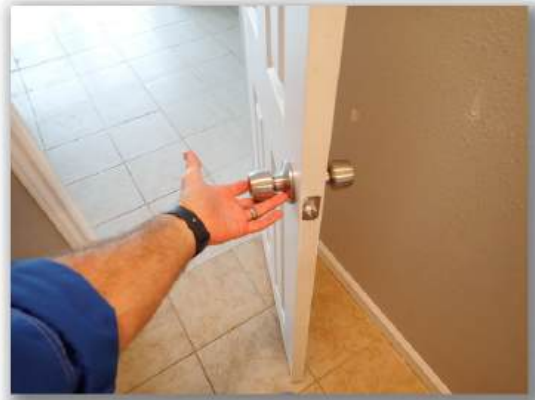
Interior Doors Unit A

- The door does not stay in position to the rear corner bedroom.
- The door is sticking to the front corner bedroom.
- The door hardware is loose to the primary bathroom.

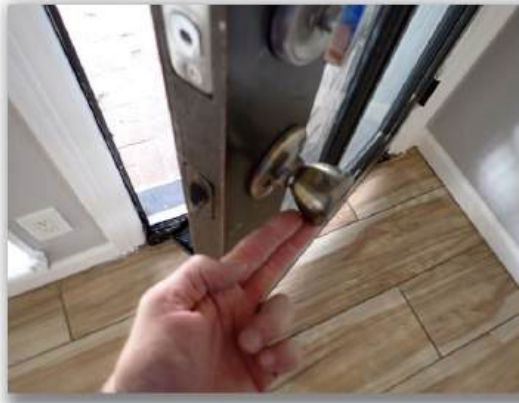
Exterior Doors A

- The door hardware is loose to the front entry door.
- The door is sticking to the front entry door.
- Weather-stripping improvements are recommended for the front entry exterior door(s).

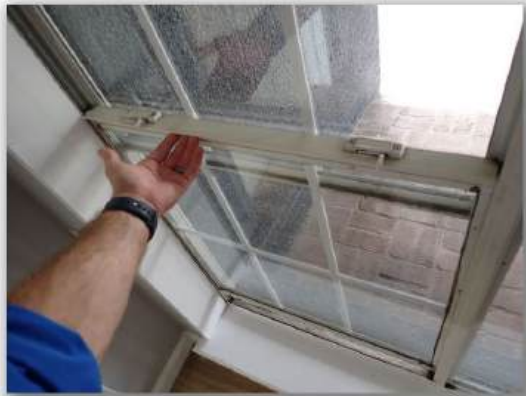
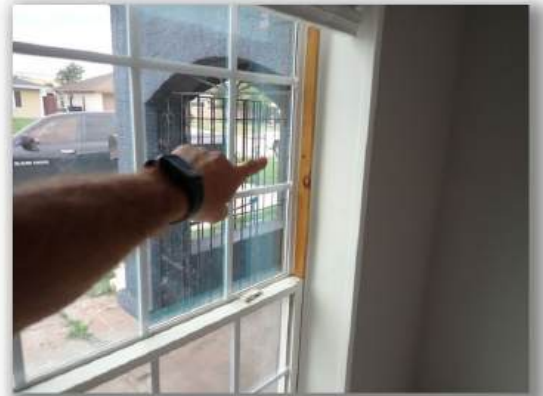
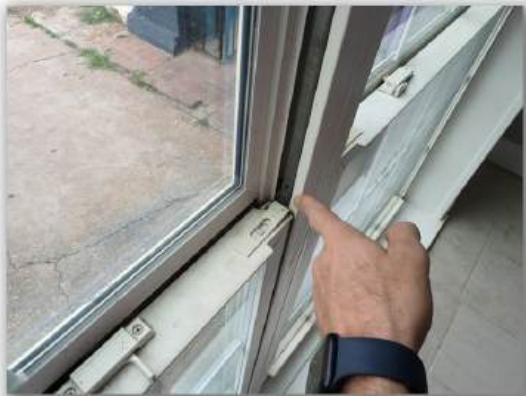
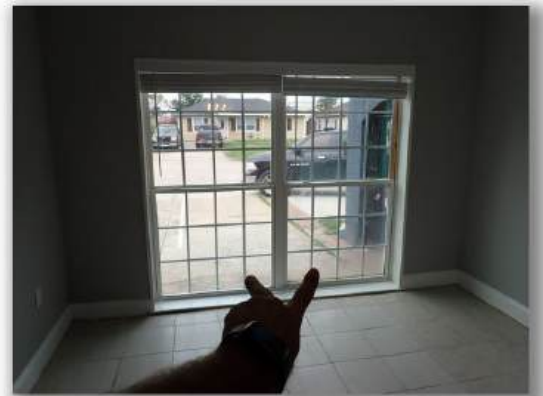
Windows, Unit B

- The window guide is damaged and the window will not stay in the open position in the kitchen.
- One or more of the thermal pane windows were observed to have lost their seals. This has resulted in condensation or a fog like film to develop between the panes of glass. The thermal pane windows no longer function as designed when they lose their seal and replacement may be necessary. The windows that have noticeably lost their seals are listed but may not be limited to the following:
living room.

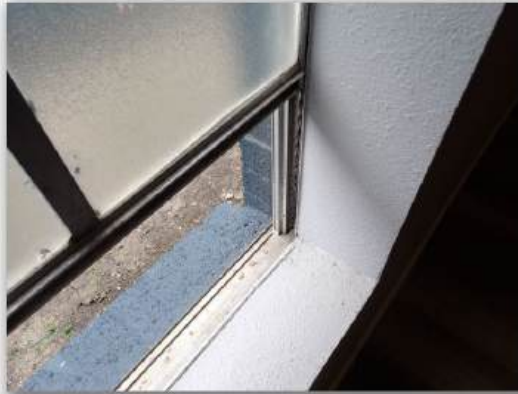
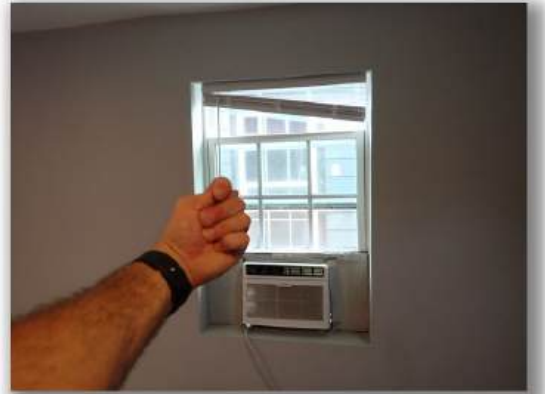
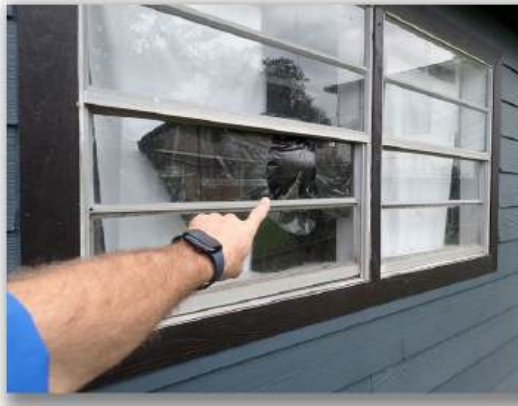
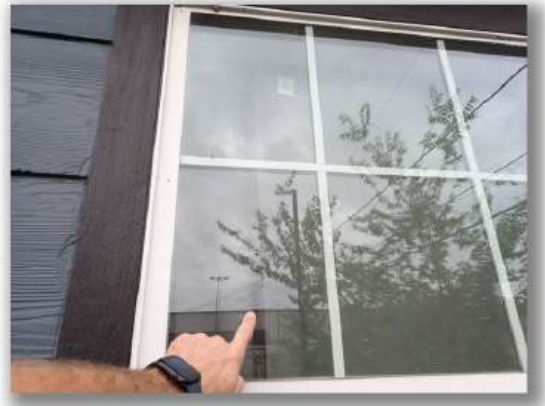
Windows, Unit C

- Cracked and/or broken window glass was observed in the living room, primary bedroom.
- Water stains were observed at and/or around the window(s) in the living room. The cause and remedy should be investigated and corrected as necessary.

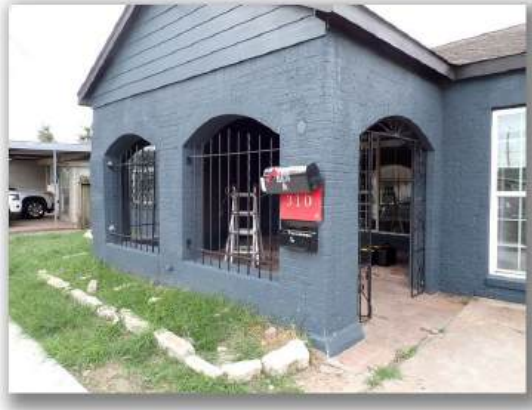
Porches / Patio

- Larger than typical cracks and/or deficiencies were observed in the patio.

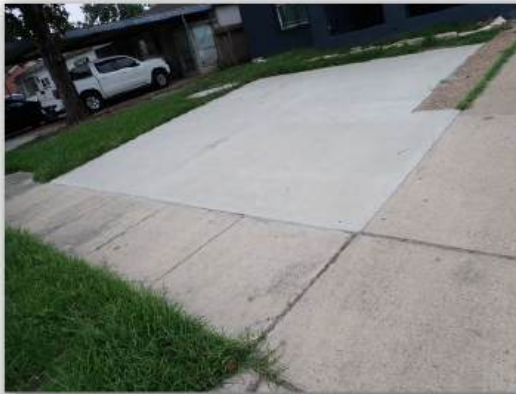
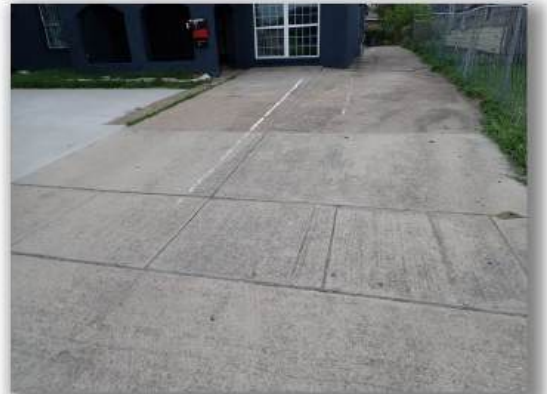
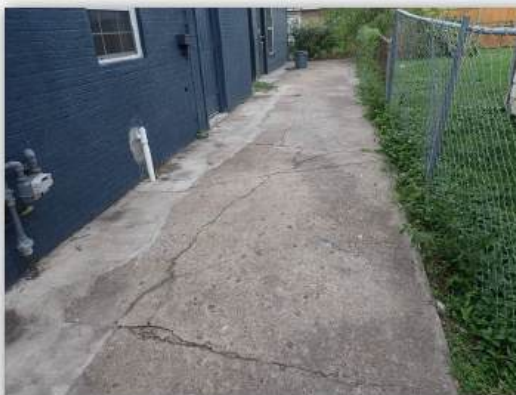
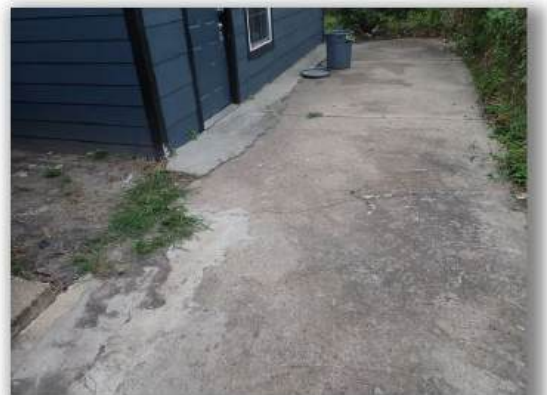
Driveway

- Minor cracks and/or deficiencies were observed in the driveway.

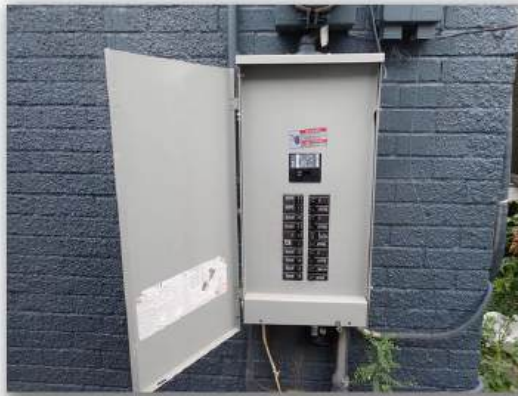
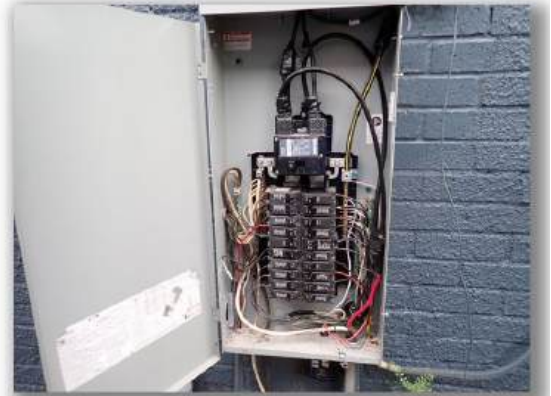
- One or more of the main service connections in the electrical cabinet were observed to be double lugged (i.e. two wires under one screw). The connectors in place are not listed or labeled for this type of installation and should be corrected as necessary.

- One or more of the cabinet cover plate screws are missing and should be replaced with blunt tip screws.
- There was no anti-oxidant gel observed on the exposed aluminum conductor terminations.

- There is a 20-amp breaker wired with a 15-amp wire. The breaker in place is not listed or labeled for this type of installation. This condition should be further evaluated and corrected as necessary.

- One or more of the breakers in the electrical cabinet were observed to be double lugged (i.e. two wires under one screw). The breakers in place are not listed or labeled for this type of installation and should be corrected as necessary.

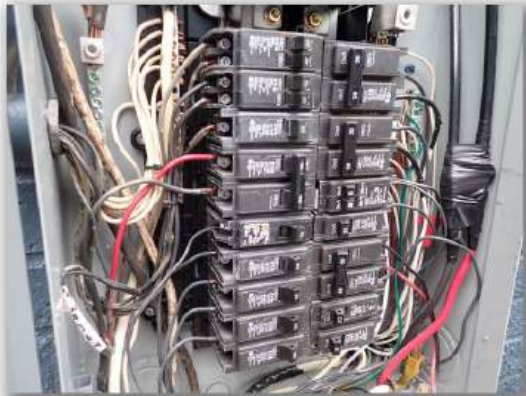
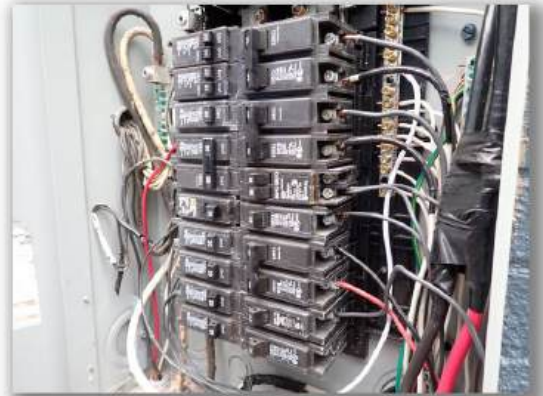
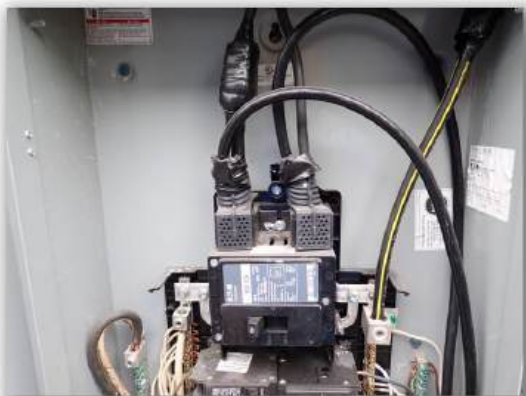
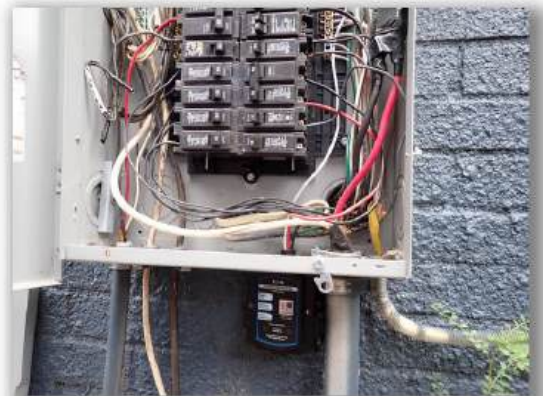
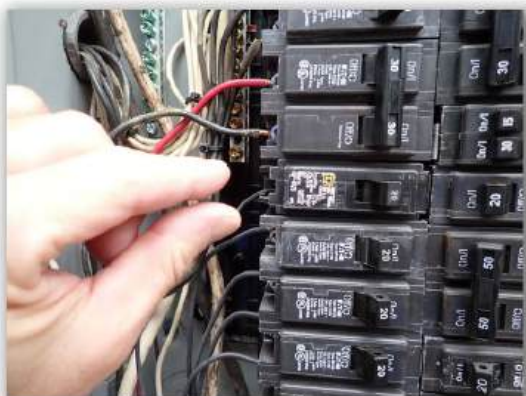
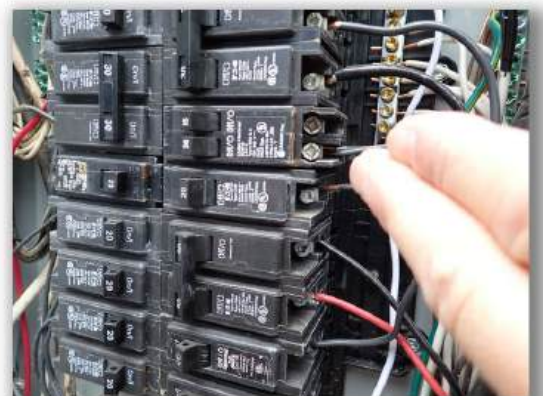
Sub Panel

- There is a 40-amp breaker wired with a 30-amp wire. The breaker in place is not listed or labeled for this type of installation. This condition should be further evaluated and corrected as necessary.
- One or more of the neutral wires in the electrical cabinet were observed to be double lugged (i.e. two wires under one screw). Under current electrical standards, the neutral wires should be separated to prevent damage to the panel box and electrical system.

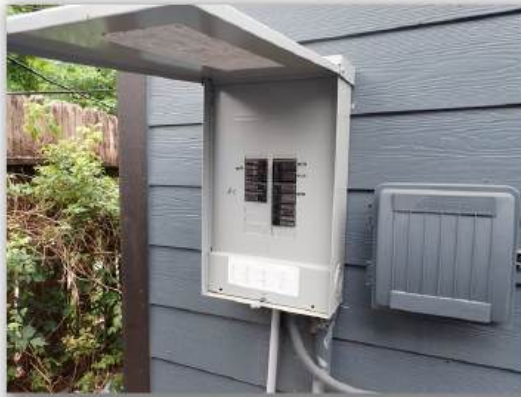
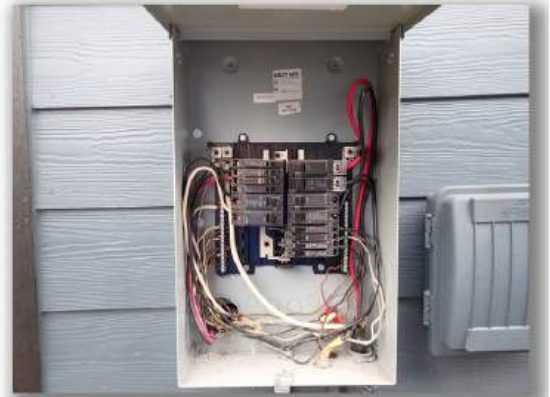
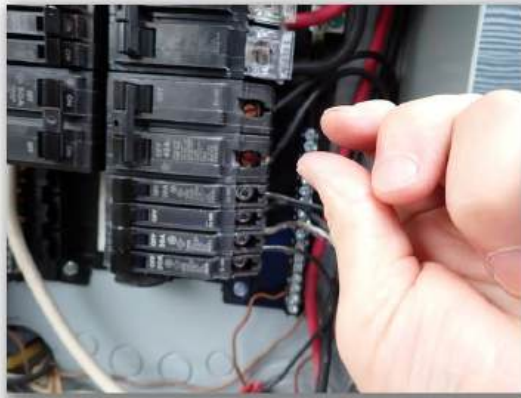
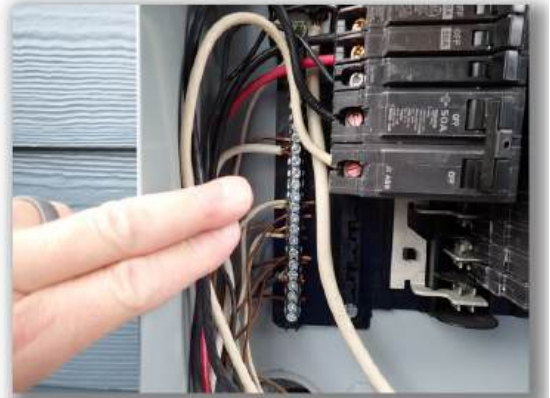
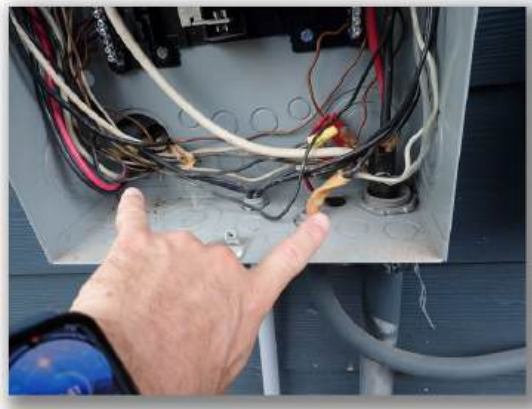
- The ground wires and the neutral wires are not properly separated in the sub-panel electrical cabinet. The neutral wires should be on their own isolated bus bar and the ground wires should be connected to the sub-panel cabinet. Although the sub-panel is functional, it does not meet current National Electrical Code standards.
- The sub-panel electrical cabinet should not be bonded (connected) to the neutral bar.
- The wires entering the electrical cabinet are not properly secured or protected from the sharp edges of the cabinet.

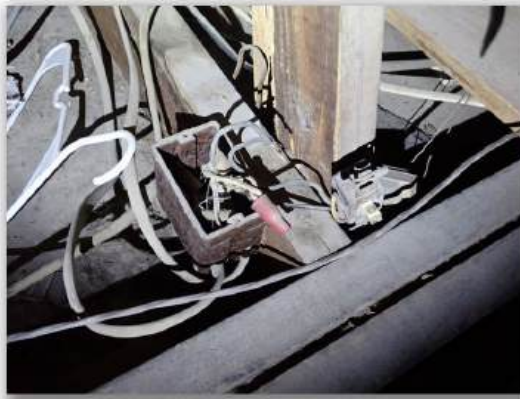
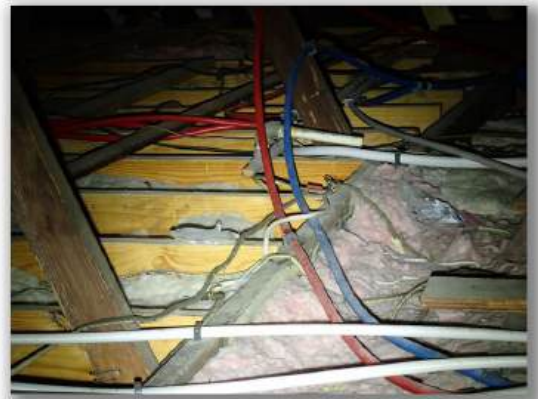
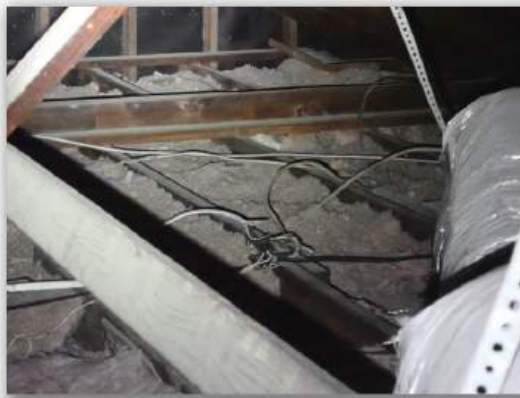
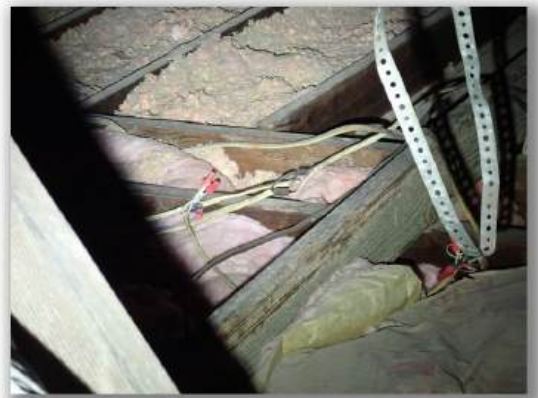
Distribution Wiring Unit A

- Spliced electrical wires were observed in the attic area. Spliced wires should be properly enclosed in junction box(es) for reasons of safety.
- Open electrical junction box(es) were observed in the attic area. All open junction box(es) should be properly enclosed for reasons of safety.

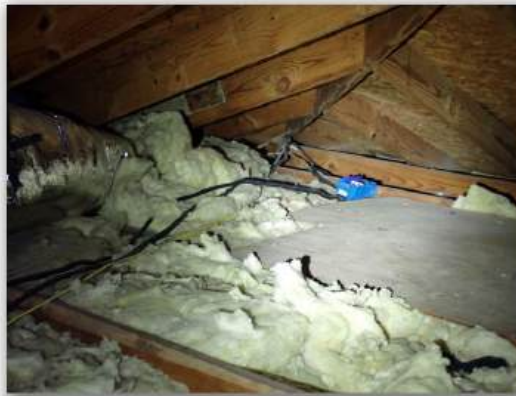
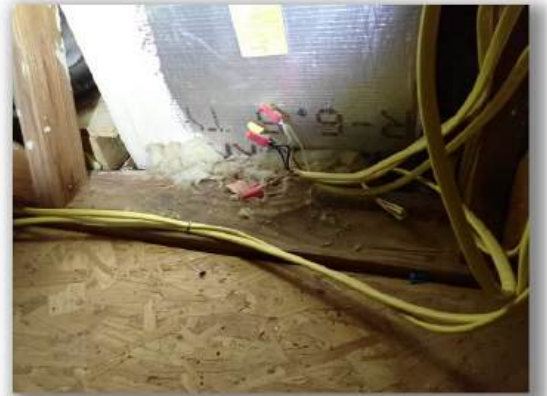
Distribution Wiring Unit C

- Open electrical junction box(es) were observed in the attic area, utility room. All open junction box(es) should be properly enclosed for reasons of safety.
- Spliced electrical wires were observed in the attic area. Spliced wires should be properly enclosed in junction box(es) for reasons of safety.
