September 10, 2024

PROPERTY INSPECTION REPORT FORM

310 Terminal St. A,B,C, Houston, TX 77020

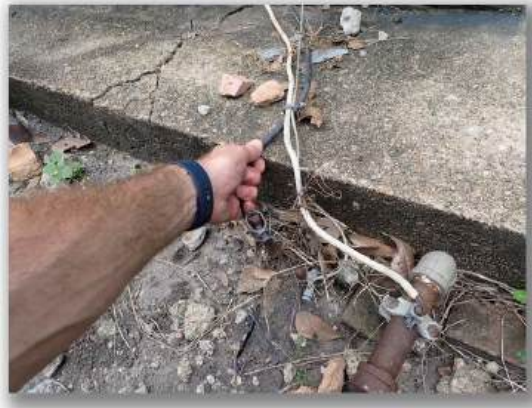
Grounding / Bonding

- I was unable to locate a grounding rod (Grounding Electrode) or supplement grounding source for the electrical system in the detached building. This condition should be further investigated and corrected if necessary.
- I was unable to locate the electrical bond connection for the gas piping back to the grounding electrode system. All bond connections should be accessible for inspection, repair or replacement. This condition should be further investigated and corrected if necessary.
- I was unable to locate the electrical bond connection for the metal water piping to the grounding electrode system. All bond connections should be accessible for inspection, repair or replacement. This condition should be further investigated and corrected if necessary.

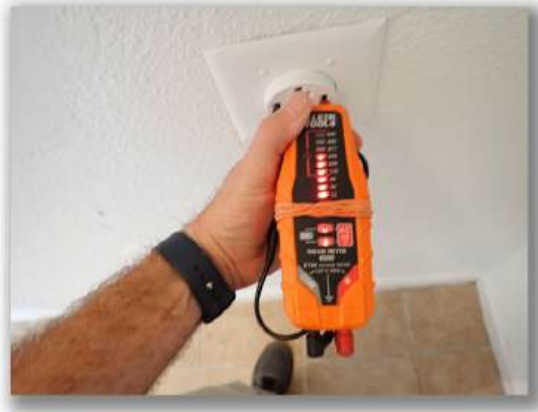
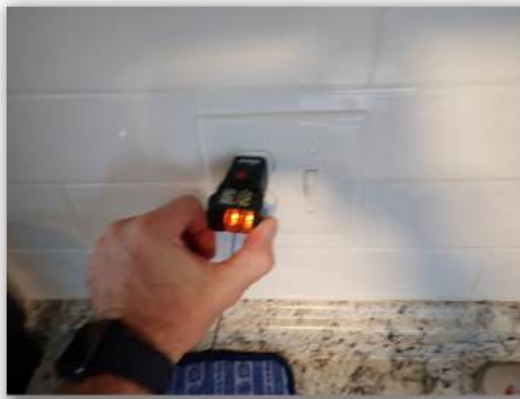
Receptacle Outlets Unit B

- Not all of the receptacles in the wet/damp areas have ground fault circuit interrupter (GFCI) protection. Under current electrical standards all of the exterior/accessory building receptacles, all crawl space receptacles, all kitchen counter top receptacles, all bathroom receptacles, all attic receptacles, all laundry room receptacles, all garage receptacles, dishwasher receptacle, receptacle in cabinet under kitchen sink, any receptacle within 6-feet of the sink, all wet bar area receptacles and pool equipment should have GFCI protection.

- One or more of the receptacles were observed to be loose at the wall mount in the several locations throughout the house.
- There are no tamper resistant receptacles installed at the time of inspection. Under current building standards, all receptacles that are less than five and a half feet above the floor should be tamper resistant. This is an "as built" condition, but per TREC standards of practice, we are required to report this condition as deficient. Tamper Resistant outlets are required per the 2008 National Electric Code. You may consider corrective measures for improved safety.

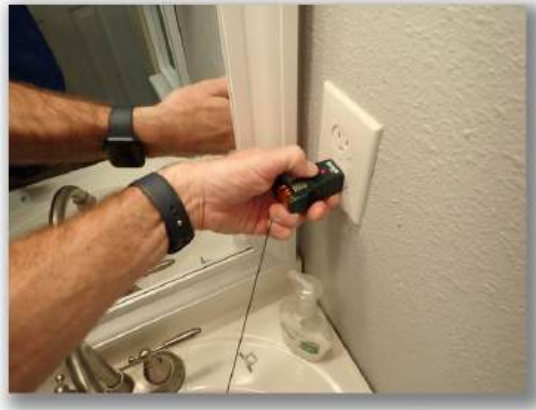
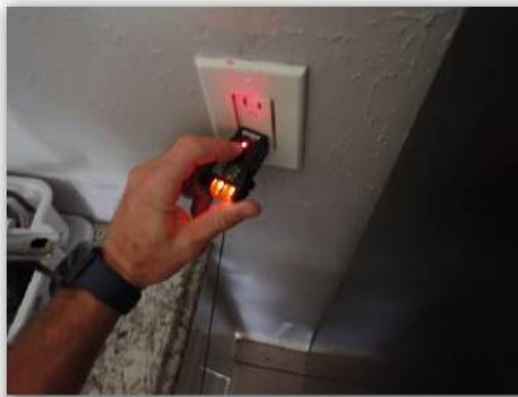
Receptacle Outlets Unit C

- One or more of the receptacles were observed to be damaged in the kitchen.
- One or more of the receptacles were observed to be loose at the wall mount in the several locations throughout the house.

- Not all of the receptacles in the wet/damp areas have ground fault circuit interrupter (GFCI) protection. Under current electrical standards all of the exterior/accessory building receptacles, all crawl space receptacles, all kitchen counter top receptacles, all bathroom receptacles, all attic receptacles, all laundry room receptacles, all garage receptacles, dishwasher receptacle, receptacle in cabinet under kitchen sink, any receptacle within 6-feet of the sink, all wet bar area receptacles and pool equipment should have GFCI protection.

- There are no tamper resistant receptacles installed at the time of inspection. Under current building standards, all receptacles that are less than five and a half feet above the floor should be tamper resistant. This is an "as built" condition, but per TREC standards of practice, we are required to report this condition as deficient. Tamper Resistant outlets are required per the 2008 National Electric Code. You may consider corrective measures for improved safety.

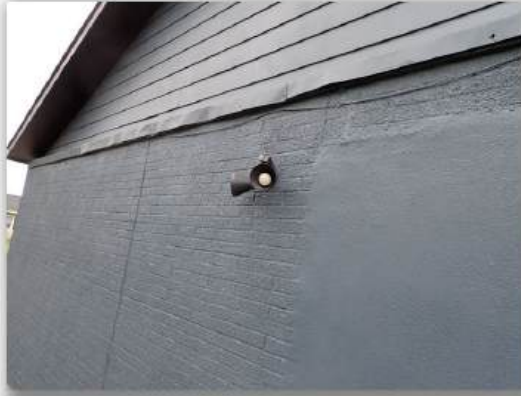
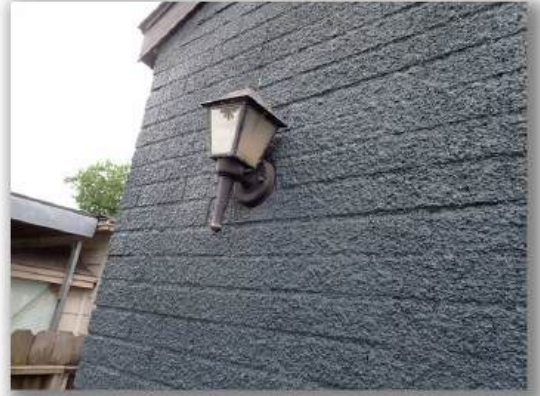
Fixtures Unit A

- One or more of the light fixtures are inoperative in the west exterior wall, east exterior wall. This may be due to a bad bulb or some other unknown condition. This condition should be further evaluated and corrected as necessary.
- The fan/light fixture pull string is damaged in the rear corner bedroom.

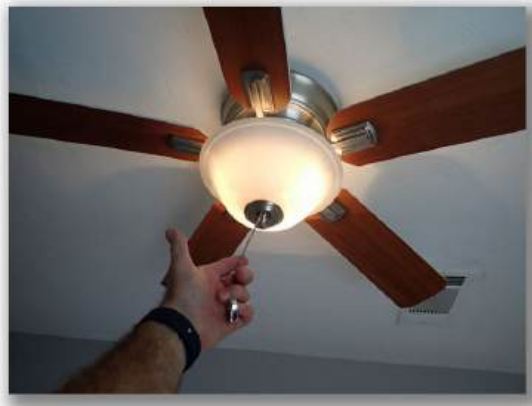
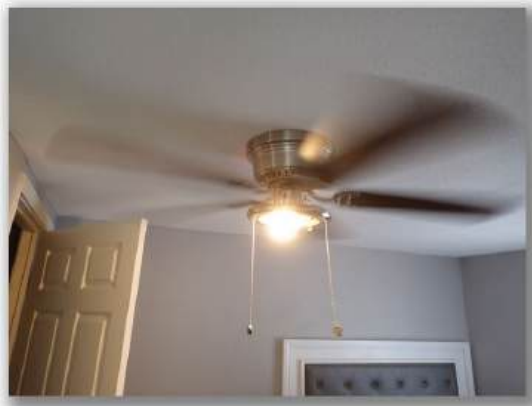
Fixtures Unit B

- One or more of the light fixture globes and/or covers are missing in the primary bedroom.
- The ceiling fan is not balanced properly and wobbles when operated in the primary bedroom.

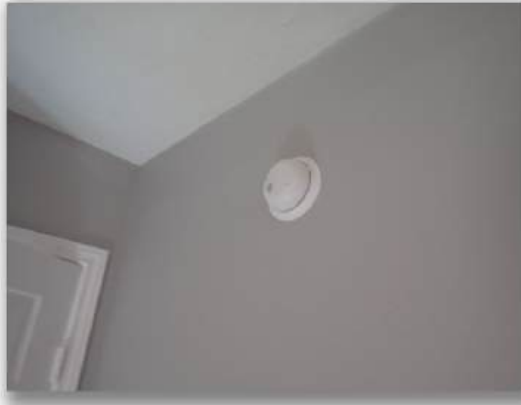
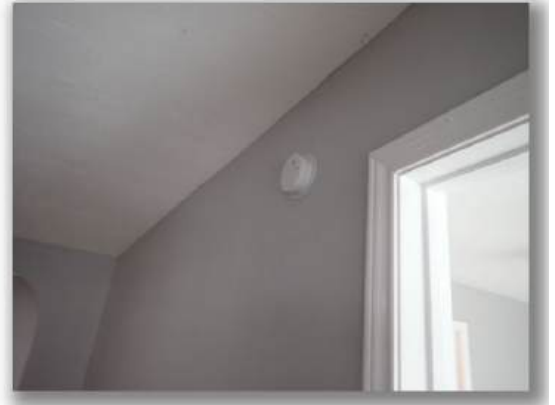
Carbon Monoxide Alarms Unit C

- There are not enough carbon monoxide alarms located in the home. Under current building standards, there should be a CO alarm located outside each separate sleeping area in the immediate vicinity of the bedrooms in dwelling units within which fuel-fired appliances are installed and in dwelling units that have attached garages.

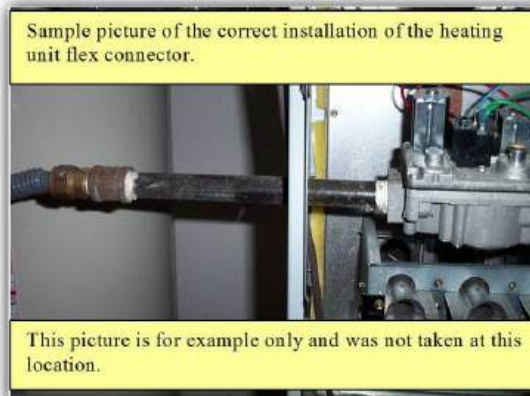
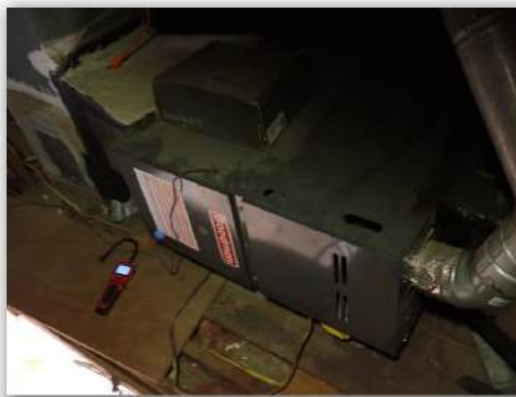
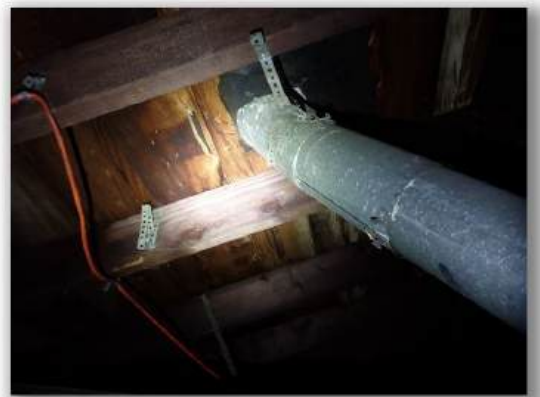
- The heating unit flue (vent pipe) has inadequate clearance from combustibles materials. Double walled vent pipes should have at least 1-inch of clearance and single walled vent pipes should have at least 6-inches of clearance from combustibles material.

- The heater flue was observed to be terminated at the roof level into a bonnet type vent. This configuration is susceptible to back drafting which could emit Carbon Monoxide into the attic area, which is a known safety hazard.

- The heater gas supply line is not equipped with a sediment trap just before the gas appliance connector. This condition does not meet current installation requirements and should be corrected.

- The gas supply flex connector was observed to be passing through the heating unit cabinet. Under current mechanical installation standards, this is no longer an accepted practice. Only rigid black gas pipe is allowed to pass through the heating unit cabinet.

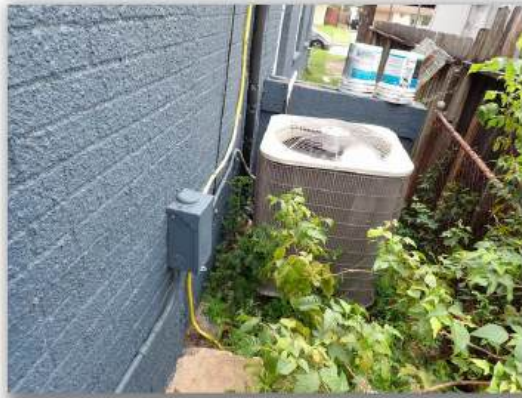
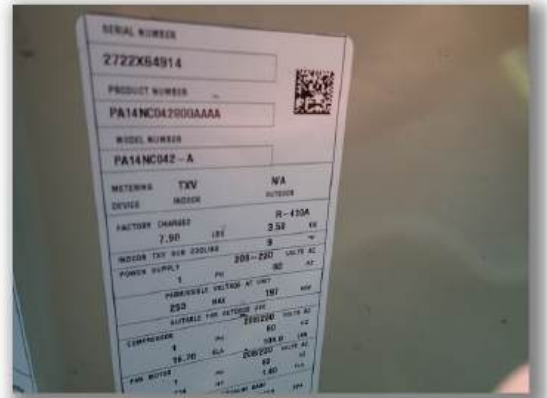
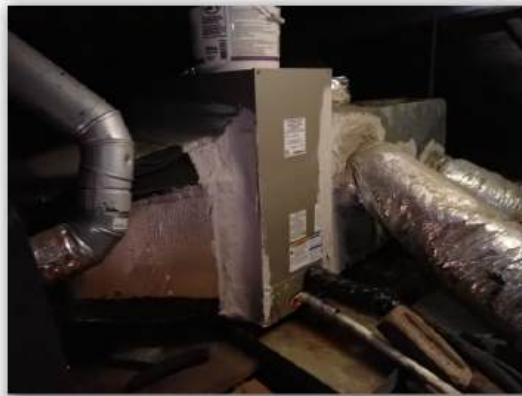
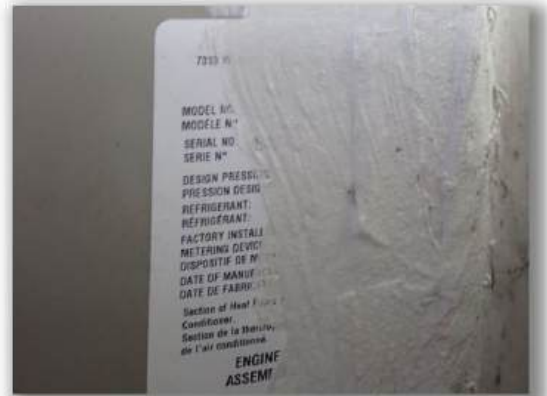
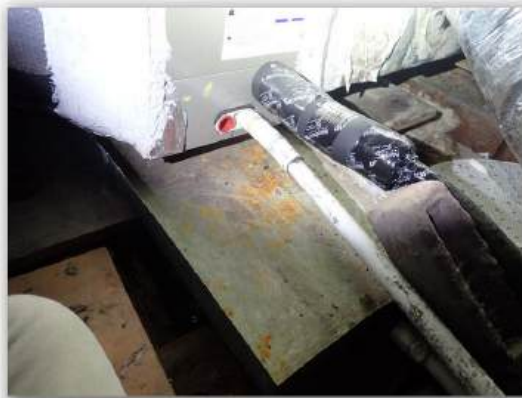
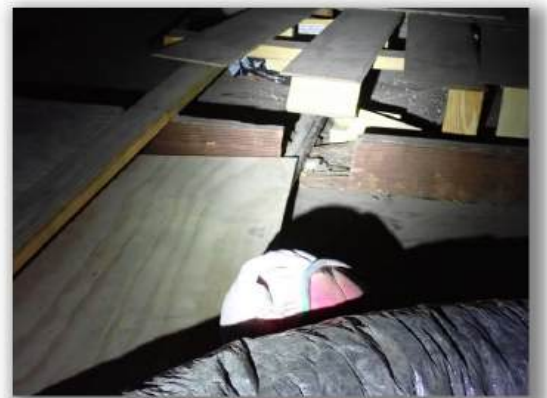
- The primary drain line is not properly insulated in the attic at the time of inspection. It is recommended to add insulation to prevent condensation build up and moisture damage.
- The secondary drain line on the coil housing is capped at the time of this inspection. It is recommended to remove the cap on the secondary drain line to allow for the drain to function properly when necessary.

Note: The primary condensate drain line is terminated next to the exterior foundation perimeter beam. It is recommended that the drain line terminate further away from the foundation beam or to an approved waste system.

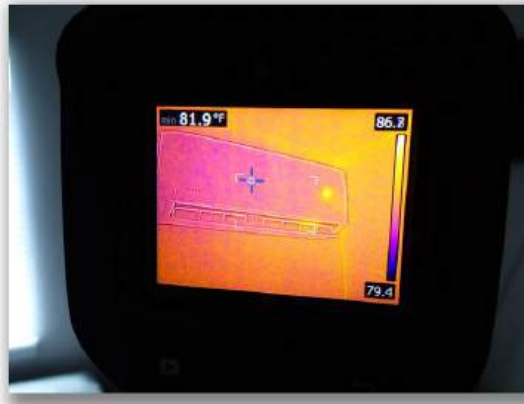
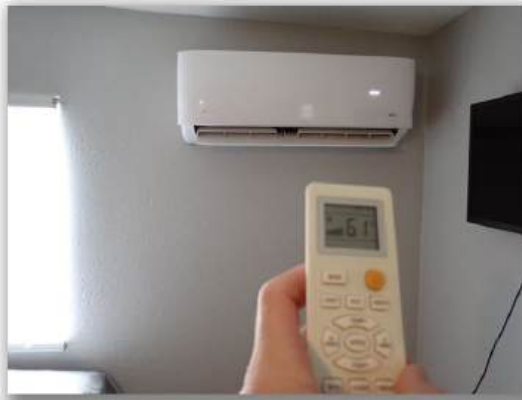
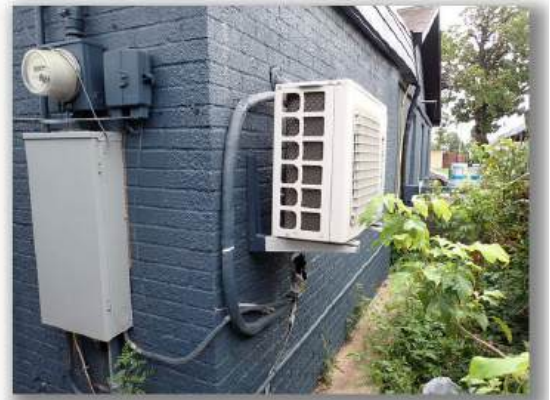
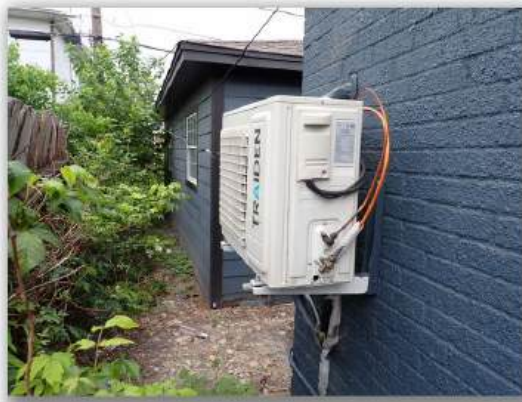
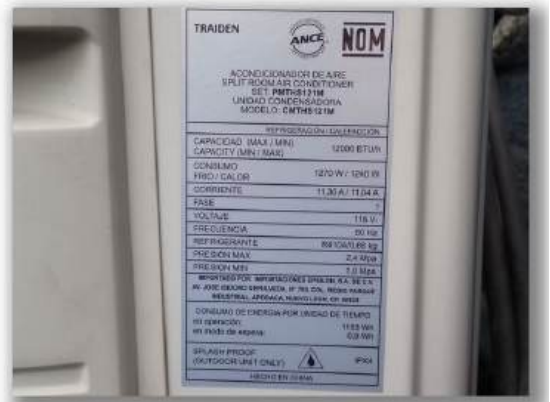
Unit B, Window Unit. Living Room

All components were found to be performing and in satisfactory condition on the day of the inspection.

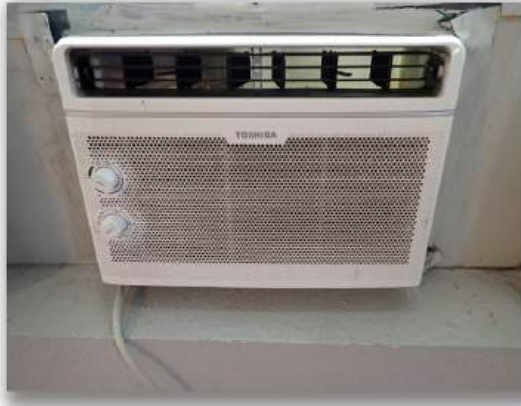
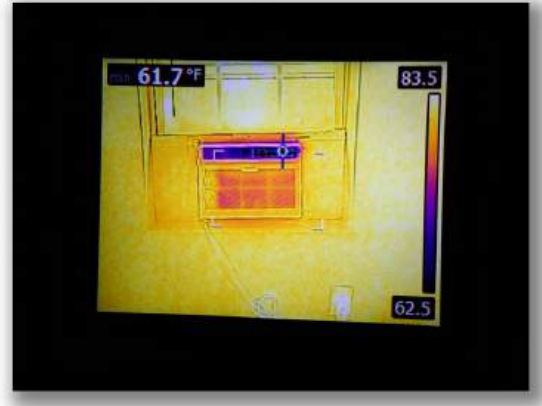
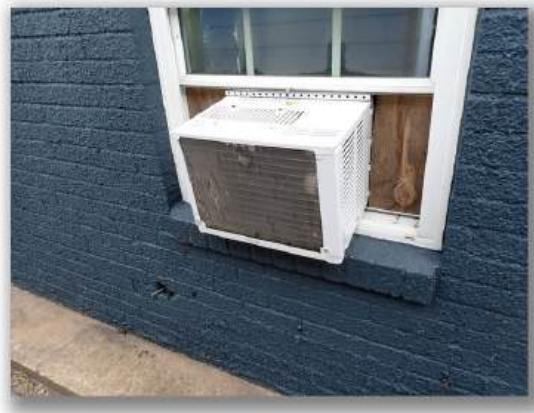
Unit B, Window Unit. Bedroom

All components were found to be performing and in satisfactory condition on the day of the inspection.

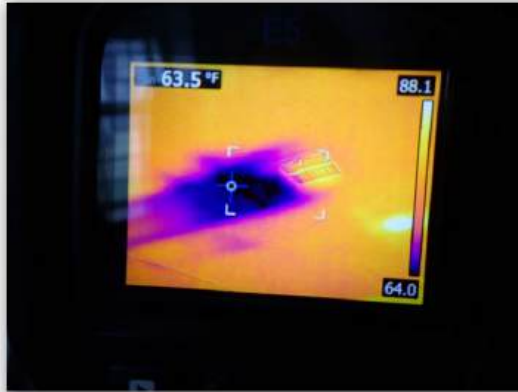
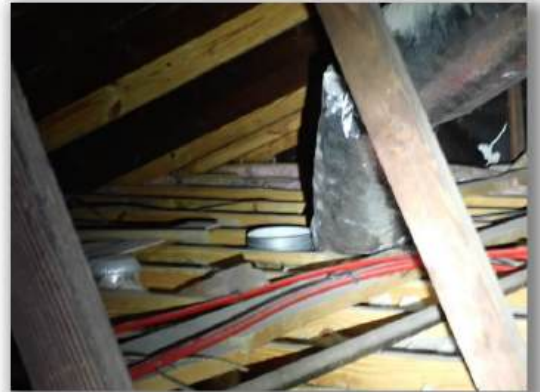
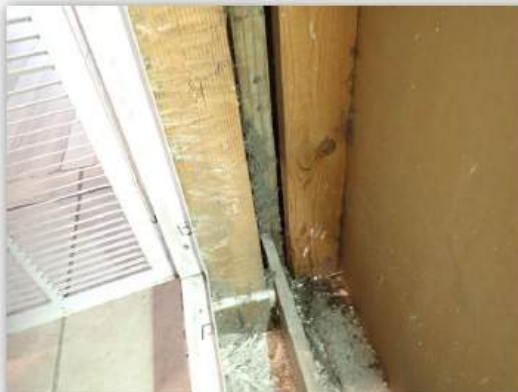
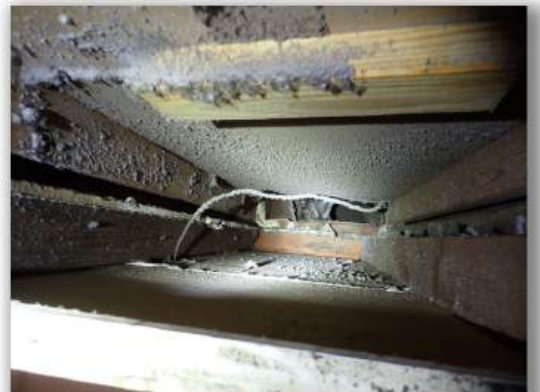
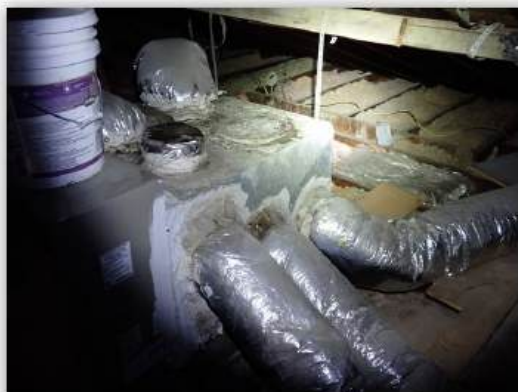
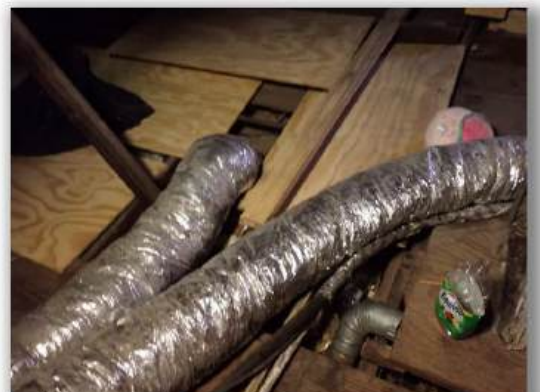
- The duct work in the attic area is not properly suspended and separated to help prevent condensation from developing. It is recommended to separate and suspend the duct work with supports in minimum intervals of 4-feet that have a minimum width of 1.5-inches.

- Some of the ductwork in the attic area is separated and should be repaired.
- Ductwork insulated covering was observed to be damaged and/or pulling loose.

- The air-return chase for the HVAC system is dirty and should be cleaned to help maintain good air quality.
- There was an unknown mold like substance observed on the outer surface of the duct work. Evaluation of this substance is beyond the scope of this inspection. If any concerns exist on the type and/or nature of this substance, we recommend further evaluation by a professional in the Air Quality sampling field.

- Some of the attic area ductwork was observed to be damaged and/or crushed. This condition should be further evaluated and corrected as necessary.

Note: Due to the limited nature of a general home inspection, it is possible that additional deficiencies will be discovered by a licensed technician. It is recommended to have the system serviced prior to the expiration of any option/warranty period.

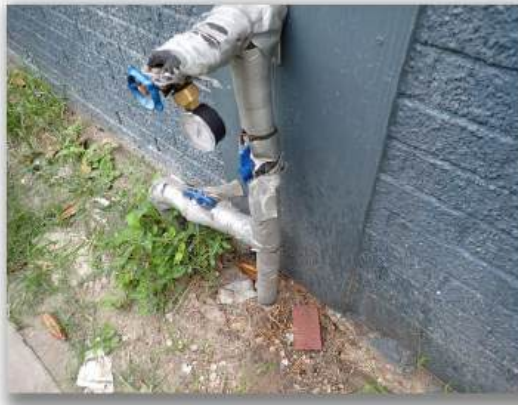
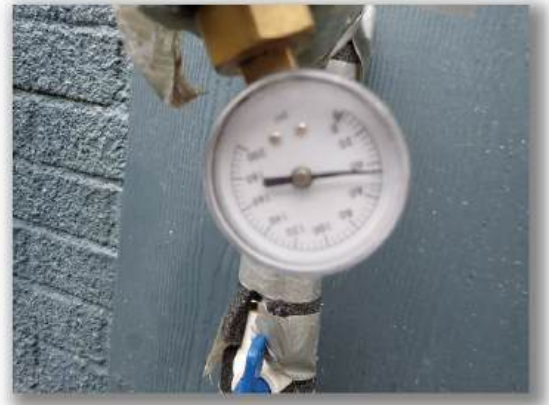
- All exposed water supply lines in the attic area should be insulated to help protect them from possible freeze damage.
- There are galvanized water lines in use at the time of this inspection. This is an older obsolete water supply system that is prone to water leaks. Full evaluation of all of the galvanized water line components and the integrity of those components are beyond the scope of this inspection. You are strongly encouraged to have the integrity of all of the galvanized water line components further evaluated by a qualified plumber prior to the expiration of any time limitations such as option or warranty periods. All plumber recommended repairs should be made. It would be wise to budget for replacement of all the older galvanized water supply system and to make a conversion over to a newer type of water supply system as soon as it is financially feasible.

Note: Previous repairs to the water supply system components were observed. The inspector is unable to identify/verify the extent of the repairs. The homeowner should be consulted on the previous water supply system repairs performed and possible warranty information that may apply.

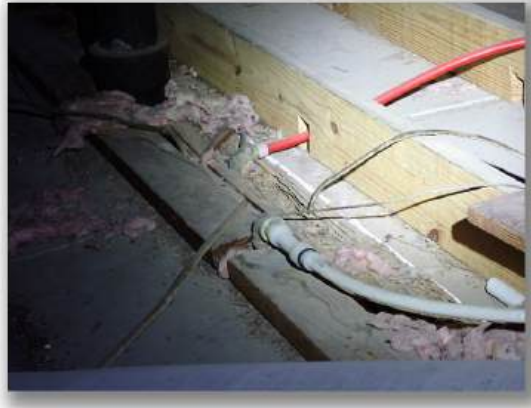
Water Supply System Unit B

- PVC (polyvinyl chloride) plastic water supply distribution piping observed to be in use at the time of this inspection. Use of PVC plastic for water distribution does not meet current plumbing standards and should be corrected as necessary.
- The water lines in the attic space & the exterior should be insulated within 5 feet of the exterior walls to protect from weather damage (freeze).

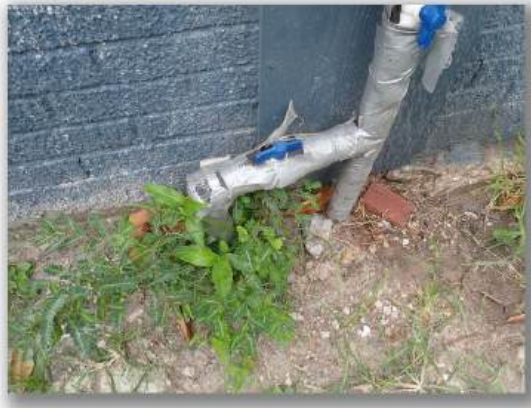
Water Supply System Unit C

- I. The water lines in the attic space & the exterior should be insulated within 5 feet of the exterior walls to protect from weather damage (freeze).
- PVC (polyvinyl chloride) plastic water supply distribution piping observed to be in use at the time of this inspection. Use of PVC plastic for water distribution does not meet current plumbing standards and should be corrected as necessary.

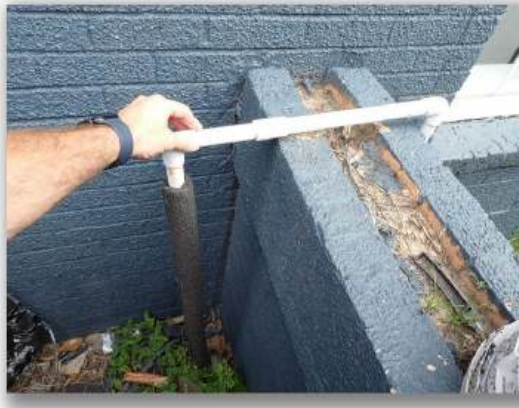
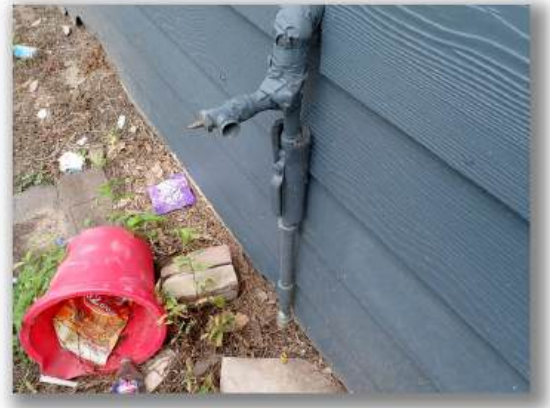
Exterior Faucets/Fixtures

- One or more of the exterior water hose bibs (faucet) do not have a back-flow or anti-siphon device (Vacuum Breakers) in place.
- The exterior water hose bib (faucet) handle is damaged and/or missing on the west side of the structure.

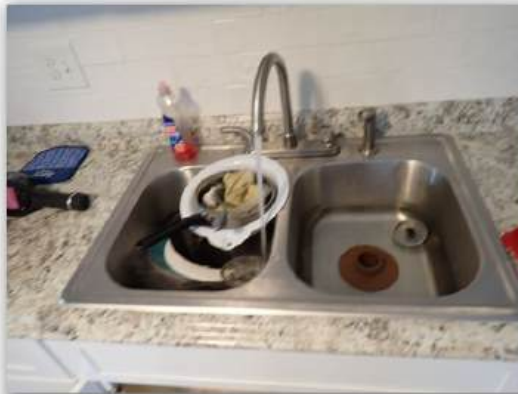
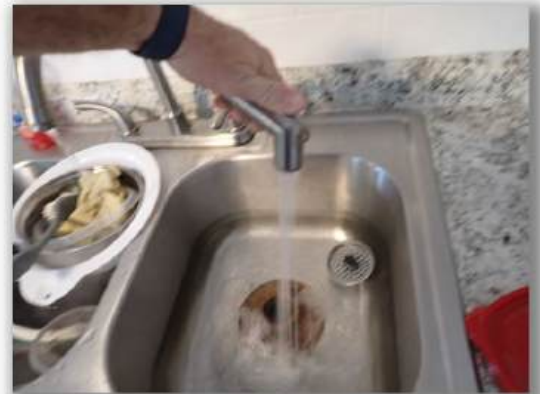
Unit C, Kitchen Sink

- The faucet has low water pressure on the hot and cold sides of the faucet when operated. The cause and remedy should be further evaluated and corrected as necessary.
- The drain line under the sink is poorly installed. Repairs are recommended.
- The drain line is made of corrugated material. It is recommended to use smooth wall/PVC type material to prevent blockage/poor drainage.
- The shelf in the cabinet under the sink is damaged.
- The faucet assembly leaks water into the cabinet when operated.

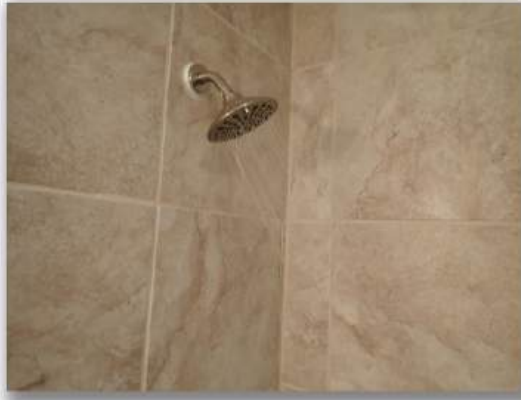
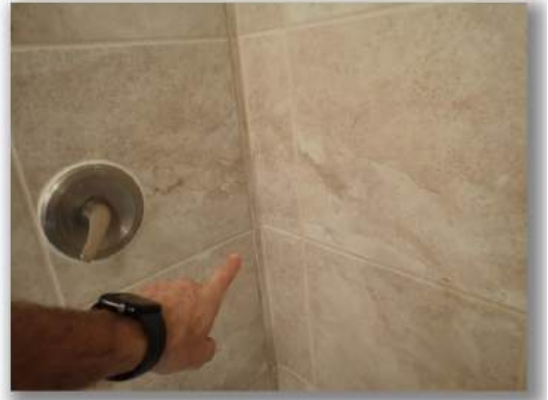
Unit A Primary Bathroom

- The commode tank is loose at the bowl connection.

- The faucet has low water pressure when operated.

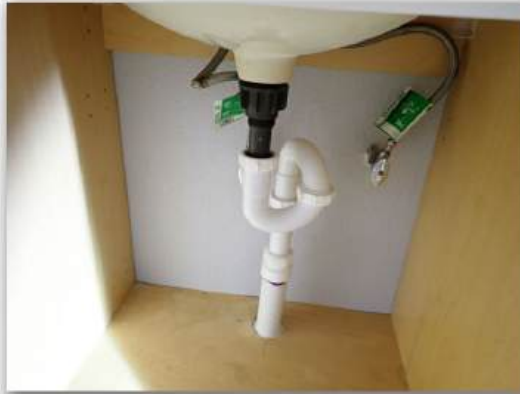
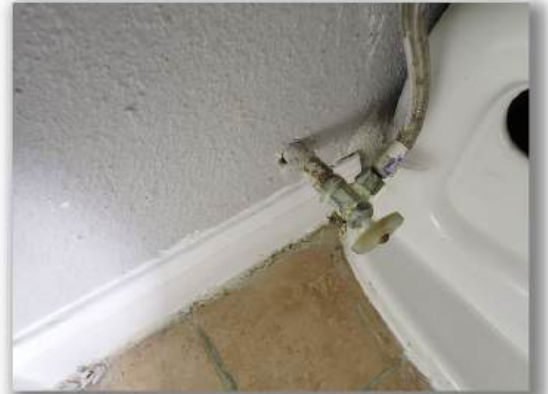
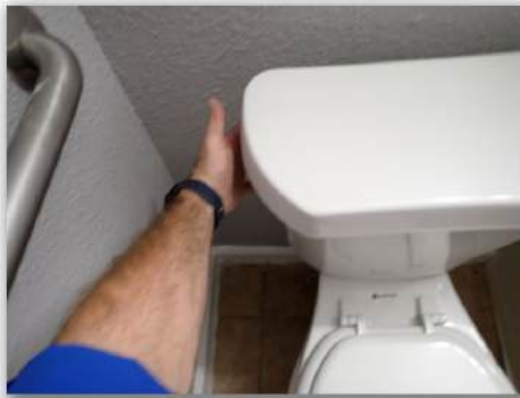
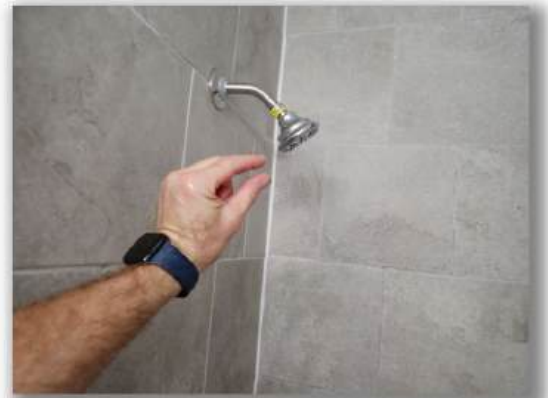
Unit B, Primary Bathroom

- The commode tank is loose at the bowl connection.
- The commode leaks water onto the floor. The cause and remedy should be further evaluated and corrected as necessary.

- Cracked, deteriorated and/or missing grout and/or caulking should be repaired or replaced as necessary.

- The sink was observed to drain slowly, suggesting that an obstruction may exist.

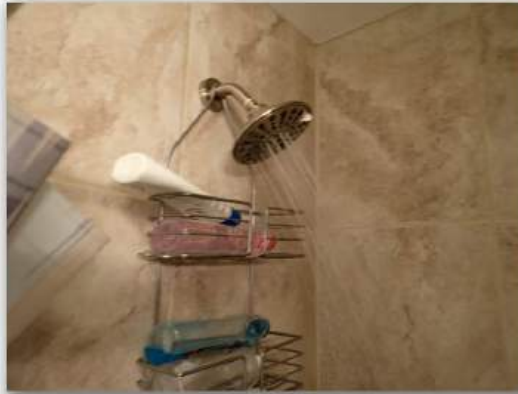
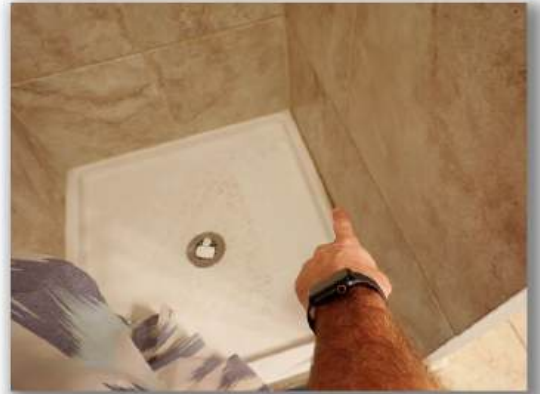
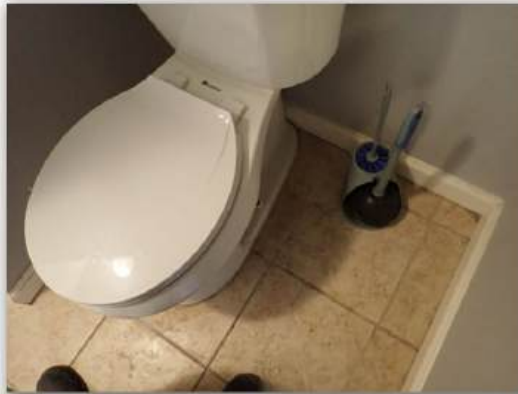
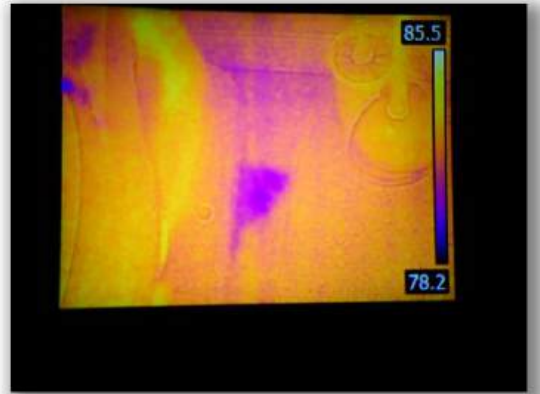
Unit C, Hall Bathroom

- The stopper is damaged.
- The faucet assembly is loose.

- The commode is excessively loose at the floor mount. This condition should be further evaluated and corrected as necessary.
- **The commode leaks water onto the floor. The cause and remedy should be further evaluated and corrected as necessary.**

- The faucet assembly is not properly sealed at the wall. This condition has the potential to allow water to leak back into the wall cavity.
- The tub spout is not properly sealed at the wall. This condition has the potential to allow water to leak back into the wall cavity.
- Cracked, deteriorated and/or missing grout and/or caulking should be repaired or replaced as necessary.
- The shower head assembly is loose within the wall cavity area.
- The bathtub has some rust/surface damage.
- The drain line is made of corrugated material. It is recommended to use smooth wall/PVC type material to prevent blockage/poor drainage.

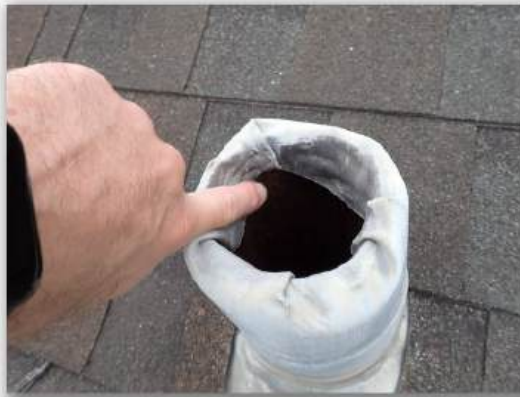
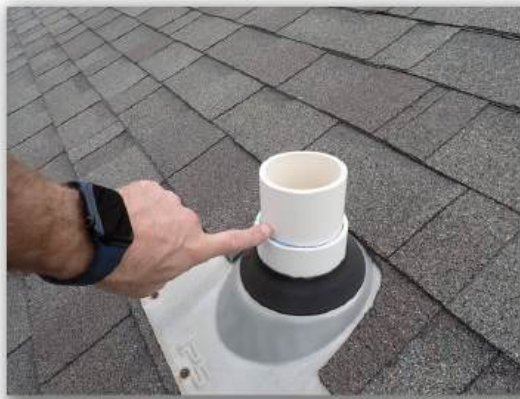
- Cast iron material was observed to be present at some of the drains, wastes and vents system. Full evaluation of the integrity of this type of material is beyond the scope of this inspection. Due to the known latent defects that are associated with this type of older material, it is recommended to have the integrity of the drain system further evaluated by a qualified plumber. It is recommended to have a hydrostatic test performed and to have the inaccessible and buried pipes scoped with a camera as part of this evaluation. This evaluation should occur prior to the expiration of any time limitations such as option or warranty periods.

- The plumbing cleanout and/or cover(s) located in the yard were observed to be damaged on the west side of the structure.
- The roof level plumbing vents stacks are not painted. It is recommended to paint the roof level vent stacks and flashing details to help prevent UV breakdown.

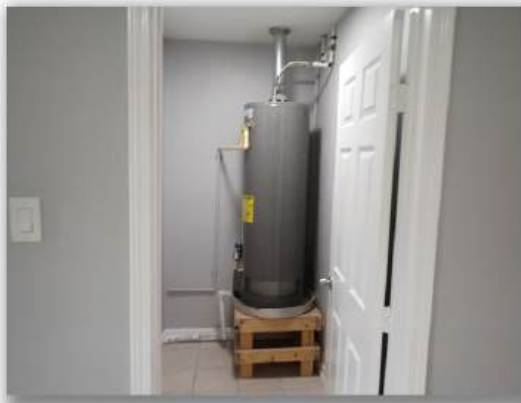
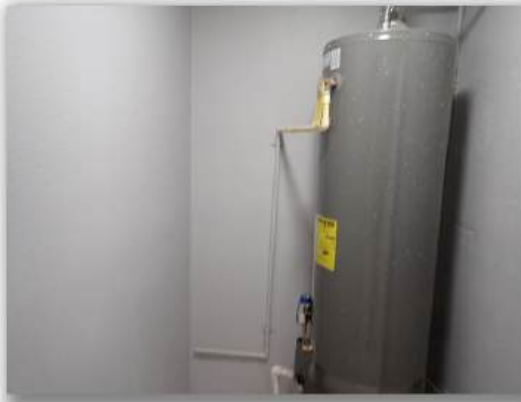
- The temperature and pressure relief valve discharge pipe is terminating in the water heater closet area. Under current building standards, this discharge pipe should run downward to the exterior of the structure, turn downward, and terminate within 6-inches of the ground.
- The roof level flue storm collar should be properly sealed to help prevent water intrusion into the structure.
- The water heater gas supply line is not equipped with a sediment trap just before the gas appliance connector. This condition does not meet current installation requirements and should be corrected.

Note: The water temperature was observed to be over 140 degrees Fahrenheit when running the hot water. This high temperature could cause scalding/burning of the skin. It is recommended to adjust the temperature on the water heater to a lower setting. The general recommended setting for water heaters is between 120-130 degrees Fahrenheit.

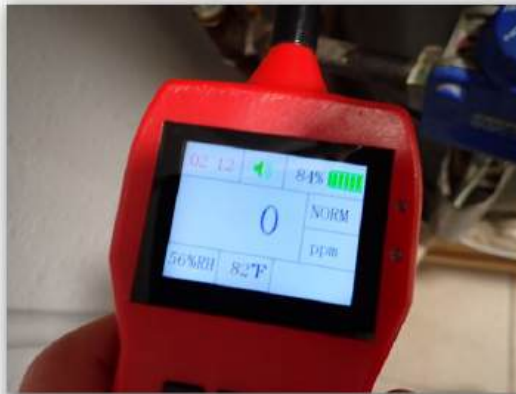
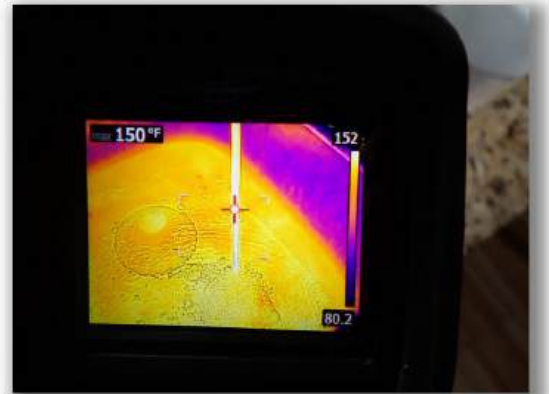
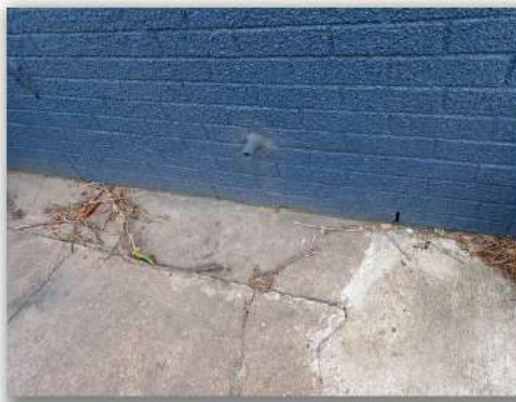
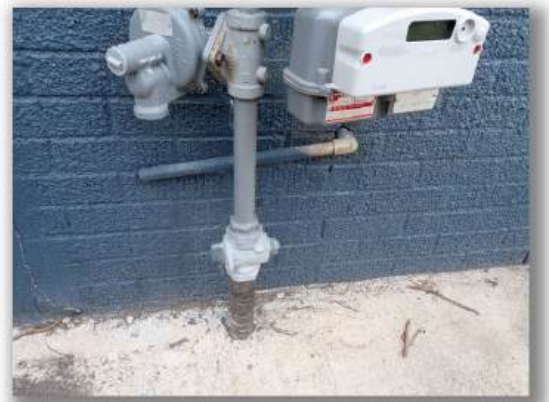
Unit C Water Heater – *Energy Source: Gas*
Location: Mechanical Closet
Approximate Capacity: 40 Gallons
Approximate Age: 2023
Brand Name: Rheem

- The water heater flue (vent pipe) has inadequate clearance from combustible materials. Double walled vent pipes should have at least 1-inch of clearance and single walled vent pipes should have at least 6-inches of clearance from combustible material.

- The water heater gas supply line is not equipped with a sediment trap just before the gas appliance connector. This condition does not meet current installation requirements and should be corrected.

- There is no pan installed under the water heater.
- There is no temperature and pressure relief valve (TPR) discharge pipe in place at the time of this inspection. For safety reasons, it is recommended that a TPR valve discharge pipe be installed. Under current building standards, the discharge pipe should run downward to the exterior of the structure, turn downward, and terminate within 6-inches of the ground.

- The water heater compartment has inadequate combustion air ventilation. There should be a minimum of 100 square inches of combustion air ventilation provided within 12-inches of the top and bottom of the closet.

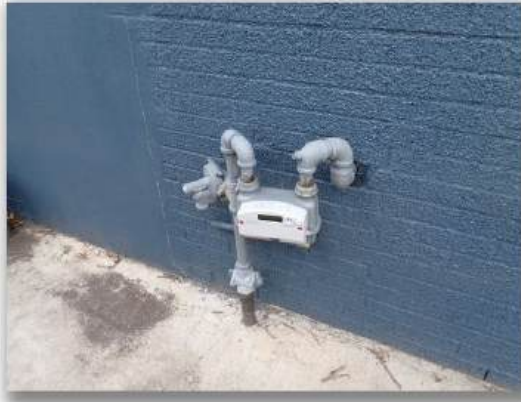
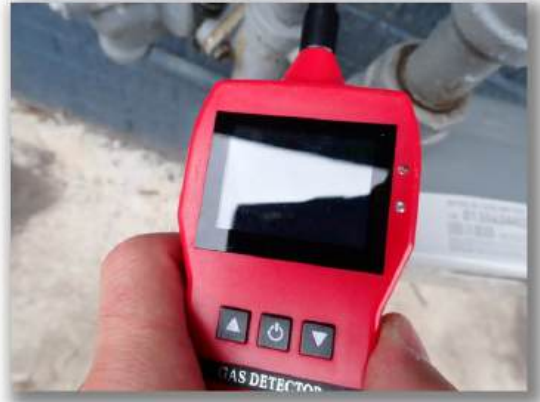
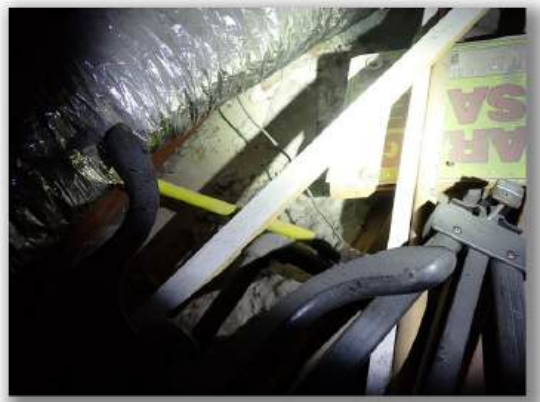
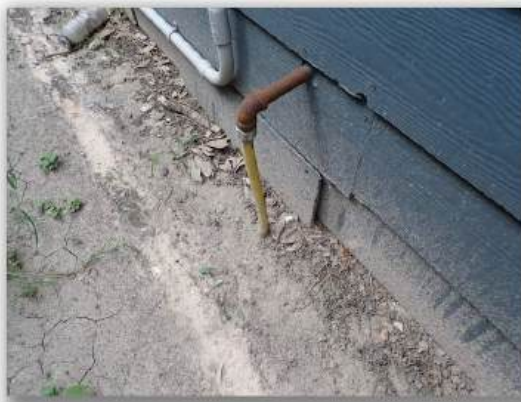
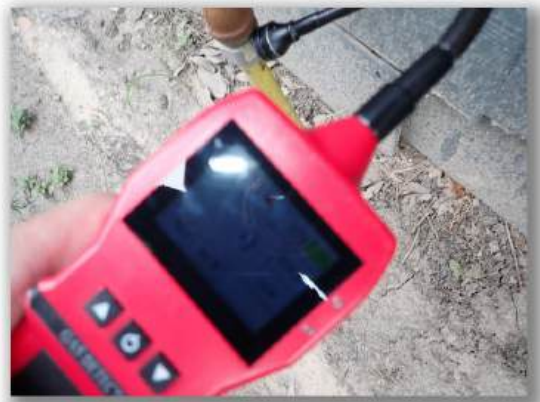
- Corrugated Stainless Steel Tubing (CSST) was observed to be in use at the time of this inspection. This product is known to have various installation and grounding / bonding problems or deficiencies. Full evaluation of this product is beyond the scope of this inspection. You are strongly encouraged to have a licensed plumber evaluate the installation and a licensed electrician investigate for proper bonding and grounding of this component of the gas distribution system. **Such follow-up should take place prior to the expiration of any time limitations such as option or warranty periods.** Evaluations by qualified tradesmen may lead to the discovery of additional deficiencies which may involve additional repair costs.

- I was unable to locate an accessible bonding connection to the corrugated stainless steel tubing (CSST) gas supply lines. Under current gas piping installation standards, all CSST piping systems should be bonded back to the grounding electrode system. It is strongly recommended that an electrician further evaluate this condition and recommended repairs made.

- It is recommended that the older spring load gas valves be changed out to the new style ball valves.
- All unused gas valve ends should be capped off for safety purposes.

- The Heater&Water Heater gas supply line is not equipped with a sediment trap just before the gas appliance connector. This condition does not meet current installation requirements and should be corrected.

- The gas shutoff valve for the Unit A Range is in a poor location and will be hard to reach.
- The gas supply flex connector was observed to be passing through the heating unit cabinet. Under current mechanical installation standards, this is no longer an accepted practice. Only rigid black gas pipe is allowed to pass through the heating unit cabinet.

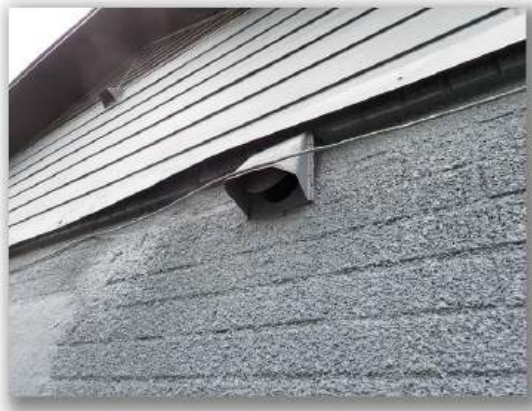
Unit A Range Exhaust Systems

- The damper at the range exhaust termination does not function properly. The damper does not reset to the closed position when not in use.

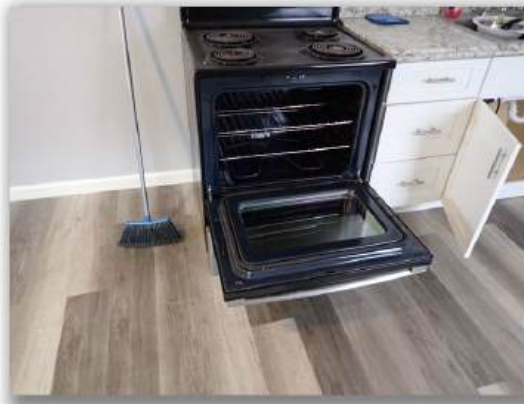
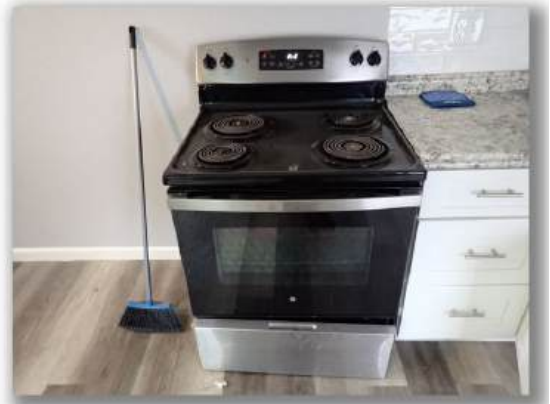
- The range can be easily tipped over and should be equipped with an anti-tip device, for safety.
- The range utility drawer is damaged and does not function properly.

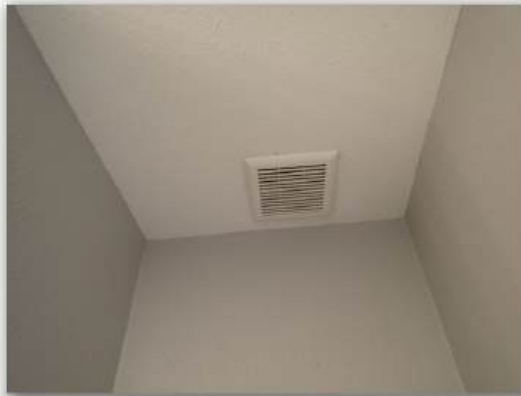
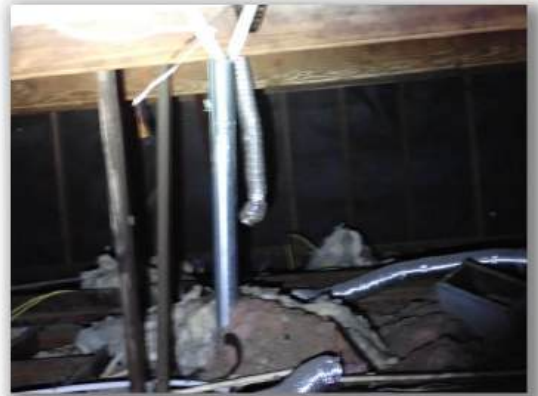
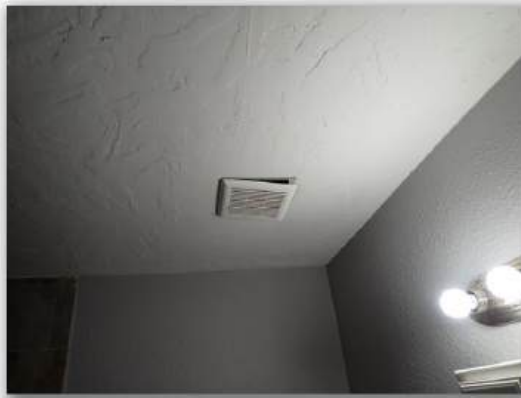
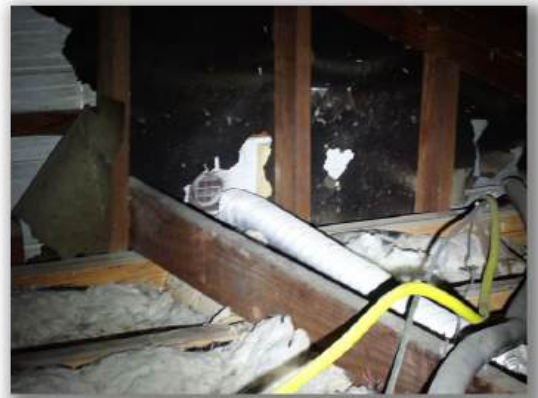
- The ducting to one of the mechanical exhaust fans was observed to be separated in the attic area over several locations throughout the house.

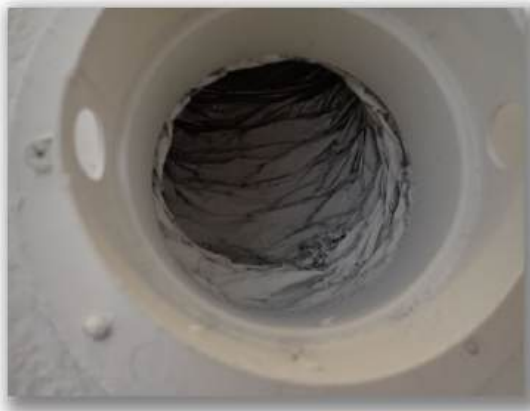
- The dryer duct was observed to terminate into the attic area. Under current installation standards the dryer should vent to the exterior of the structure and not into the attic.
- The material used for the dryer duct is not listed or labeled for this type of installation.

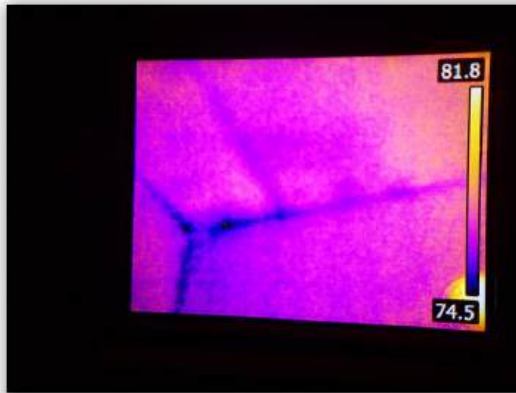
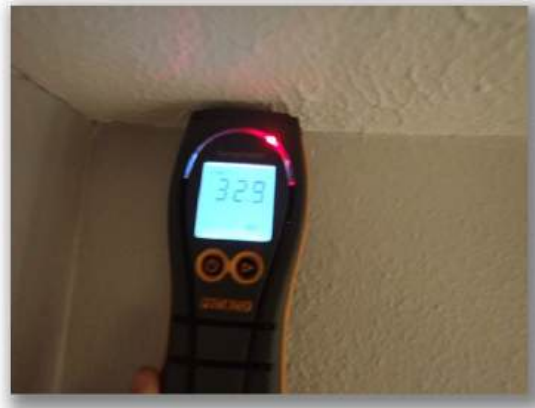
Unit A

- Elevated moisture was observed in the bedroom hallway. The cause should be further evaluated and corrected as necessary. **Additional Note:** Due to the elevated moisture, other adverse conditions such as mold-like substance growth, wood rot/deterioration and wood destroying insects are possible.
- Missing insulation was observed within the wall cavity in several locations throughout the house.
- Missing insulation was observed at the ceiling in several locations throughout the house.

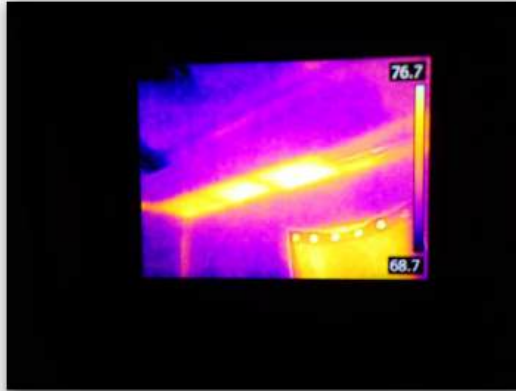
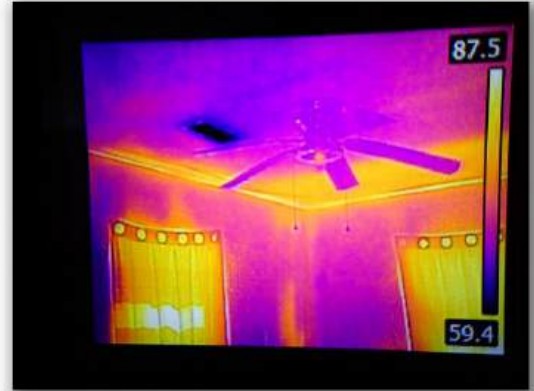
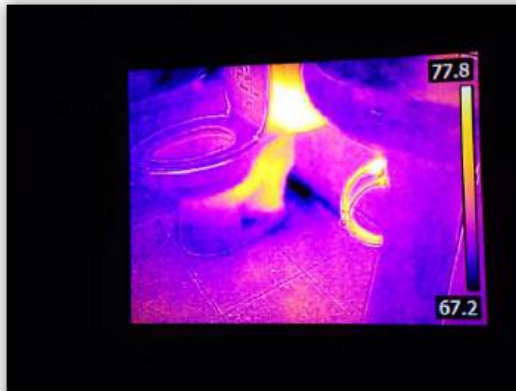
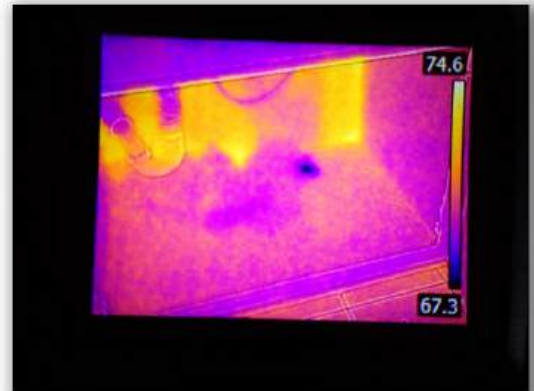
Unit C

- Missing insulation was observed at the ceiling in the front corner bedroom, rear corner bedroom.
- Elevated moisture was observed in the kitchen, hall bathroom. The cause should be further evaluated and corrected as necessary. **Additional Note:** Due to the elevated moisture, other adverse conditions such as mold-like substance growth, wood rot/deterioration and wood destroying insects are possible.
