EVALUATION SUMMARY
GMS Home/Commercial Inspection Service, LLC
281-413-1511
28342 Emerald Oaks
Magnolia, TX 77355

As requested a review of the foundation system was performed on 12/26/24. The home is a two story wood frame home approximately 3387 sq ft with a brick and siding exterior. The foundation system type is a conventional rebar floating slab.

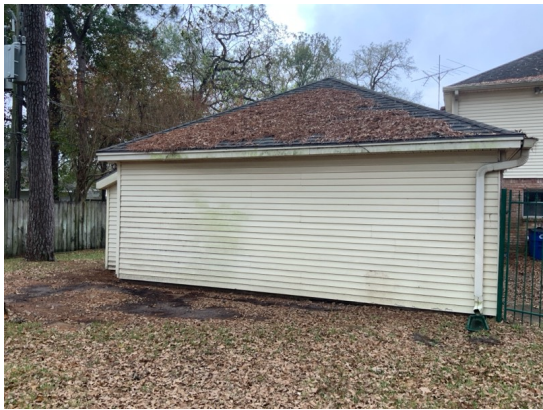
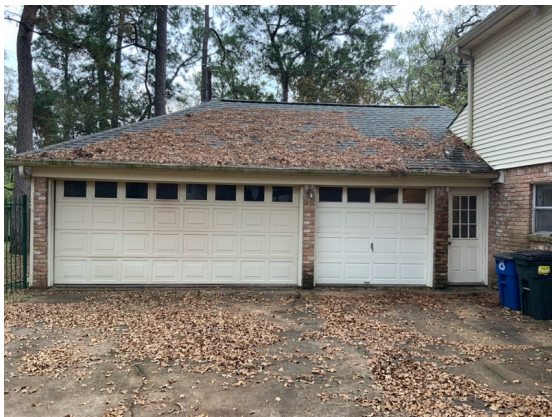
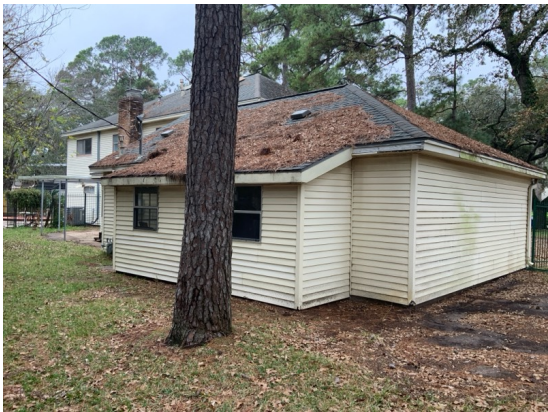
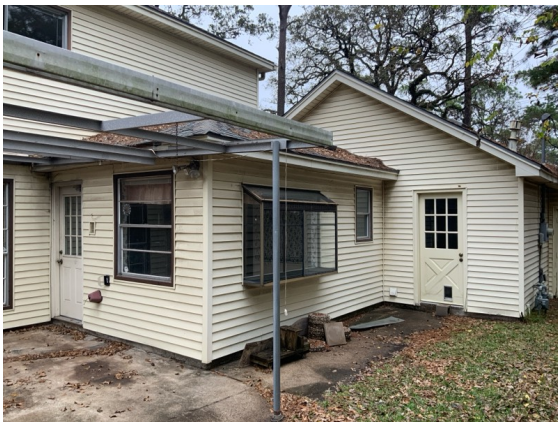
The home is built on a floating concrete slab movement and settlement is expected and considered normal. Some minor cracking/seperation in the exterior brick was found. This condition is considered normal. Brick is a non structural component of the home. See pictures on page 4 and 5. No excessive movement in the exterior was noted.
