Property Inspection Report

Texas Premium Inspections

6611 Etchstone Dr
Inspection Prepared For: Janice Christiansen
Agent: Lori Delaney -

Date of Inspection: 9/19/2024
Year Built: 1994 Size: 2983
Weather: 79°, sunny, no breeze

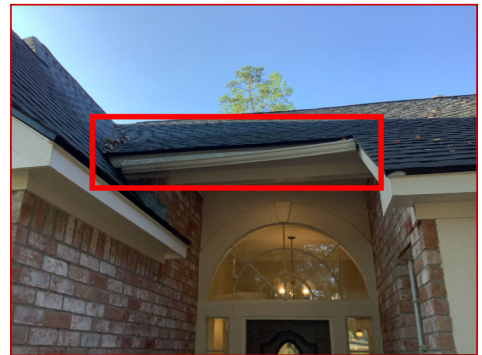
Gutter in disrepair

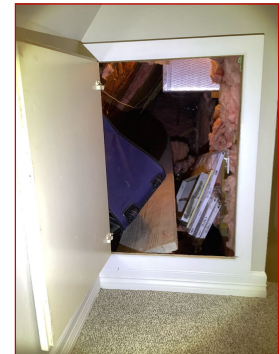
Loose covers

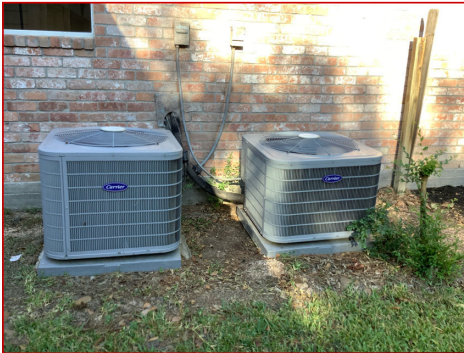
A/C condenser units

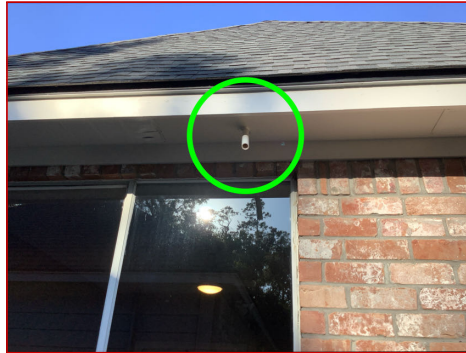
Secondary / catch pan drain termination location

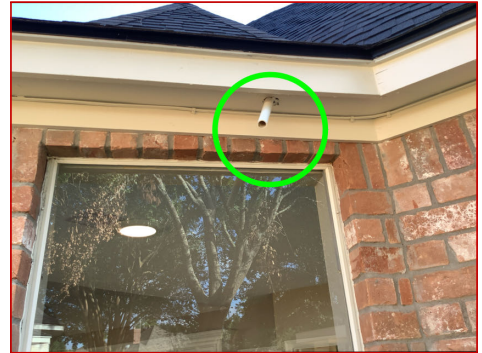
Secondary / catch pan drain termination location

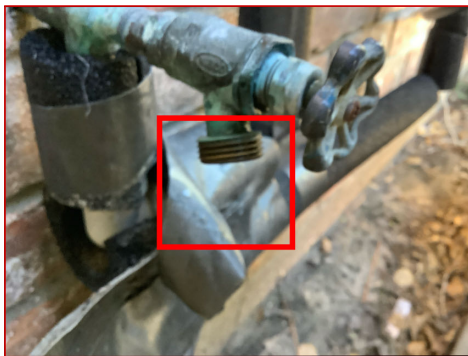
- The shower had functional flow and functional drainage at the time of the inspection.
- At the time of the inspection, the kitchen sink and operation of the faucet, spray unit, sink basin and under sink plumbing appeared to be in serviceable condition in the kitchen.
- The kitchen sink had functional flow and functional drainage at the time of the inspection.
- It is recommended that a backflow preventer device be added to the hose bib(s). (i.e. vacuum breaker/ anti-siphon device)
- A supply faucet was missing a handle at the time of the inspection.

Anti siphon devices absent

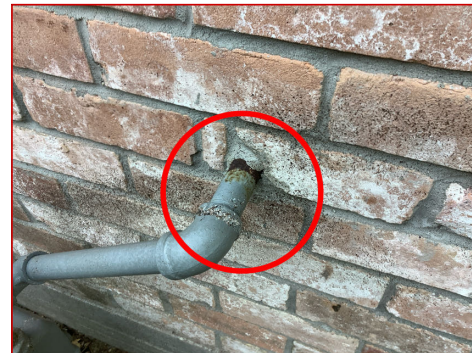
No pipe protection

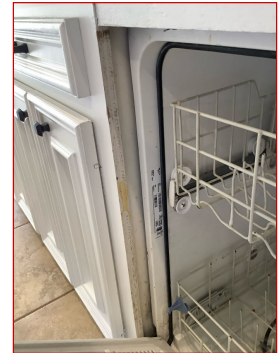
Not fastened properly
