## MECHANICAL REPORT

3763 Rice Boulevard  
Houston, TX 77005

# PROPERTY INSPECTION REPORT FORM

3763 Rice Boulevard, Houston, TX 77005

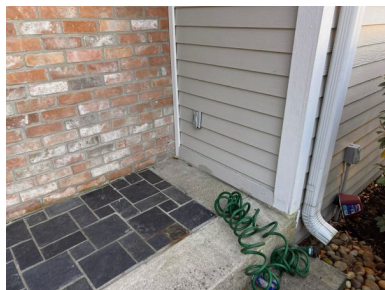
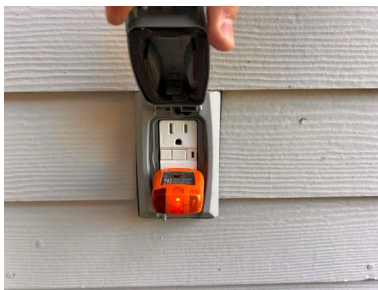
The electrical system was observed to be a 2-wire ungrounded system and three prong outlets, which are intended to be grounded, were installed on the ungrounded circuits. The ungrounded three prong outlets were retrofitted by protecting the ungrounded outlets with a GFCI device (which is an acceptable repair for an ungrounded three prong outlet). Each GFCI protected ungrounded outlet should be equipped with a sticker label to indicate that it is a GFCI protected outlet.

Recommendation: Contact a qualified professional.

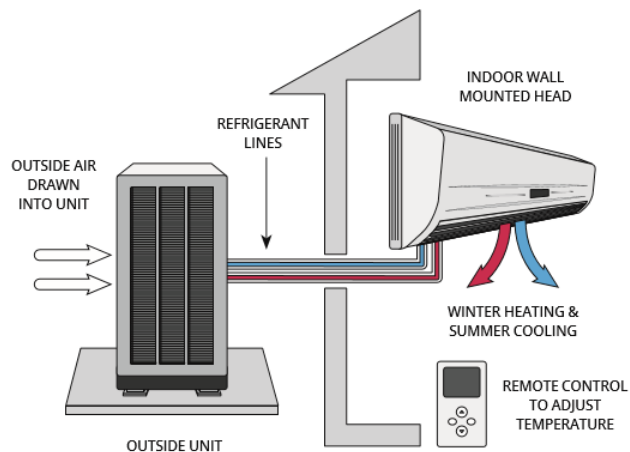
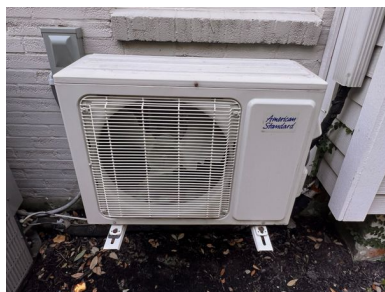
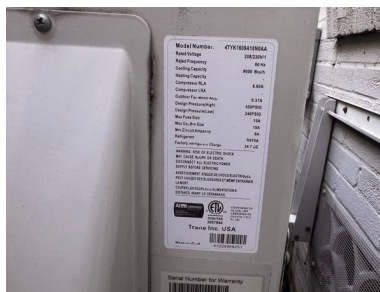
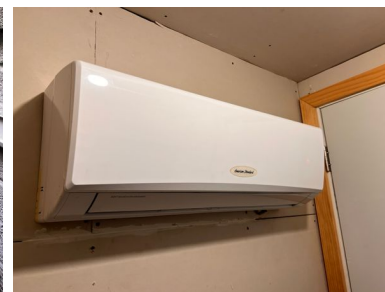
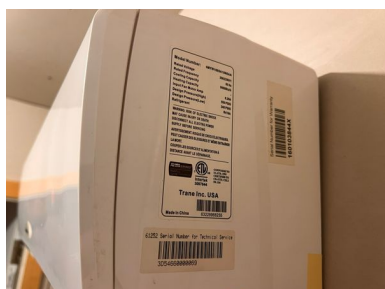
### Limited Life:

Due to the age and/or condition of the equipment, it is our opinion that the equipment has only a limited amount of life remaining. It would be a prudent to have the equipment thoroughly checked by a licensed air conditioning service company and further investigation is recommended.

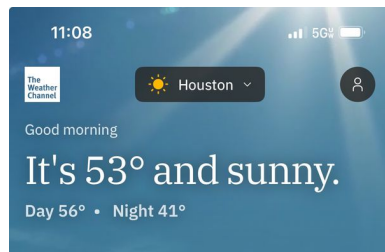
**3: A/C Equipment - Possibly oversized**

The total tonnage of the cooling equipment was 7.5-tons. As a ballpark method of estimation, approximately one ton of air conditioning can cool approximately 500-600 square feet of living area. By this method of estimation, 7.5-tons of air conditioning can cool approximately 3,750-4,500 square feet of living area. It is pointed out that a house that has an oversized air conditioning system cannot be expected to properly remove the humidity from the air. Further investigation is recommended by an air conditioning service company to determine if the existing equipment is sized properly to adequately and efficiently cool this house.

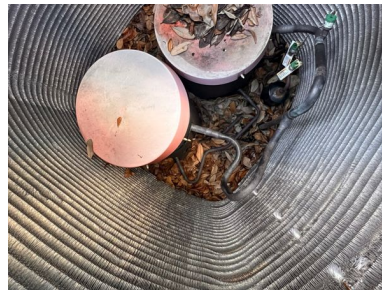
#### 7: Coil - Secondary drain capped

Debris was observed to be inside of the housing and needs to be removed and the inside of the unit thoroughly cleaned by a service company.

**Obtain Cost Estimate**

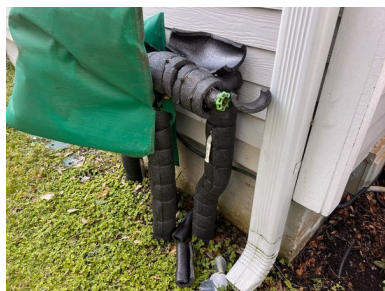
*Main Water Shut Off Valve Location:* East side -

The main shut-off valve for the water line service piping is intended to provide a means to disconnect the water service to the structure/property.

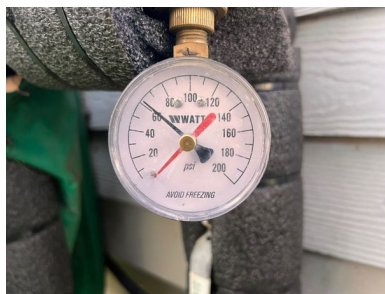
*Static Water Pressure:* 60-65 PSI -

The static water pressure at the property was measured with a water pressure gauge at the hose bibb nearest to the shut off valve at the time of the inspection.

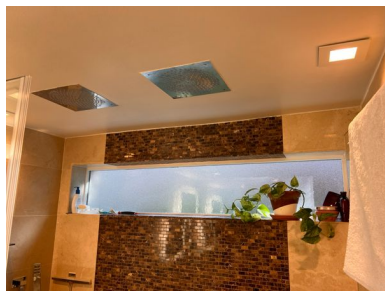
*Tub/Shower - Window sealants:*

A window was located within the spray of the shower head and it is recommended that the window sealants be maintained to prevent water penetration to the interior of the wall. No evidence of a current leak were visible, however leaks can occur should the sealant begin to deteriorate.

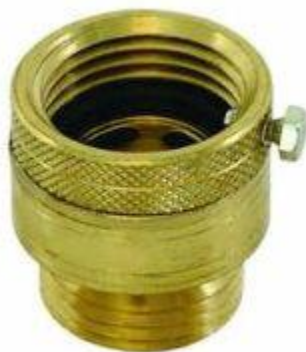
**1: Vacuum Breaker - Missing**

The atmospheric vacuum breaker devices were missing at one or more of the hose bibbs, and it is recommended that they be installed to prevent cross connections, which can allow contaminated water to enter the potable water supply.

**Obtain Cost Estimate**

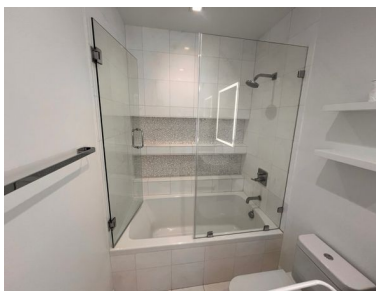
South West Guest Bath

The handle(s) on the hot/cold water valve was damaged/missing and needs to be replaced on the tub/shower.

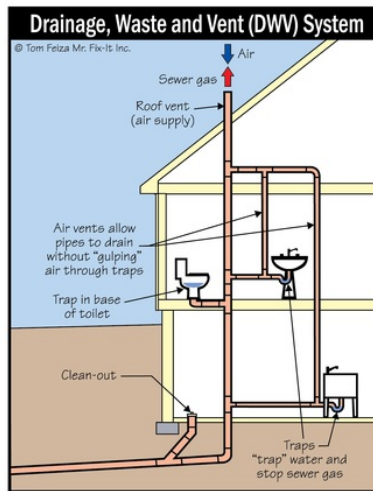
#### *Sewer Clean Out - Not visible:*

A clean out for the sewer line was not visible. It is recommended that you check with the owner to determine if a clean out is present, and if so, to determine the location of the clean out. This is needed for access to the sewer line should the sewer line become clogged and need to have a sewer snake run down the line to clean it out.

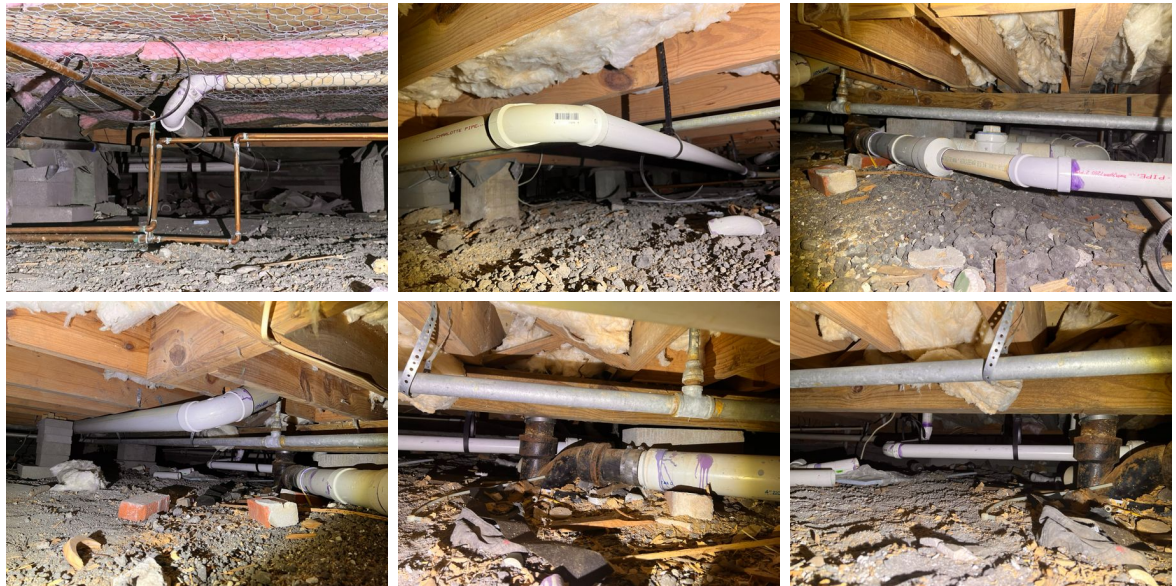
#### *Sewer Lines - PVC:*

The visible above ground sewer piping at the crawlspace under the house was observed to be PVC. The sewer piping appeared to be installed properly and no leaks were visible when we ran water down the piping during the crawlspace inspection.

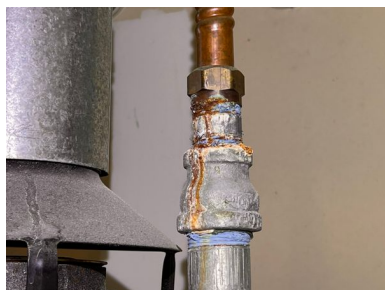
#### **1: Fittings - Corroded**

The piping at the top of the water heater was severely corroded at the fittings and is in need of repair.

#### **Obtain Cost Estimate**

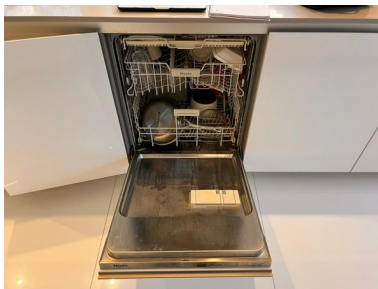
#### 1: No Anti-Siphon

The drain line under the sink was not equipped with an anti-siphon device, nor was it looped up so that the top of the loop is at least six inches above the entrance of the drain line into the disposal. It is recommended at least that the drain line be looped to prevent the water from the garbage disposal from siphoning back into the dishwasher, or an anti-siphon device installed.

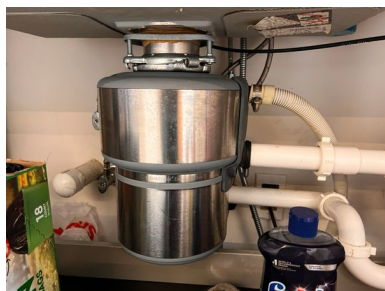
#### 1: Drain leaking at disposal

The dishwasher drain line is leaking at the point where it connects to the disposal.

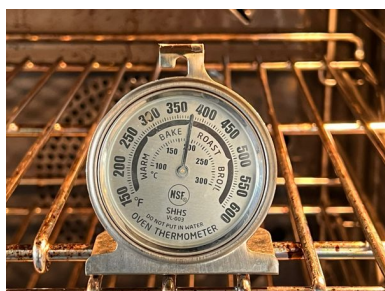
*Oven - Calibrated properly:*

No repair was needed to the calibration of the oven thermostat. The thermostat was set at 350 degrees, and the oven heated to within the allowable  $\pm 25$  degrees. The oven was checked with an oven thermometer and found to heat to 375 degrees.

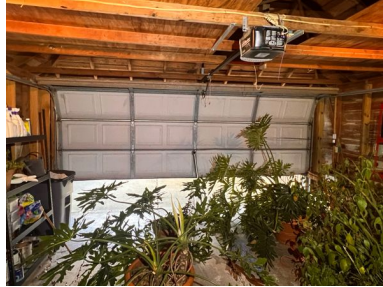
## 2: Door Lock

The door lock was still connected to the garage door. Manufacturers of garage door openers recommend that the locks be disengaged or removed when an automatic opener is installed. Damage to the door and/or door opener may occur if the door is operated with the garage door lock is engaged.

**Obtain Cost Estimate**

Recommendation: Contact a qualified professional.

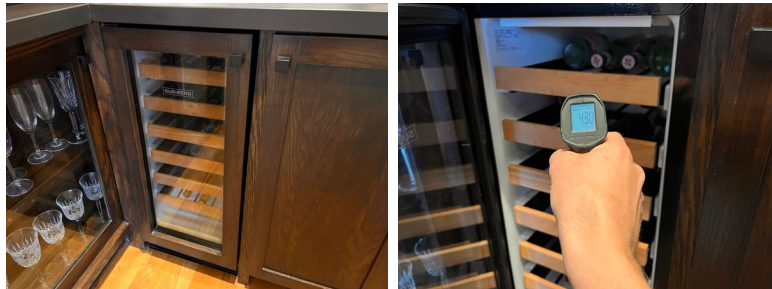
No items requiring repair were visible at the time of the inspection for the small refrigerator. The refrigerator was observed to be cooling adequately at the time of the inspection. It is noted that the unit was not

dismantled and the interior components were not checked.

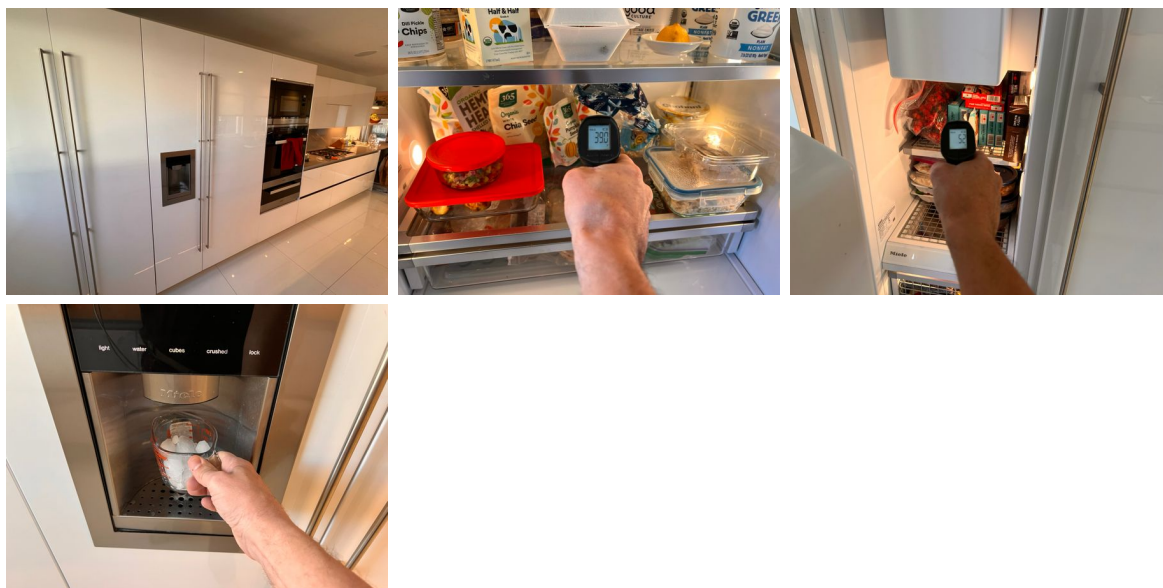
*Refrigerator with Ice Maker - Functional:*

No items requiring repair were visible at the time of the inspection for the built-in refrigerator and freezer sections. The refrigerator and freezer sections were observed to be cooling adequately at the time of the inspection. It is noted that the unit was not dismantled and the interior components were not checked. The ice maker inside the freezer also appeared to be functional and ice was observed inside the ice compartment. It is pointed out that we did not visibly observe the ice maker producing ice at the time of the inspection.

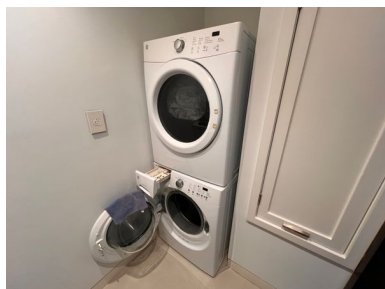
*Washer/Dryer Connections - Not visible :*

No access was provided behind the washer and dryer and the area was not visible for inspection. Further investigation is recommended. It is also recommended that you check with the owner to determine which dryer connection options are available.

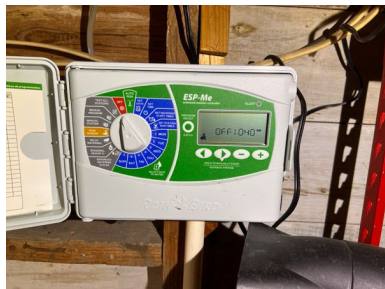
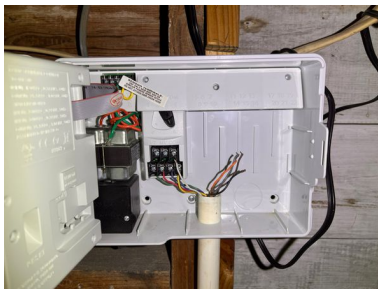
*Sprinkler System:* Rainbird, Located inside garage, 4 zones -

An automatic sprinkler system was installed. The system included a control panel, one or more solenoid valves, underground water lines and with sprinkler heads.

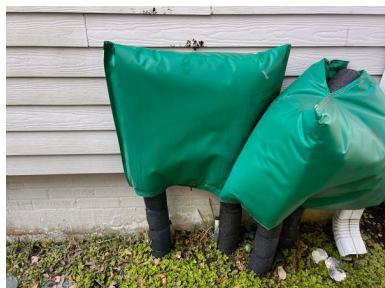
East

*Backflow Prevention Device - present:*

A backflow prevention device was present and was equipped with the two water shut off valves on the water supply line to the sprinkler system.

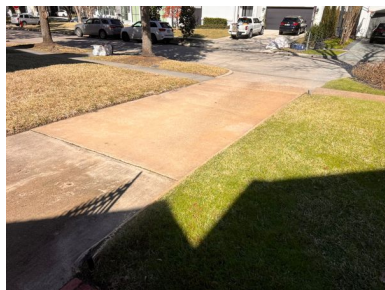
The sprinkler head spray was in need of adjustment/repair.

**Obtain cost estimate**

Recommendation: Contact a qualified professional.
