HEDDERMAN ENGINEERING. INC.

## STRUCTURAL REPORT

3763 Rice Boulevard  
Houston, TX 77005

REF: CONDITION OF PROPERTY SURVEY

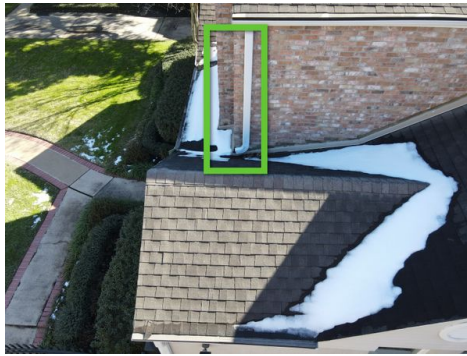
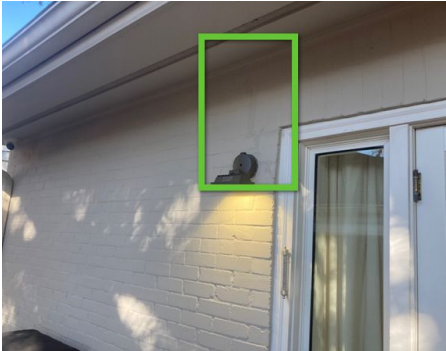
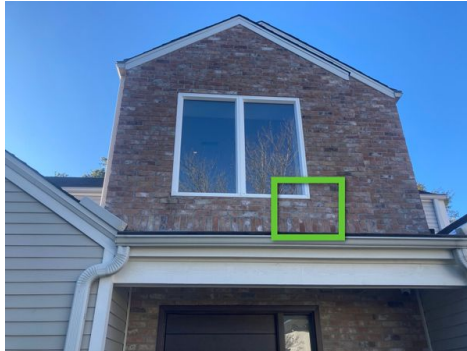
**Differential Movement: Veneer - Cracks/Patches**

Cracks and/or patches were observed in the exterior veneer at the time of the inspection, including at the locations shown in the photos. It is recommended that the cracks be repaired for cosmetic purposes.

**Obtain Cost Estimate**

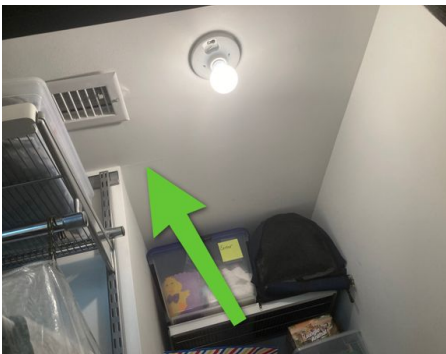
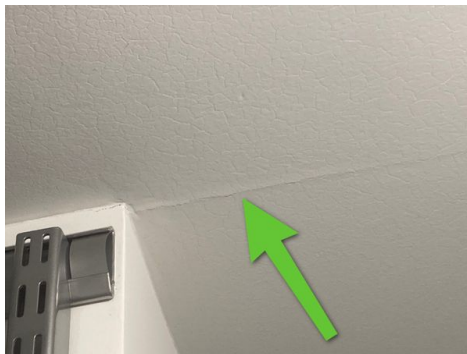
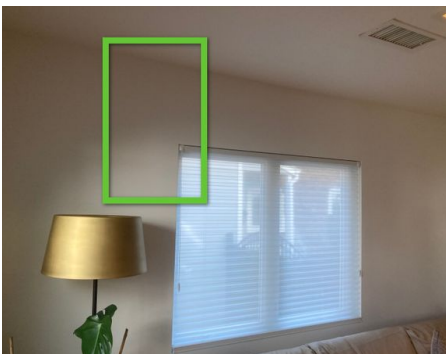
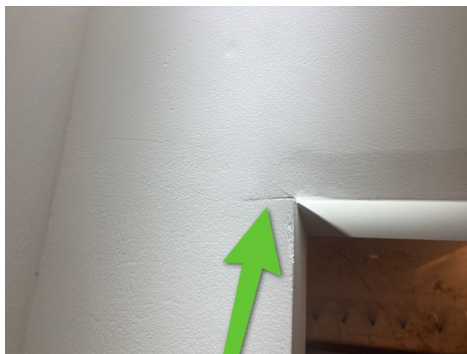
Dining room, family, living room, and the west bedroom closet.

**Differential Movement: Sheetrock Cracks - Minimal**

We observed that sheetrock cracks were minimal in number and degree at the time of the inspection.

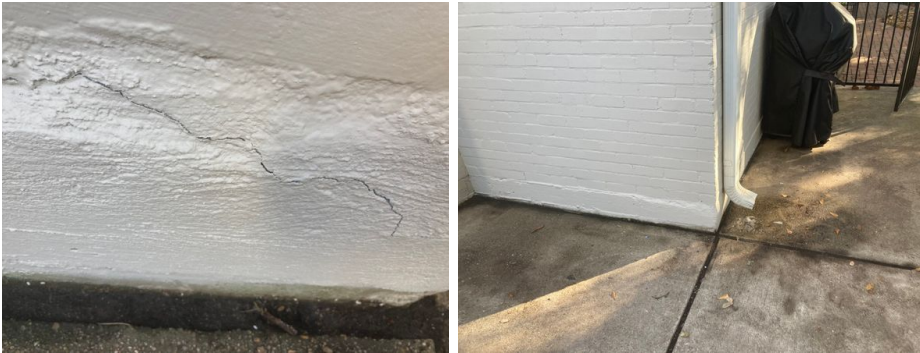
East side of the house

### Differential Movement: Concrete Cracks - Observed

The foundation concrete was observed to have hairline cracks, including at the above locations.

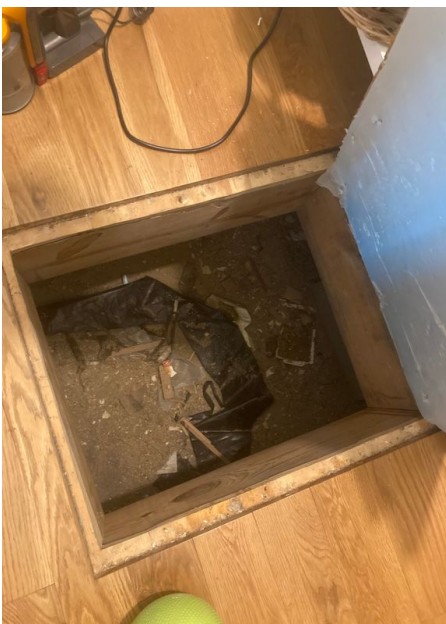
### Crawlspace: Access Opening - OK

The access to the crawlspace under the house was located as shown below, and we entered the crawlspace during the inspection. It is pointed out that the inspector only crawls to those areas under the house that can be safely accessed without having to crawl through water or other hazardous conditions.

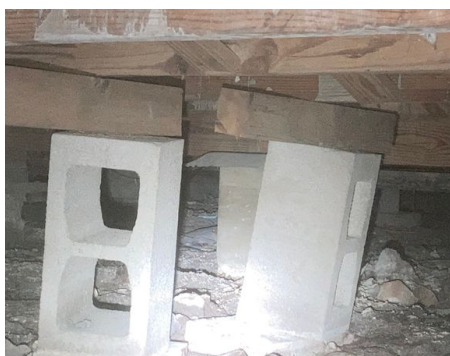
### Crawlspace: Cinder Block Piers - Functional

We observed concrete block piers under the house at the crawlspace that utilized CMU concrete cinder blocks rather than solid concrete blocks. The cinder blocks will be more vulnerable to cracking than the solid concrete blocks. While we did not observe significant cracking of the cinder blocks, it is recommended that the condition be monitored in the future. If the cinder blocks begin to crack, it may become necessary to replace them with solid concrete blocks.

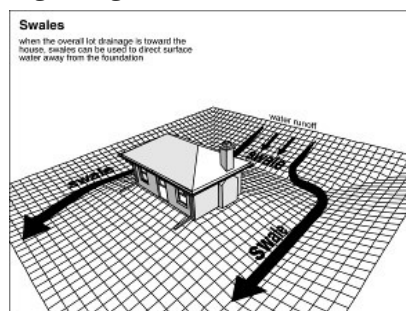
### **Perimeter Grading/Drainage: Appeared Adequate**

The perimeter drainage around the property appeared to generally be adequate. It could not be determined with certainty if water would pool at any localized low areas around the property. Further investigation with the homeowner is recommended to determine if there are any drainage problems or water that ponds on the property after a rain.

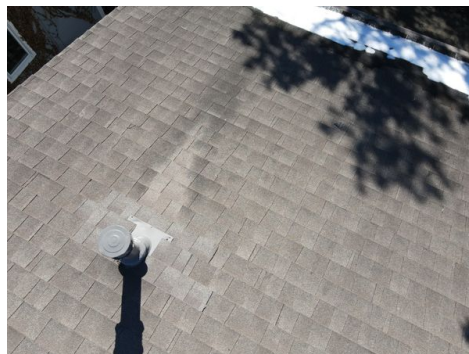
**Wear and Deterioration: Composition - Some**

Discolored, Nail Heads not Sealed, Aggregate Missing

The composition roof surface was showing evidences of some deterioration of the roof surface as described above and shown below.

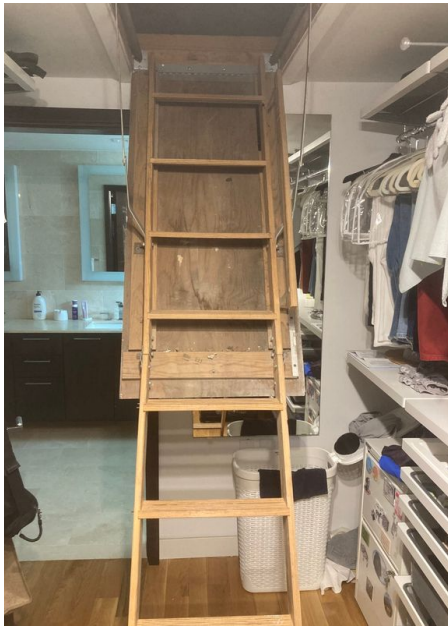
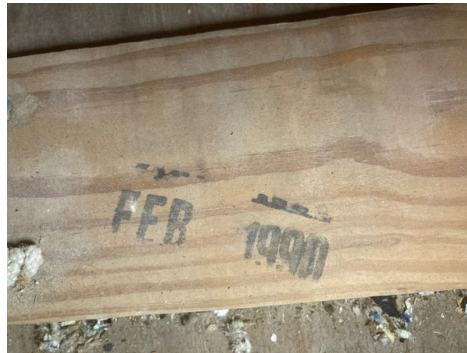
##### Ladder: Original ladder - Not rated

The access ladder into the rear attic appeared to be the original installation ladder, and the ladder was not labeled to indicate the rated capacity of the ladder.

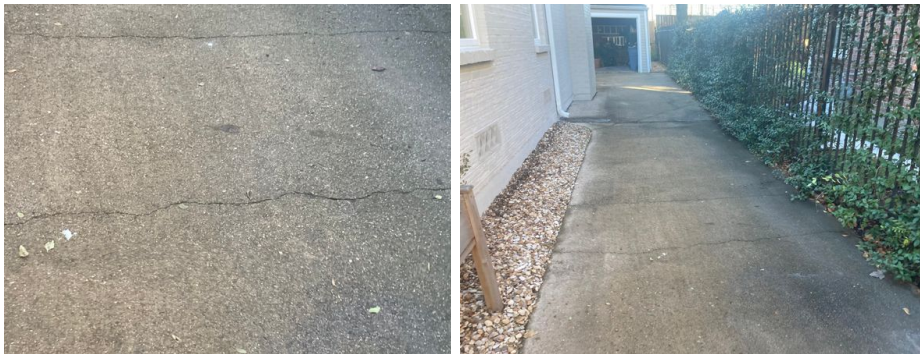
##### Driveway

The flatwork concrete listed above was in generally good condition at the time of the inspection with no significant repairs needed. Note that there may be some small cracks in the concrete, but in the opinion of the inspector, the concrete is still functional.

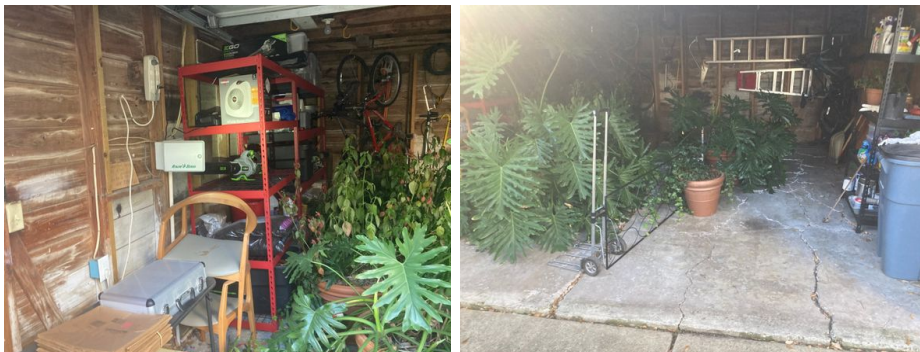
#### Garage: Stored Items

The garage had stored items in the garage, and access was limited inside the garage. We did not move any item in the garage, and not all of the garage was viewed at the time of the inspection.

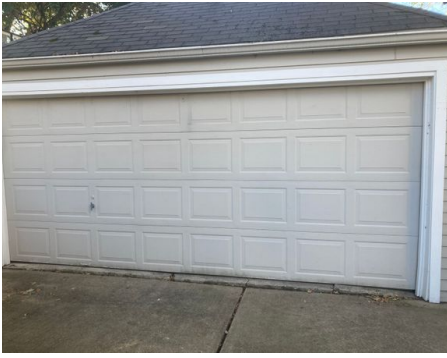
#### Garage Door: Garage door - OK

The garage door was in generally good condition at the time of the inspection, and no significant repairs needed.
