PROPERTY INSPECTION REPORT

Concerning: 128 Dolphin Avenue, Galveston, TX 77550
(Address or Other Identification of Inspected Property)

By: Danny Marlow Lic.#: 23187 04/23/2021
(Name and License Number of Inspector) (Date)

DATE OF INSPECTION: 04/23/2021
Inspection No. 521350-683

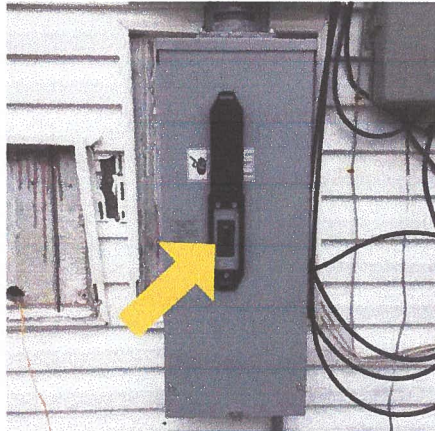
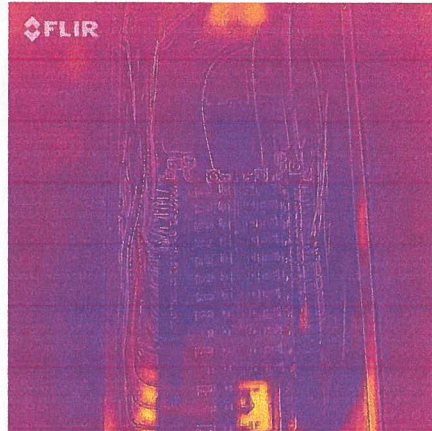
☒ ☐ ☐ ☐**A. Service Entrance and Panels***Comments:*

- 120/240 volt, 200 amp service.
- Grounding is through grounding rod to earth.
- Main disconnect is located in service panel on back exterior of home.
- Normal operating temperatures observed with a thermographic camera on the day of the inspection.
