PROPERTY INSPECTION REPORT FORM

Marleen DeLeon <i>Name of Client</i>	12/13/2023 <i>Date of Inspection</i>
5319 Laurel Creek Way , Houston, TX 77017 <i>Address of Inspected Property</i>	
Kevin Akins <i>Name of Inspector</i>	22211 <i>TREC License #</i>
<i>Name of Sponsor (if applicable)</i>	<i>TREC License #</i>

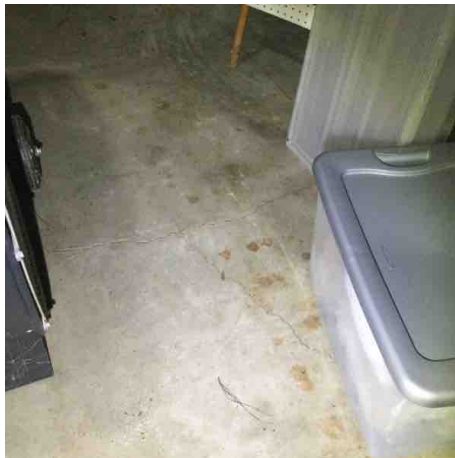
- **Cracks and buckling noted at the garage floor. This indicates adverse settling. Corrections should be made by a foundation specialist.**

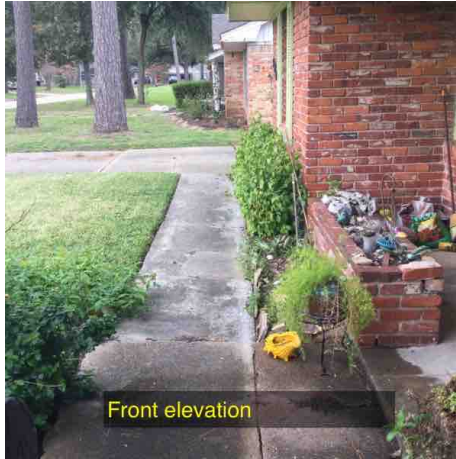
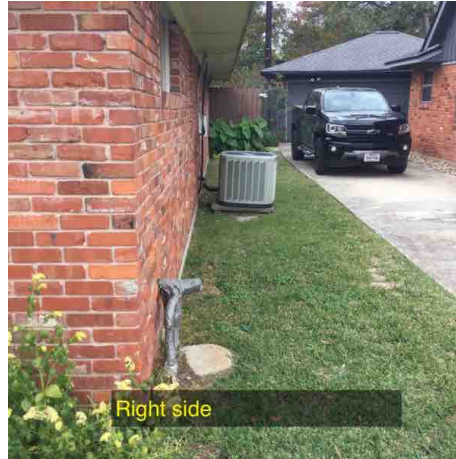
- Grading and walkway is slopping towards the foundation. Soil and walkway should be sloped away from the foundation to reduce possible moisture intrusion and related damages.

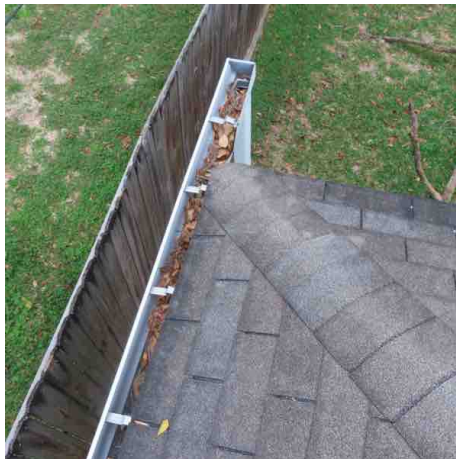
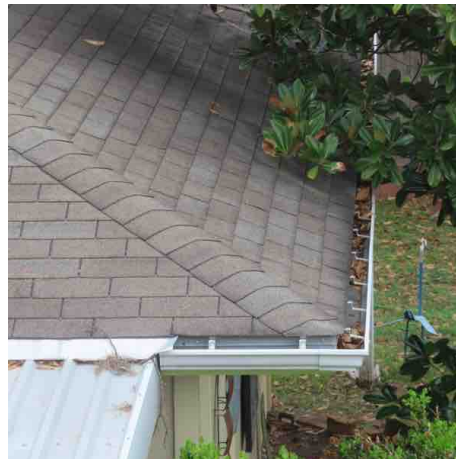
- Gutters have debris from nearby trees. Cleaning gutters will insure storm water is processes to the ground and away from the structure as efficiently as possible.

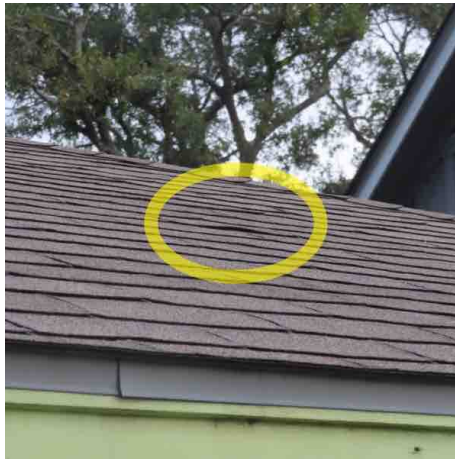
- **Lifted shingles noted at the roof covering which could peel back under heavy wind conditions (see photo). A qualified roofing contractor should make repairs where needed.**

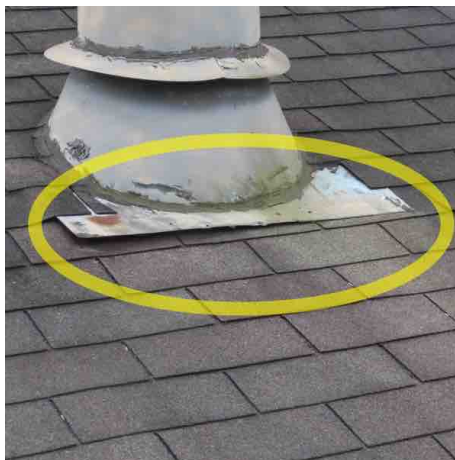
- **Lifted flashing observed at the roof covering. Lifted flashing can allow wind driven storm water to intrude under the roof covering. Recommend corrections by a qualified roofing contractor.**

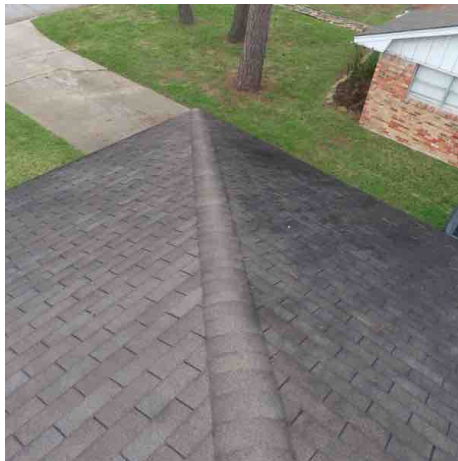
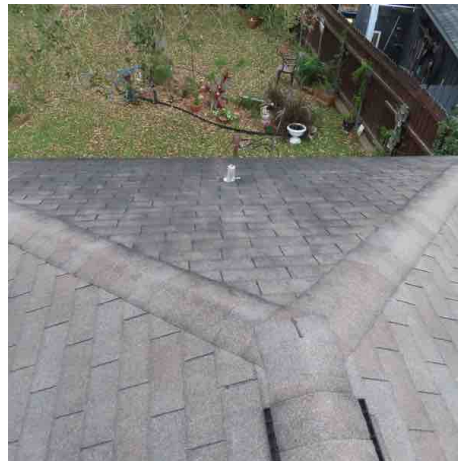
• **Tree branches were observed to be overhanging and in contact with the roof covering. During windy conditions branches can swipe away shingle granules and cause the covering to accelerate deterioration. Branches should be cut back away as needed. (Garage)**

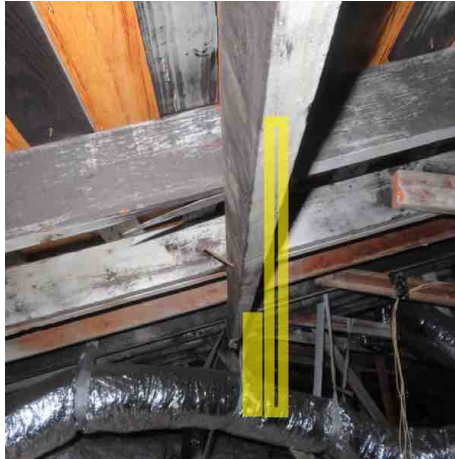
- **Structural purling's observed in the attic do not have enough purling braces (see photo). Recommend adding additional purling braces such that bracing spans do not exceed 48" on-center.**

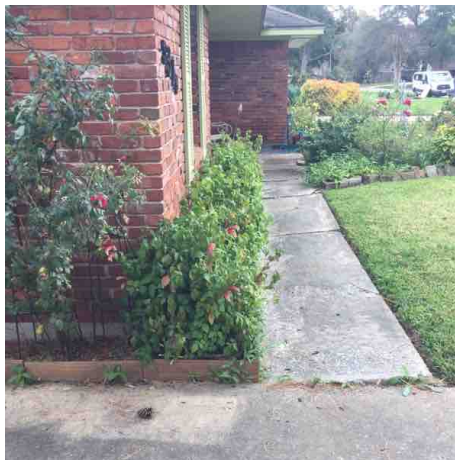
- The walls are inspected for structural performance and water penetration. Specifically excluded from this report is the presence of cosmetic concerns such as paint, minor cracks, scuffs and dings.
- **Observe general painting needs, gaps and caulking touch-ups around the structure. Recommend corrective actions by a painting and general contractor as needed.**
- **Vegetation was in direct contact with the structure at several locations around perimeter of the residence creating a conducive condition for potential pest infestation. Recommend pruning / cutting back vegetation so that a minimum of 6 - 8" of distance exists between the structure and the vegetation.**

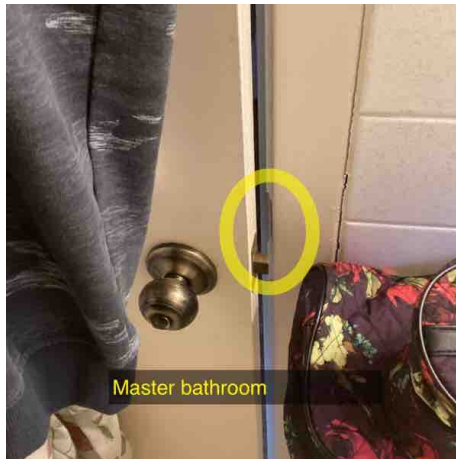
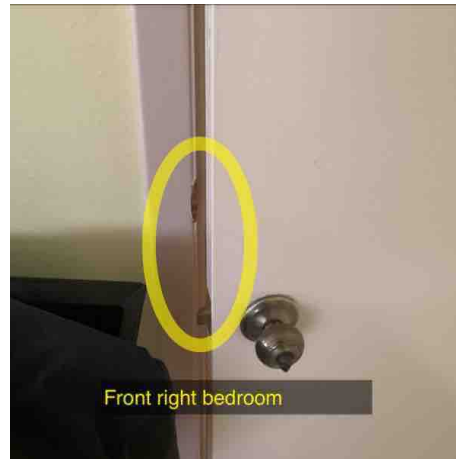
- **Door hardware does not latch properly. Recommend installing and adjusting strike plates to promote proper closure.**

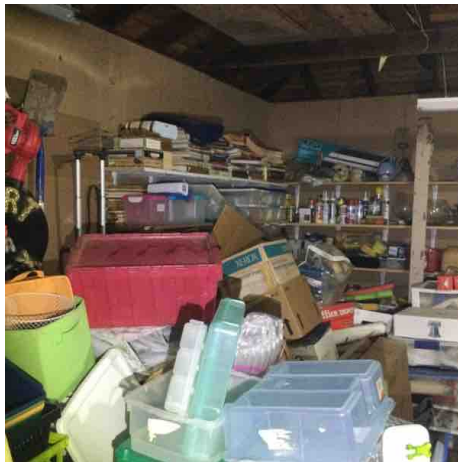
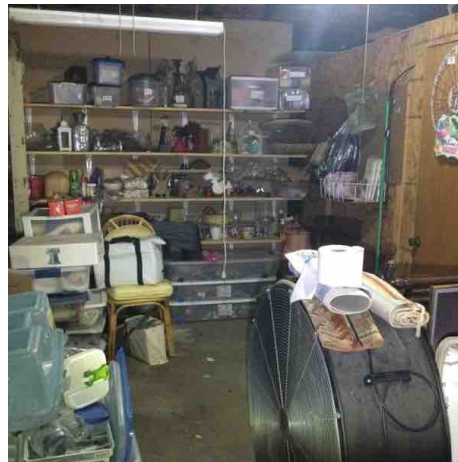
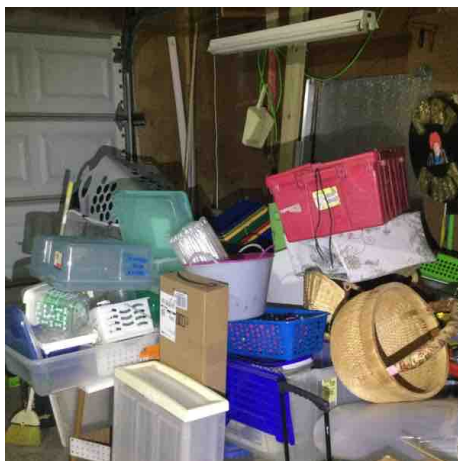
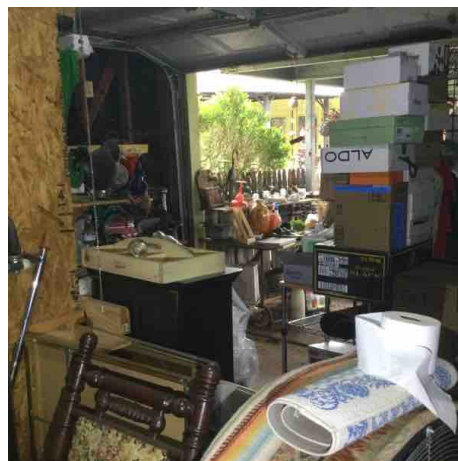
• The garage has an abundance amount of the homeowner’s belongings. This condition limited the Inspector’s view.

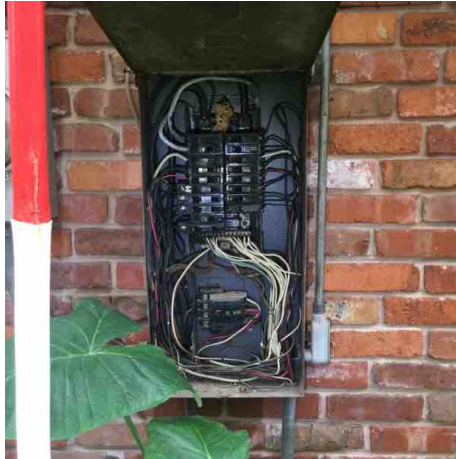
- **The Inspector did not locate a main electrical shut-off switch, which is required when there are 6 or more circuit breakers. A licensed Electrician should make corrections as needed.**

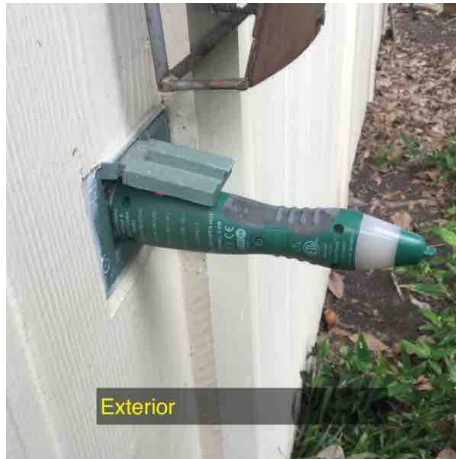
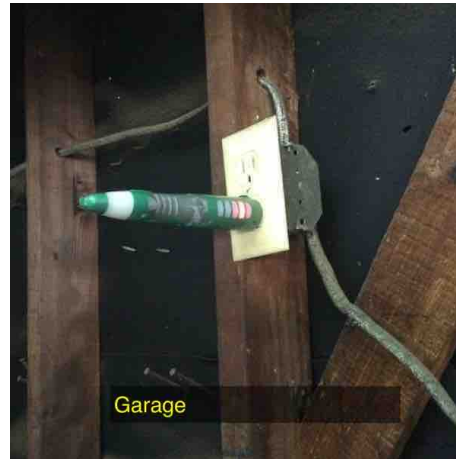
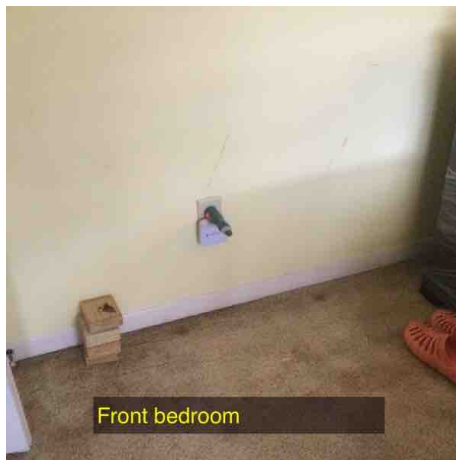
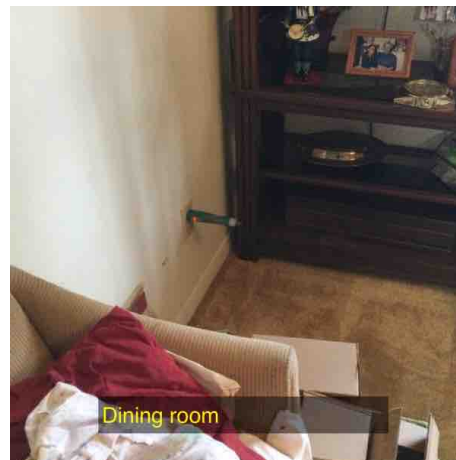
- Outlets have “open ground” indication during testing. Repairs should be performed by a licensed Electrician. (Garage)

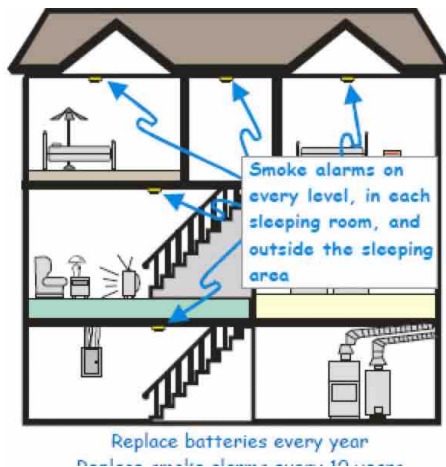
- Smoke detectors are missing around the structure. Current code requires smoke detectors in each sleeping quarters, adjoining each sleeping quarters and on each level. Recommend corrections by a qualified person or Electrician.

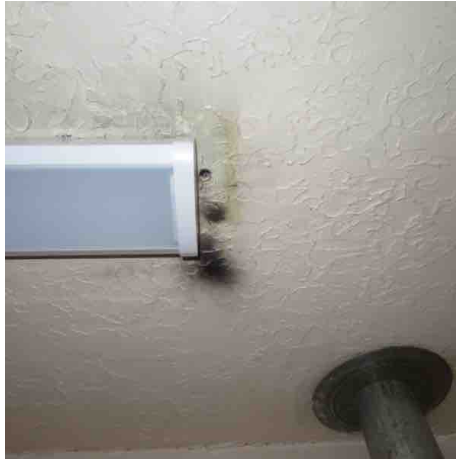
- **Burn marks noted on the ceiling in the utility room. A licensed Electrical should provide further evaluation and corrections where needed.**

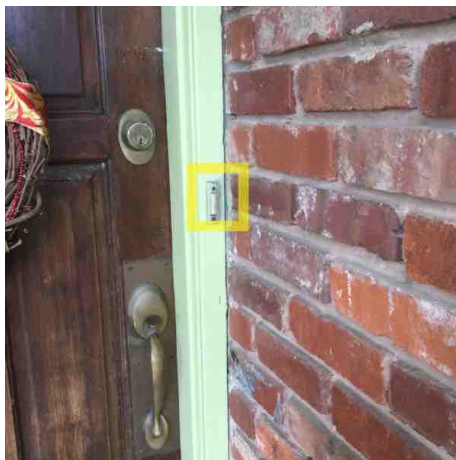
- **Doorbell and chimes were not functioning at the time of the inspection. Recommend repair or replacement as needed.**

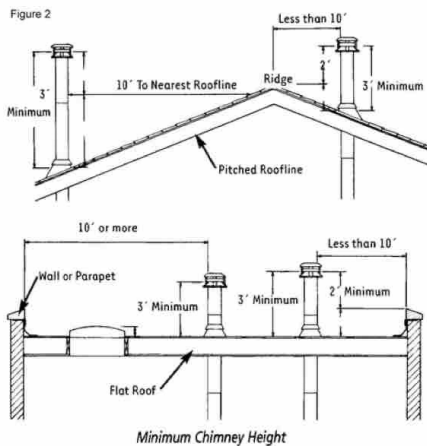
- **Roof vents for the furnace/water heater did not have the required clearance (2 feet above anything within 10 feet). Recommend repairs by a qualified contractor to establish proper clearance.**

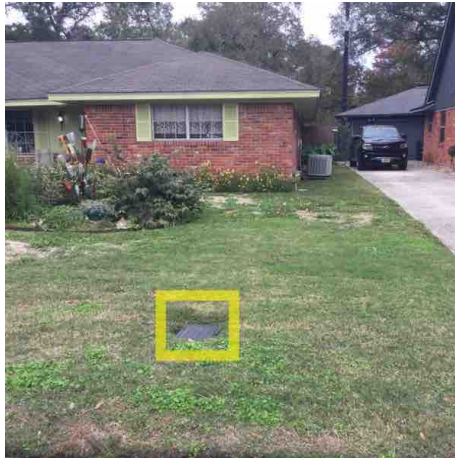
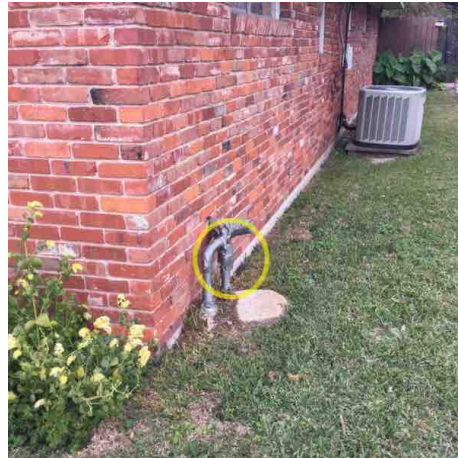
- Location of the water meter and shut off valve. No deficiencies noted.

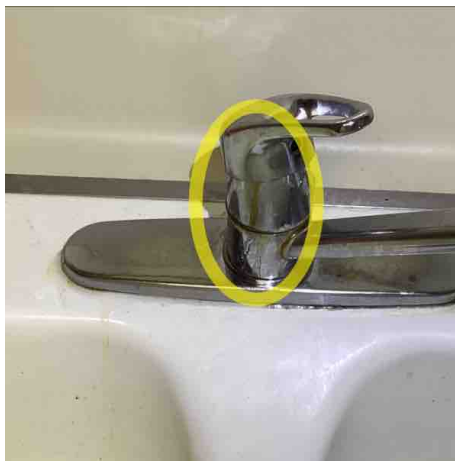
- Leaks observed at the kitchen faucet. Recommend corrective actions by a licensed Plumber.

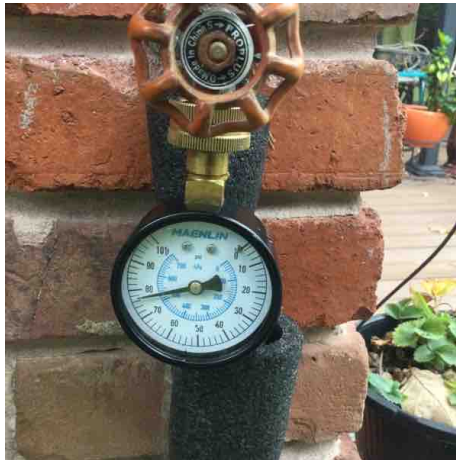
- Static water pressure below 80 PSI's - no deficiencies noted.

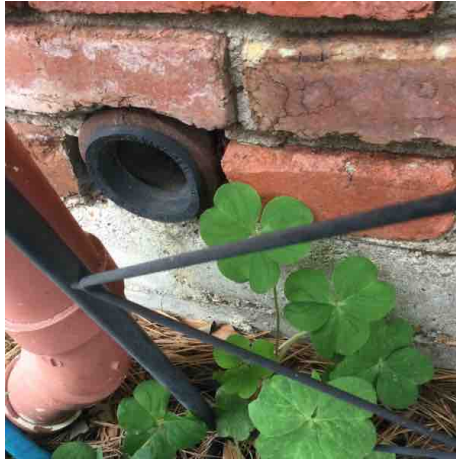
- The left side clean out cover has a missing cap. A fully enclosed cap should be installed to prevent debris from falling into the pipe and causing a blockage to the sewer system.

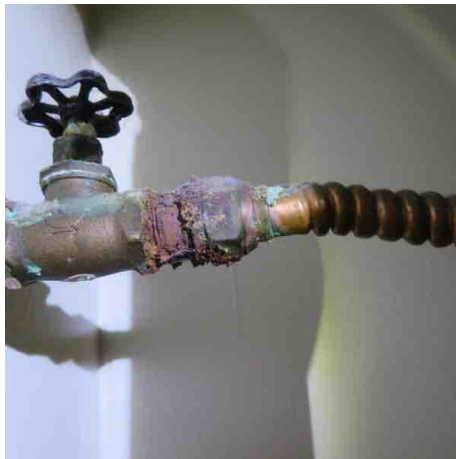
- A gas-fired water heater is present and was in operation at the time of the inspection. The capacity of the hot water system appears adequate for the normal needs of this size house.
- **Corrosion observed at the water heater connections (see photo). Repairs should be performed by a licensed Plumber.**

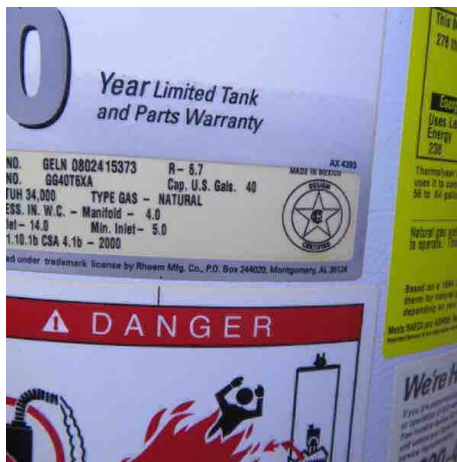
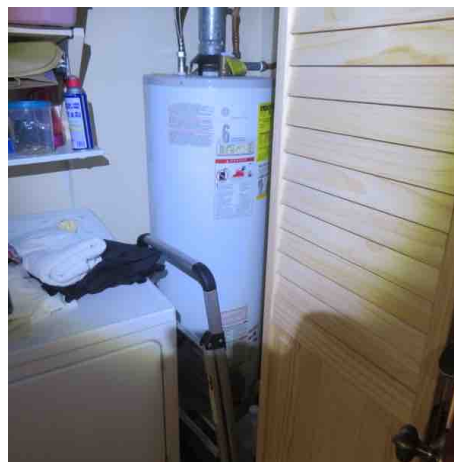
Although functioning normally at time of inspection, hot water heater is older (manufactured in 2002) and has exceeded its normal life expectancy. Recommend replacement.

- 40 gallon unit manufactured in 2002.

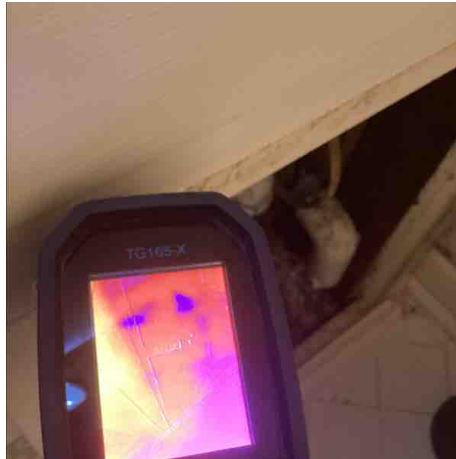
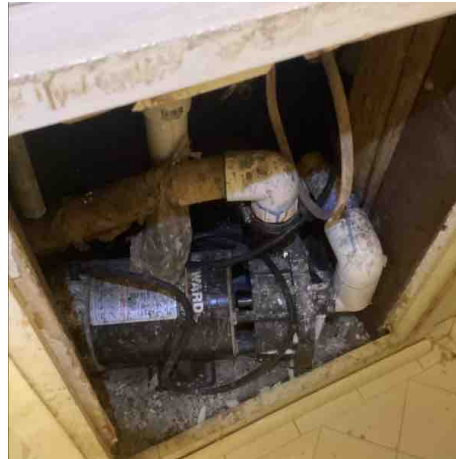
- **Inspector scanned the motor, jets and drains. No leaks detected at the time of the inspection. (Master Bathroom)**

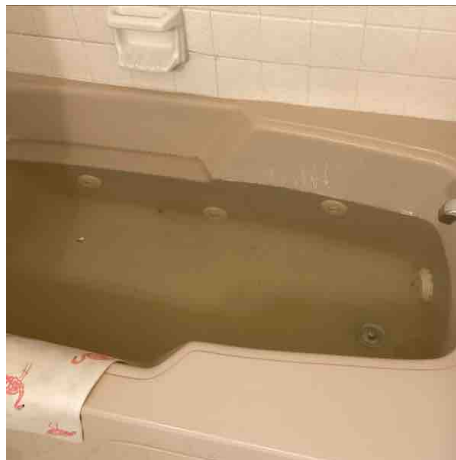
- **Whirlpool was not functional at time of inspection. A qualified plumbing contractor should make repairs where needed. (Master Bathroom)**

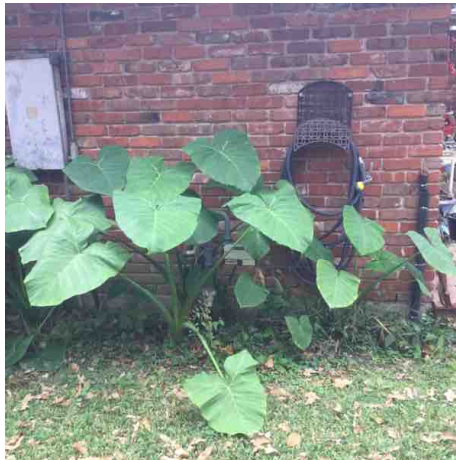
- Gas meter located at the rear of the home. No deficiencies noted.

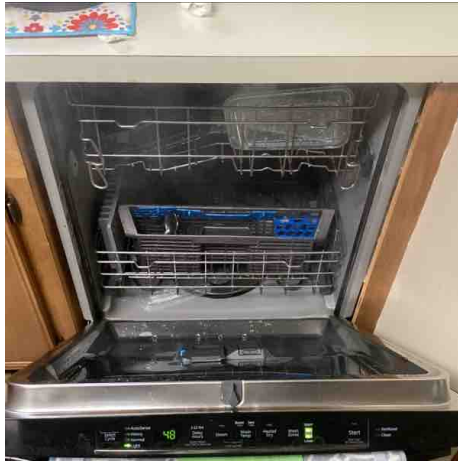
- Dishwasher was operated and run through a complete cycle. Functionality and operation appear to be normal with no leaks detected.

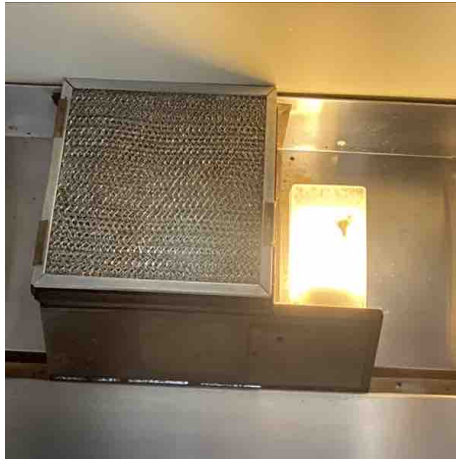
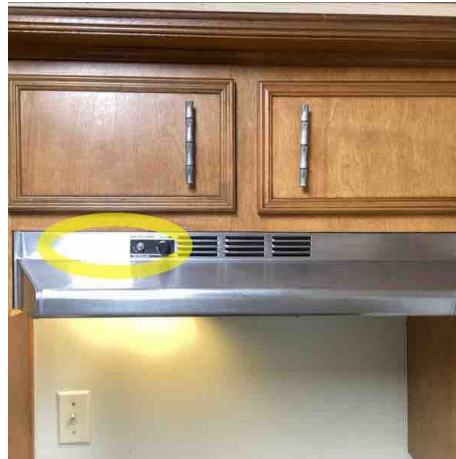
- The exhaust fan was inoperable, this unit is older and may be nearing the end of its useful life expectancy.

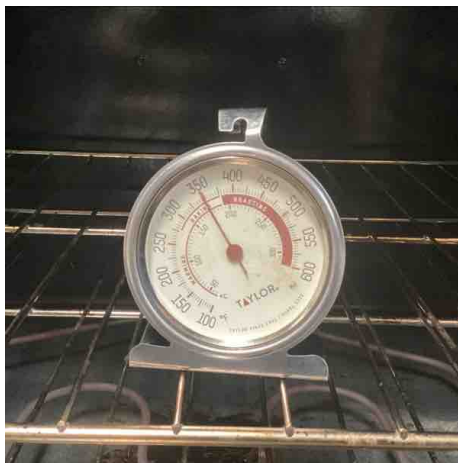
- Oven was tested at a temperature setting of 350 degrees. The oven measured 349 degrees; which is considered within normal operation parameters (+ / - 25 degrees).

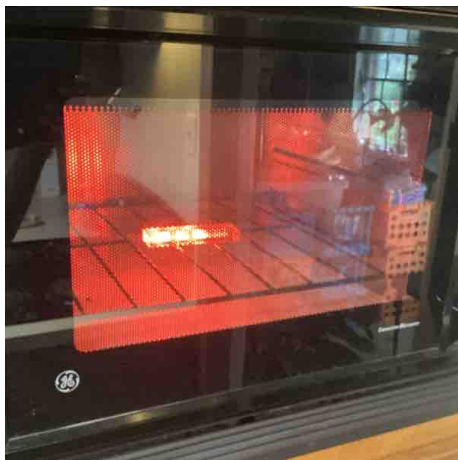
- Although operated, this unit is older and may require replacing in the near future.
