Property Inspection Report

Texas Premium Inspections

16203 Oak Lace Ln
Inspection Prepared For: Marcelo Lopez
Agent: Lawrence Cevallos - Vive Realty

Date of Inspection: 2/26/2025
Year Built: 1997 Size: 1288
Weather: 55° F, Partly Cloudy, Faces East, Vacant

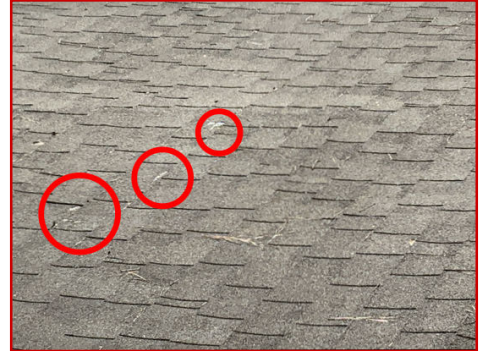
Example of fiber glass visible in shingle surface

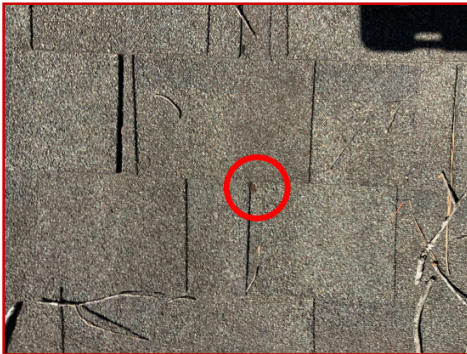
- Exposed nail heads are evident and should be sealed to avoid water penetration.
- Debris should be removed from the roof to avoid moisture damage to the shingles.
- One or more rubber vent boots were concave and will trap and or allow water to penetrate the roof structure.

Example of exposed nail heads

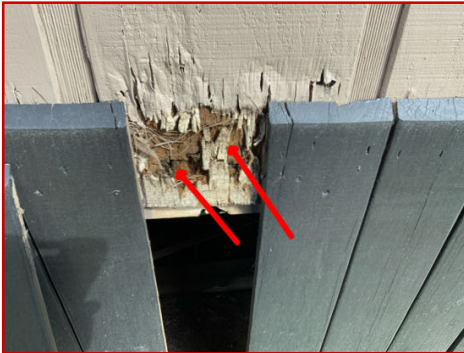
Example of damaged siding

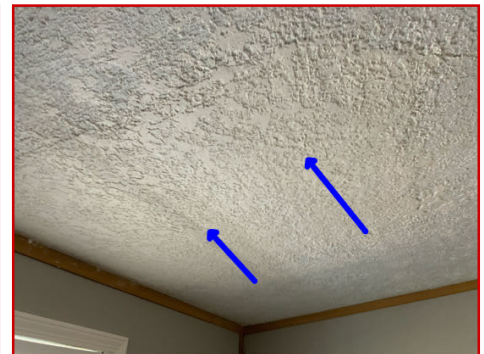
Example of ceiling patches

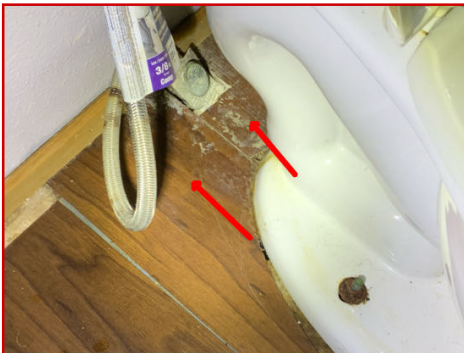
Sub floor behind toilet is completely deteriorated

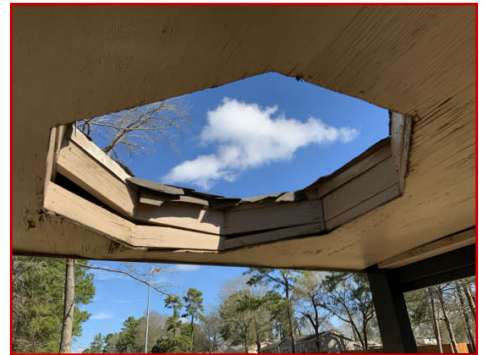
Hole in cover for tree that has been removed

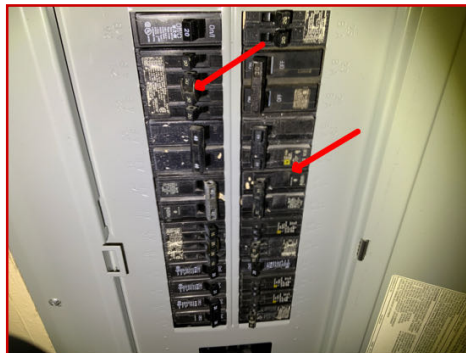
Sub panel, different brand breakers

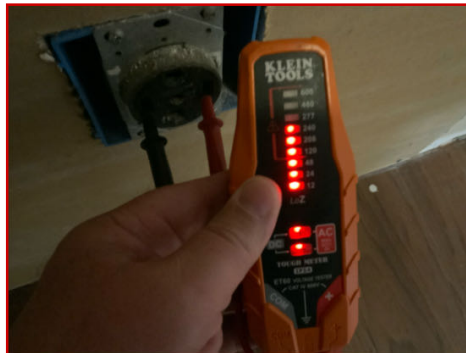
4 wire dryer receptacle is functional at inspection

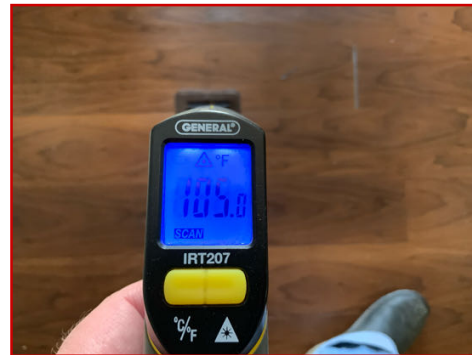
Furnace producing approximately 105° F at register

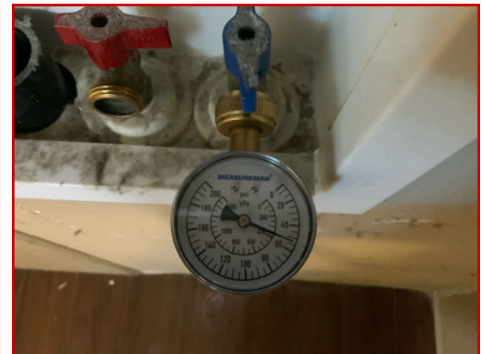
Static water pressure approximately 50 psi

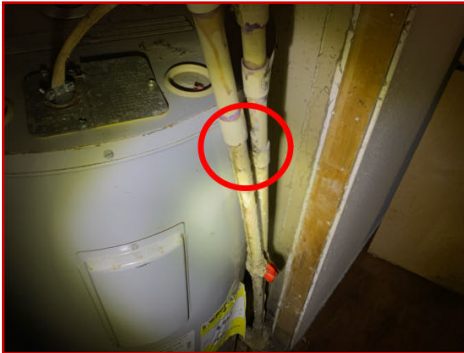
- The faucet in the kitchen leaked while not in use. This typically indicates that a valve seal needs replacement.
- The water pipes servicing the water heater were leaking at the time of inspection. Recommend further evaluation and correction, as needed, by a qualified professional.

Water leak in pipes by water heater

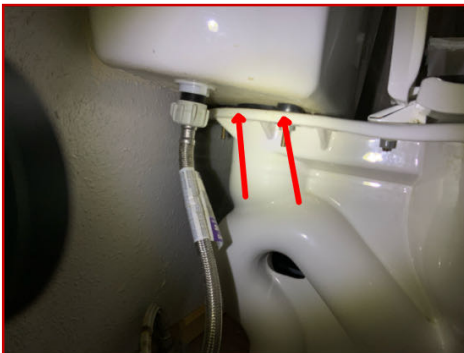
Hallway bath, leak at toilet tank

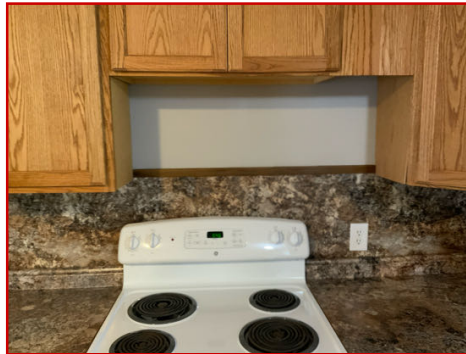
- There is no exhaust hood present at the time of inspection.

No vent hood

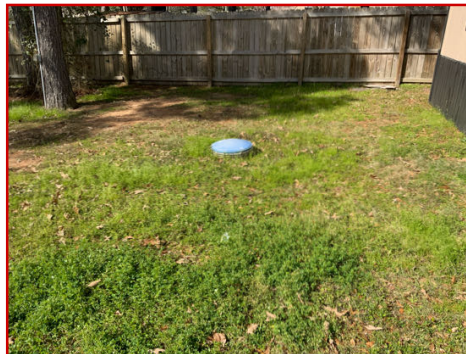
• The home had a private onsite wastewater sewage treatment system. Inspection of this system lies beyond the scope of the General Home Inspection, expertise and experience of this inspector and therefore was not inspected. These systems can be extremely expensive to replace, and the Inspector recommends that before the expiration of your Inspection Objection Deadline, you have the system inspected by the supplier, service company which has maintained or is expected to maintain the system, or a licensed, qualified inspector. Texas septic system owners are required by law, to properly maintain their septic systems because system failure or improper procedures could cause pollution or other hazardous conditions.

Septic not inspected
