## **INSPECTION REPORT**

**52WB-4YPW  
Ibraheem Malkawi  
4635 Beech St  
Bellaire, TX 77401**

# PROPERTY INSPECTION REPORT FORM

<u>Ibraheem Malkawi</u> Name of Client	<u>06/05/2025</u> Date of Inspection
<u>4635 Beech St, Bellaire, TX 77401</u> Address of Inspected Property	
<u>Zachary Ramage</u> Name of Inspector	<u>#25653</u> TREC License #
<u></u> Name of Sponsor (if applicable)	<u></u> TREC License #

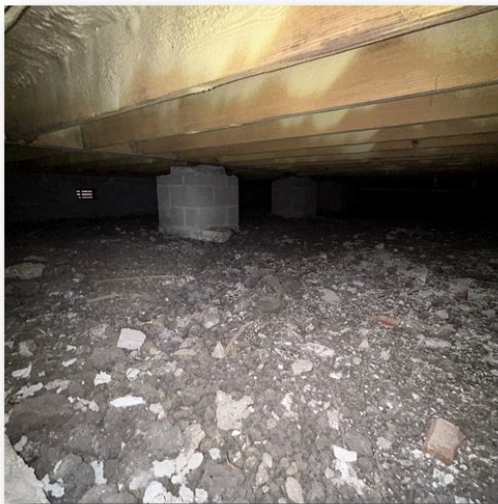
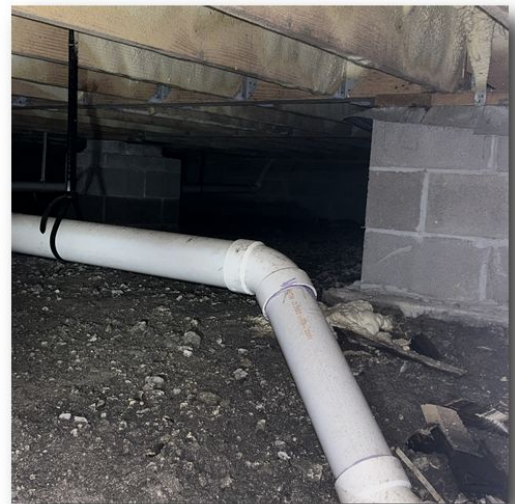
**Settle crack**

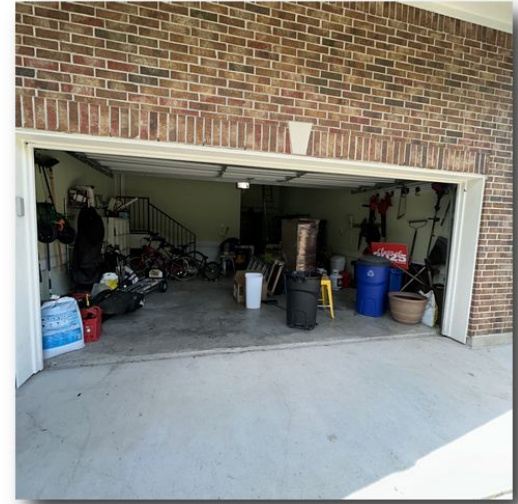
### Damaged weatherstrip

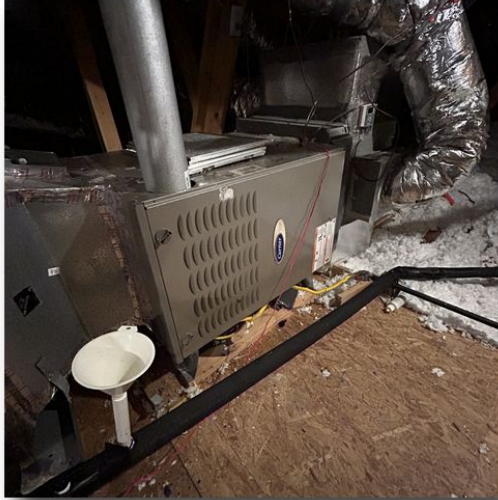
Manufacturer:Carrier. Age: 8.  
Model number: 58PHB090-10116  
Serial number: 5117A17406  
Filter location:At the unit.

The furnace(s) operated as intended and all visible components were in serviceable condition at the time of our inspection.

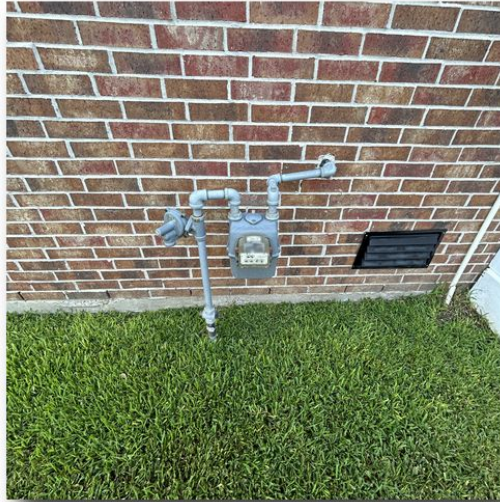
Type of piping used: Black iron  
Location of gas meter West exterior.

All visible components were in serviceable condition at the time of our inspection.
