PROPERTY INSPECTION REPORT

Concerning: 2121 Garnet Ct, Texas City, TX 77591
(Address or Other Identification of Inspected Property)

By: Tom Langley, Lic #TREC #20644 04/14/2021
(Name and License Number of Inspector) (Date)

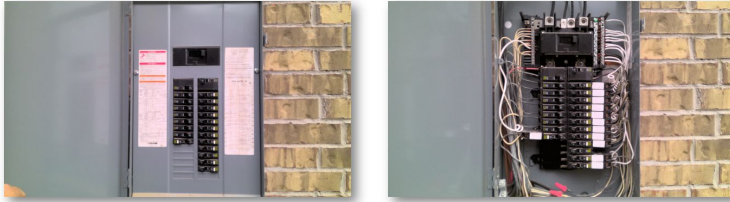
A. Service Entrance and Panels

Panel Box : Square D
Box Rating : 200 amps
Box Location: South Exterior Wall
Main Service Entrance: underground
Type of Main Service Wiring: Copper
Main Disconnect Rating: 100 amps
