3107 Planters Peak Drive Houston TX 77080

PROPERTY INSPECTION REPORT

Prepared For:	Davis Badger		
	(Name of Client)		
Concerning:	3107 Planters Peak Drive, Houston, TX 77080		
	(Address or Other Identification of Inspec	ted Property)	
By:	Steve Fusselman TREC 10405 / BPG Inspection, LLC	4/15/2019	
	(Name and License Number of Inspector)	(Date)	
	(Name, License Number of Sponsoring Inspector)

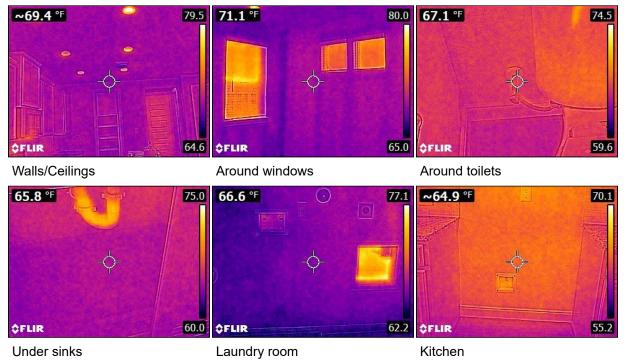
We have utilized an infrared camera during the course of this inspection. This camera allows the inspector to analyze surface temperature differentials which would not ordinarily be visible to the inspector. Prior to using the camera, the inspector will ensure the HVAC system is operational to increase the temperature differential between the interior and the exterior of the home. The camera can aid in the inspector's identification of moisture intrusion, electrical system defects and other anomalies in the home. This camera does not change the scope of the inspection as defined by the above cited standard of practice nor does it allow the inspector to definitively identify any conditions behind finished surfaces. The camera is a tool, much like an outlet tester or flashlight, that allows the inspector to make better recommendations to the client regarding current conditions in the home. Any number of factors can negatively affect the inspectors ability to identify thermal anomalies including; atmospheric conditions (wind, humidity, cloud cover, etc.), surface moisture and debris. The presence or absence of infrared camera photographs does not indicate the presence or absence of concealed defects. Sample photos added to show examples of areas of concentration during the full home infrared scan.
