# GW STANDARD HOME INSPECTION

14231 Lost Meadow Ln Houston, TX 77079

# PROPERTY INSPECTION REPORT FORM

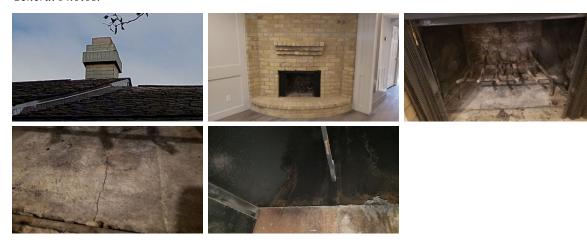
Comments:
General Photos:

Fireplace Fuel Source: Wood Burning

Cclamp?: N/A
Damper: Operational
Chim Flue: Metal
