## GW STANDARD HOME INSPECTION

4727 Shetland Ln Houston, TX 77027

# **PROPERTY INSPECTION REPORT FORM**

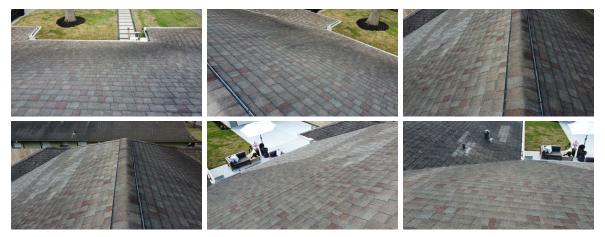
General Roof Photos:

Roof Viewed From: Ladder, Roof Edge, Drone, Binoculars

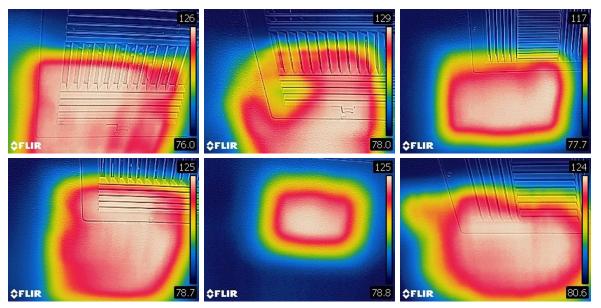
#### **⊠** □ □ **□** A. Heating Equipment

#### Unit Information:

The National Association of Home Builders and Bank of America Home Equity division produced a Study of Life Expectancy of Home Components in February 2007. Life expectancy is based on first owner use.

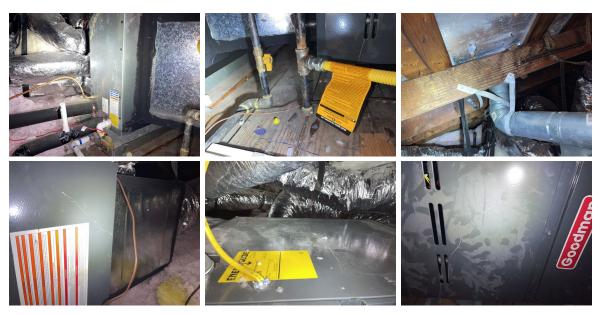
Furnace Energy Source: Gas Furnace Type: Forced Air - Gas Fired Furnace Location: Attic Heating Temperatures:

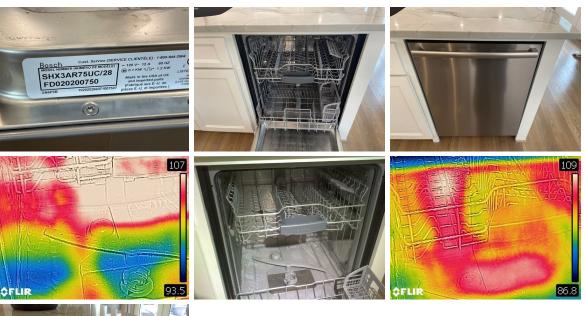
# 🛛 🗆 🗆 🗠 A. Dishwashers

Appliance Information:

DW Back Flow: Not Present

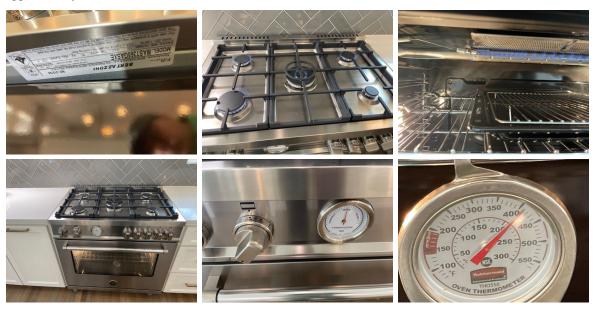
## **D. Ranges, Cooktops, and Ovens** *Appliance Information:*

Oven Type: N/A Range Type: Gas Gas Line Access: No
