**DRAIN INSPECTION**  
**LIMITATIONS AND DISCLOSURES**

Client Name: Kevin Akins (Care of Marleen Deleon)  
Address: 5319 Laurel Creek Way, Houston, Texas 77017

### **DETAILED INSPECTION FINDINGS**

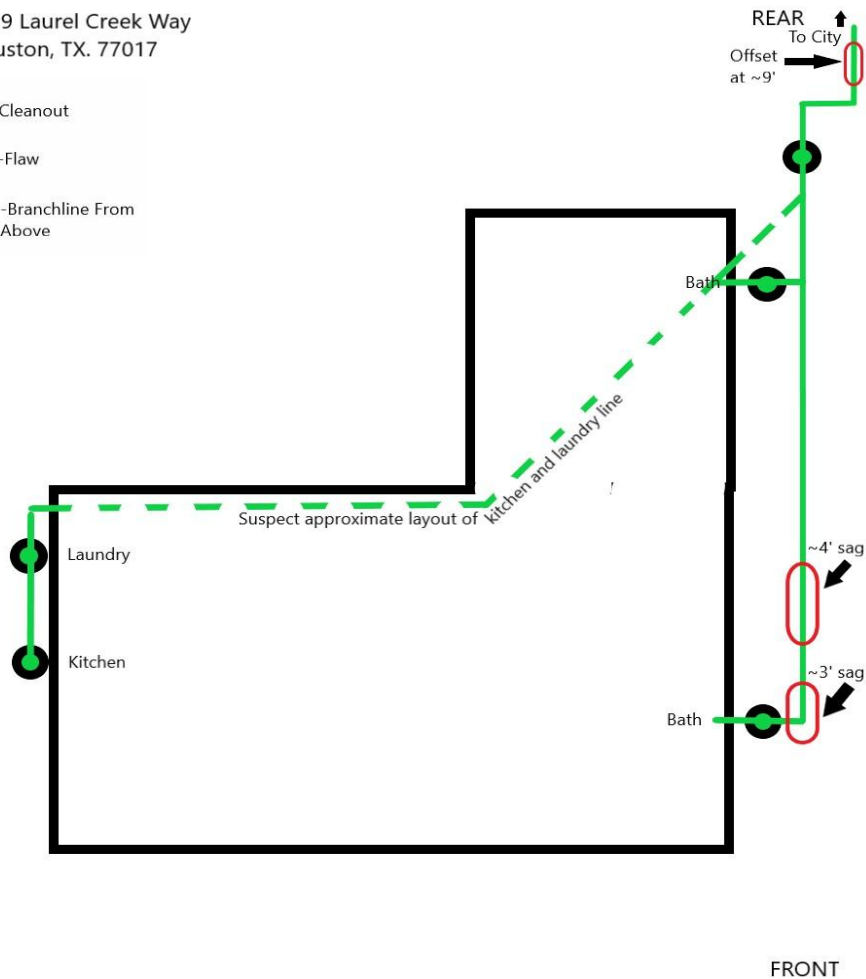
5319 Laurel Creek Way  
Houston, TX. 77017

-   -Cleanout
-   -Flaw
-   -Branchline From Above

Location of Sewer Cleanout Cap(s): Rear right of house, Right side x2, Exterior kitchen, Exterior laundry
