Inspection #105.00

TEXAS OFFICIAL WOOD DESTROYING INSECT REPORT

26910

Gadwall Bayou Ln

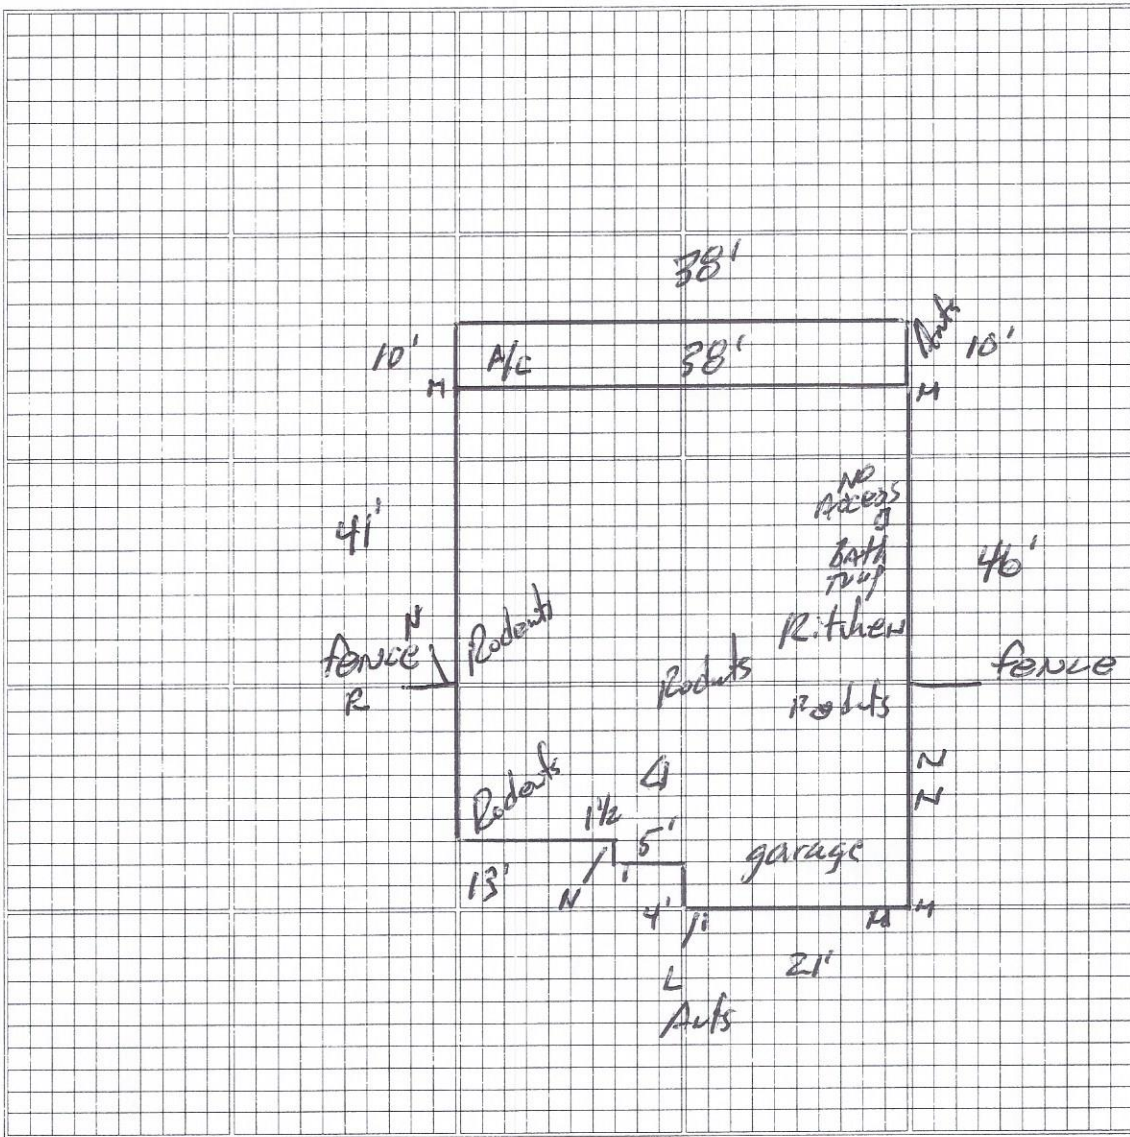
Diagram of Structure(s) Inspected

The inspector must draw a diagram including approximate perimeter measurements and indicate active or previous infestation and type of insect by using the following codes: E-Evidence of Infestation, A-Active; P-Previous; D-Drywood Termites; S-Subterranean Termites; F-Formosan Termites; C-Conducive Conditions; B-Wood Boring Beetles; H-Carpenter Ants; Other(s) - Specify _____

Additional Comments signs of rodents in attic and corners of baseboards
