**ENGINEERING OPINION**  
INSPECTION OF FOUNDATION LEVELING  
RESIDENCE AT 1182 BOURNEWOOD DRIVE, SUGAR LAND, TEXAS, 77498  
Date of Inspection: April 29, 2020  
Date of Report: May 2, 2020

# POST-LEVELING SLAB SURFACE ELEVATIONS

1182 Bournewood Drive, Sugar Land, Texas, 77498

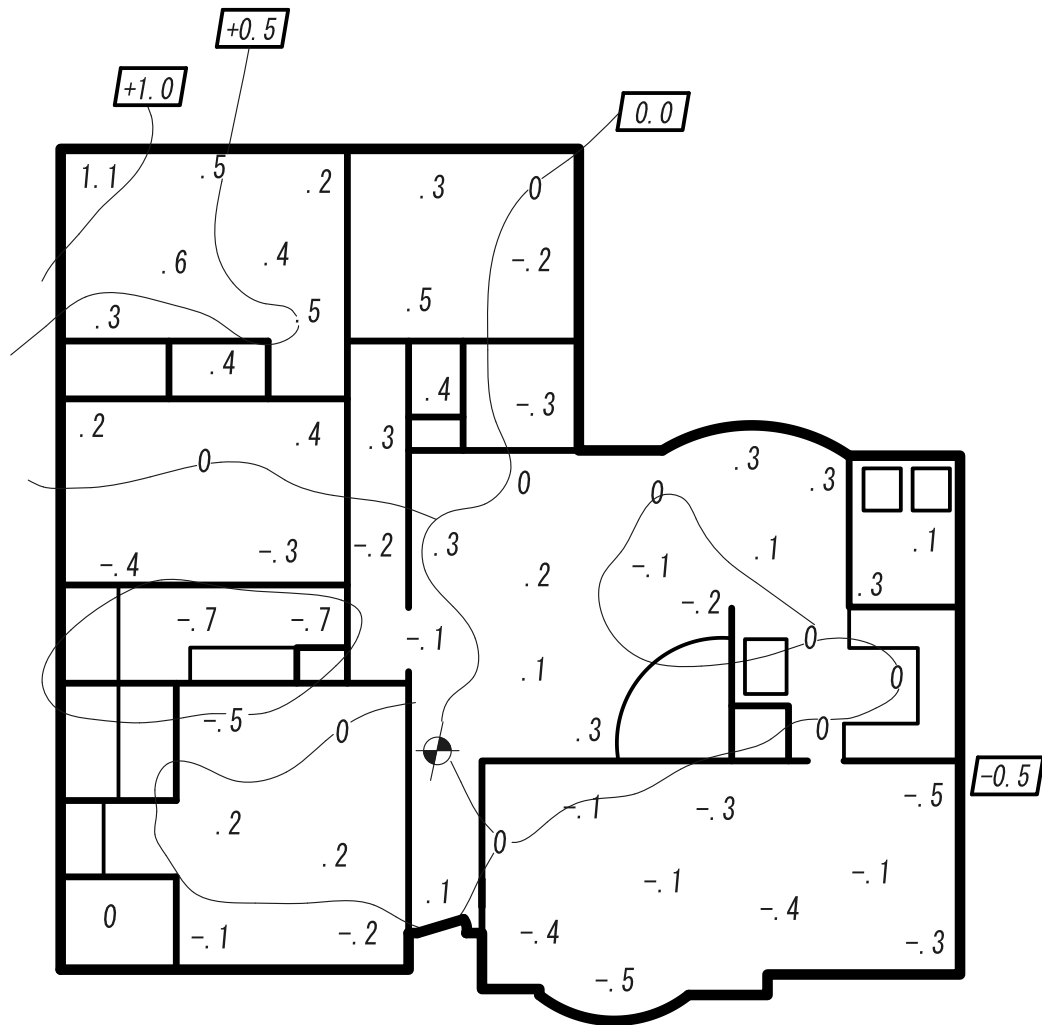
An elevation survey throughout the house was performed using a Technidea Zipllevel. The foundation surface elevations fall within the generally accepted standard for foundation repair performance. See attached survey.

- ELEVATIONS IN INCHES
- CORRECTED FOR FLOORING
- ISO-ELEVATION (CONTOUR) LINES AT .5 INCH INTERVALS
