## Job Summary

<b>Customer Name:</b>	krzysztof Cebulak	<b>Insurance / Client:</b>	
<b>Claim / PO Number:</b>		<b>Policy / WO Number:</b>	
<b>Servpro Job Number:</b>		<b>Customer Phone:</b>	(713) 205-3360
<b>Job Address 1:</b>	14318 Corktree Knolls	<b>Customer Email:</b>	Kceb58@gmail.com
<b>Job Address 2:</b>			
<b>City, State, Zip:</b>	Cypress, TX 77429

<b>Category of Water:</b>	3	<b>Class of Water:</b>	3
<b>Days to Achieve Dry Standard:</b>	5.08	<b>Total Affected SF:</b>	2474.02
<b>Drying Zones:</b>	1

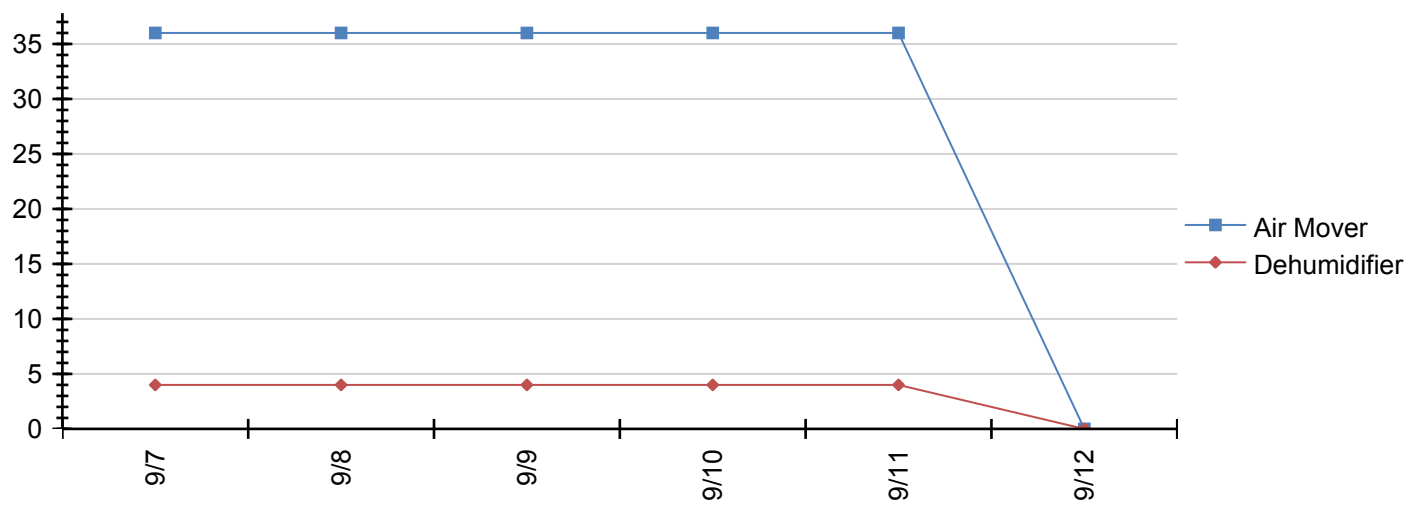
**Usage Chart**

\* Equipment Calculations are based on the difference between the "Removed Timestamp" and the "Placed Timestamp" for each piece of equipment. In the event that a piece of equipment has not yet been removed from the job, then the "Report Run Timestamp" will be used for calculations. Hours are calculated by multiplying the days by 24.

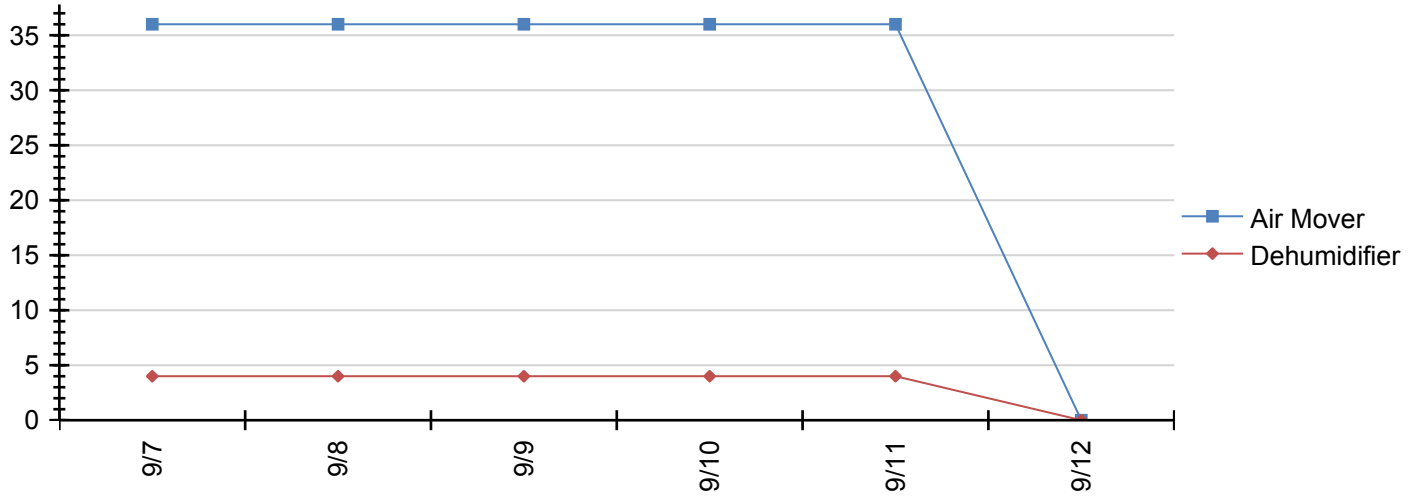
### Zone 1 Equipment Usage

Date	Room	Air Mover Count	Dehu Model	Dehu Rating	Asset No	Dehu Hour Counter
9/7/2017 10:05 AM Tech: Cw	Bed	2				
	Bed 2	4				
	Dining Room	3	Revolution	80 PPD	014D	0
	Entry	1				
	Garage	2				
	Hall 2	1				
	Kitchen	3				
	Linnen	3	R200 LGR	125 PPD	066D	0
	Lvr	5	Revolution	80 PPD	065D	0
	Mbr	5	Revolution	80 PPD	009D	0
	Mbr cl	1				
	Mbr tlt	1				
	Office	2				
	Office cl	1				
	Tlt	1				
	Utl	1				
				<b>4</b>	<b>365 PPD</b>
