**Note: Job still in progress**

NiteOwl Restoration  
PO BOX 1164  
Tomball, TX 77375  
832-593-1600

**Ramiro Lopez**  
**24503 Hartwick Falls Dr, porter, TX 77365**

# Job#: NO19-Lopez,R

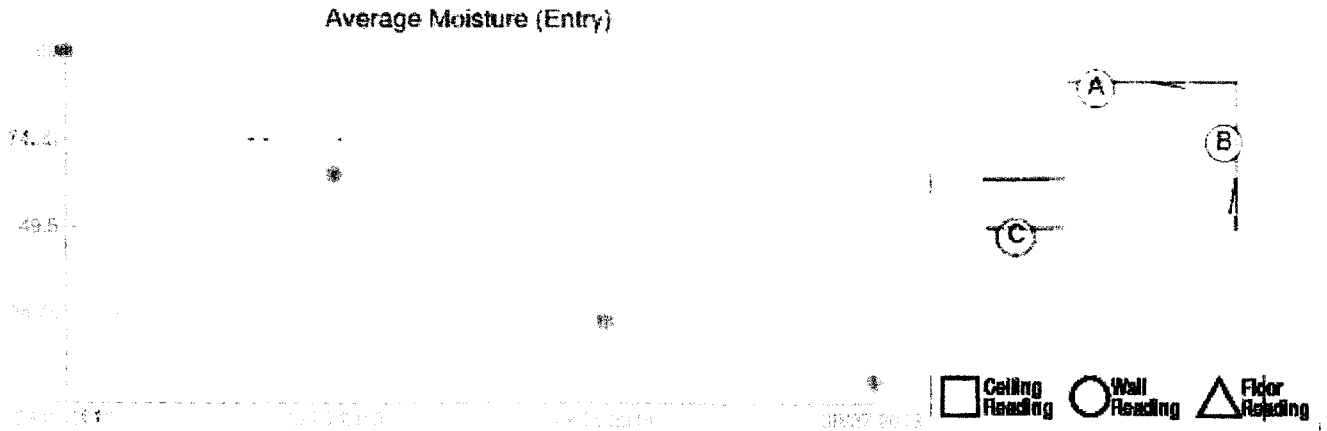
Moisture Readings A: 99 B: 99 C: 99

Moisture Readings A: 69 B: 59 C: 66

**Moisture Readings** A: 29 B: 22 C: 19

**Moisture Readings** A: 7 B: 4 C: 7

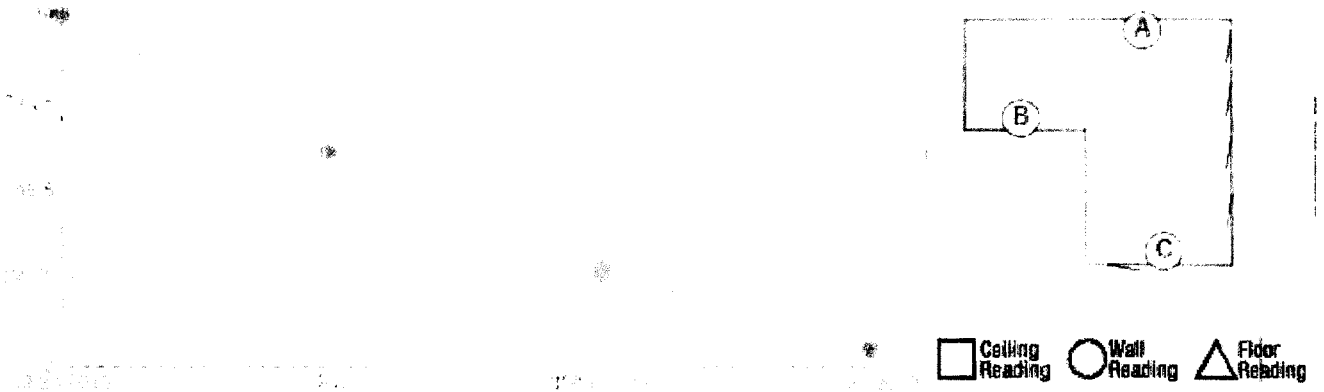
**Average Moisture (Garage)**

**User** Jason Scott  
**Moisture Readings** A: 99 B: 99 C: 99  
**Room Readings** Temp In: 73 RH In: 69 GPP In: 84.9  
**Equipment** Air Mover: 4 Axial: 0 Dehumidifier: 1 Negative Air Fan: 0 Other: 0  
**Notes**

**Moisture Readings** A: 65 B: 61 C: 55  
**Room Readings** Temp In: 84 RH In: 50 GPP In: 87.7  
**Equipment** Air Mover: 4 Axial: 0 Dehumidifier: 1 Negative Air Fan: 0 Other: 0  
**Notes**

**User** Jason Scott  
**Moisture Readings** A: 24 B: 22 C: 34  
**Room Readings** Temp In: 87 RH In: 43 GPP In: 82.7  
**Equipment** Air Mover: 4 Axial: 0 Dehumidifier: 1 Negative Air Fan: 0 Other: 0  
**Notes**

**User** Jason Scott  
**Moisture Readings** A: 4 B: 5 C: 7  
**Room Readings** Temp In: 90 RH In: 32 GPP In: 67.3  
**Equipment** Air Mover: 4 Axial: 0 Dehumidifier: 1 Negative Air Fan: 0 Other: 0  
**Notes**

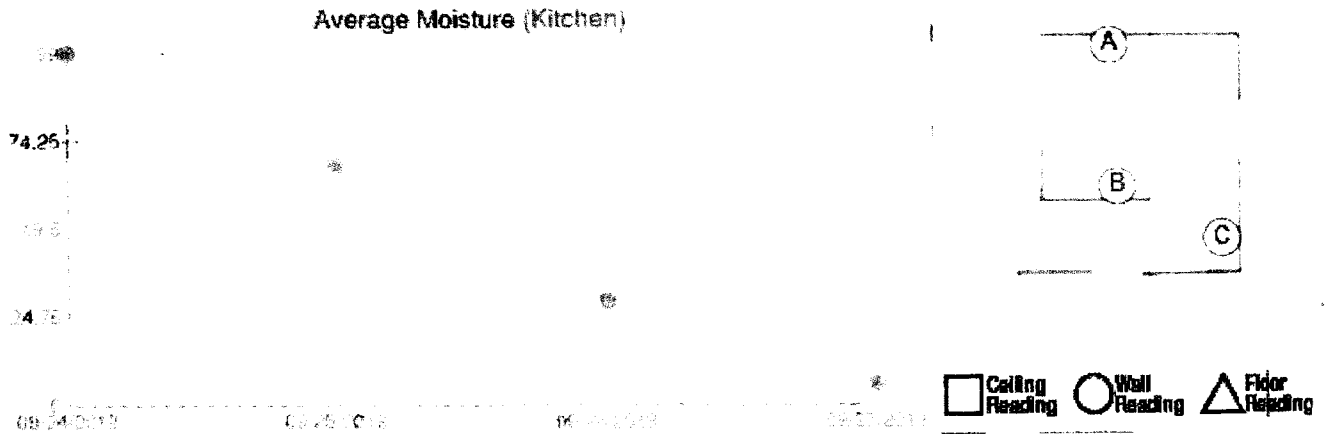
**User** Jason Scott  
**Moisture Readings** A: 99 B: 99 C: 99  
**Room Readings** Temp In: 73 RH In: 69 GPP In: 84.9  
**Equipment** Air Mover: 4 Axial: 0 Dehumidifier: 0 Negative Air Fan: 0 Other: 0  
**Notes**

**User** Jason Scott  
**Moisture Readings** A: 69 B: 66 C: 67  
**Room Readings** Temp In: 84 RH In: 50 GPP In: 87.7  
**Equipment** Air Mover: 4 Axial: 0 Dehumidifier: 0 Negative Air Fan: 0 Other: 0  
**Notes**

**User** Jason Scott  
**Moisture Readings** A: 33 B: 21 C: 34  
**Room Readings** Temp In: 87 RH In: 43 GPP In: 82.7  
**Equipment** Air Mover: 4 Axial: 0 Dehumidifier: 0 Negative Air Fan: 0 Other: 0  
**Notes**

Moisture Readings A: 5 B: 7 C: 7

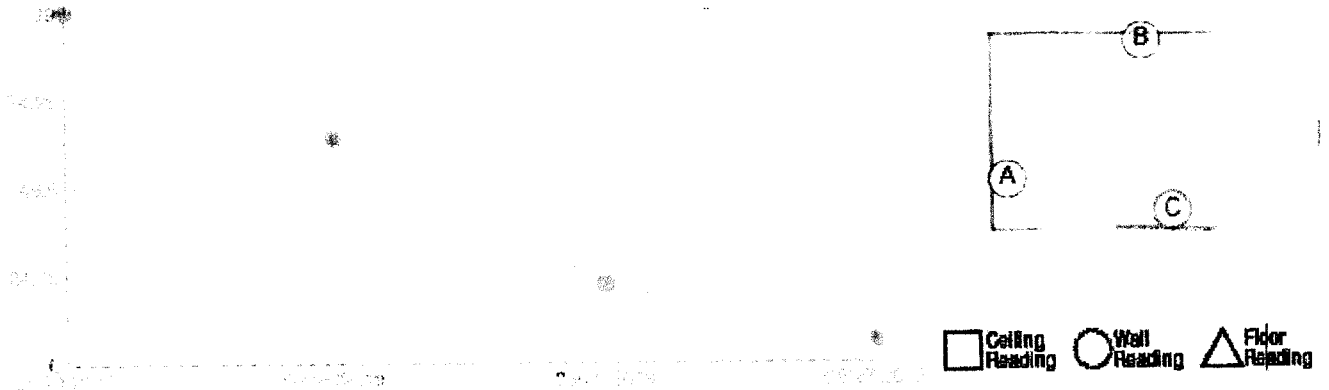
### Average Moisture (Living Room)

**User** Jason Scott  
**Moisture Readings** A: 99 B: 99 C: 99  
**Room Readings** Temp In: 73 RH In: 69 GPP In: 84.9  
**Equipment** Air Mover: 3 Axial: 0 Dehumidifier: 1 Negative Air Fan: 0 Other: 0  
**Notes**

**User** Jason Scott  
**Moisture Readings** A: 66 B: 64 C: 61  
**Room Readings** Temp In: 84 RH In: 50 GPP In: 87.7  
**Equipment** Air Mover: 3 Axial: 0 Dehumidifier: 1 Negative Air Fan: 0 Other: 0  
**Notes**

**User** Jason Scott  
**Moisture Readings** A: 21 B: 22 C: 23  
**Room Readings** Temp In: 87 RH In: 43 GPP In: 82.7  
**Equipment** Air Mover: 3 Axial: 0 Dehumidifier: 1 Negative Air Fan: 0 Other: 0  
**Notes**

Moisture Readings A: 7 B: 6 C: 7

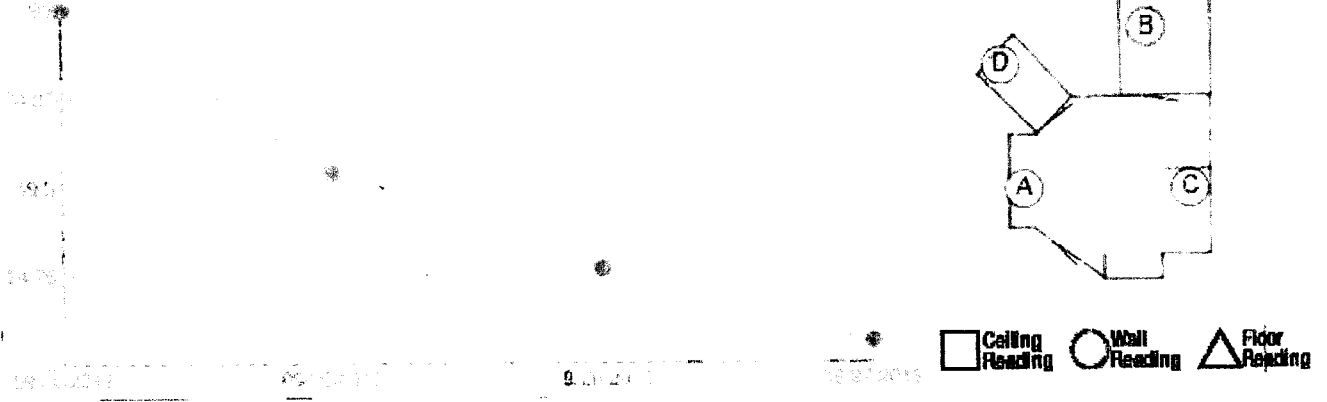
### Average Moisture (Master Bathroom/ Closet)

Moisture Readings A: 99 B: 99 C: 99 D: 99

**User** Jason Scott  
**Moisture Readings** A: 69 B: 55 C: 49 D: 41  
**Room Readings** Temp In: 84 RH In: 50 GPP In: 87.7  
**Equipment** Air Mover: 5 Axial: 0 Dehumidifier: 0 Negative Air Fan: 0 Other: 0  
**Notes**

**User** Jason Scott  
**Moisture Readings** A: 19 B: 24 C: 26 D: 37  
**Room Readings** Temp In: 87 RH In: 43 GPP In: 82.7  
**Equipment** Air Mover: 5 Axial: 0 Dehumidifier: 0 Negative Air Fan: 0 Other: 0  
**Notes**

**User** Jason Scott  
**Moisture Readings** A: 4 B: 7 C: 5 D: 6  
**Room Readings** Temp In: 90 RH In: 32 GPP In: 67.3  
**Equipment** Air Mover: 5 Axial: 0 Dehumidifier: 0 Negative Air Fan: 0 Other: 0  
**Notes**

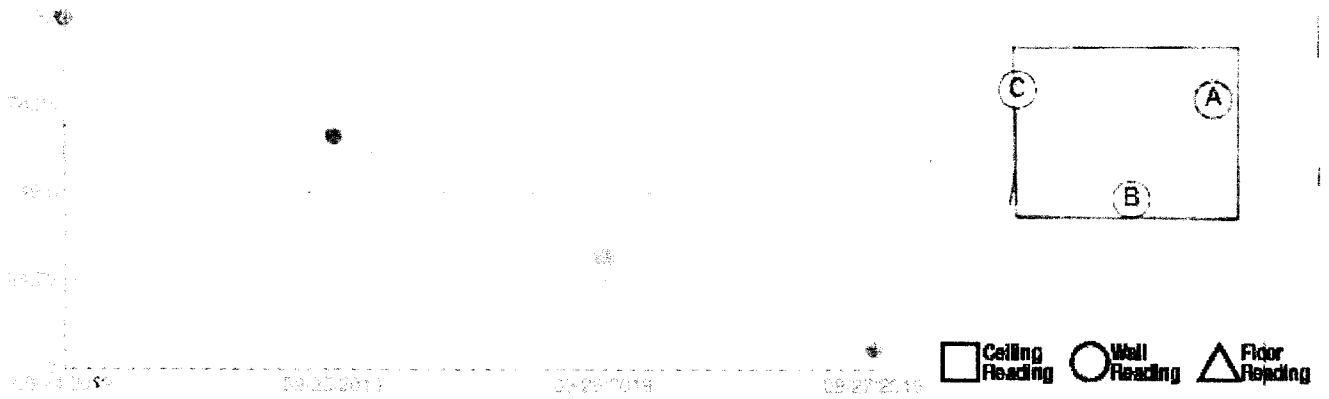
### Average Moisture (Office)

**User** Jason Scott  
**Moisture Readings** A: 99 B: 99 C: 99  
**Room Readings** Temp In: 73 RH In: 69 GPP In: 84.9  
**Equipment** Air Mover: 2 Axial: 0 Dehumidifier: 0 Negative Air Fan: 0 Other: 0  
**Notes**

**User** Jason Scott  
**Moisture Readings** A: 69 B: 66 C: 61  
**Room Readings** Temp In: 84 RH In: 50 GPP In: 87.7  
**Equipment** Air Mover: 2 Axial: 0 Dehumidifier: 0 Negative Air Fan: 0 Other: 0  
**Notes**

**User** Jason Scott  
**Moisture Readings** A: 31 B: 29 C: 34  
**Room Readings** Temp In: 87 RH In: 43 GPP In: 82.7  
**Equipment** Air Mover: 2 Axial: 0 Dehumidifier: 0 Negative Air Fan: 0 Other: 0  
**Notes**

Moisture Readings A: 4 B: 6 C: 7
