1149 ARLINGTON ST.
Inspected Address

TEXAS OFFICIAL WOOD DESTROYING INSECT REPORT

Diagram of Structure(s) Inspected

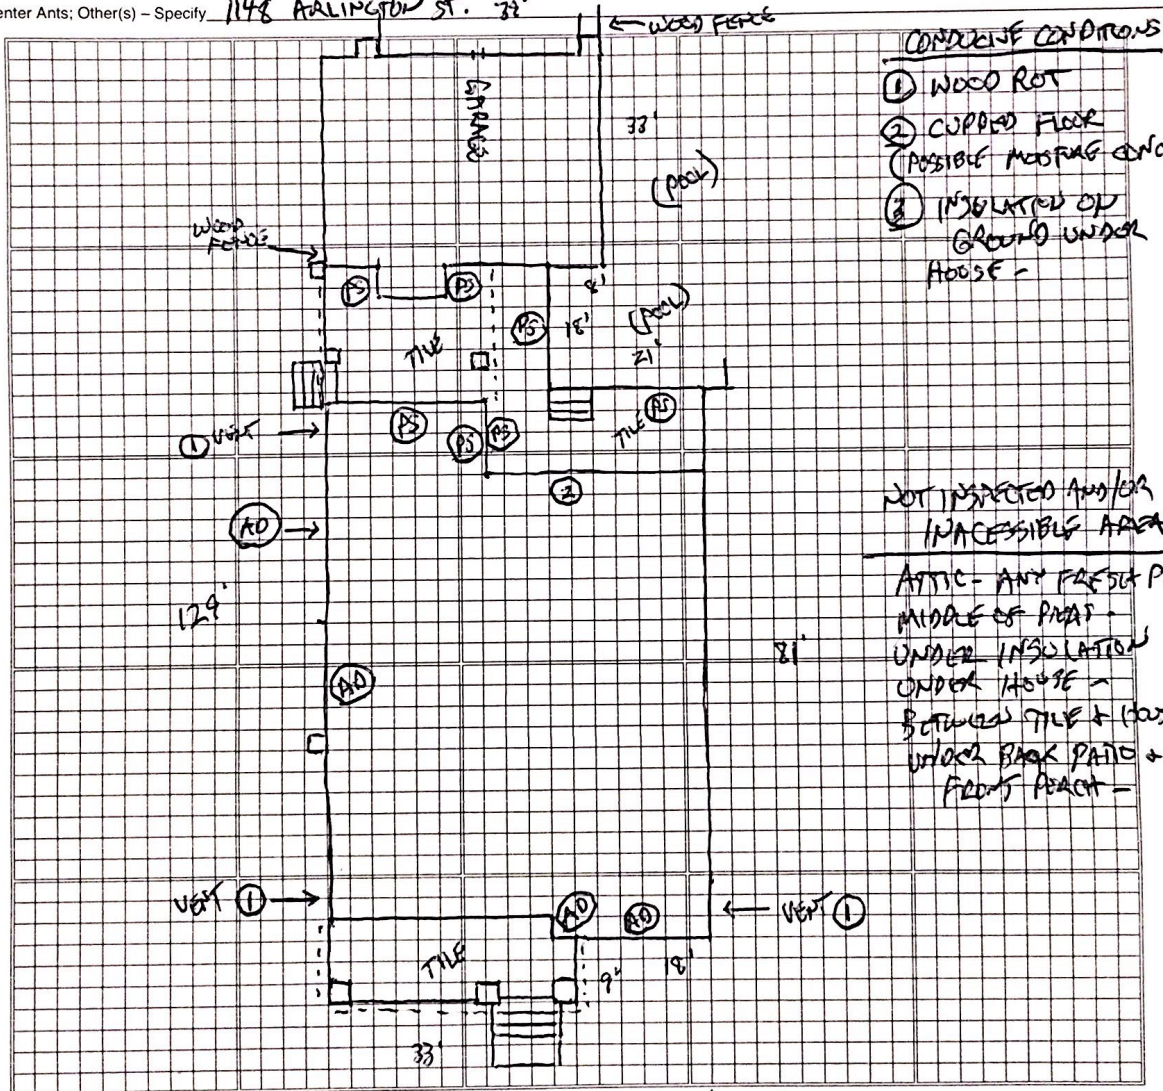
8F. Explanation of signs of previous treatment (including pesticides, baits, existing treatment stickers or other methods) identified:
8G. Visible evidence of: TERMITES has been observed in the following areas: SEE GRAPH PAGE - AS - PREVIOUS SUB-TERRA TERMITES
AO - ACTIVE DRYWOOD TERMITES -
If there is visible evidence of active or previous infestation, it must be noted. The type of insect(s) must be listed in the first blank and all identified infested areas of the property inspected must be noted in the second blank. (Refer to Part D, E & F, Scope of Inspection)

The inspector must draw a diagram including approximate perimeter measurements and indicate active or previous infestation and type of insect by using the following codes:
 E-Evidence of Infestation, A-Active; P-Previous; D-Drywood Termites; S-Subterranean Termites; F-Formosan Termites; C-Conducive Conditions; B-Wood Boring Beetles;
 H-Carpenter Ants; Other(s) - Specify 1148 ARLINGTON ST. 32'

- CONDUCIVE CONDITIONS**
- ① WOOD ROT
 - ② CUPPED FLOOR (POSSIBLE MISSING CONCERN)
 - ③ INSULATED ON GROUND UNDER HOUSE -
- NOT INSPECTED AND/OR INACCESSIBLE AREAS**
- ATTIC - ANY FRESH PAINT
 - MIDDLE OF FRONT
 - UNDER INSULATION UNDER HOUSE -
 - BETWEEN TILE & HOUSE
 - UNDER BACK PATIO & FRONT PORCH -

Additional Comments IF NOT UNDER A CURRENT SUB-TERRA TERMITE CONTRACT -
I WOULD RECOMMEND A TREATMENT -
I WOULD RECOMMEND FUMIGATION AS TREATMENT FOR DRYWOOD TERMITES -
