MORTGAGE LOAN INSPECTION PLAT

BUYERS: J. BENITO PASTORA & WIFE, EDDA S. PASTORA  
 1225 CRESTMONT DRIVE  
 WHARTON, TEXAS 77488

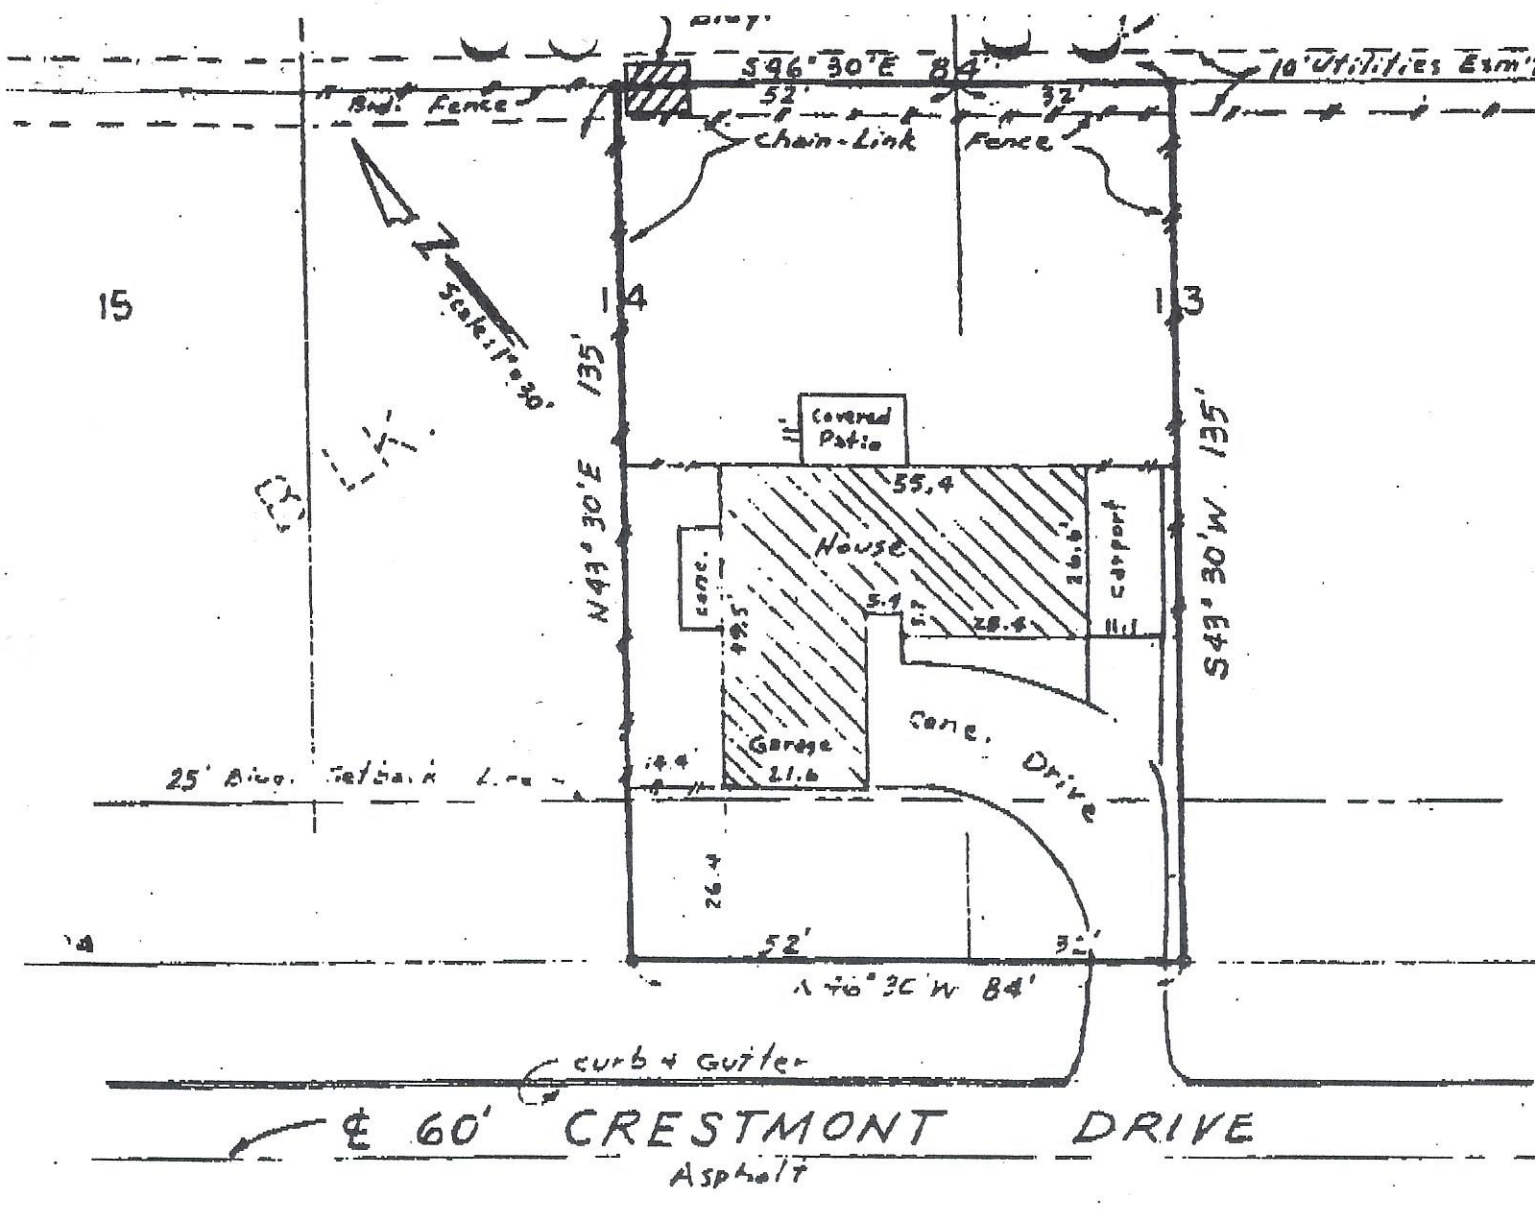
The Plat hereon is a true, correct, and accurate representation of the property as determined by survey, the lines and dimensions of said property being as indicated by the Plat; the size, location, and type of buildings and improvements are as shown, all improvements being within the boundaries of the property, set back from property lines the distances indicated. THERE ARE NO ENCROACHMENTS, CONFLICTS, OR PROTRUSIONS EXCEPT PORTABLE STORAGE BLDG. BELONGING TO OTHERS AS SHOWN.

FLOOD HAZARD BOUNDARY INFORMATION:  
 PROPERTY IS IN FLOOD HAZARD BOUNDARY ZONE "B" COMMUNITY NO. 480654, PANEL NO. 0005-C DATED SEPTEMBER 16, 1982. PROPERTY IS NOT IN THE 100 YEAR FLOOD FLAIN.
