National Register of Historic Places
Inventory—Nomination Form

Site No. 81

NAME <u>House at ...</u>	COUNTY <u>Harris</u>	BLOCK <u>42</u>
ADDRESS <u>2402 Rutland st.</u>	CITY <u>Houston</u>	LOT <u>26-29</u>
	UTM <u>Zone 15 E 267,930 N 3,299,730</u>	
ARCHITECT/BUILDER <u>unknown</u>	DATE <u>1908-10</u>	PERIOD <u>1900--</u>
OWNER <u>J. C. Williams</u>	STYLE <u>Queen Anne influence</u>	
<u>2402 Rutland, Houston, Texas 77008</u>	THEME

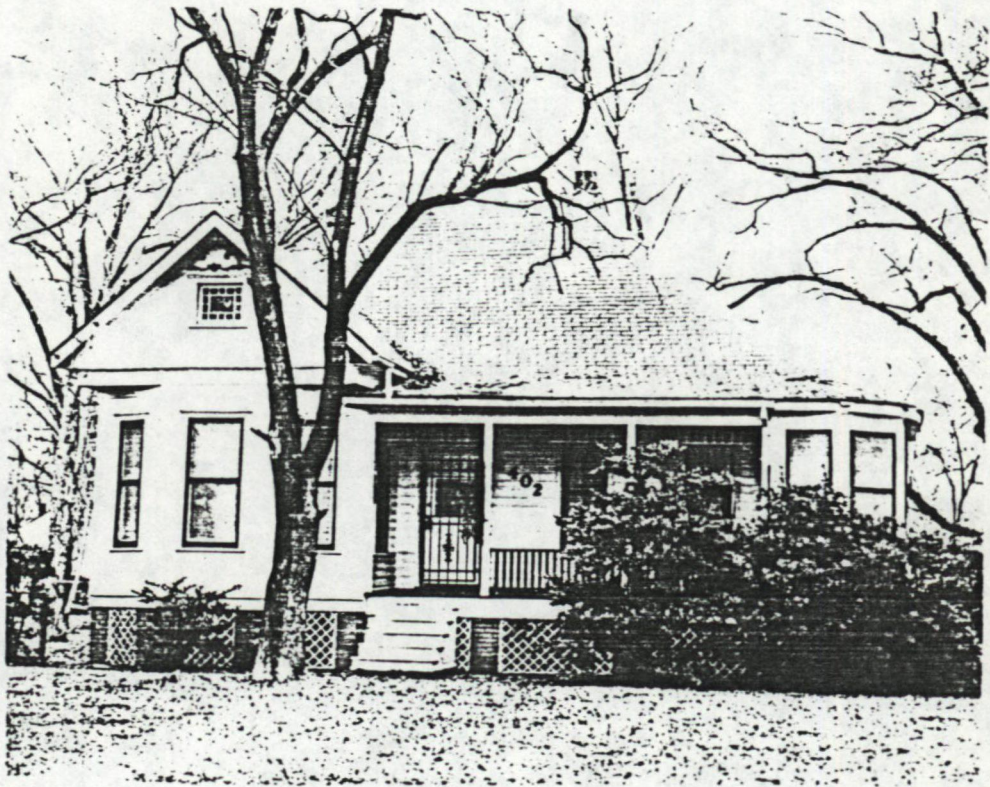
DESCRIPTION: Cottage, frame, 1-story, combination roof with projecting gable end bay (shingled gable), attached porch supported by turned posts, simple, squared balusters, decorative bargeboard, brick piers under house.

ALTERATIONS: Small additions to rear.
SIGNIFICANCE: Good example of type of cottage typical of the area and the period; nice details.

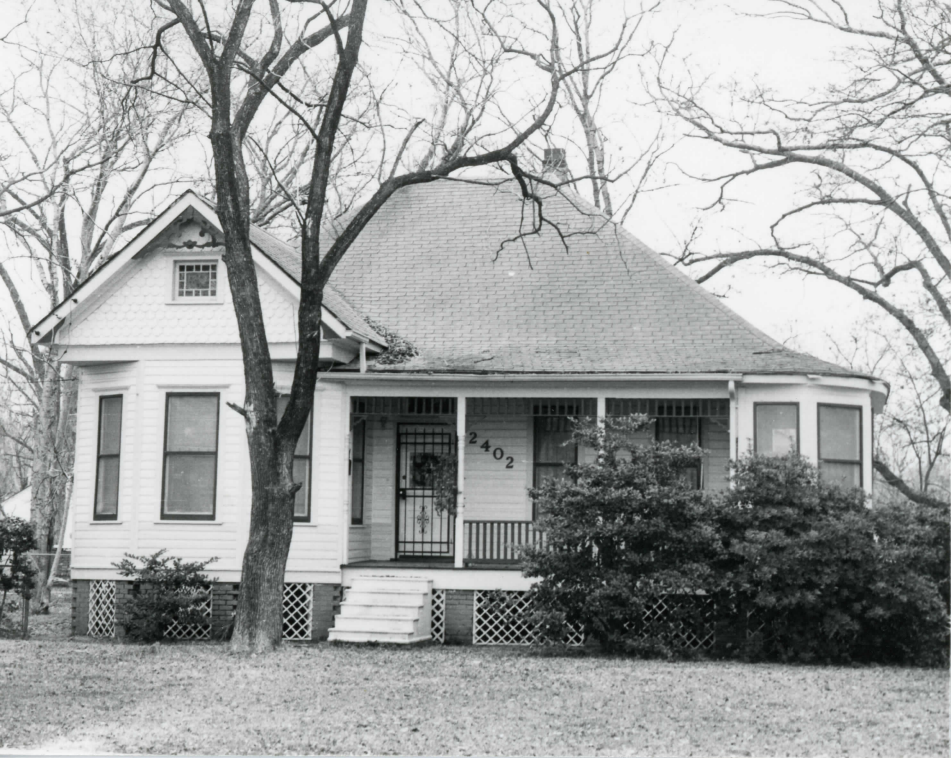
Photo 102 of
127

DESCRIPTION One-story frame cottage; hipped roof with projecting front gable over chamfered bay with three windows; gable end with round-butt shingles, small window with stained glass, and cut-out decorative vergeboard; front porch once wrapped around side, but outside corner has been enclosed; turned porch posts with square fretwork and balusters between; windows have one-over-one lights; house sits on brick piers spanned by lattice; interior brick chimney.

Alterations Small additions to rear; intrusive burglar bars on front door,*

Front facade, looking east
