Building Information

Building Type: Residence

Building Address: 3406 Watersedge Drive

Project Scope

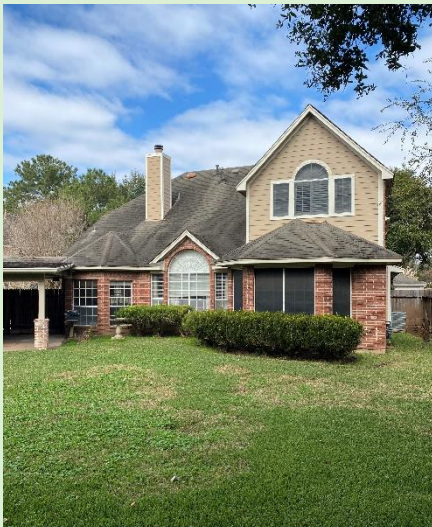
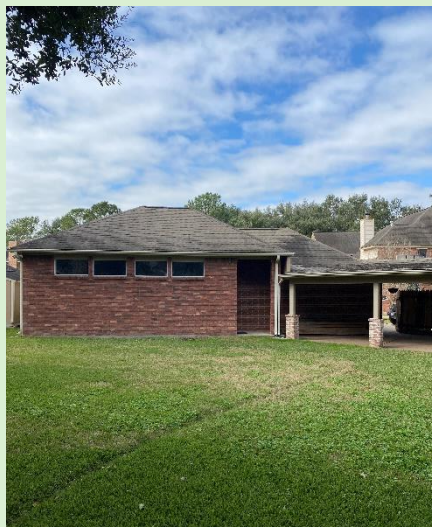
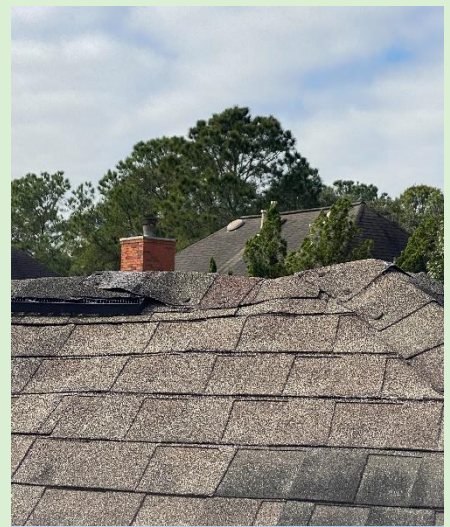
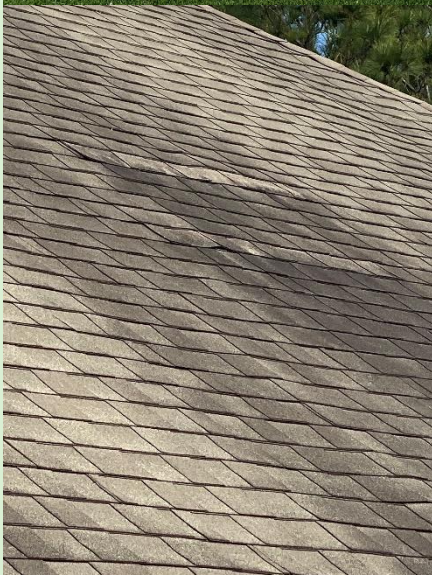
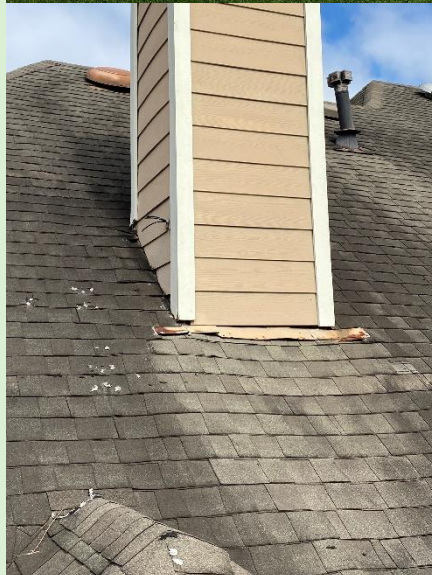
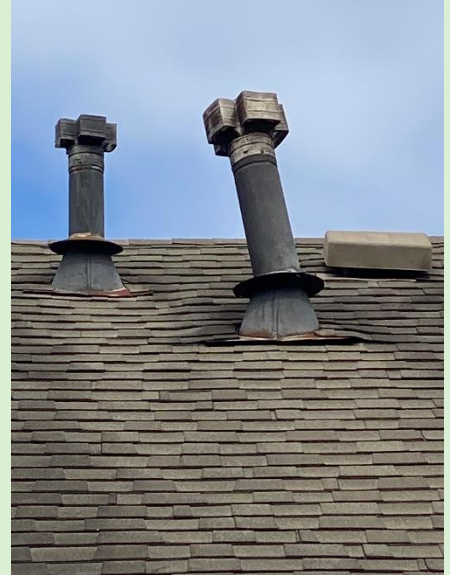
- **Roof Inspection of Residence:**
 - Inspection found areas of roof that need maintenance and minor repairs.
 - Field Shingles: Several shingles are torn, damaged and should be replaced.
 - Ridge Shingles: Inspection found a few ridge course shingles needing replacement and /or sealant applied.
 - Flashings: Inspection found areas of roof to headwall flashings that need to be re-fastened and sealed.
 - Chimney: Inspection found possible deck deflection at base and should be addressed and repaired.
 - Penetrations: Re-fasten and seal roof penetrations to ensure watertightness.
 - Life Expectancy: 5-7 years with minor maintenance.

- Replace Damaged Field & Ridge Shingles with New.....\$ 1,325.00
- Re-Fasten and Seal Lifted Flashings & Penetrations..... \$ 1,580.00
- Repairs to Chimney Base at Roof (Includes Shingles) \$ 2,300.00
