**PROFESSIONAL REAL ESTATE INSPECTIONS**

**8715 Meadowcroft Dr. Unit 804**

**REPORT IDENTIFICATION**

**032922—8715**

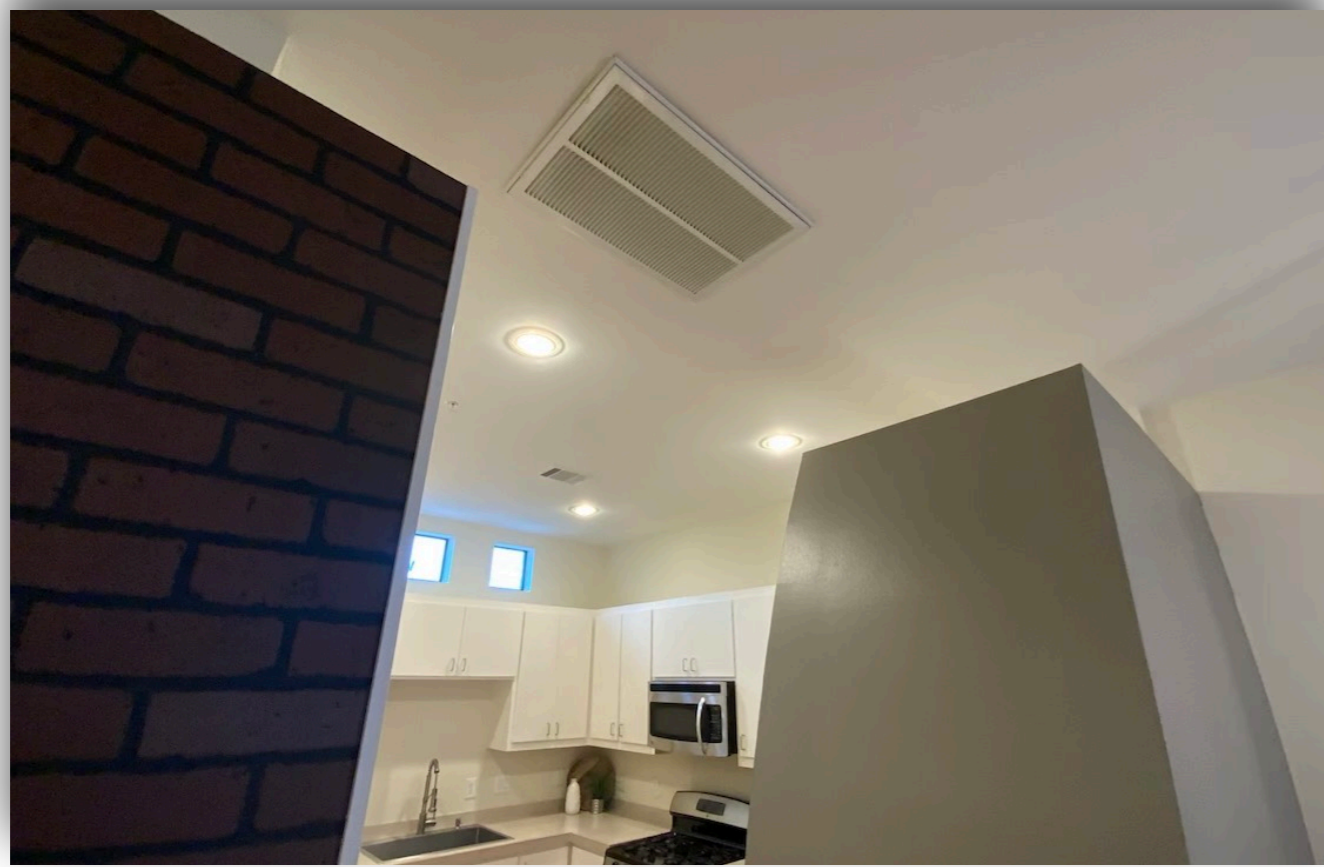
HVAC return registers are not permitted to be in close proximity to kitchen / cooking equipment, should be corrected.

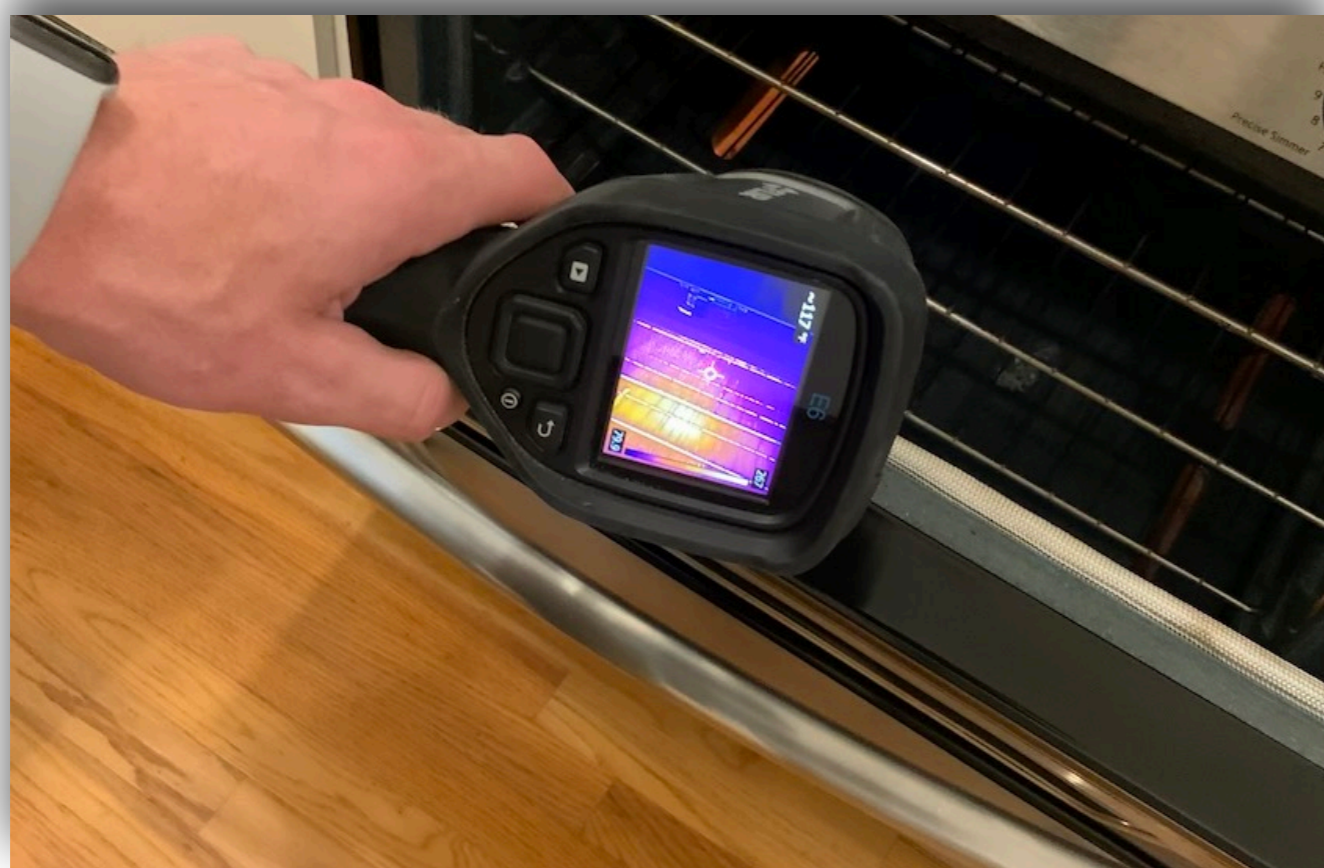
**Note:** Gas off to home at time of inspection, could only visually inspect furnace, water heater, cooking equipment and all related components.

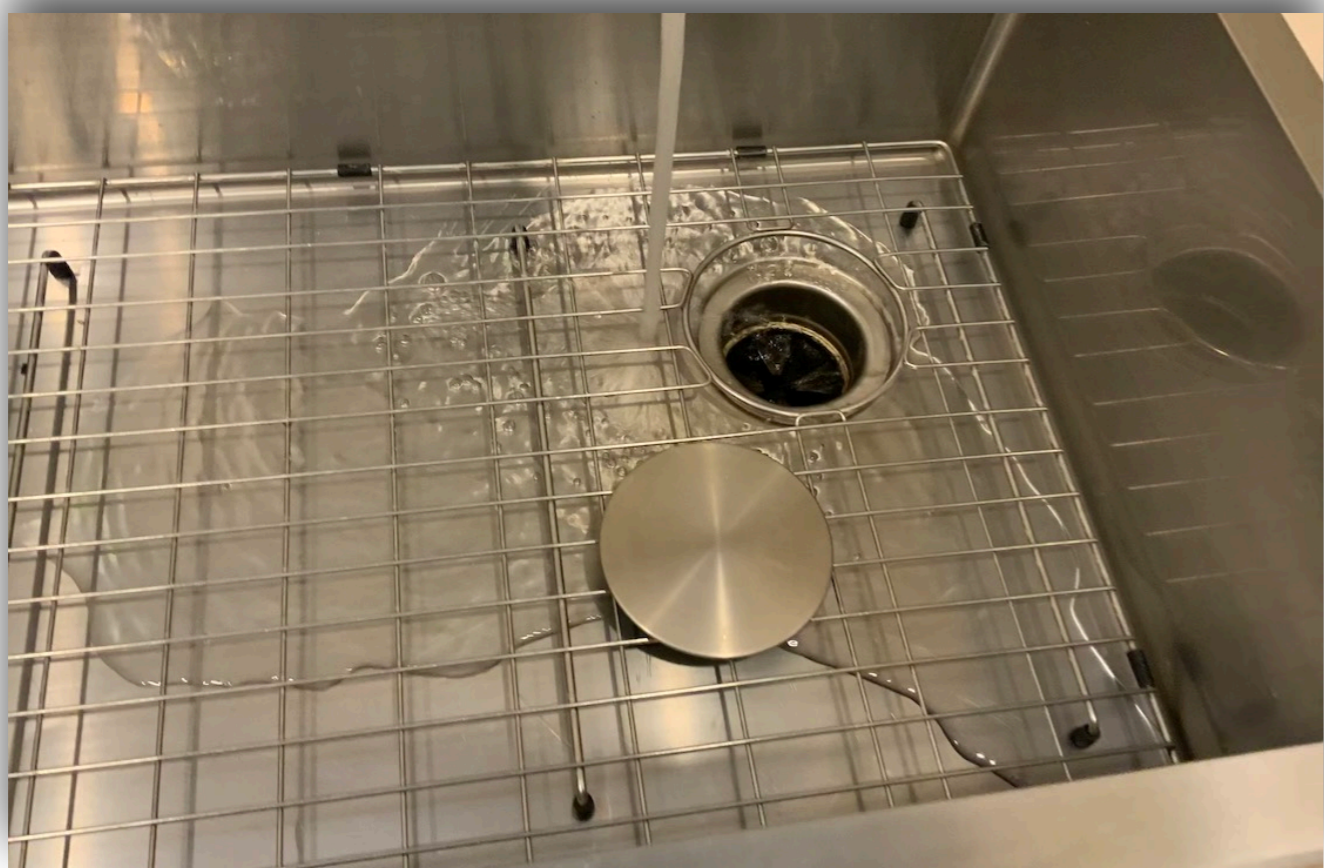
Remove all trash/debris from kitchen sink food disposal to allow for optimal operation.

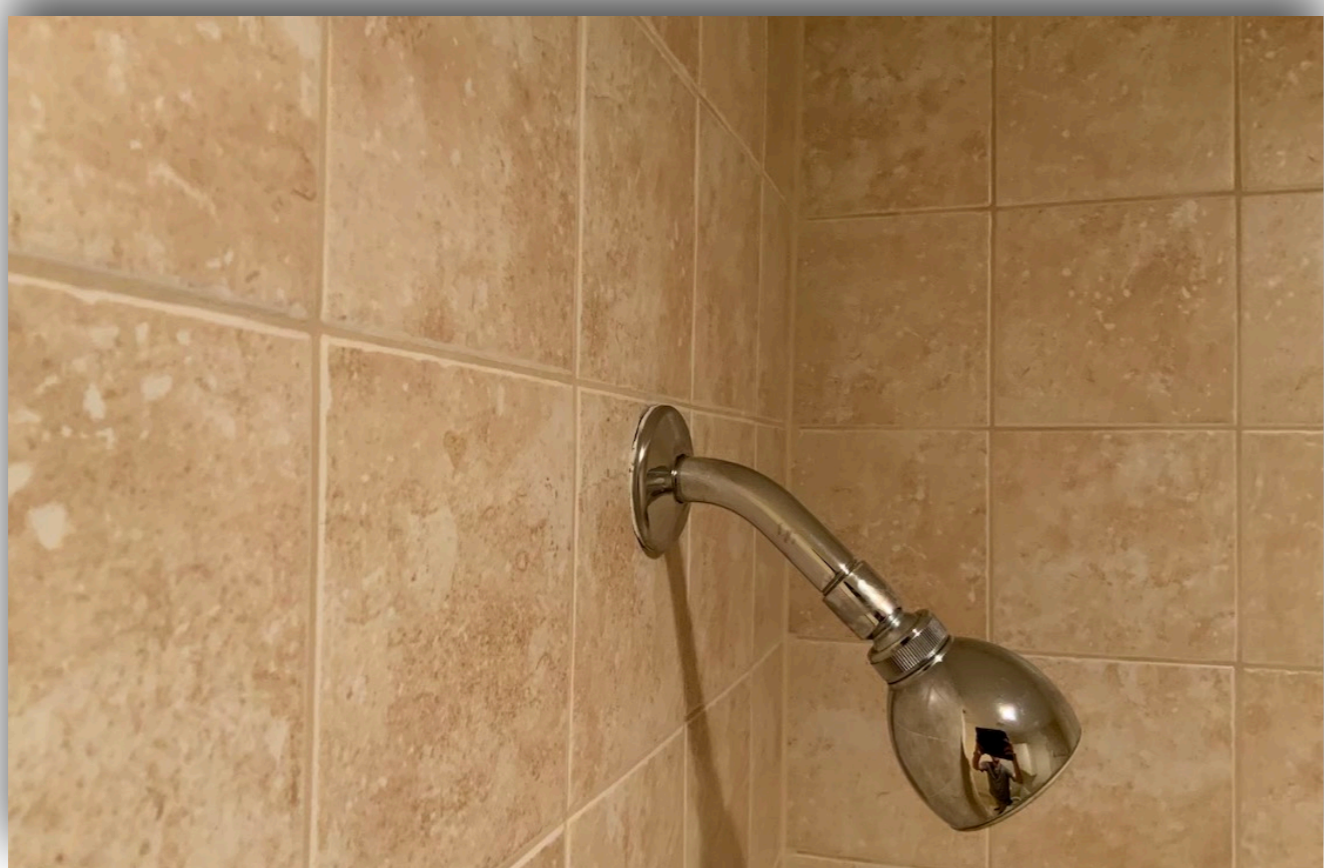
Guest bathroom shower spout is not properly secured at wall, should be repaired. Properly seal around all tub / shower spouts, valve covers & walls to help prevent moisture from entering wall cavity.

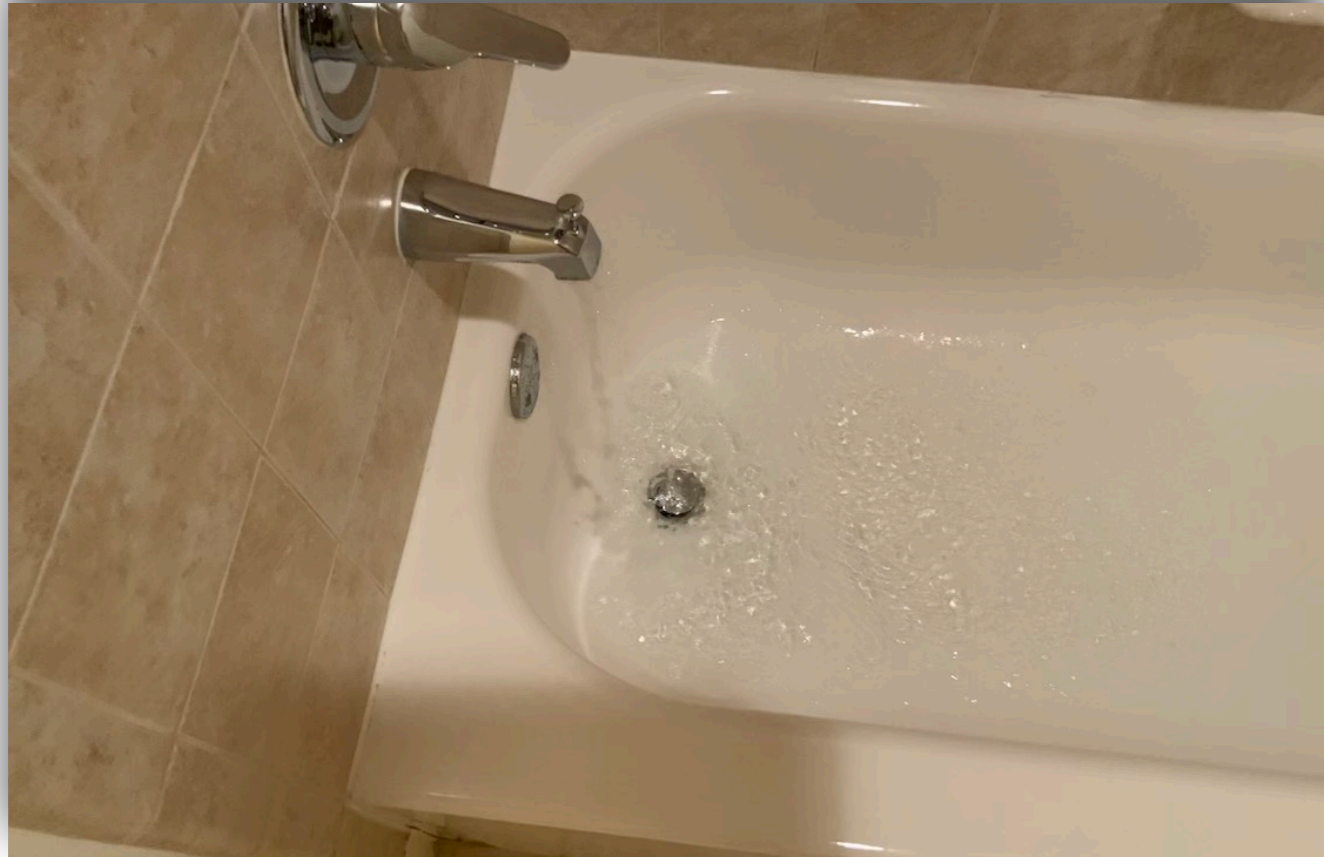
Bathroom tub diverter is faulty / did not function properly, drain is partially clogged causing drain to empty it slow rate, should be repaired.

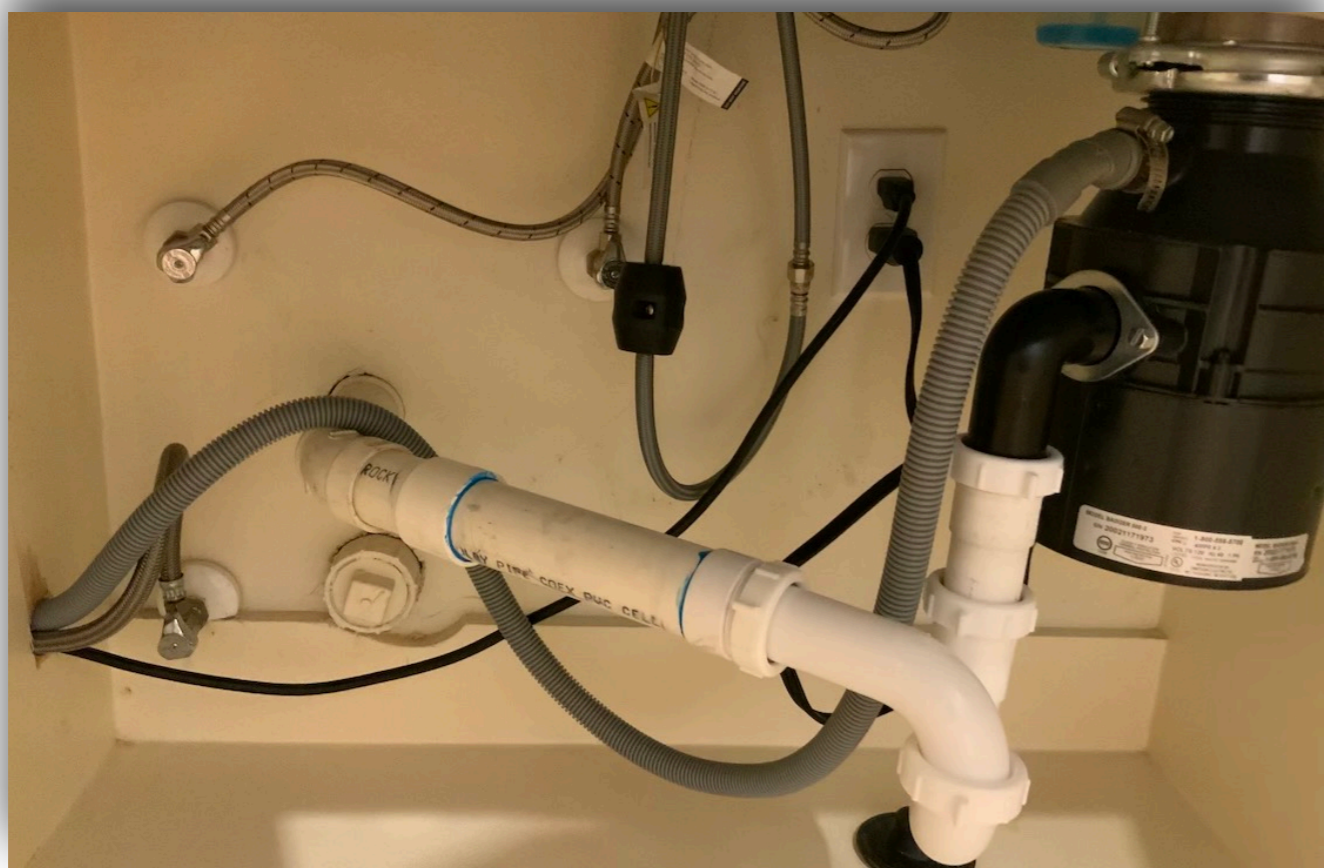
Missing anti-siphoning high loop at kitchen dishwasher plumbing drain line, this loop helps prevent backwashing of dirty water into dishwasher, should be properly repaired.

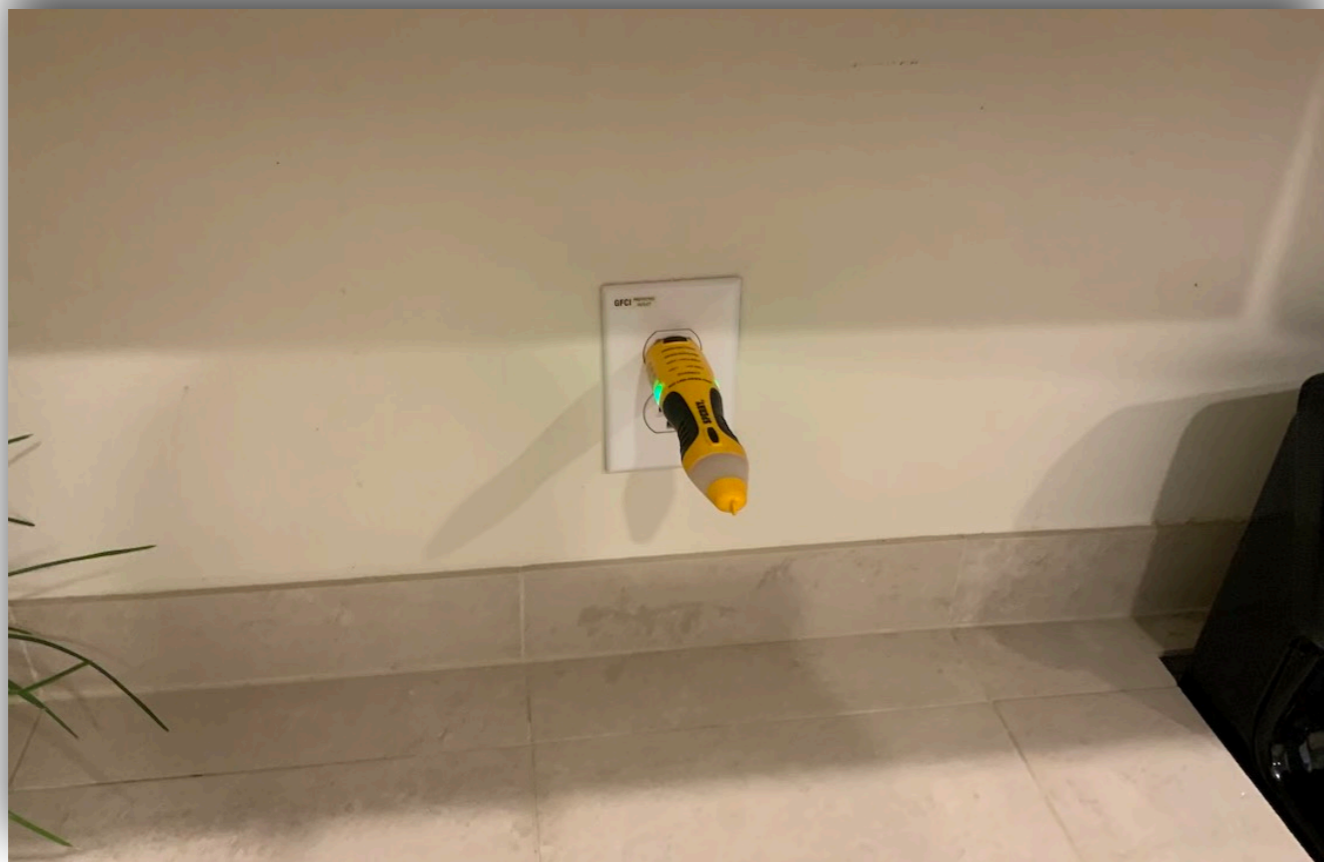
Electrical outlets in several locations throughout home are not properly secured in the wall / junction box, should be repaired for safety. (Ex: kitchen)

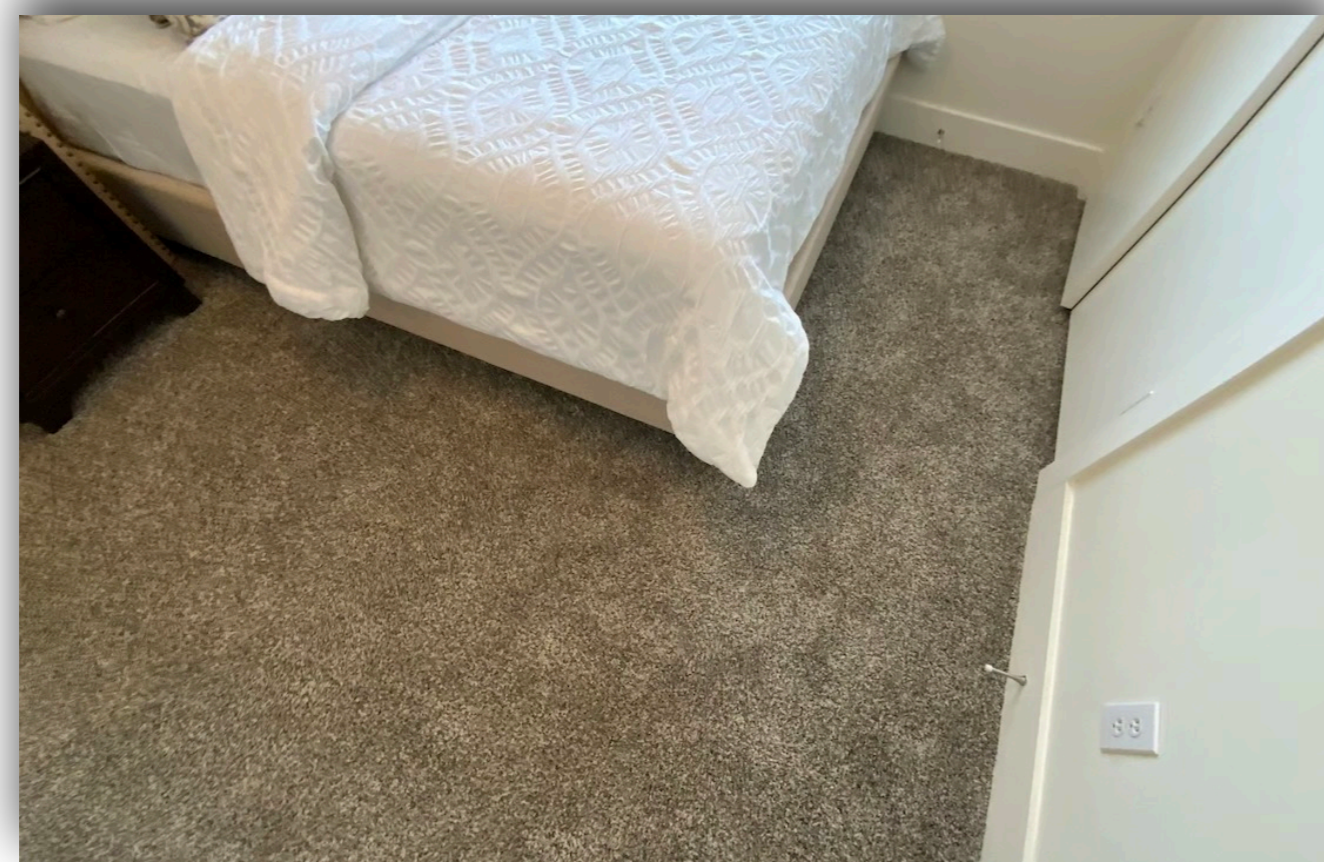
Floor decking &/or covering on second & third levels and stairs are not properly fastened at framing. Floor also has areas that slope / bow, (floor pops & squeaks), should be repaired. (Ex: bedrooms)

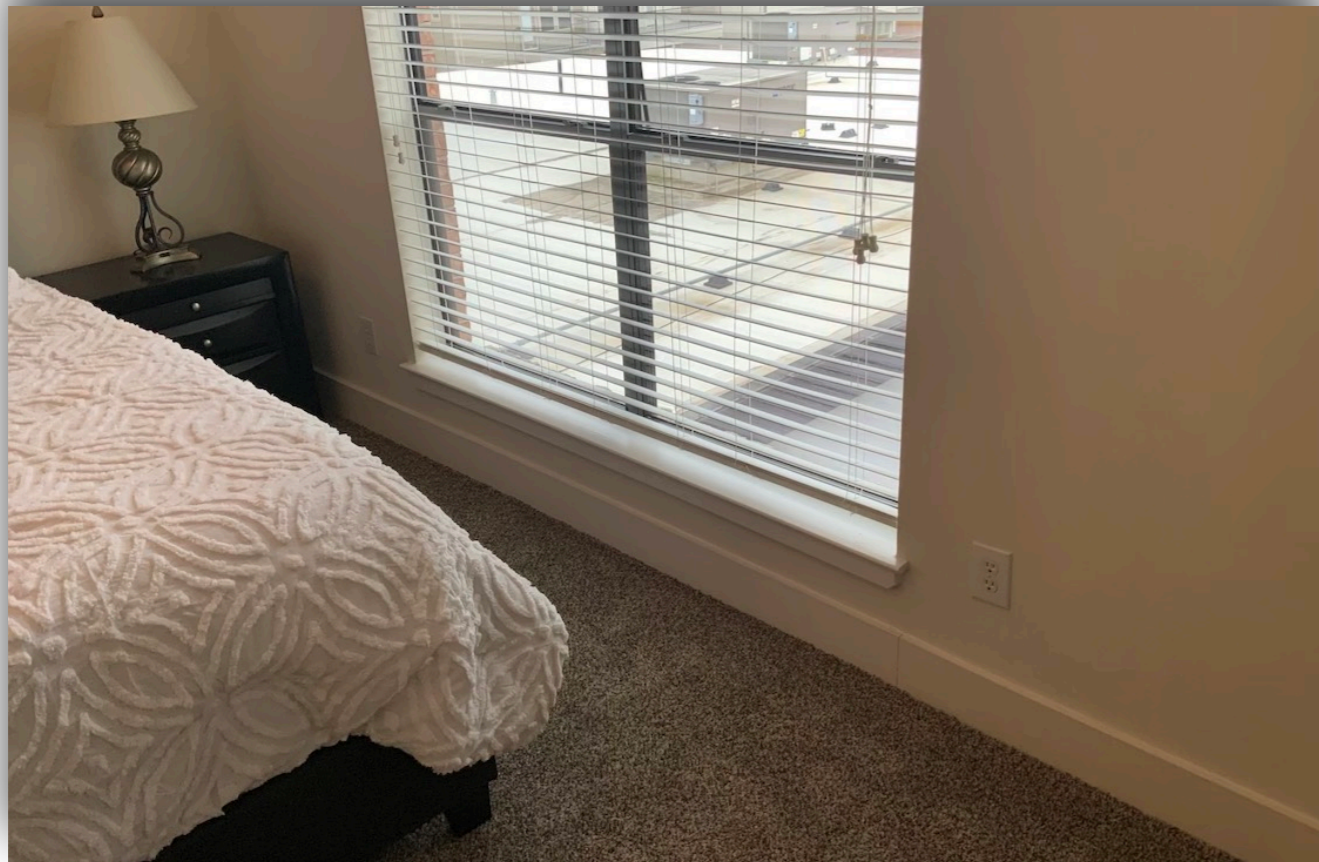
All windows located above the first floor are required to be a minimum of 24 inches above the floor level or adjacent area, or are required to be safety glass, no markings present / could not verify if safety glass is present. (Master)

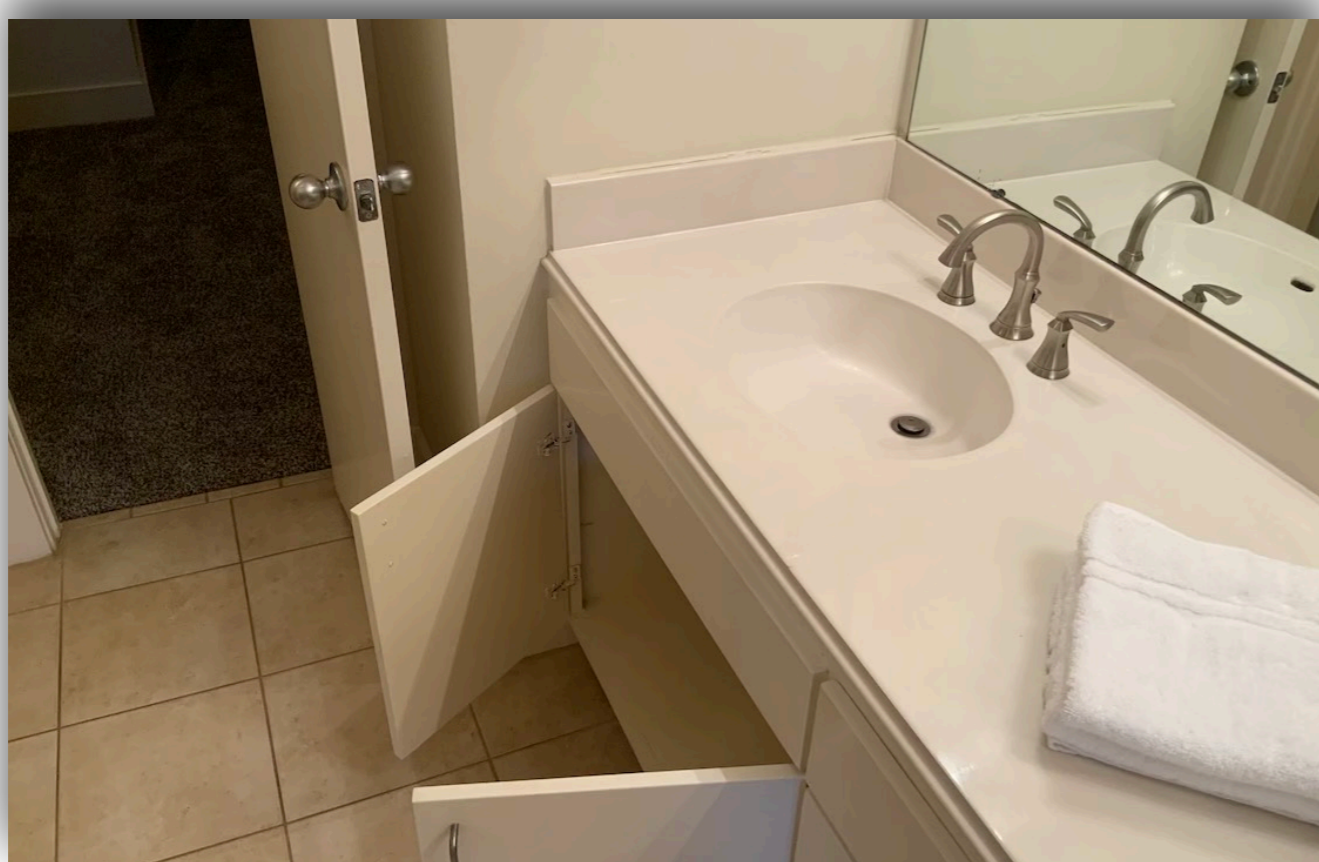
Master bathroom sink closest to closet leaks when into cabinets when operated, should be repaired.

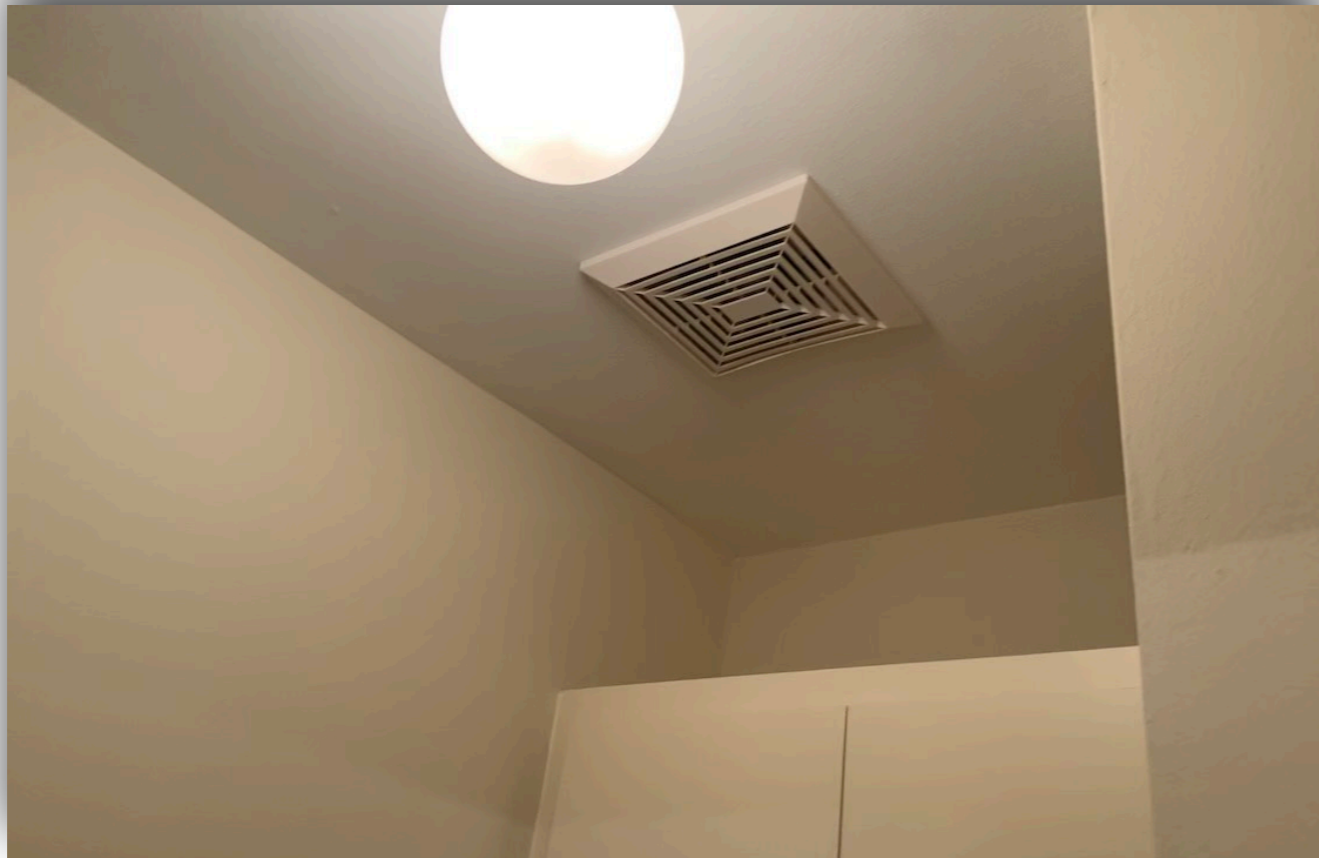
Master bathroom exhaust vent unit did not function/operate smoothly, should be repaired or replaced.

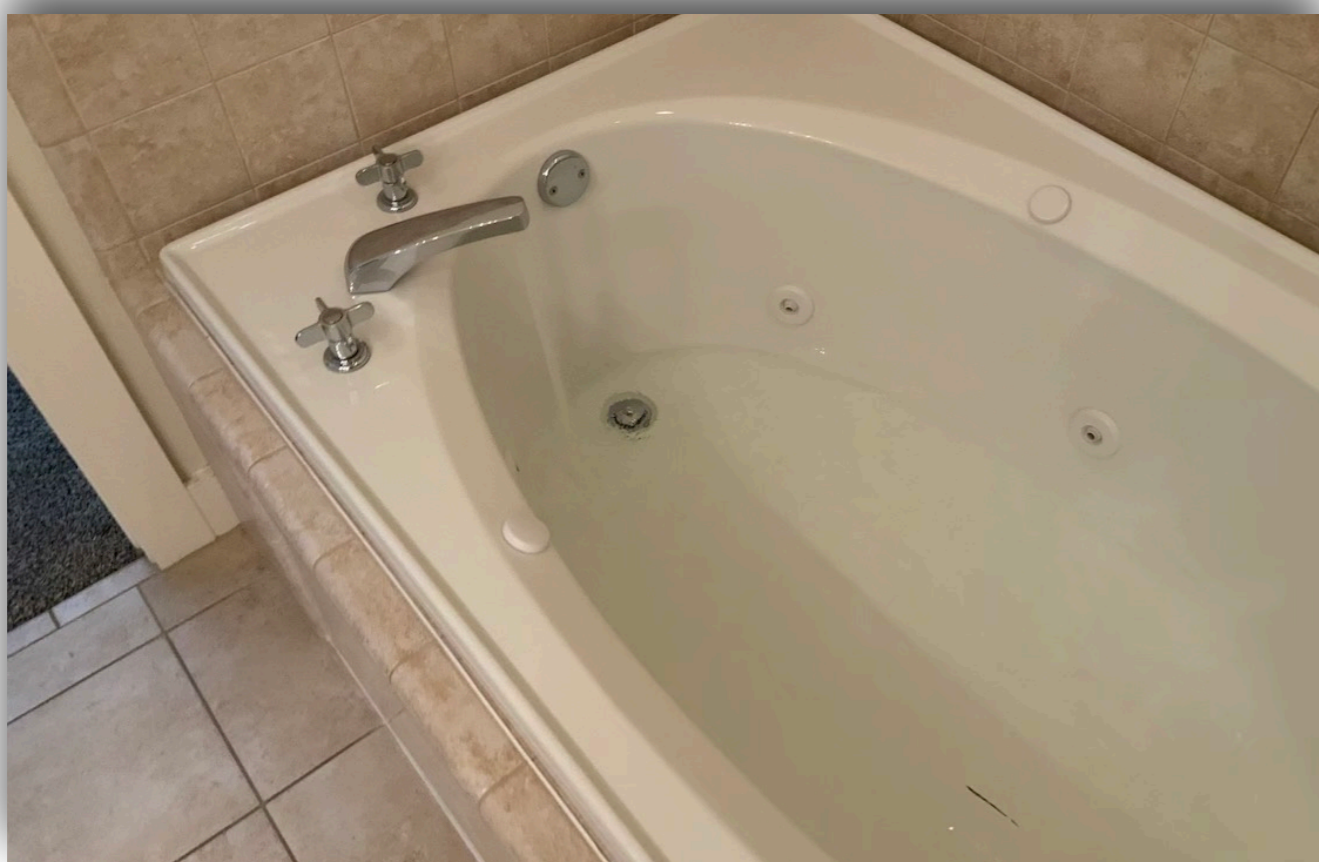
Master bathroom tub drain is partially clogged causing drain to empty it slow rate, should be repaired.

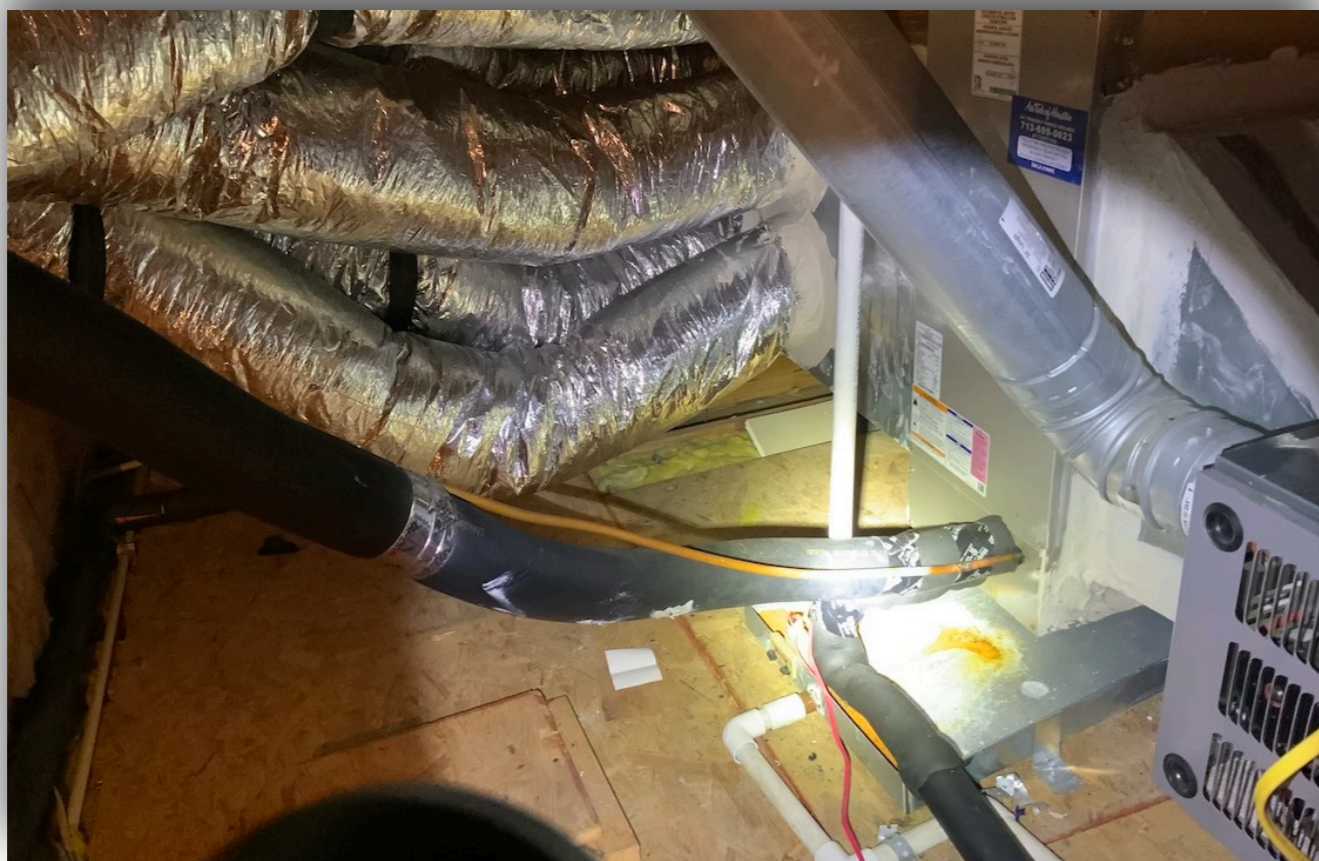
Sections of HVAC ductwork are not properly supported and suspended. Rust / corrosion build-up present in attic HVAC system's drip pan, recommend cleaning pan & having system(s) serviced.

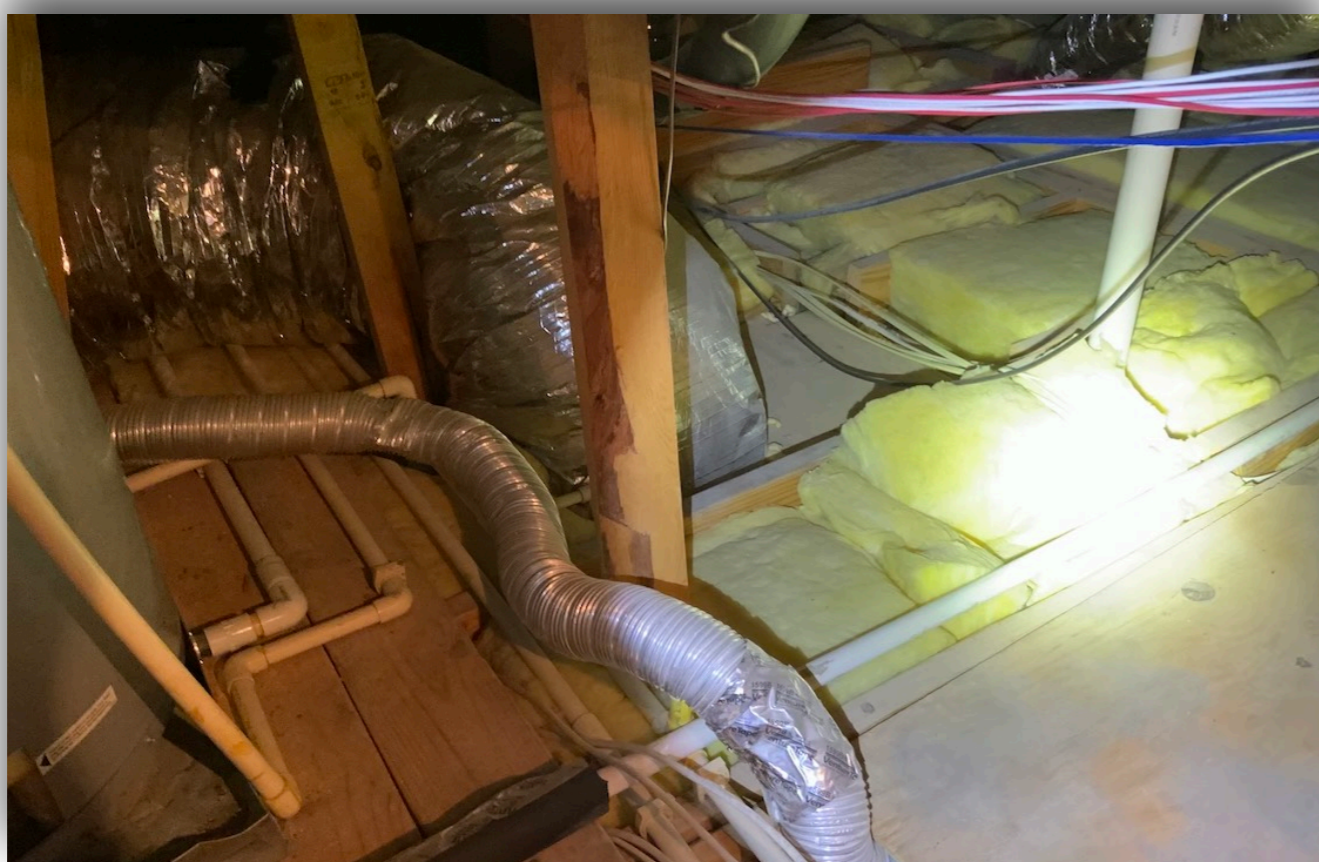
Sections of missing insulation noted at upper walls and ceilings in attic, proper insulation levels are needed for efficient heating/cooling.

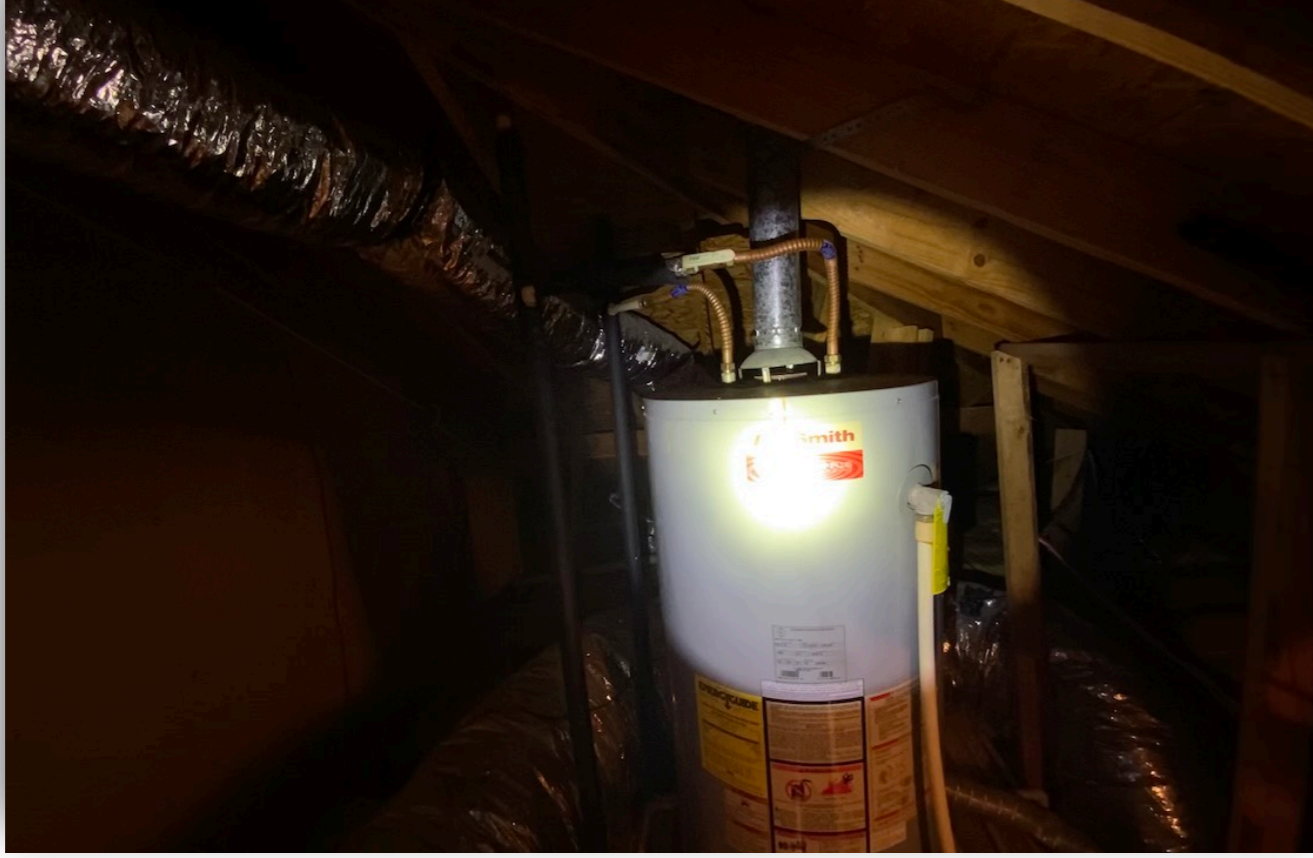
Rust / corrosion present at plumbing connections for water heater unit, damaged connections should be replaced to help prevent leaks from occurring. Unit is approx. 16 years old and is at / past its expected life-span, recommend replacing unit.

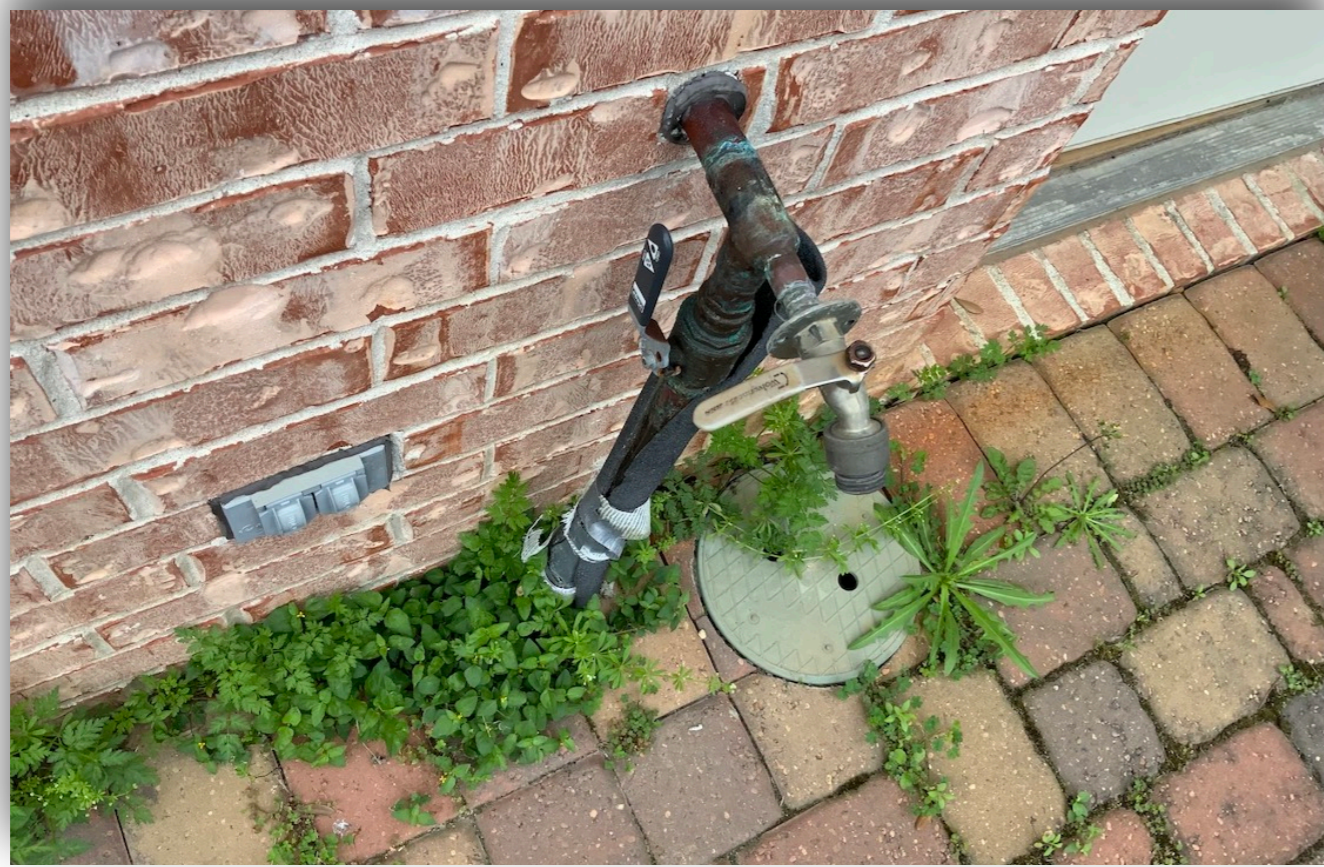
Plumbing line entry into home is corroded/oxidized and is sweating heavily / possibly has a small leak, consult plumbing specialist for further evaluation.

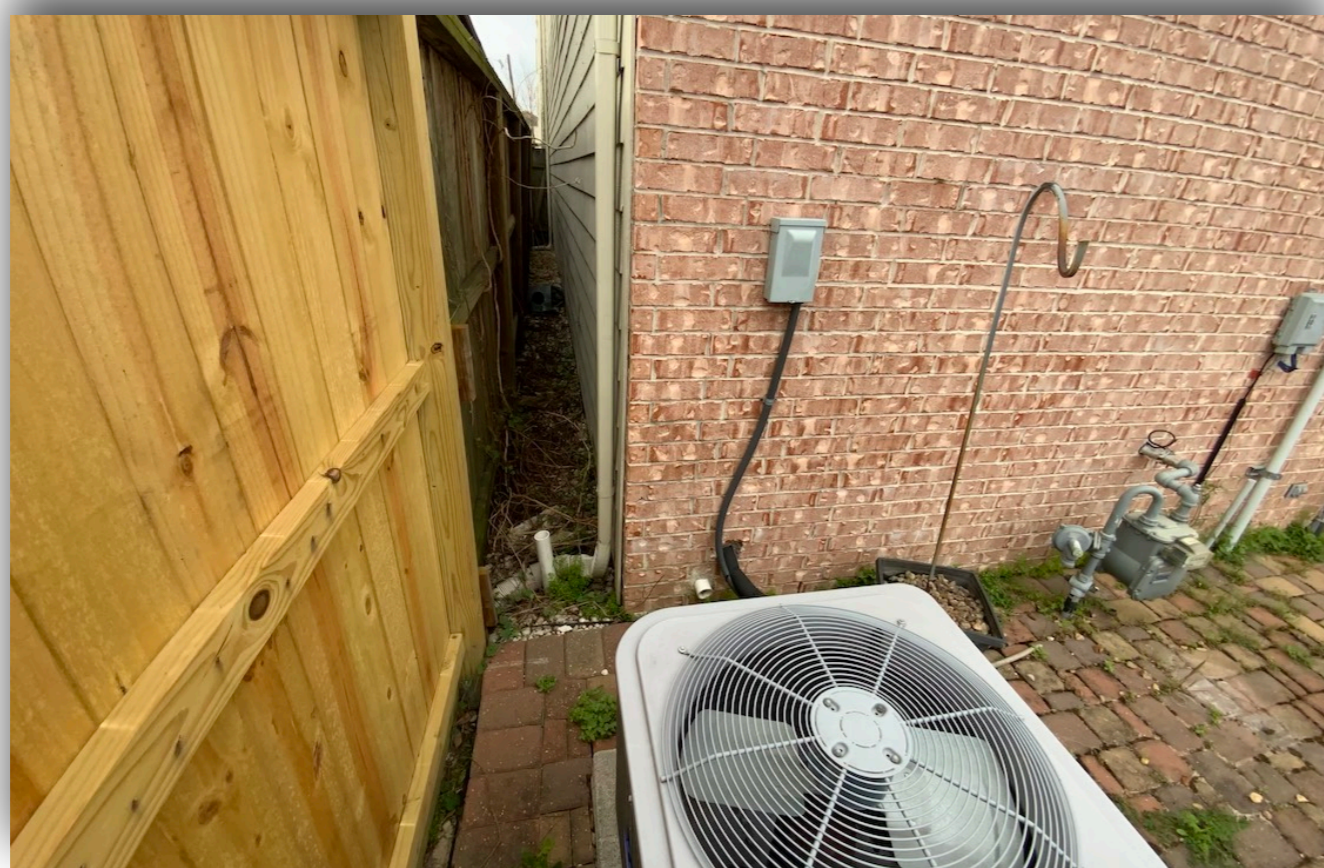
**Note:** No access to right side of property, left side is common / joined wall. Minimal to no visibility of slab face at rear due to pavers.

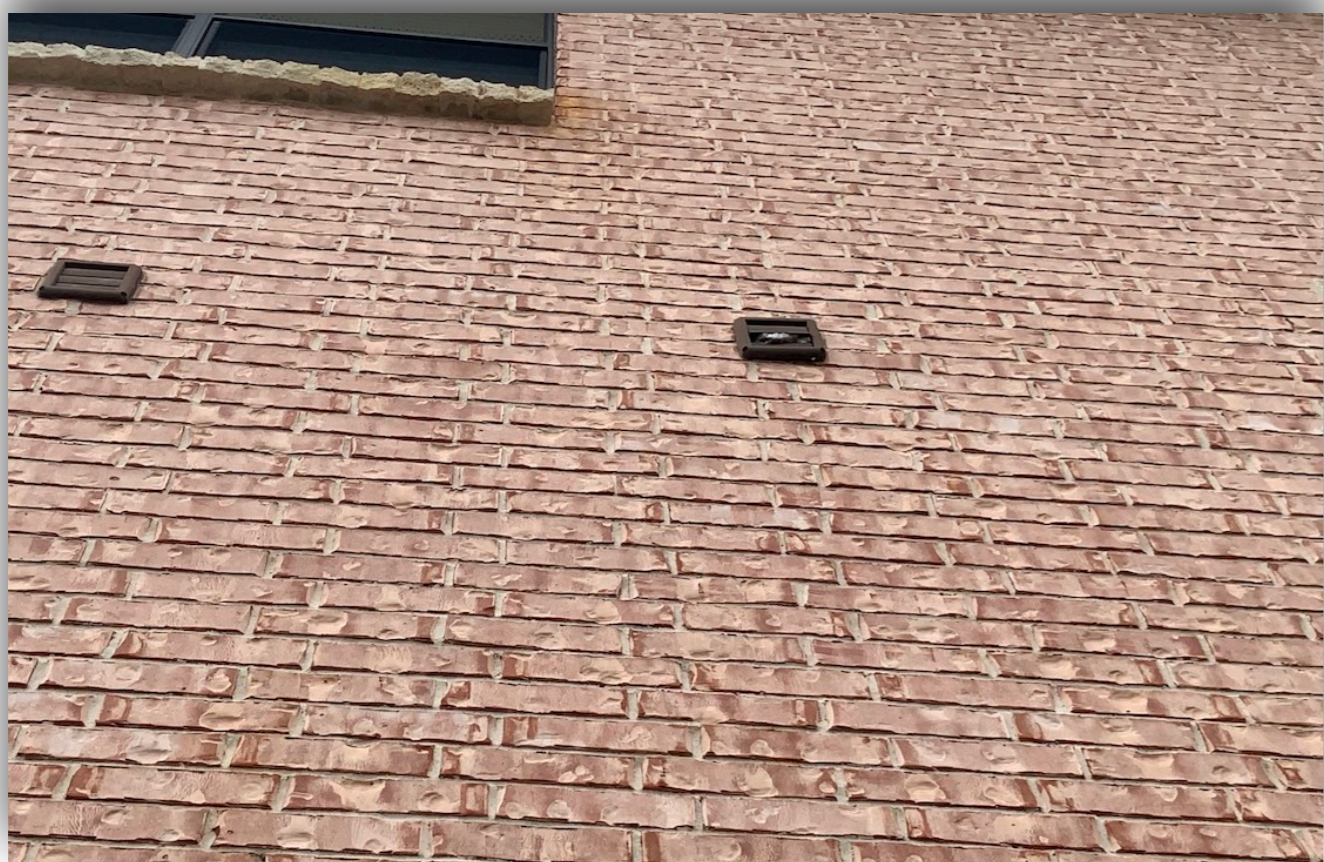
Clothes dryer exhaust vent is clogged at rear wall, should be repaired for proper ventilation.

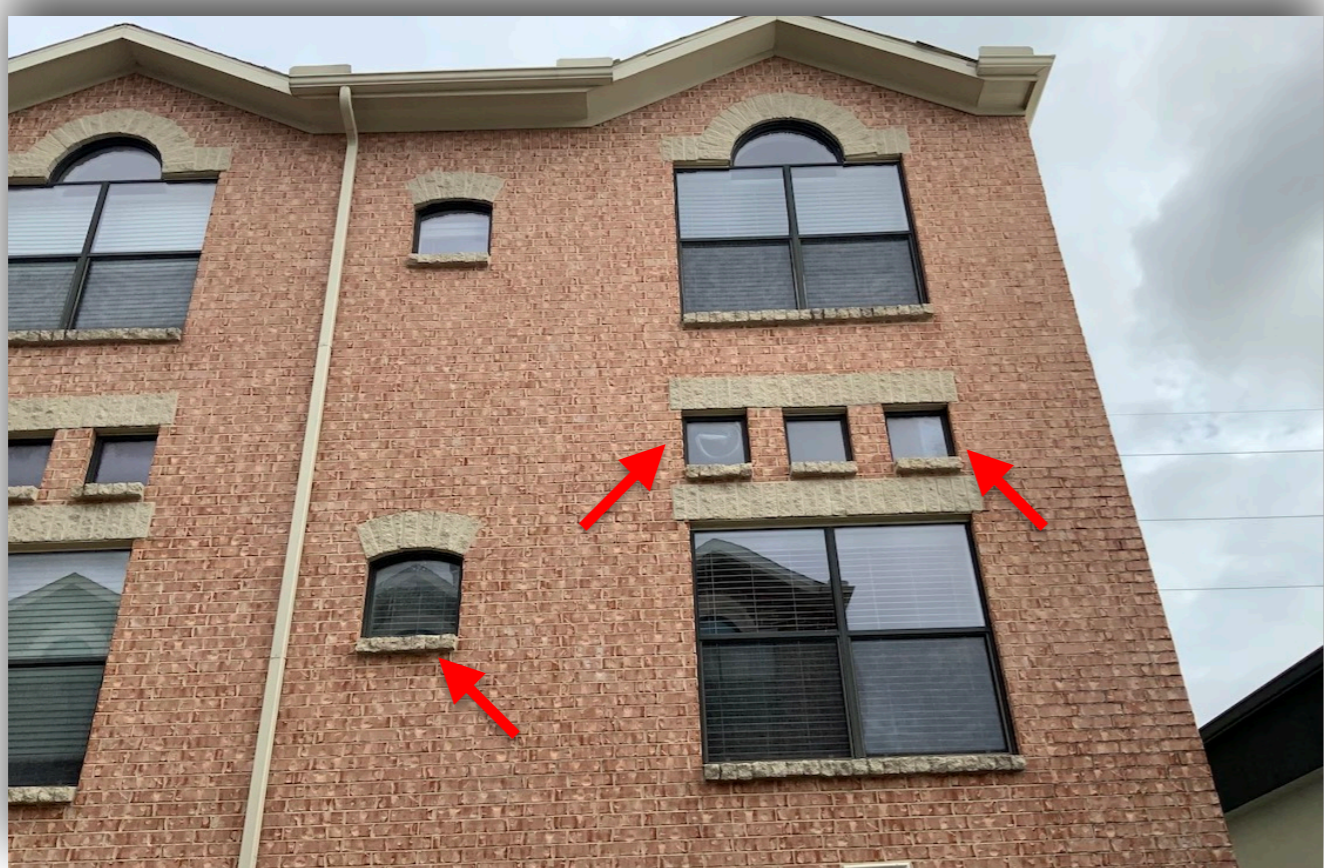
3 Failed thermal seal(s) noted at front wall window(s), failed seals no longer retain their insulation properties leading to a decrease in energy efficiency, window should be replaced.
