**PROFESSIONAL REAL ESTATE INSPECTIONS**

**8715 Meadowcroft Dr. Unit 804**

**REPORT IDENTIFICATION**

**032922—8715**

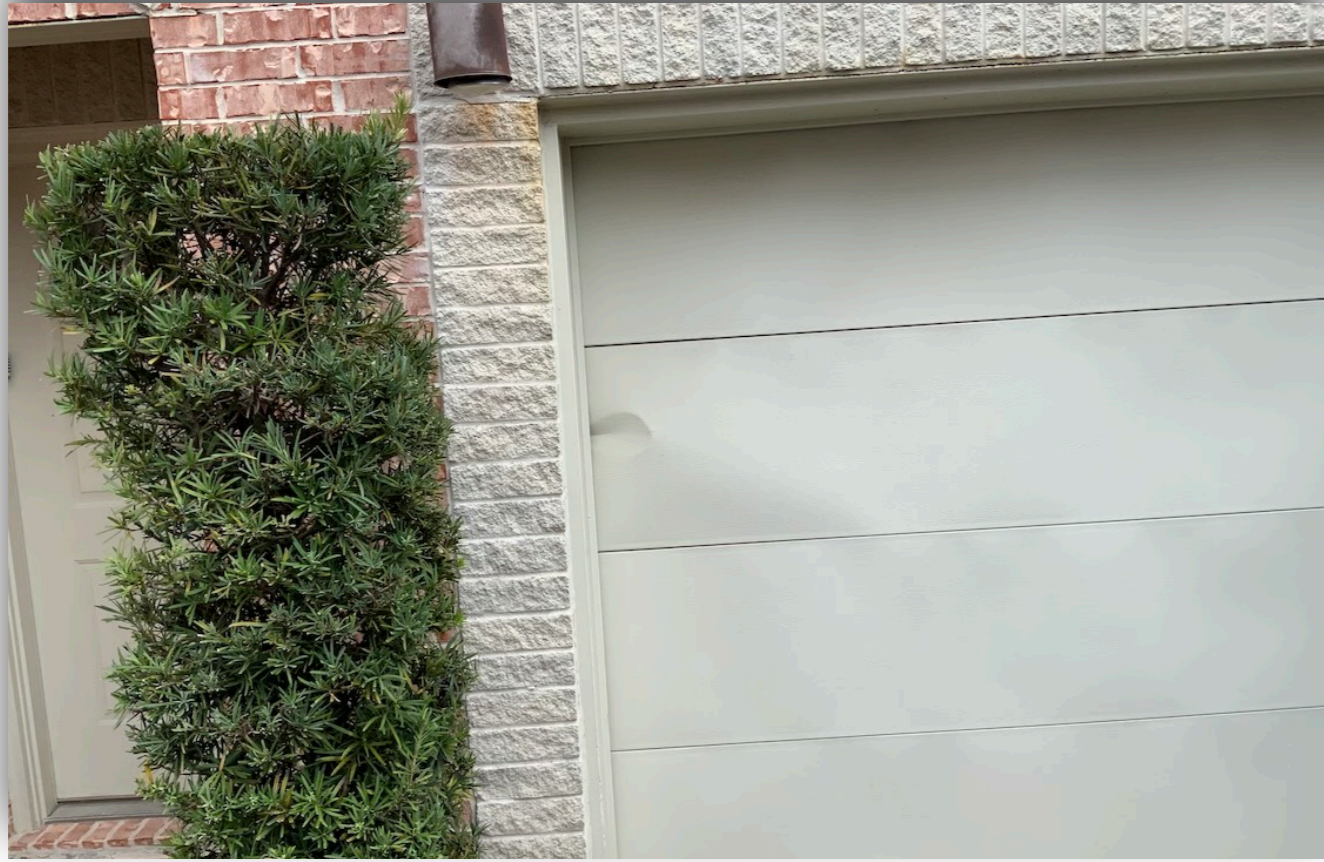
Door panels are dented/  
damaged, should be  
repaired.

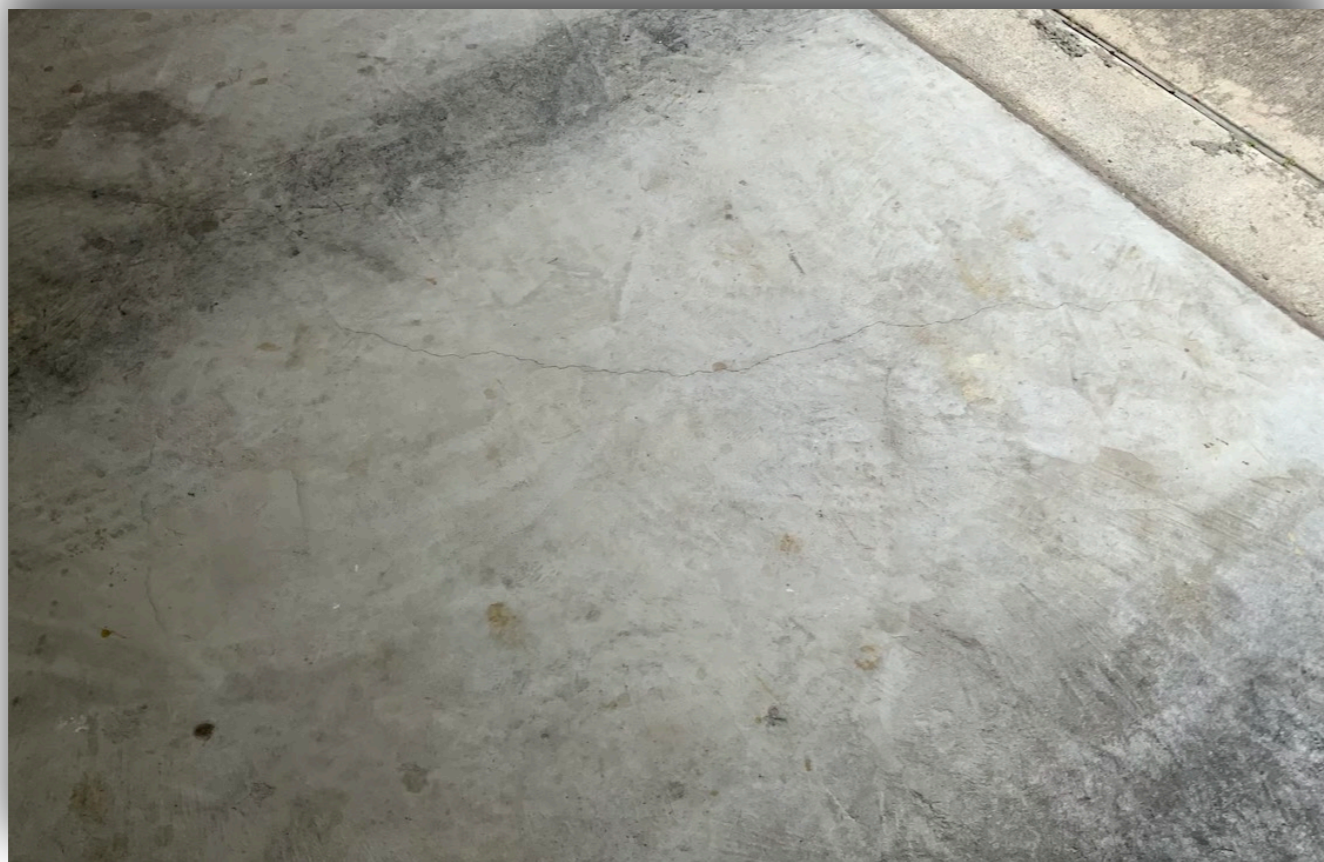
Stress crack(s) present in  
garage slab, no significant  
related effects found in areas  
at time of inspection,  
recommend monitoring.
