April 27, 2022

Mimi Fang
4329 Eigel St
Houston, TX 77007

At the request of Mimi Fang, A-Action Home Inspection Group performed a reinspection at the above listed property. We were requested to check to see if the following items have been repaired or corrected as requested and negotiated between Mimi Fang and the seller.

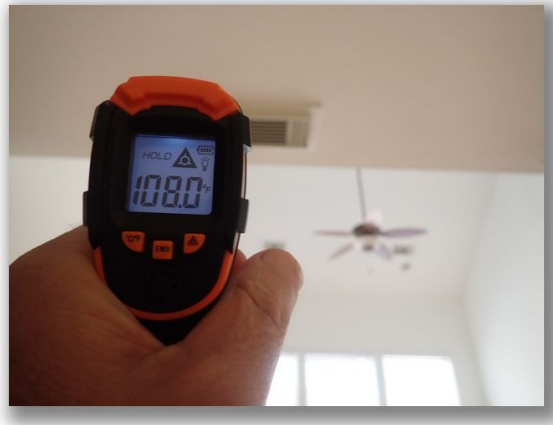
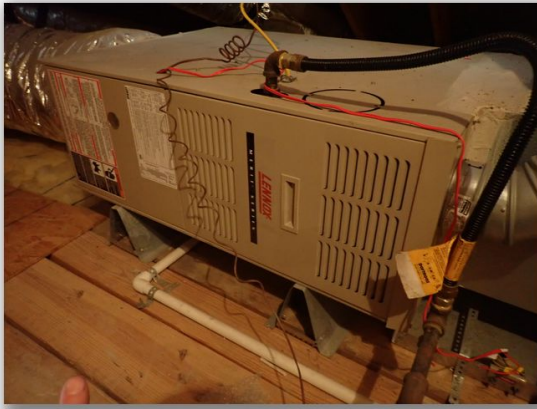
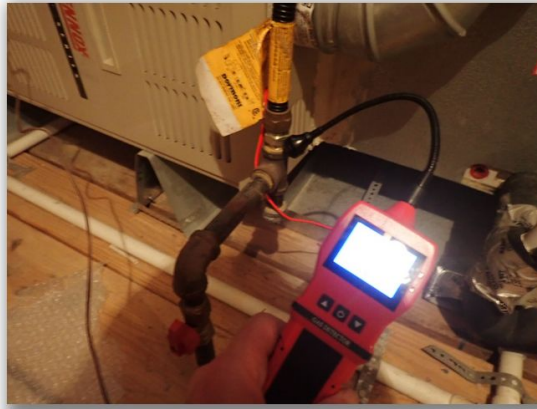
Central Heating System – *Energy Source: Gas*
Brand Name: Lennox

This component appears to be performing adequately at the time of this inspection. It is achieving an operation, function, or configuration consistent with accepted industry practices for its age.

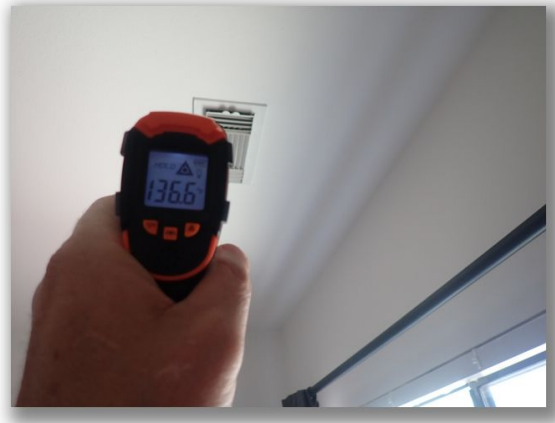
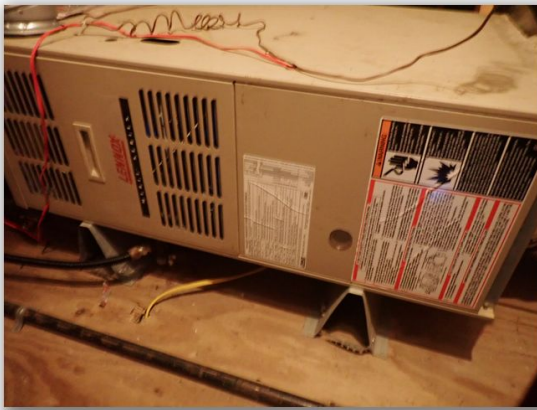
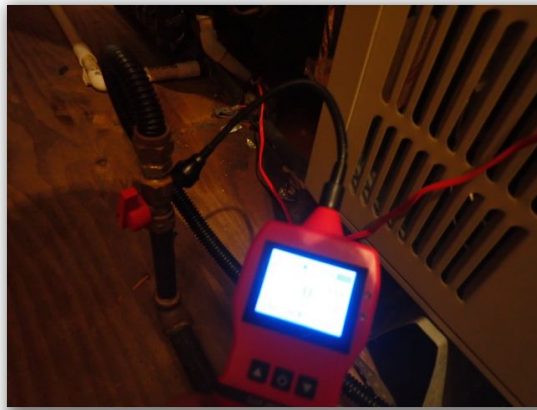
Central Heating System(2nd floor) – Energy Source: Gas
Brand Name: Lennox

This component appears to be performing adequately at the time of this inspection. It is achieving an operation, function, or configuration consistent with accepted industry practices for its age.

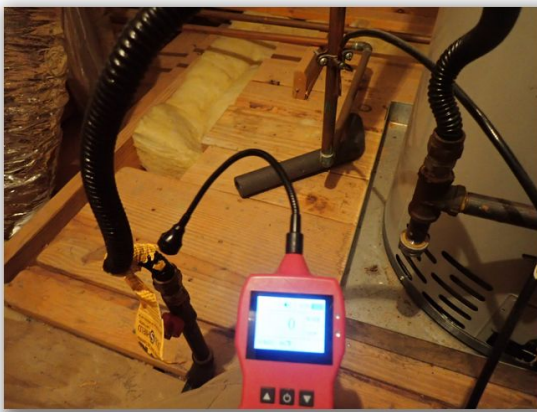
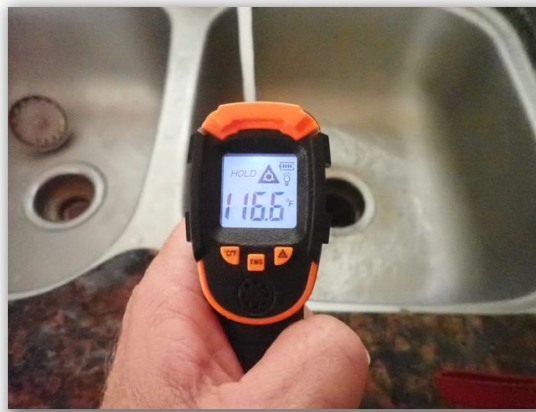
Water Heater – *Energy Source: Gas*

- The temperature and pressure relief (TPR) valve discharge pipe is running in an upwards direction in one or more locations. The TPR discharge pipe should run gravitationally downwards at all points.
- The fittings at the top of the water heater are made of dissimilar metals (galvanized steel connected to copper and/or brass). It is recommended to replace the galvanized steel fittings with brass or copper fittings or install a dielectric union between the two dissimilar metals to prevent electrolysis from occurring.
- Some corrosion was observed at the water supply connections at the top of the water heater.

The water heater and associated components need to be checked and serviced by a Qualified / Licensed Plumber. The observations made to support the rendering of this opinion are listed but may not be limited to the following:

Note: Due to the limited nature of a general home inspection, it is possible that additional deficiencies will be discovered by a licensed technician. It is recommended to have the system serviced prior to the expiration of any option/warranty period.

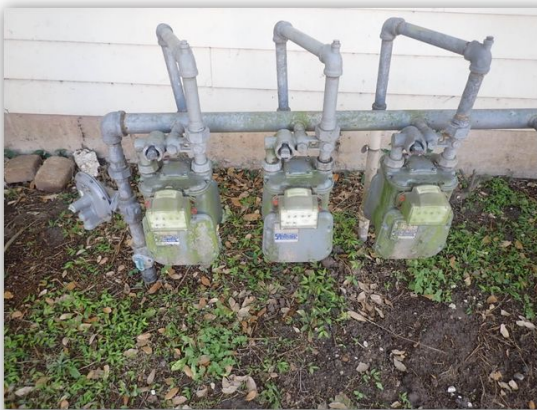
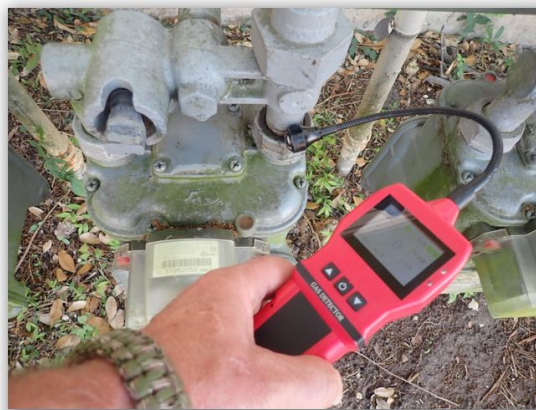
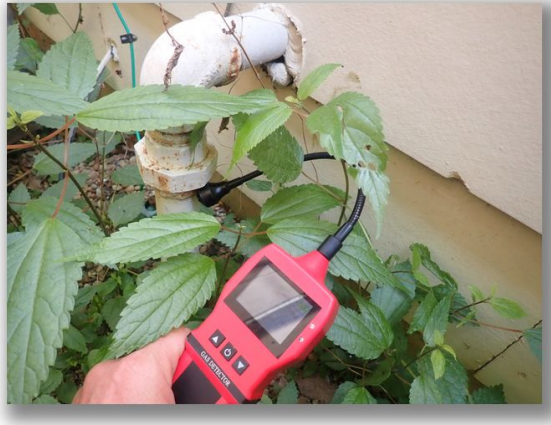
Gas Supply Lines and Related Components

All components were found to be performing and in satisfactory condition on the day of the inspection.

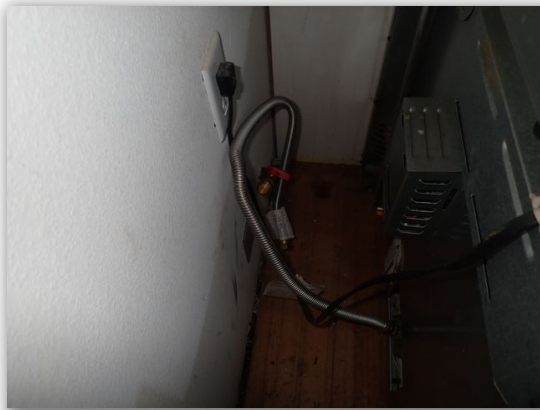
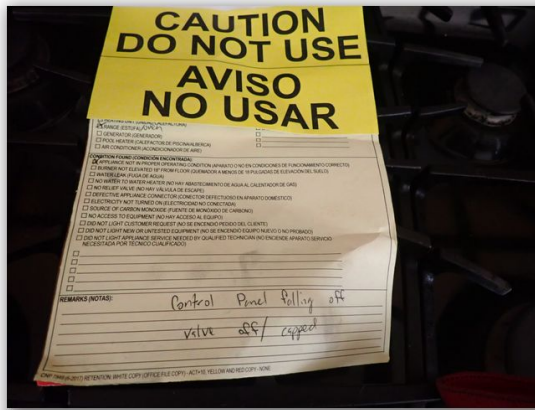
Range

- The range appears to have reached the end of its serviceable life expectancy.

Note: This appliance was not present/not installed at the time of inspection.
