Survey of Lots Ten (10), of **SEA ISLE, Section Twenty-two (22)**, a subdivision in Galveston County, Texas, according to the map or plat thereof recorded in Volume 1616, Page. 172, and transferred to Plat Record 8, Map No. 87, both of the Map Record of Galveston County, Texas.

SURVEY DATE:	MAY 25, 2016
FILE No.:	6393-0000-0010-000
DRAFTING:	JTK
JOB No.:	16-0406

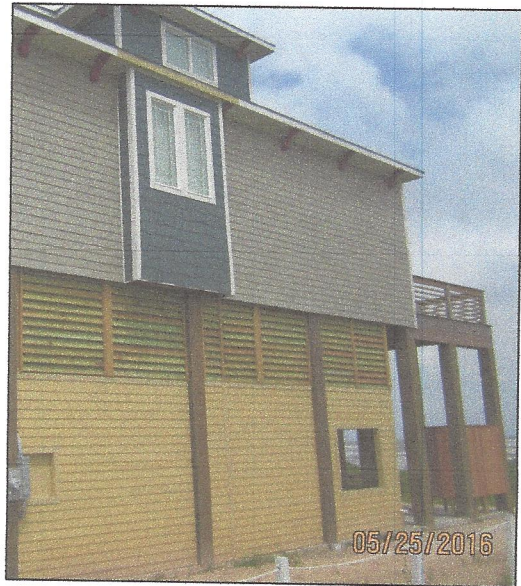
\*Encroachment Detail  
(Looking Southeast)

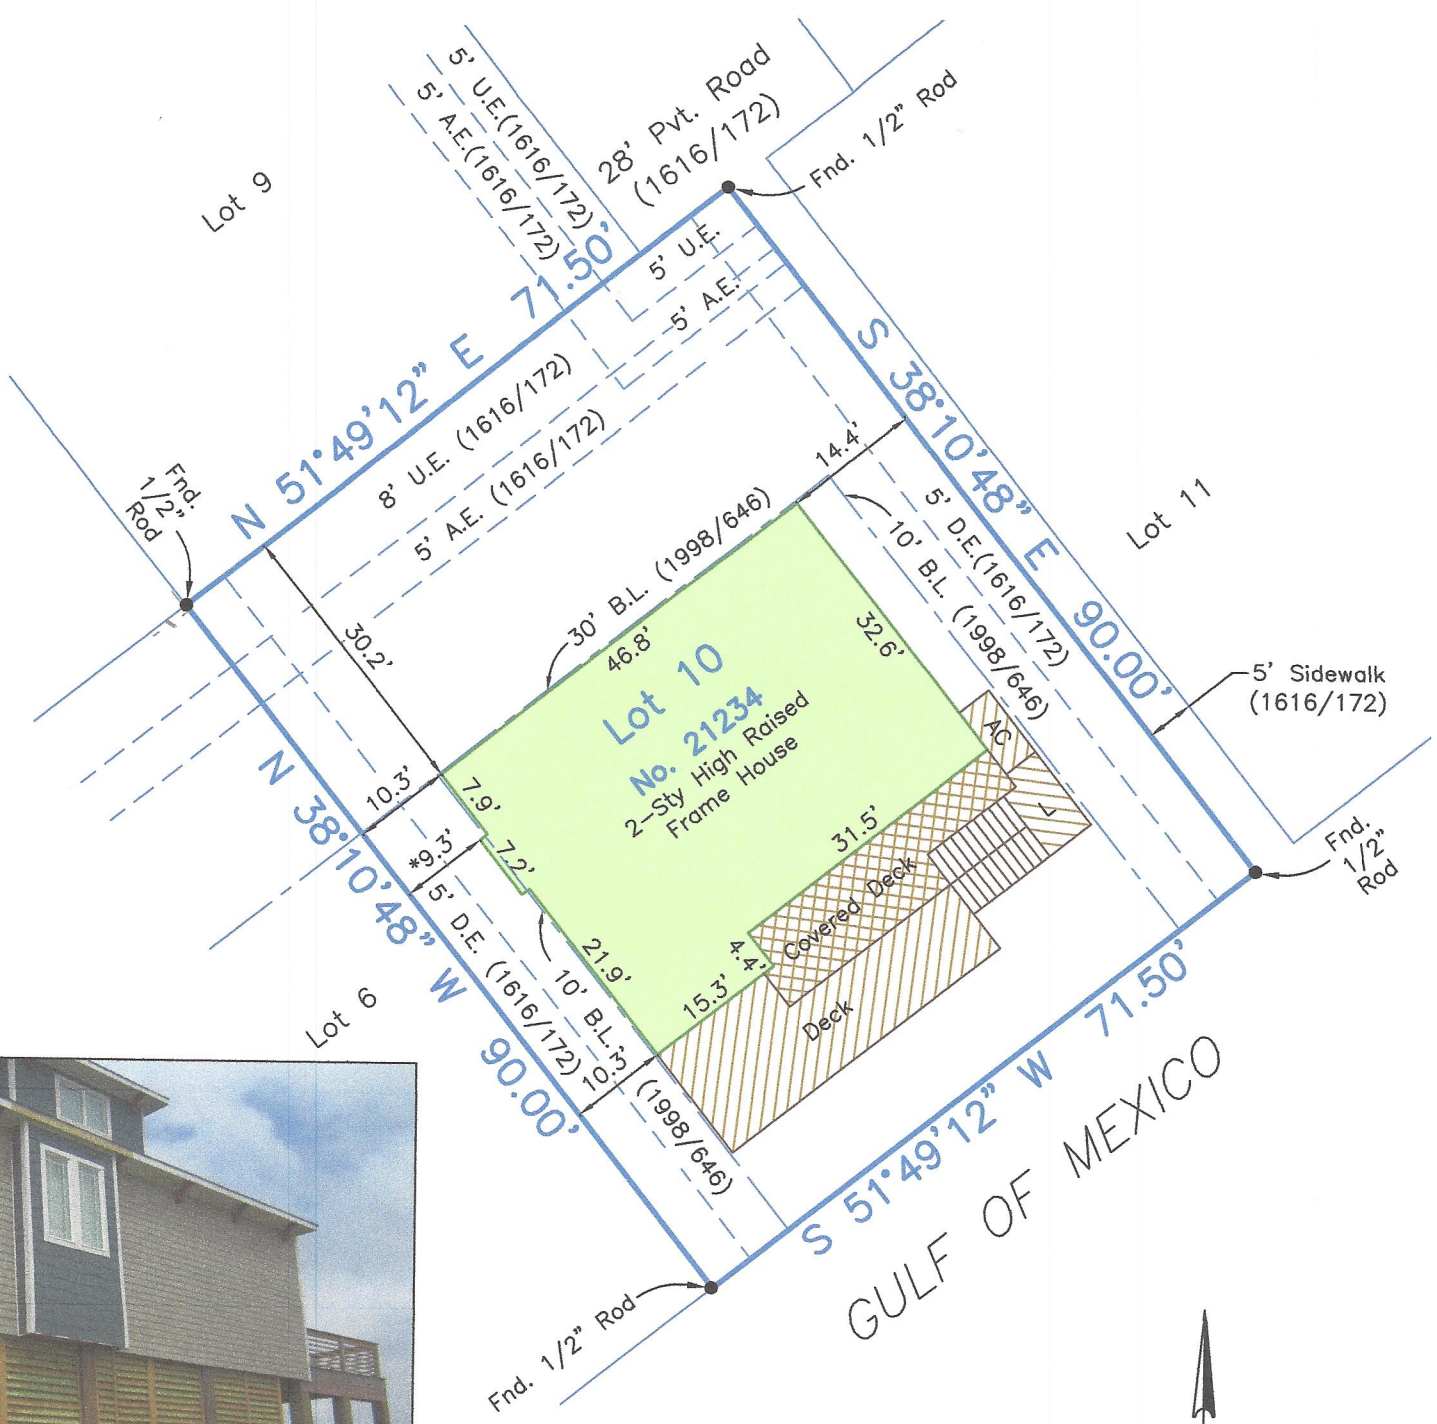
I hereby certify that on the below date, the herein described property, together with improvements located thereon, was surveyed on the ground and under my direction, and that this map, together with dimensions as shown hereon, accurately represents the facts as found on the ground this date.
