**ALLIED FOUNDATION SPECIALIST, INC.**  
**ALLIED PLUMBING LLC**  
 MPL LIC #39626

NAME Jose Orellana  
 ADDRESS 13218 Parkway Spring Dr  
 CITY ZIP Houston, TX 77074  
 HOME # \_\_\_\_\_  
 WORK # \_\_\_\_\_  
 CELL # 281-684-8064  
 EMAIL \_\_\_\_\_

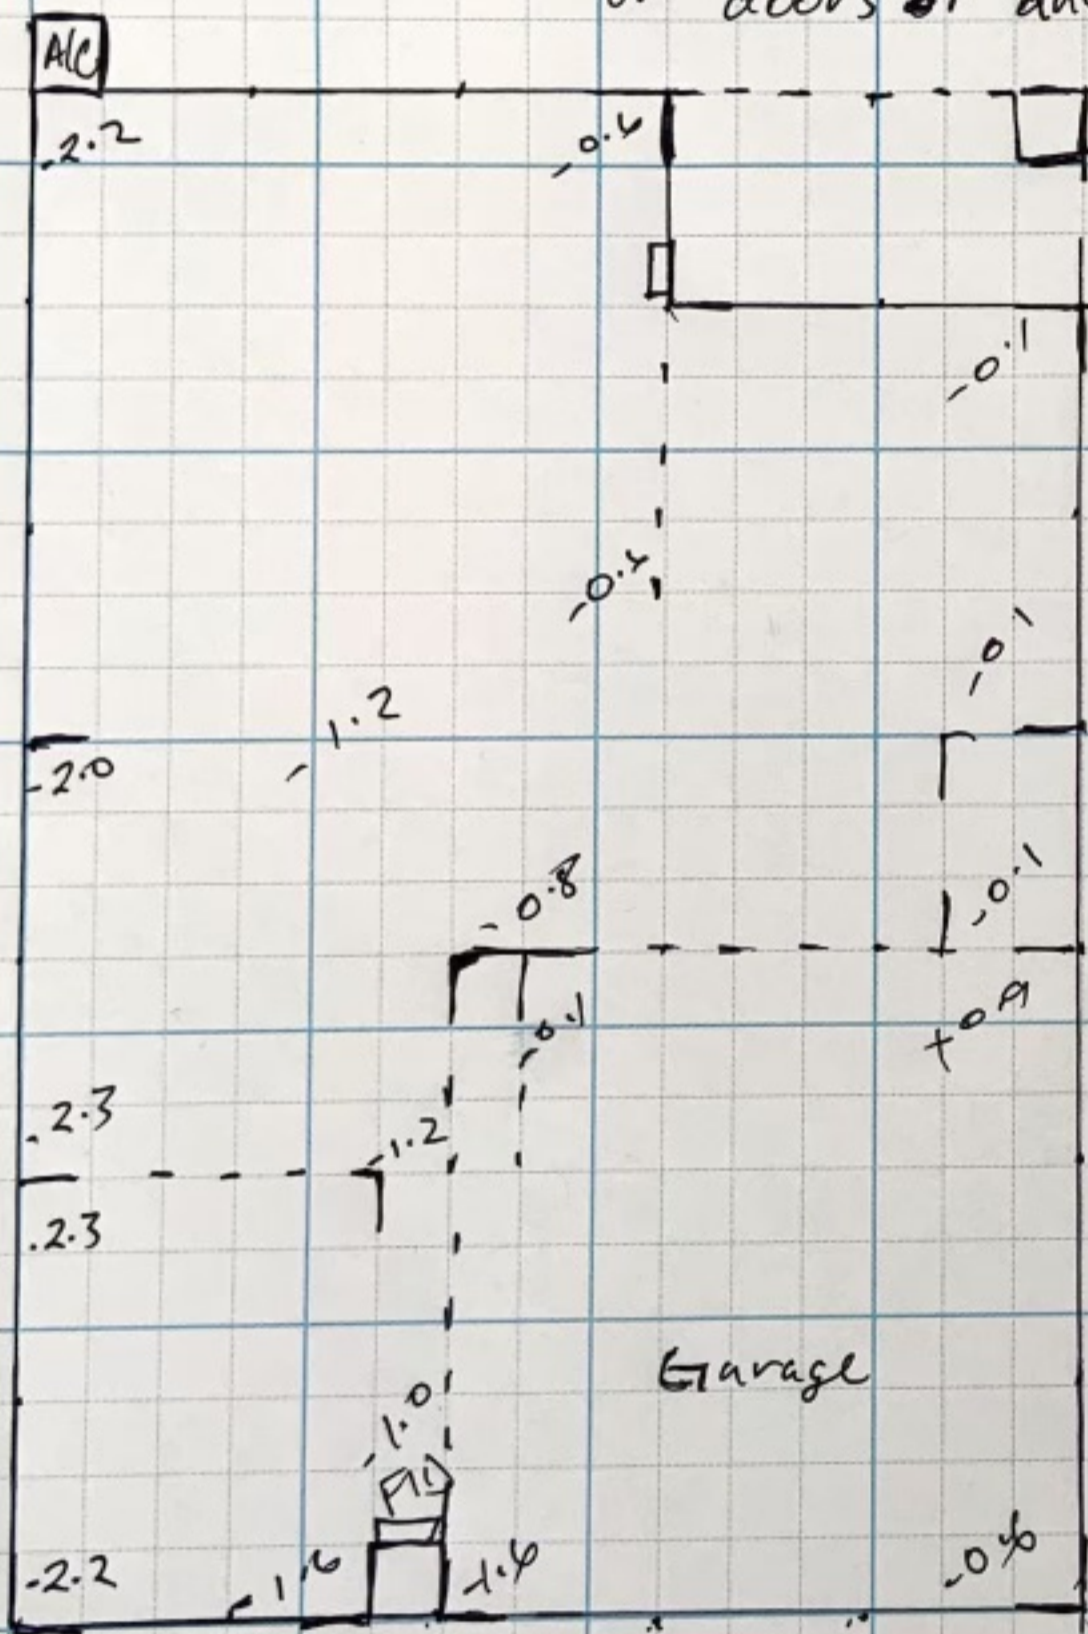
I did a reading with a zipline of the foundation inside of the home. I did see a slope on the foundation from -0.1 to -2.3 But no signs of settlement or signs of shifting showing movement to the foundation.

- No piers needed at this time.
- I did a visual inspection on the outside of the home. I did not see any signs of shifting or separation around the expansion joints windows or doors or any cracks.
