PROPOSAL FOR REPAIRS 4534 PARK COURT BELLAIRE 77401

May 1, 2023
Colton/Longo
dylan.siegman@sothebys.realty

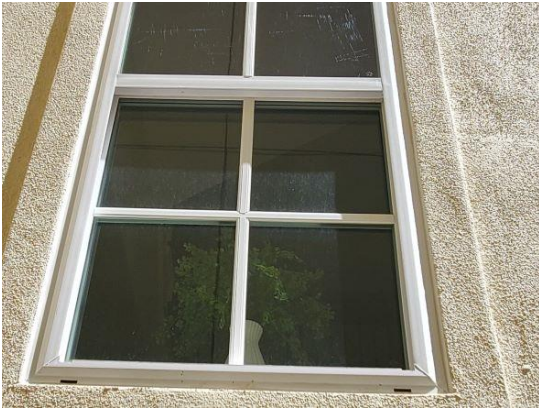
The report indicates partially inadequate sealants at windows, doors, flashings, balcony fasteners, and penetrations. The sealants for windows and door pertain to the perimeter of the window and

the appropriate color. For some penetrations clear based silicone may be the best option. We will use the best suited sealant for those areas. Sealants are addressed in this area of the scope of work and, for your convenience, will not be addressed on each page or line item. Our proposal includes all windows, doors, penetrations, and everything stucco to stucco, stucco to dissimilar material, and elevations that contain other cladding. The only portion of the home that we cannot seal are items that are located on your roof. Sealant materials are not warranted by any manufacturer.

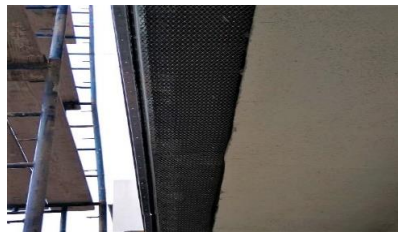
P14-Green; A proper drainage relief vent will be installed where required as shown in photo 15.4. The substrate behind the drip screed will be opened to the exposed framing to all the wall to fully allow residual moisture to escape.

We do paint larger portions to assist in blending however, the existing paint will be weathered which may be noticeable compared to the fresh paint in the repair field.
