## Property Inspection Report

1327 Falling Leaf Ln, Seabrook, TX 77586  
Inspection prepared for: Regan Bullers  
Real Estate Agent: Allison Houser - Keller Williams Realty Metropolitan

Date of Inspection: 3/17/2016 Time: 12:00 PM; 2:30 PM  
Age of Home: 26 years old Size: 2870 sqf  
Weather: Overcast

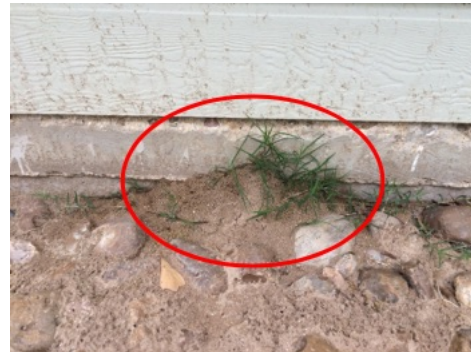
Rear: Ant activity

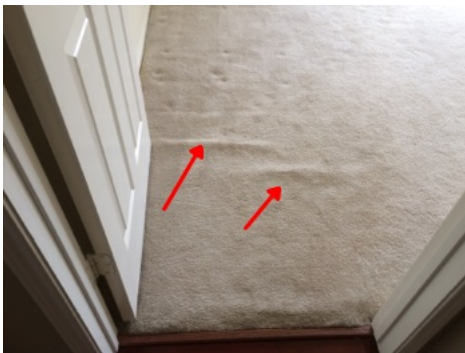
Bedroom 4: waves in carpet

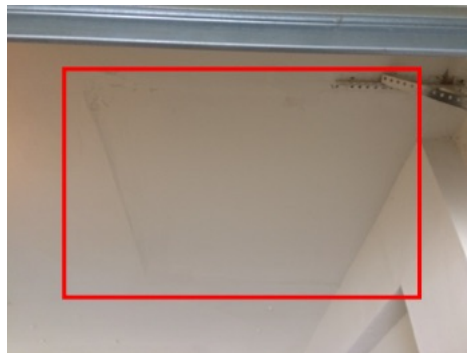
Garage: Patchwork

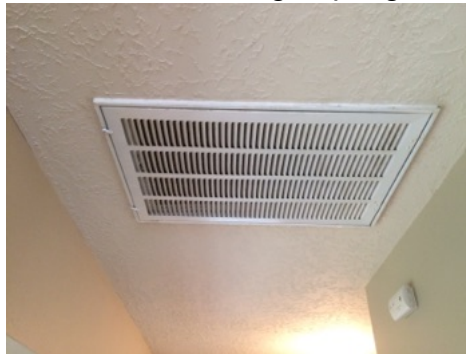
The air filters were dirty and should be changed. Conventional filters should be checked every months and replaced as necessary. Homes in areas with high indoor levels of airborne pollen or dust may need to have air filters checked and changed more frequently. Failure to change the filter when needed may result in the following problems:

- Reduced blower life due to dirt build-up on vanes, which increasing operating costs.
- Reduced indoor air quality.
- Increased resistance resulting in the filter being sucked into the blower. This condition can be a potential fire hazard.
- Frost build-up on air-conditioner evaporator coils, resulting in reduced cooling efficiency and possible damage.
- Reduced air flow through the home.

2nd floor dirty air filter size 16x25

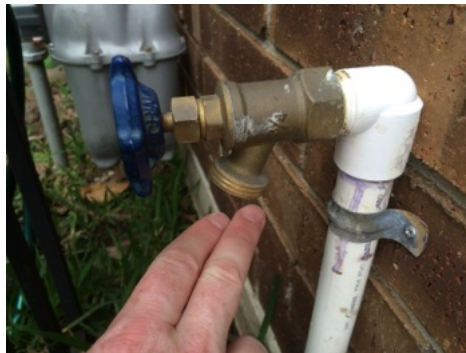
An exterior hose bibb did not have a back flow preventer. Anti-siphon devices keep contaminated water from entering the potable water of the house plumbing. These devices are cheap and can be found in most home improvement stores. We recommend making the upgrade. This was observed on the right, and front.

Right: Back flow preventer recommended

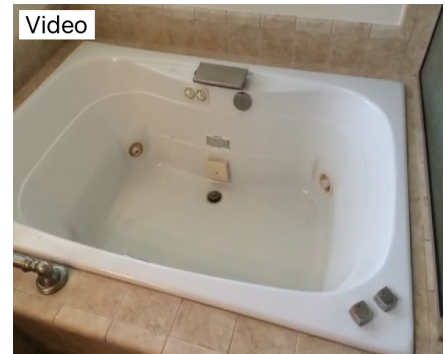
CLICK VIDEO TO PLAY: bathroom 1 noise coming from empty bathtub

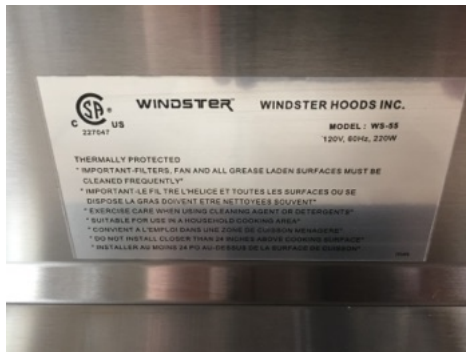
Model and Serial numbers

The range top had a re-circulating vent. The air is filtered, and then it is re-deposited in the kitchen. Most vent-hood appliances, especially ones that use gas, will have a flue which is terminated outside of the house to remove combustion products, moisture, grease, and heat. The installation of a flue will also lower your electric bill during the hot months.

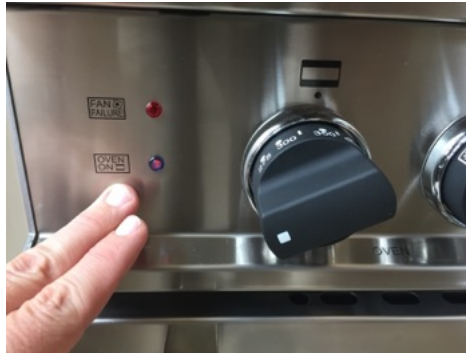
Oven light on set at 350 degrees

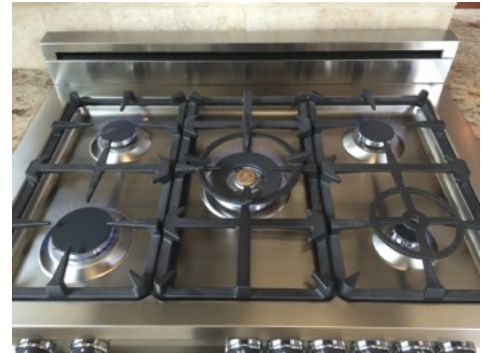
All burners on high

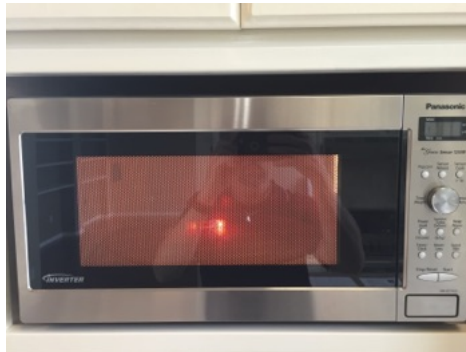
The microwave was functioning as designed under its normal operating mode, at the time of the inspection.

Microwave on

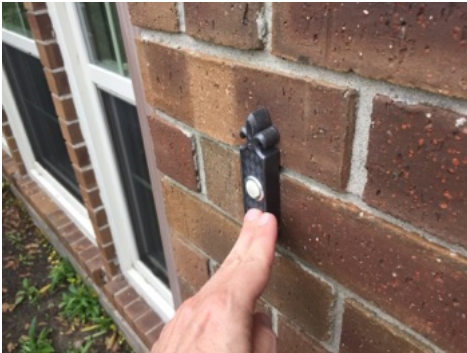
The doorbell did not operate at the time of the inspection. We recommend having this repaired.

Doorbell inoperable
