GCH Inspections, LLC

Property Inspection Report

1042 W 23rd St, Unit D, Houston, TX 77008

Date of Inspection: 4/22/2018 Time: 1:00 PM

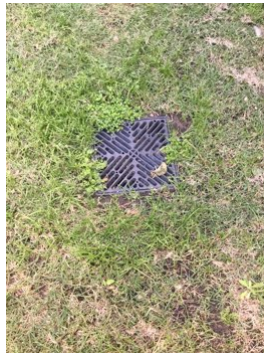
- Surface and french drains observed and not tested at the time of inspection

Subsurface drains

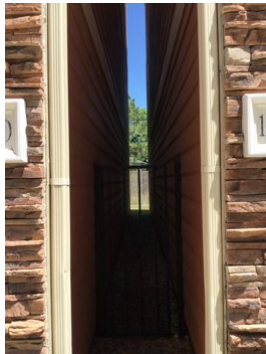
34 inch separation

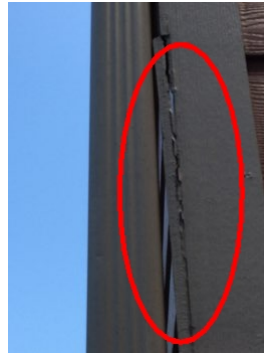
Separating

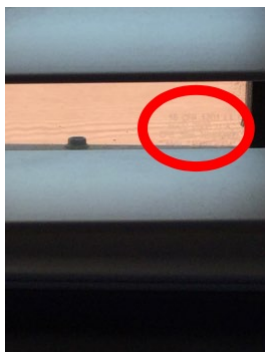
Safety glass

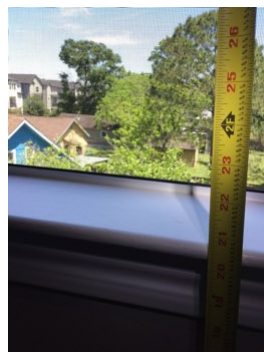
Less than 24 inches

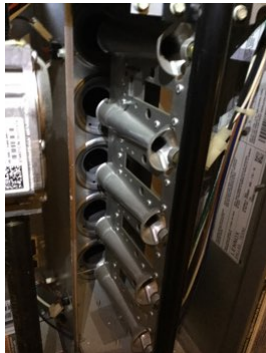
Appears clean

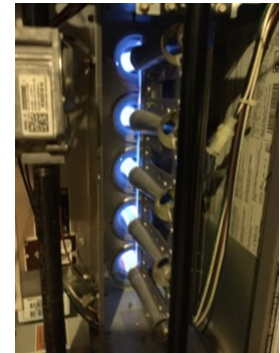
Functioning

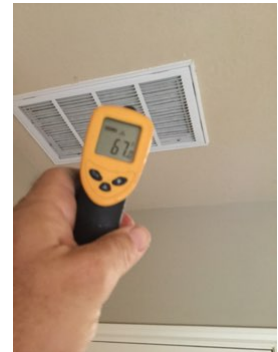
Downstairs return register - 67%

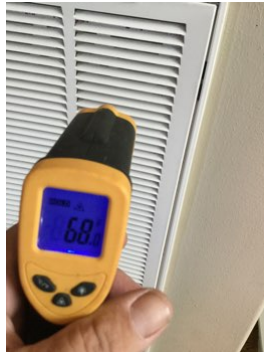
2nd floor return register 68%

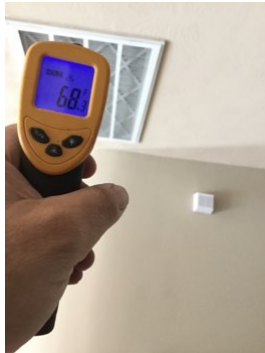
3rd floor return register 68%

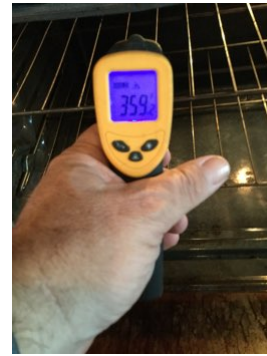
359°

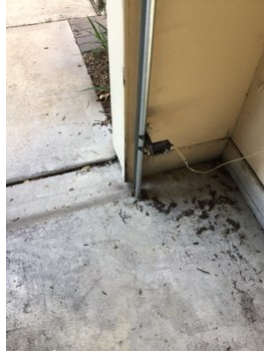
- The overhead garage door{s} was functional at the time of the inspection
- The garage door sensors should be installed within {6"} of the finished floor

Too high

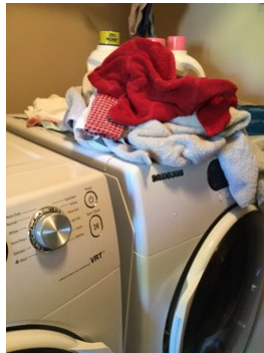
- Could not fully inspect the dryer vent, it is obscured by dryer.

Unable to access

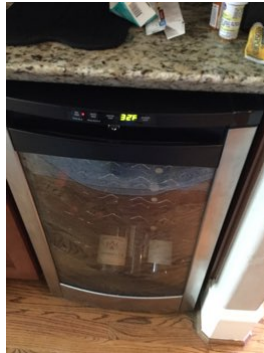
Not inspected
