Your Inspection Report

1715 Nantucket Drive
Houston, TX 77056

INSPECTION DATE:
Friday, February 1, 2019

RE: Report No. 1156
1715 Nantucket Drive
Houston, TX
77056

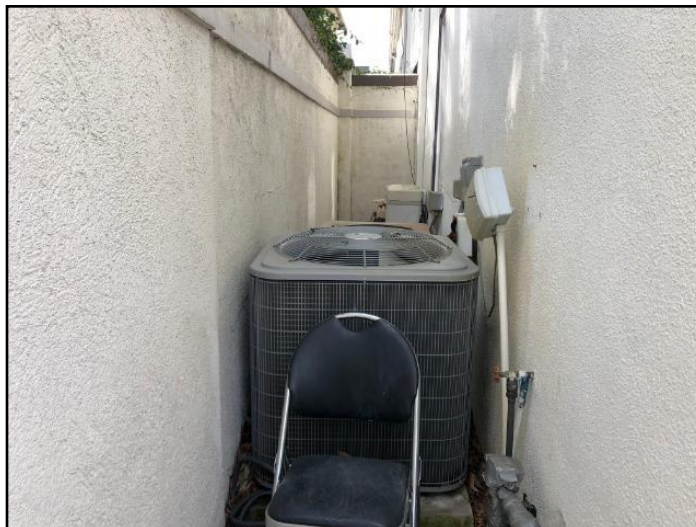
• Inaccessible wall

No clearance due to AC units.

Inaccessible wall

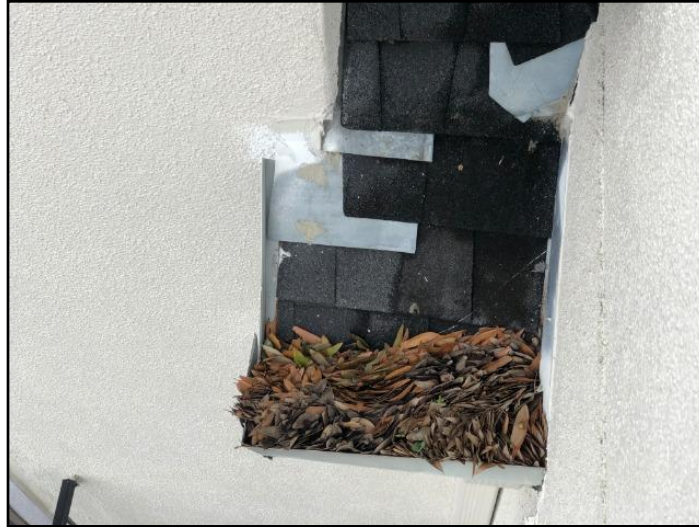
3. Condition: • [Clogged](#)

Location: Exterior

Clogged

Task: Evaluate and Address as Needed

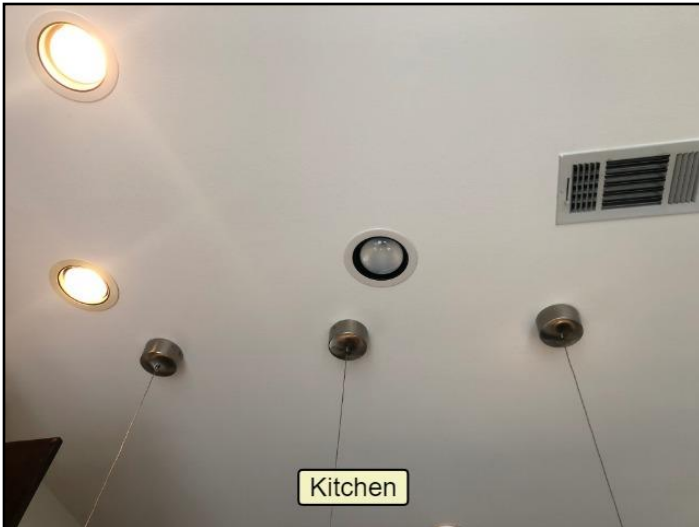
21. Condition: • [Inoperative](#)

Inoperative

Replacing bulbs is recommended to make sure fixture is fully operative.

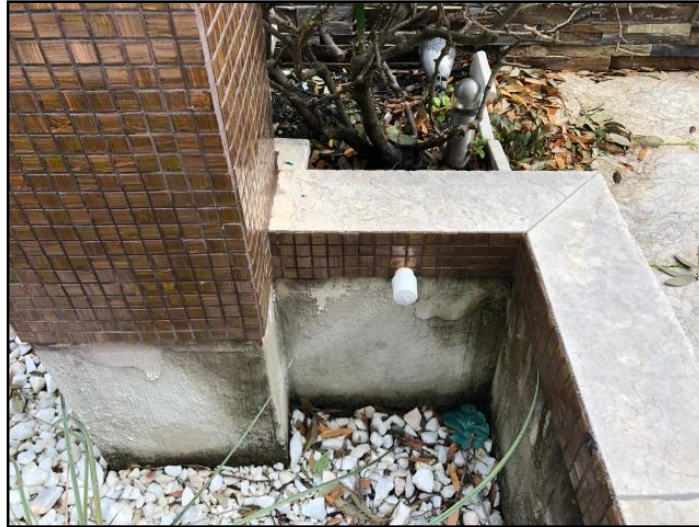
OPTIONAL \ Plumbing
25. Condition: • Other
 Water fall system is operative
Task: Evaluate and Address as Needed

Other

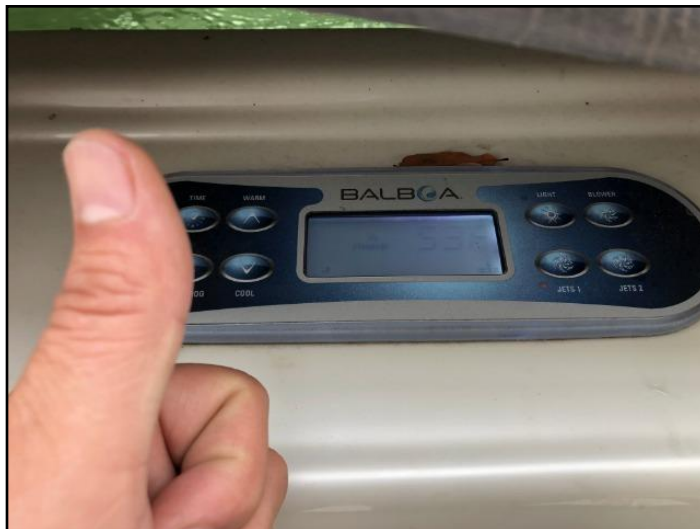
38. Condition: • Hot tub Jets 1&2, Blower, Lights functioned as intended.

Functioned as intended
