## PROPERTY INSPECTION REPORT

**Concerning:** 11942 GREENGLEN DR., Houston, TX 77044  
(Address or Other Identification of Inspected Property)

**By:** Stephen Perry, Lic #7854 07/16/2019  
(Name and License Number of Inspector) (Date)

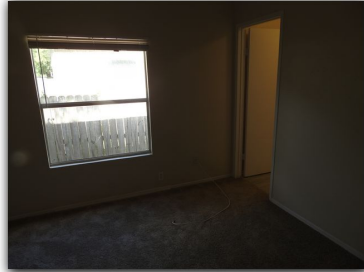
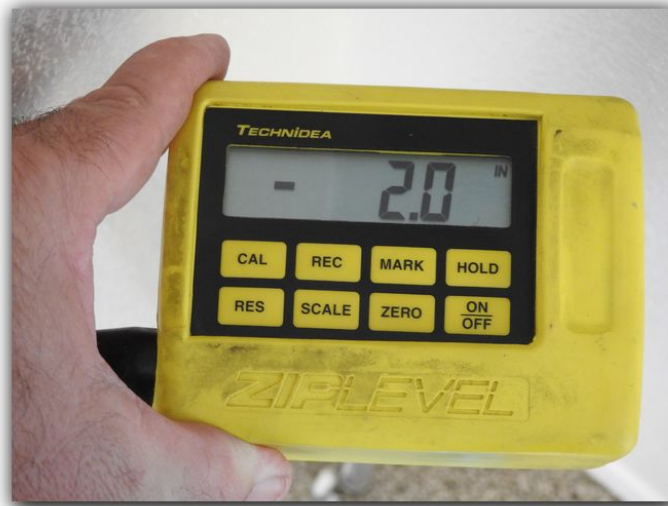
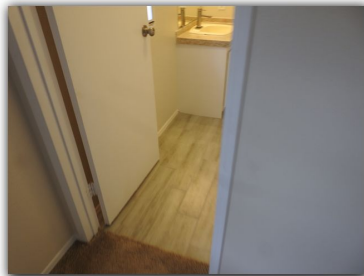
**PROPERLY LEVEL THE HOME.**

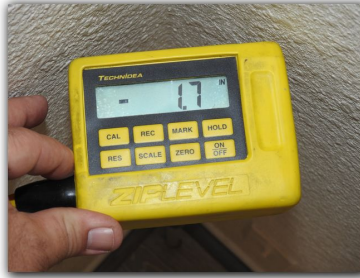
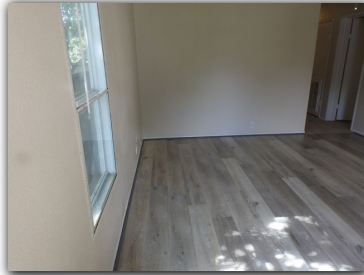
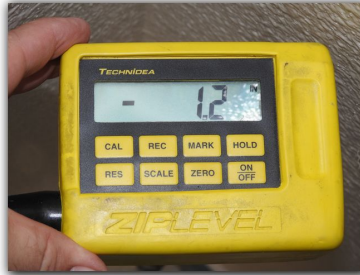
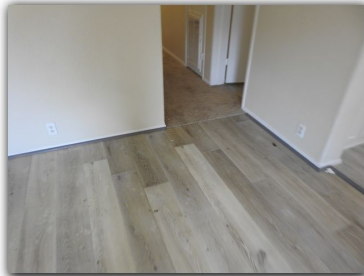
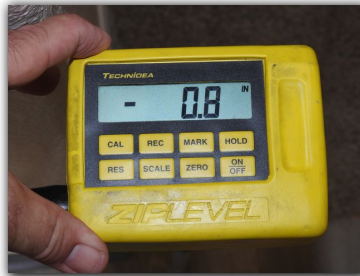
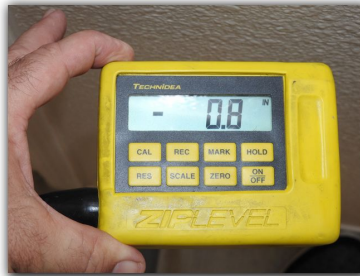
**PIERS HAVE SETTLED AND LEANING; IN NEED OF REPAIR.**

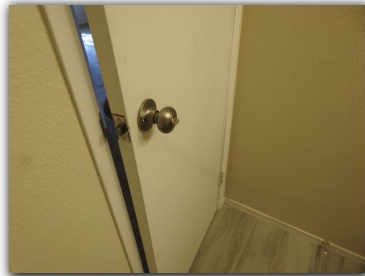
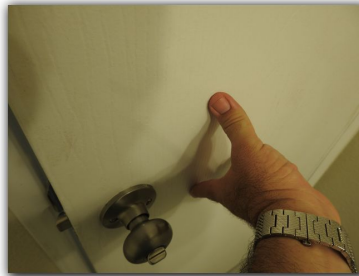
- **HALL BATH DOOR IS HARD TO CLOSE; OUT OF SQUARE AND COMMON WITH STRUCTURAL SETTLEMENT. RECOMMEND EVALUATION AND REPAIRS.**

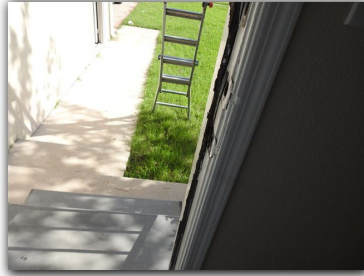
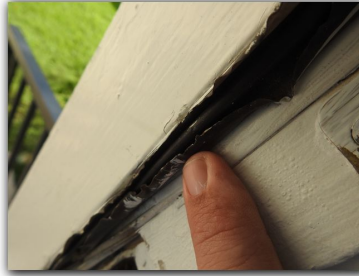
- **DAMAGED WEATHER STRIPPING ON THE FRONT DOOR FRAME THAT NEEDS TO BE REPLACED.**

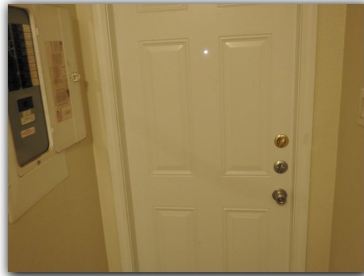
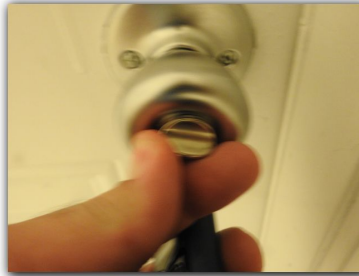
- THE BACK DOOR KNOB LOCK DOES NOT FUNCTION, ONLY THE DEAD BOLTS.

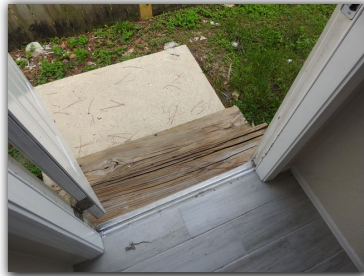
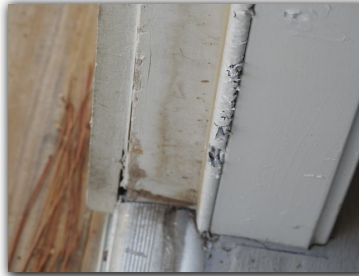
- **THE BOTTOM OF THE EXTERIOR DOOR FRAMES AT THE LOWER JAMBS NEEDS TO HAVE SMALL SQUARE FOAM RUBBER WEATHER STRIPS THAT DO PREVENT THE INSIDE JAMB FROM BECOMING ROTTED FROM WATER PENETRATIONS**

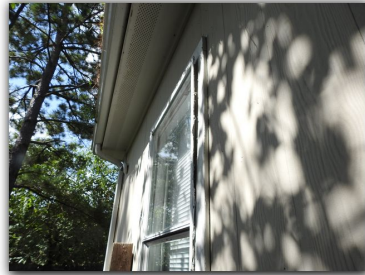
- Some window lift supports are loose, damaged or missing**
- Some window / door screens are damaged or missing**

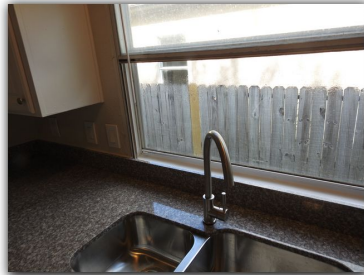
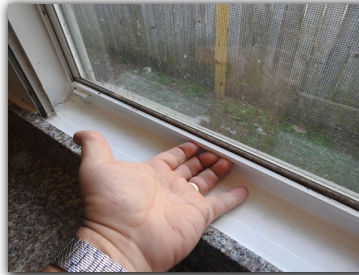
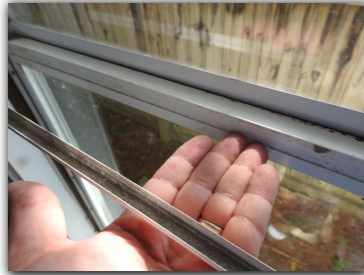
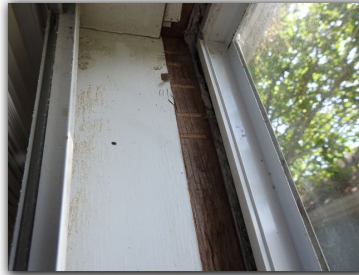
- Caulking / plastic , etc. damaged and / or missing**
- SEVERAL WINDOWS ARE DIFFICULT TO FULLY OPEN, SOME HAVE MISSING SECOND INTERIOR SIDE PANE OF GLAZING AND SOME HAVE THE EXTERIOR GLAZING MISSING. RECOMMEND EVALUATION AND REPAIRS BY A WINDOW REPAIR EXPERT.**
- THE SCREENS ARE MISSING IN SOME LOCATIONS AS WELL.**

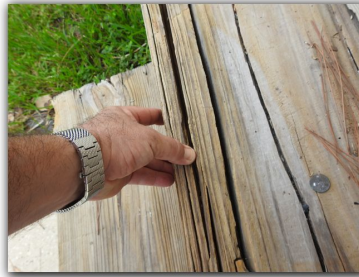
**Structural deficiencies;rotted damaged tread/steps at the back porch that needs repairs and would recommend hand railing as well.**

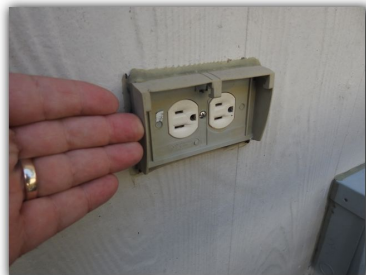
- Loose, damaged, missing outlets / switches / covers (exterior outlet missing cover)**

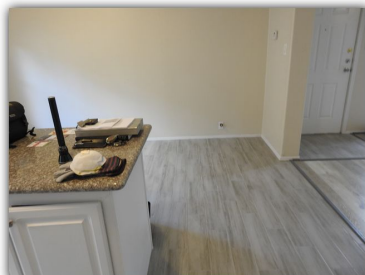
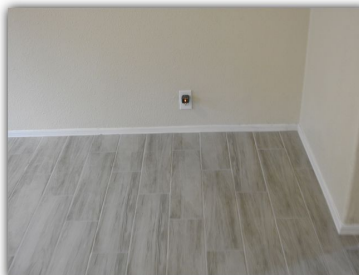
**Lack of Ground/Bonding at: \_\_\_\_\_**  
**THE OUTLET IN THE BREAKFAST AREA SHOWS OPEN GROUND AND IN NEED OF REPAIR BY AN ELECTRICIAN.**

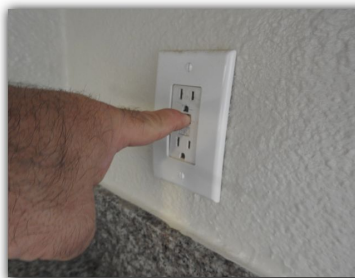
**•THE KITCHEN GFCI IS NOT FUNCTIONING AND WILL NOT RESET; IN NEED OF REPAIR OR REPLACEMENT BY AN ELECTRICIAN.**

- THE KITCHEN GFCI OUTLET WHEN TESTED DID NOT RESET AND HAS NO POWER PRESENT FOR THE CIRCUIT; WILL REQUIRE GFCI OUTLET REPLACEMENT BY A LICENSED ELECTRICIAN.**

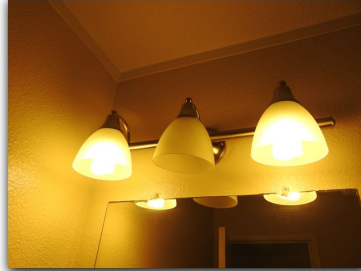
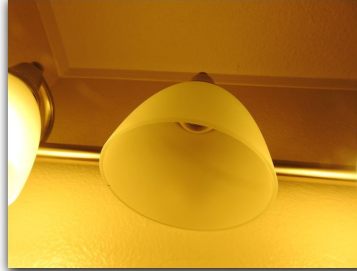
**Light fixtures inoperable or in need of repair**

(Bulb replacement in some locations)

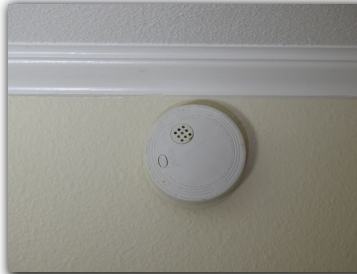
• **THE SMOKE DETECTOR IN HALLWAY WHEN TESTED DID NOT FUNCTION**

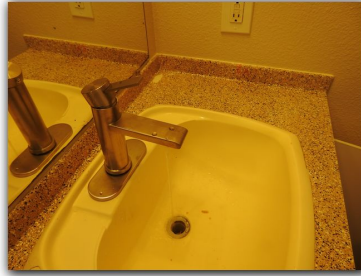
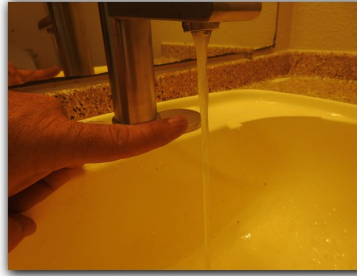
- **THE WATER PRESSURE WAS LOW WHEN RUNNING MORE THAN ONE FIXTURE AT A TIME; RECOMMEND EVALUATION BY A PLUMBER**

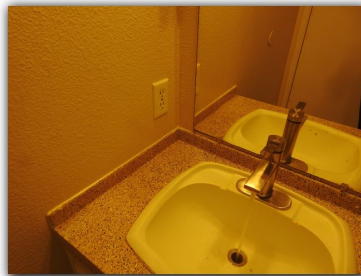
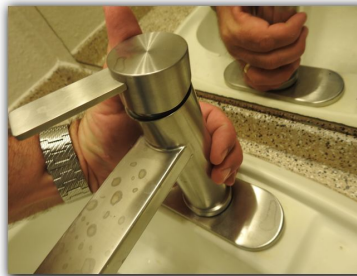
**Loose or damaged faucet handles/fixtures loose at the sink counter top. IN need of repair.**

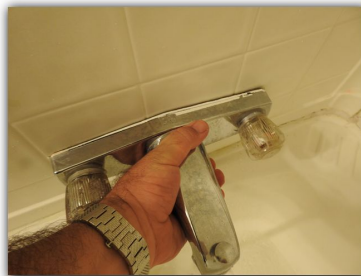
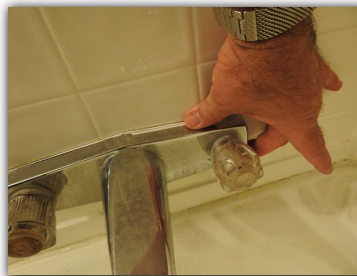
- **BOTH THE BATHROOMS HAVE TUB FIXTURES THAT ARE LOOSE, DAMAGED, COLD WATER HANDLE IN MASTER JUST SPINS BUT DOES NOT TURN ON, LEAKS AT BOTH LOCATIONS AND LOOSE INSIDE THE WALL AT THE HALL BATH. THE FIXTURES ARE VERY LOW QUALITY AND IN POOR CONDITION AND LEAKING, NEED TO BE REPLACED BY A PLUMBER.**
- **HALL BATH SHOWER HEAD LEAKS AND IN NEED OF REPAIR OR REPLACEMENT.**

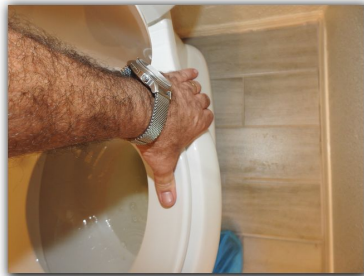
- Loose at floor mounting, both bathrooms**

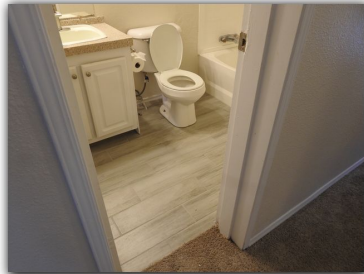
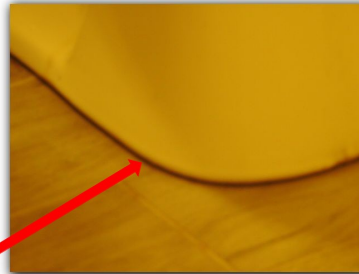
- **TOILETS NEED CALKING AT THE BOTTOM AND FLOORING**

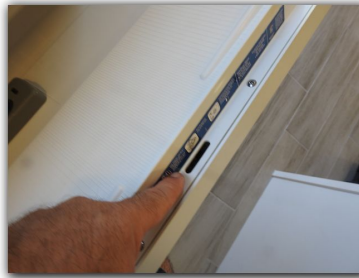
**Inoperative unit(s), recent unit but the door latch is broken and will not operate until fixed by an appliance repair person**

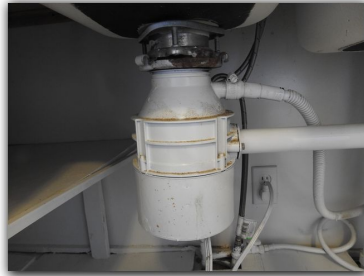
**Inoperative Unit;DID NOT FUNCTION, JUST BUZZING SOUND; IN NEED OF REPAIR OR REPLACEMENT BY A PLUMBER.**

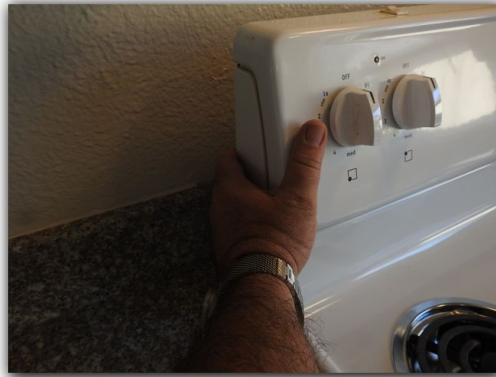
**Absence of anti-tilt device**, required for child safety
