Inspection Report

Property Address:
26 South Bethany Bend
Woodlands Texas 77382

PROPERTY INSPECTION REPORT

Concerning: 26 South Bethany Bend, Woodlands, Texas 77382

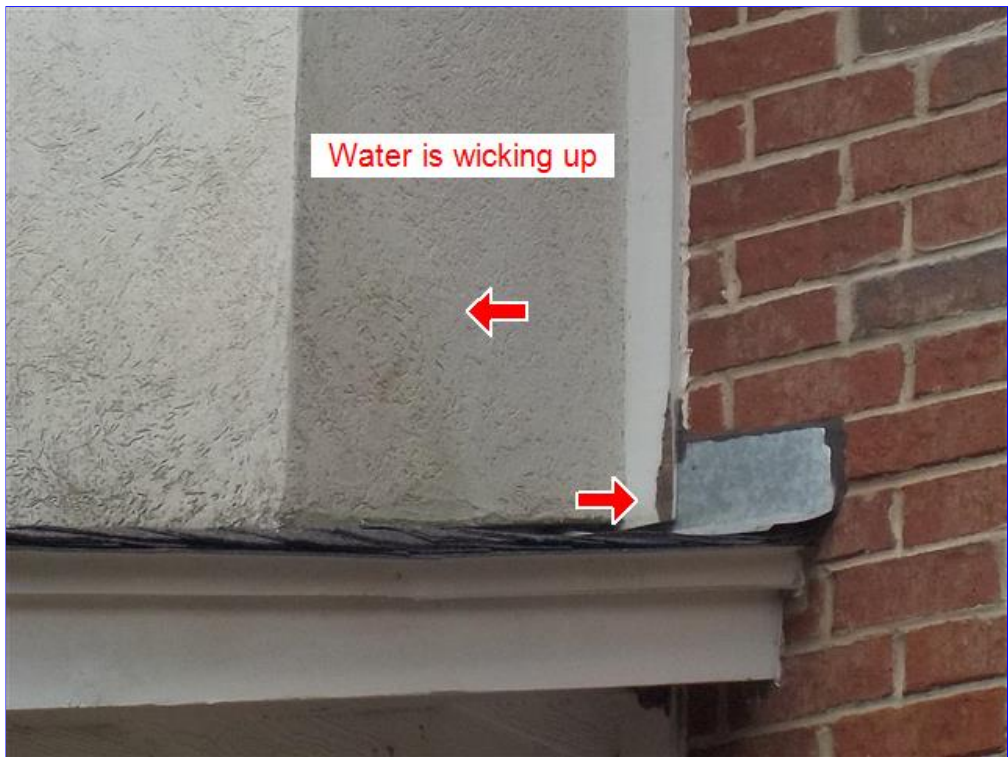
C. Item 3(Picture) Flashing needs to be followed through

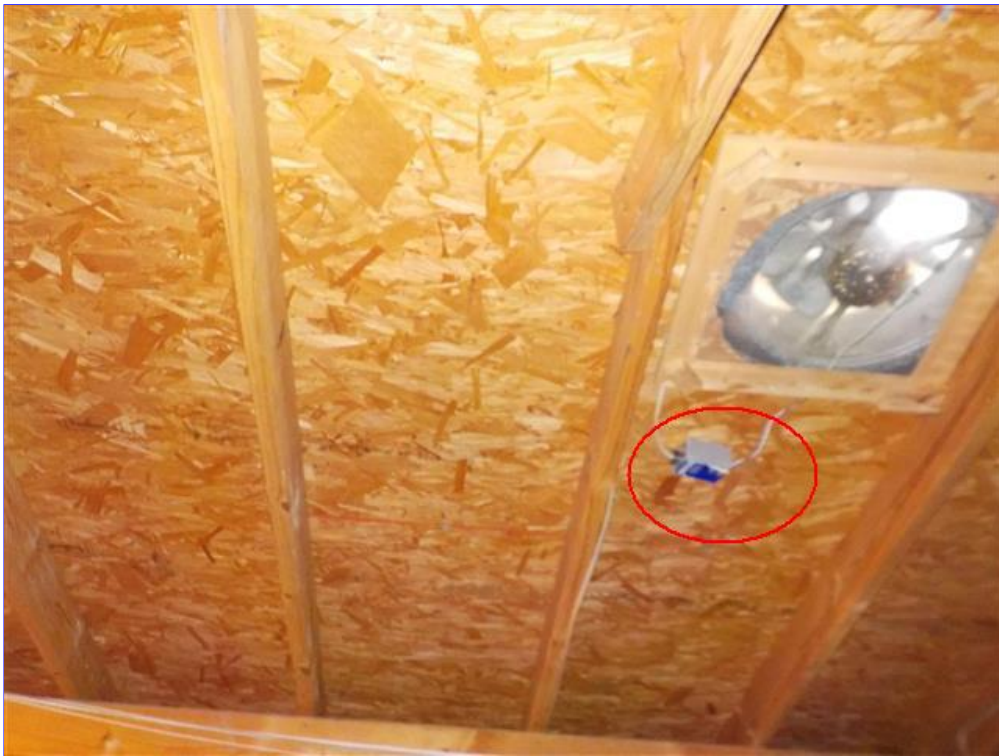
C. Item 12(Picture) Thermostat controlled vents

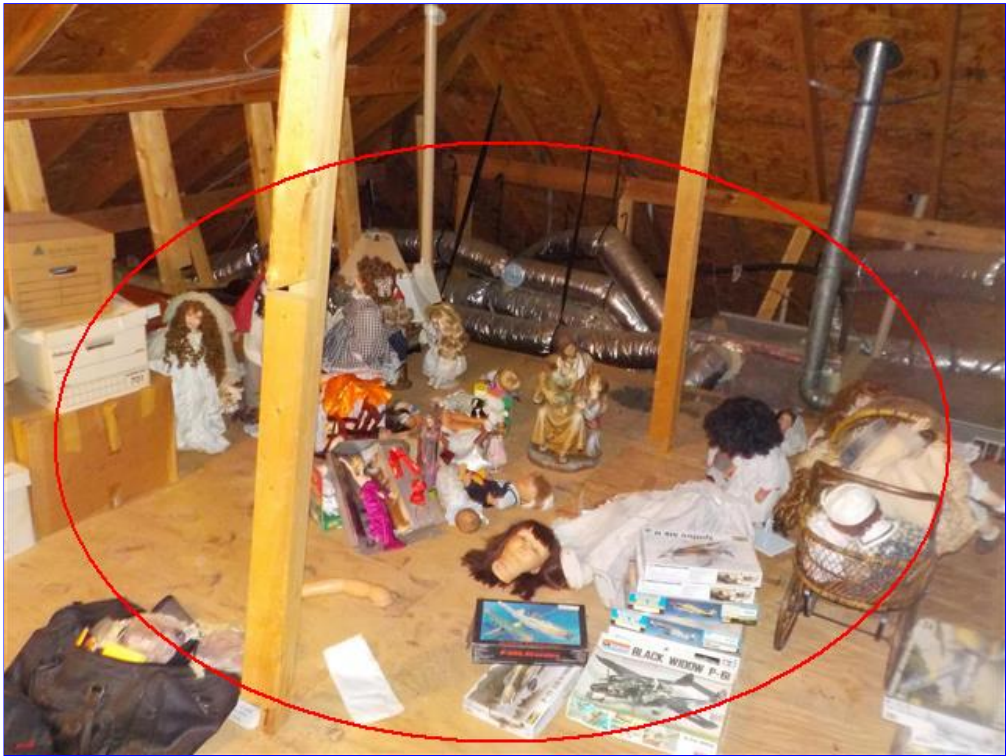
C. Item 17(Picture) Certain areas are inaccessible

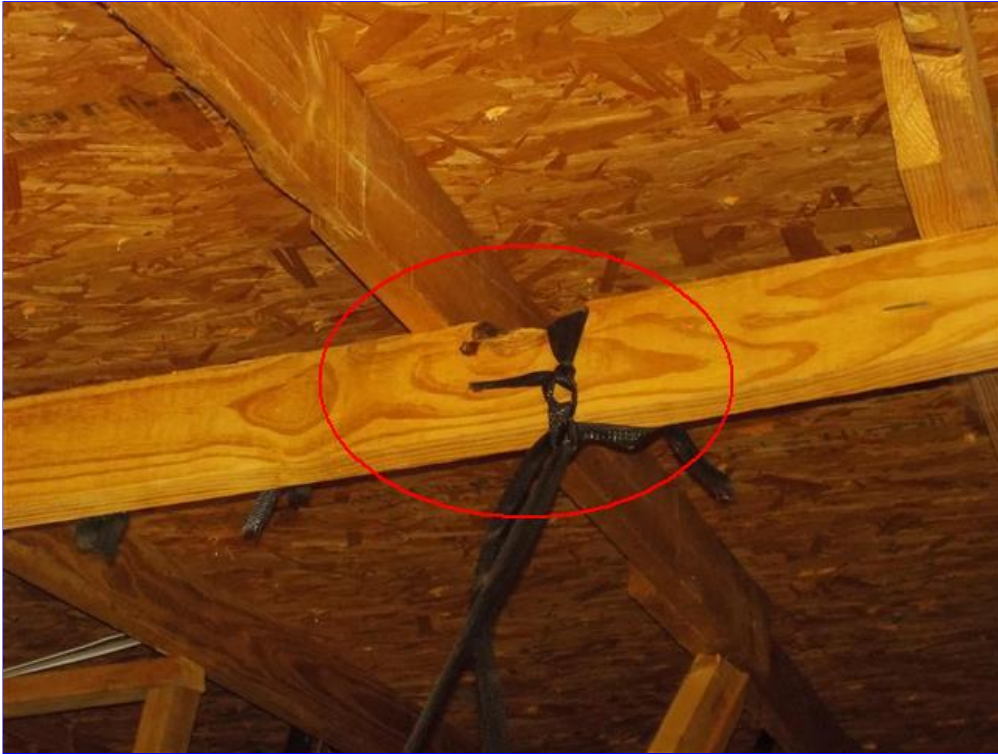
C. Item 19(Picture) Wood should be un-deteriorated

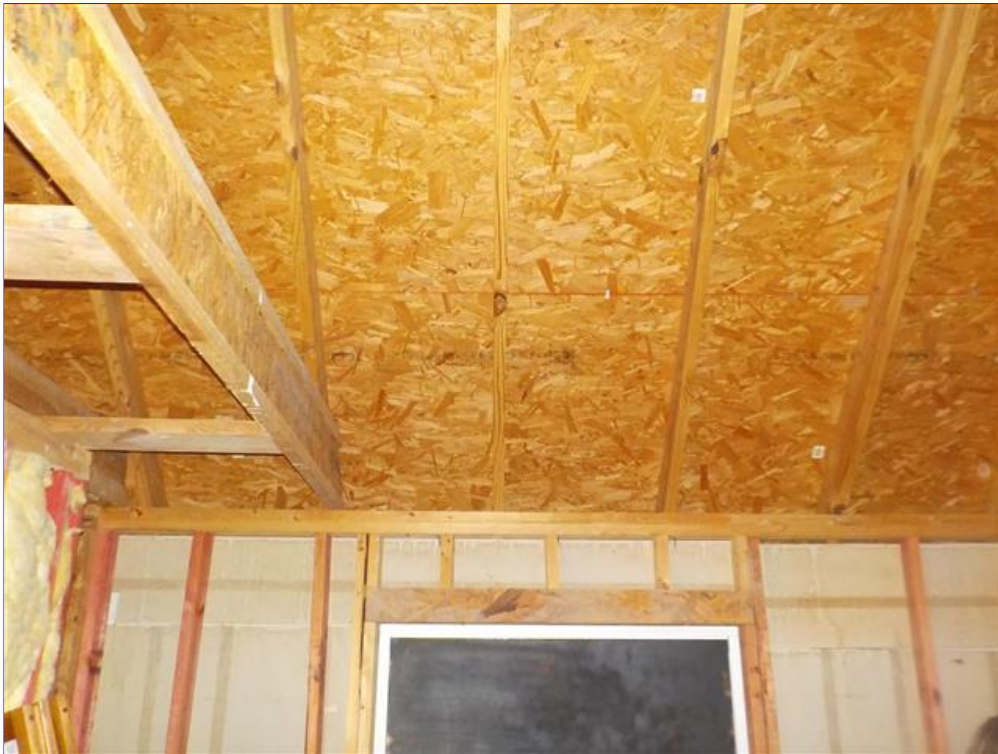
C. Item 25(Picture) Window has been blacked out

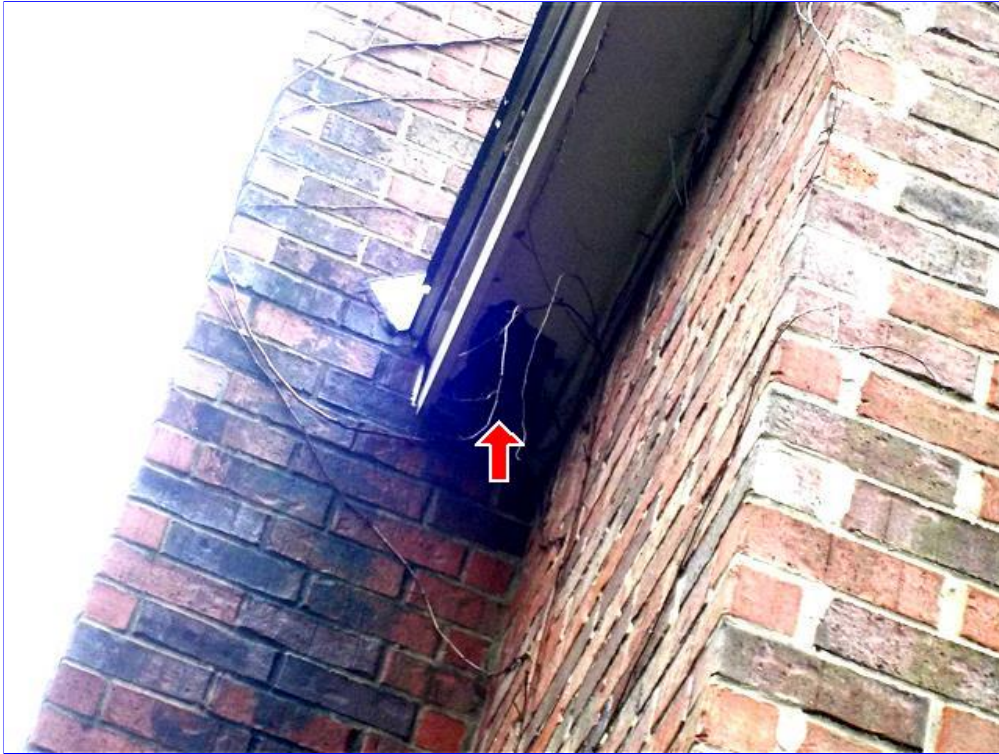
D. Item 5(Picture) Wood Rot

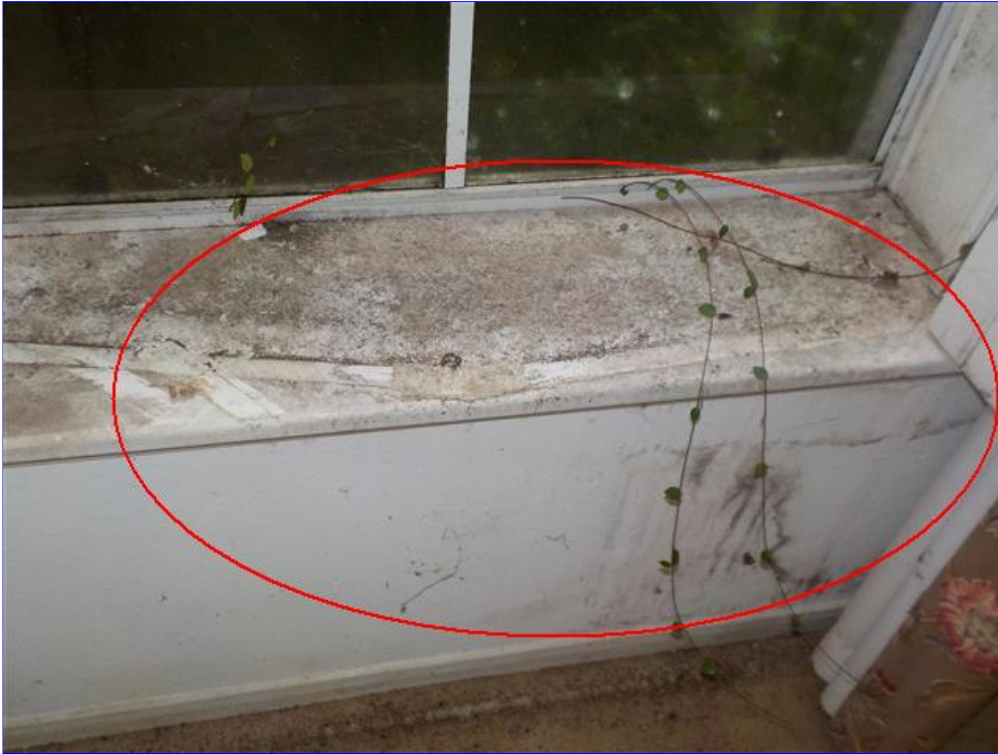
D. Item 17(Picture) WDO possibly

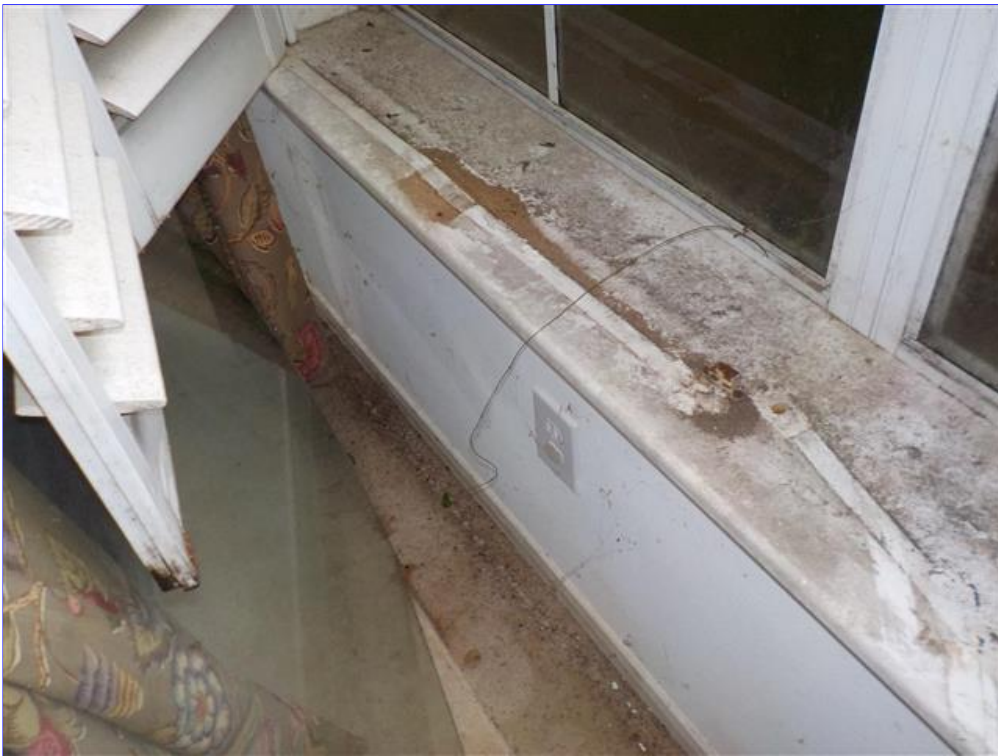
D. Item 18(Picture) possibly WDO

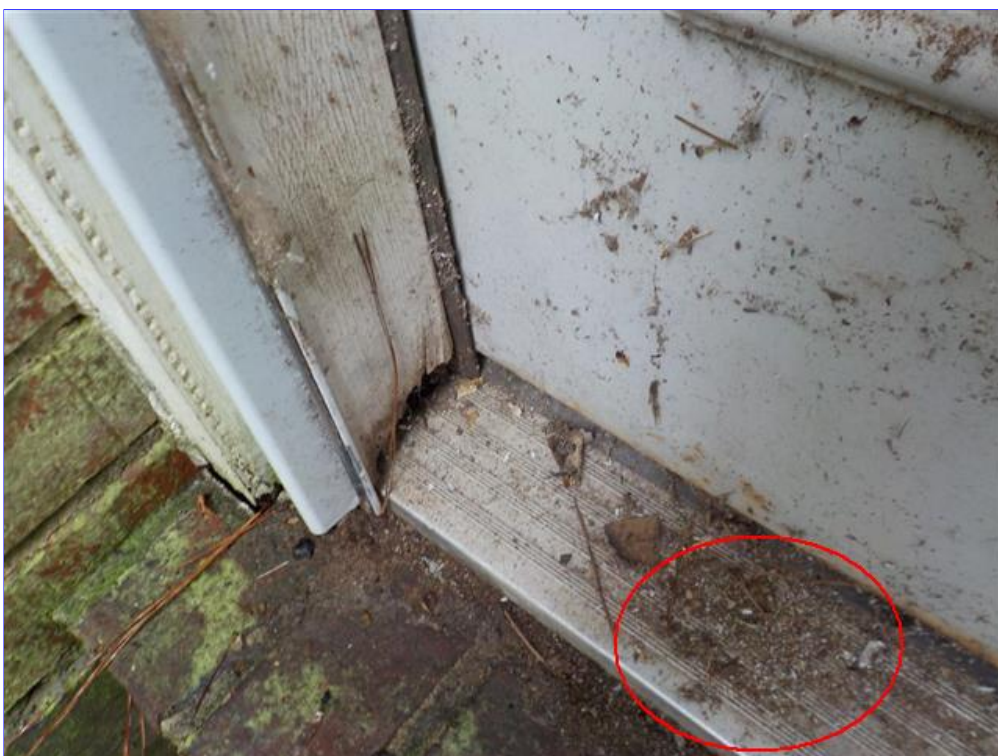
F. Item 4(Picture) Insect frass cannot identify insect class

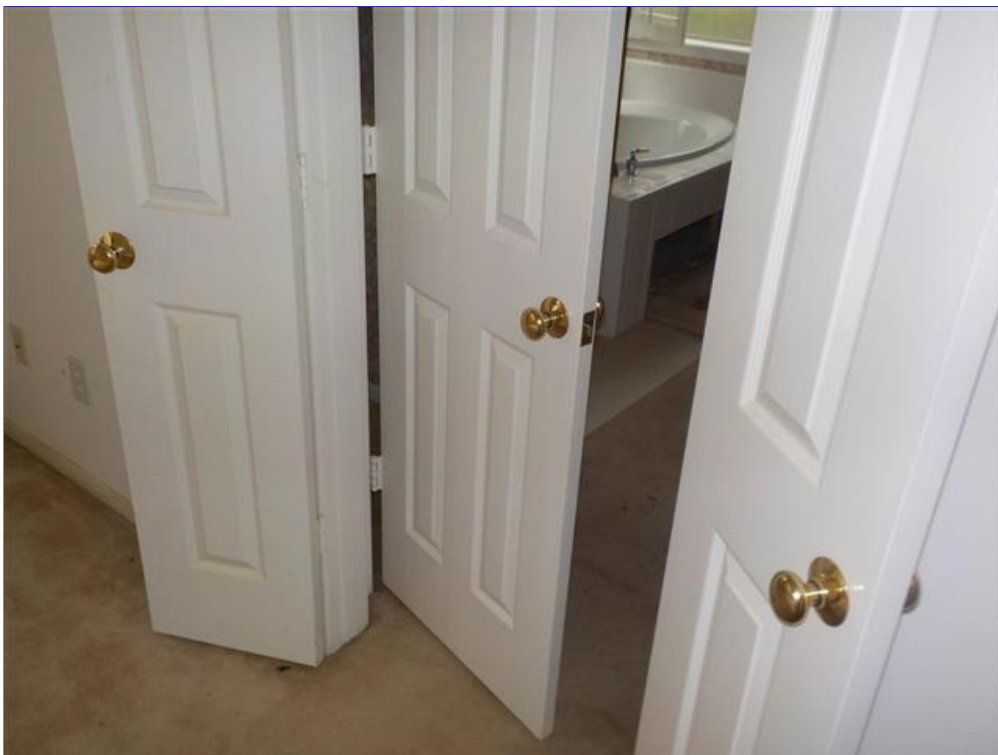
F. Item 11(Picture) Doors open into one another

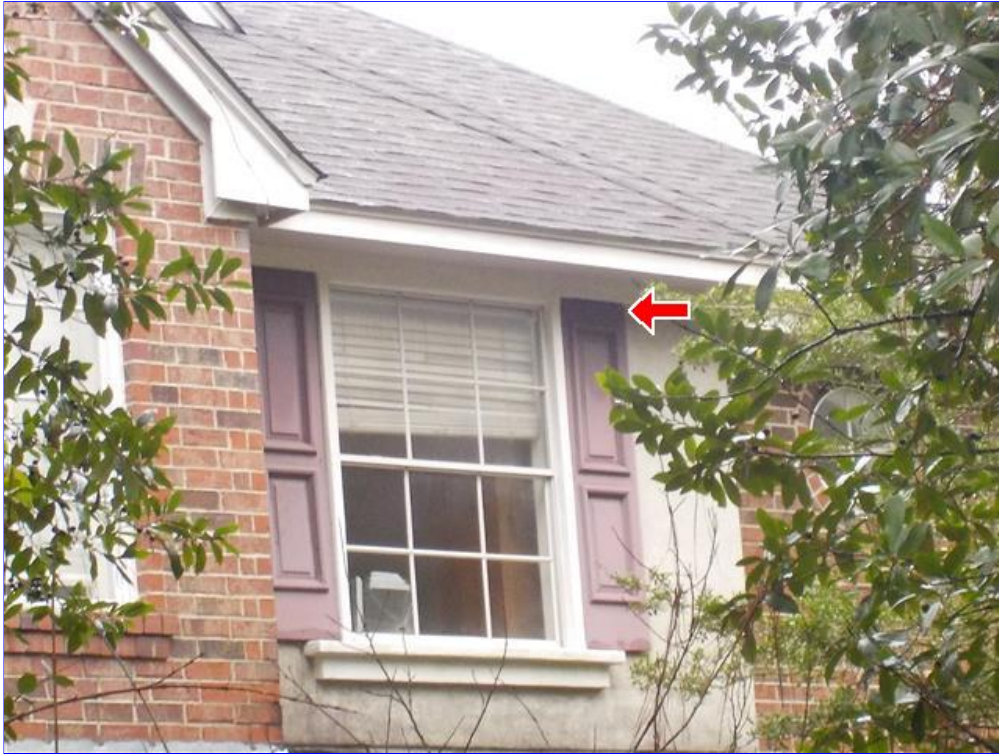
G. Item 3(Picture) Wood should not be touching the homes fascia

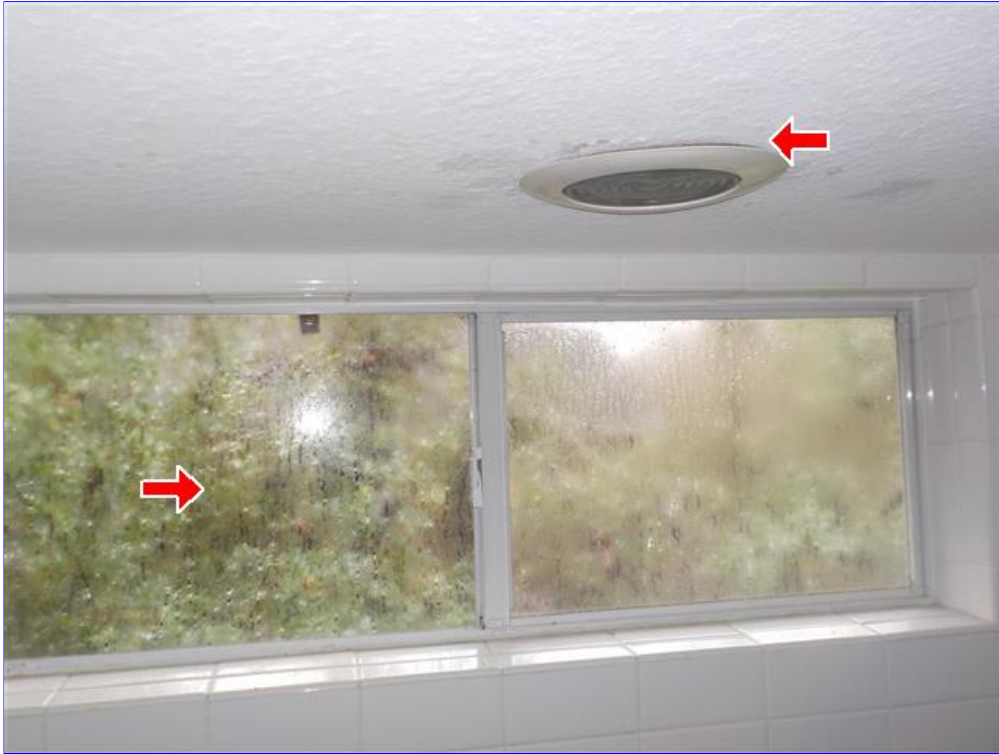
G. Item 5(Picture) High humidity evident by window condensation

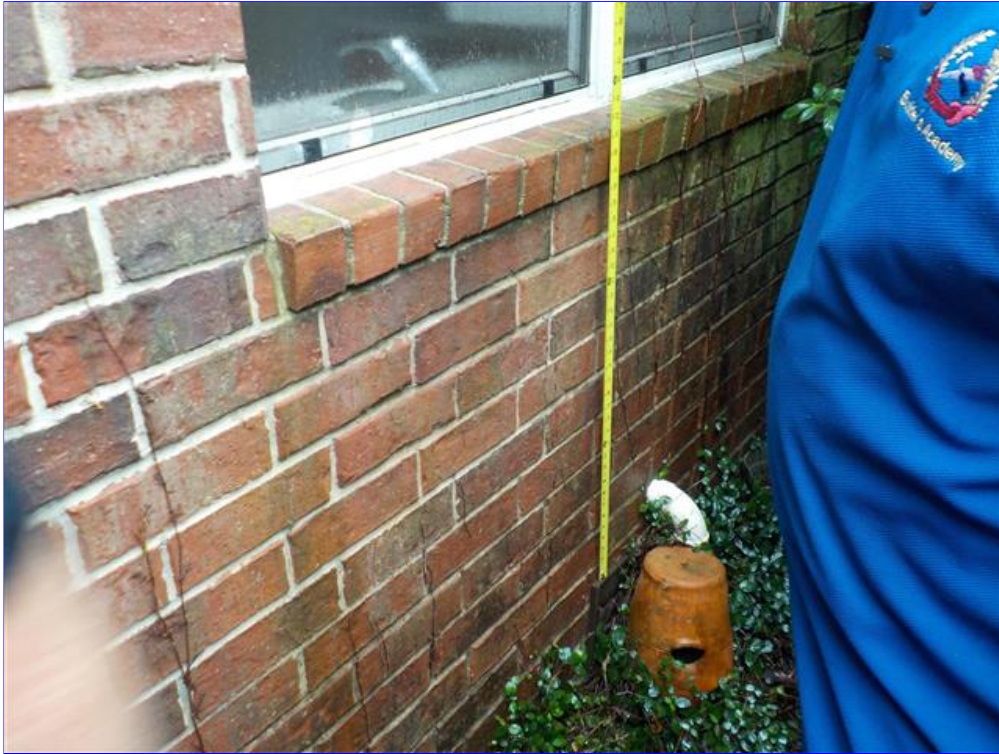
G. Item 7(Picture) Within tolerance

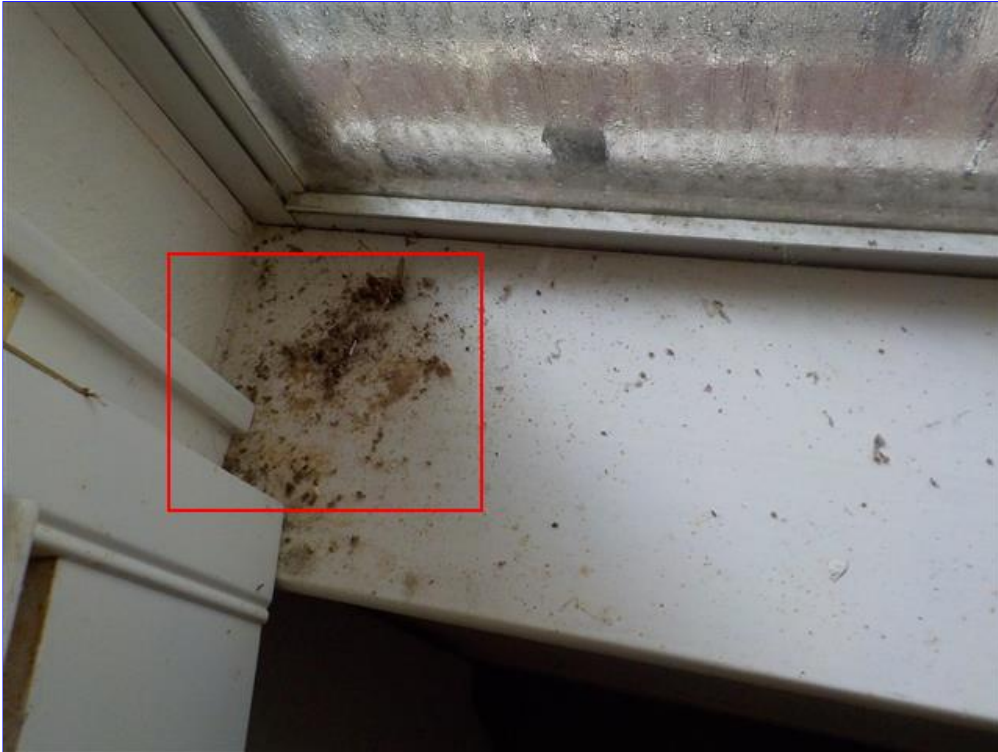
G. Item 13(Picture) Insect frass

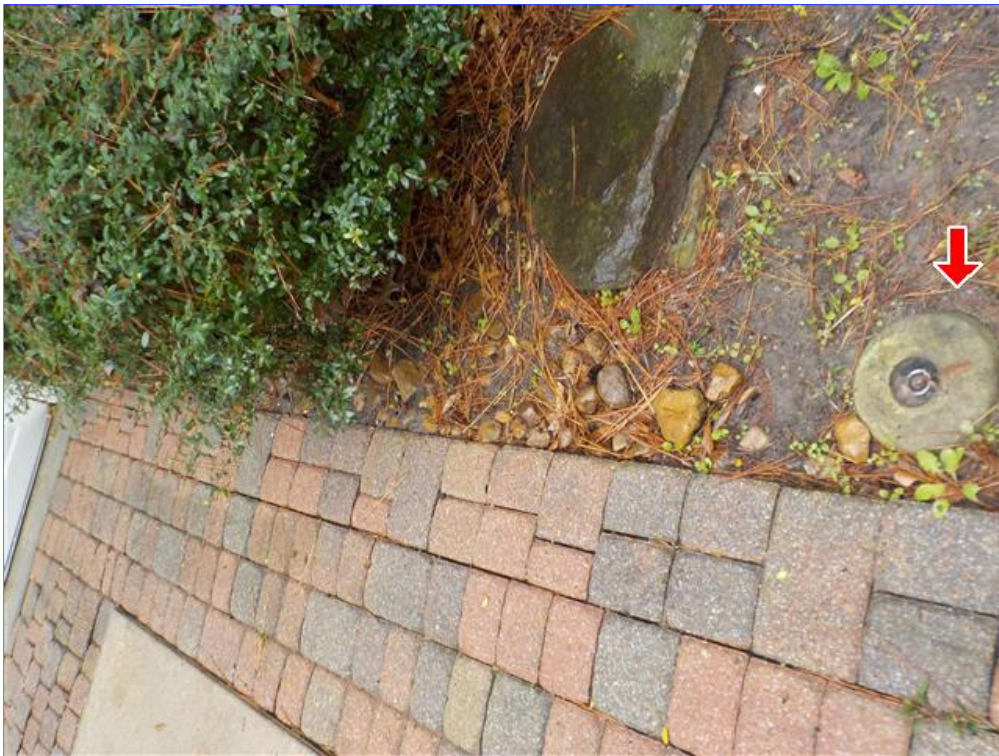
J. Item 2(Picture) Sprinkler will be hard to service

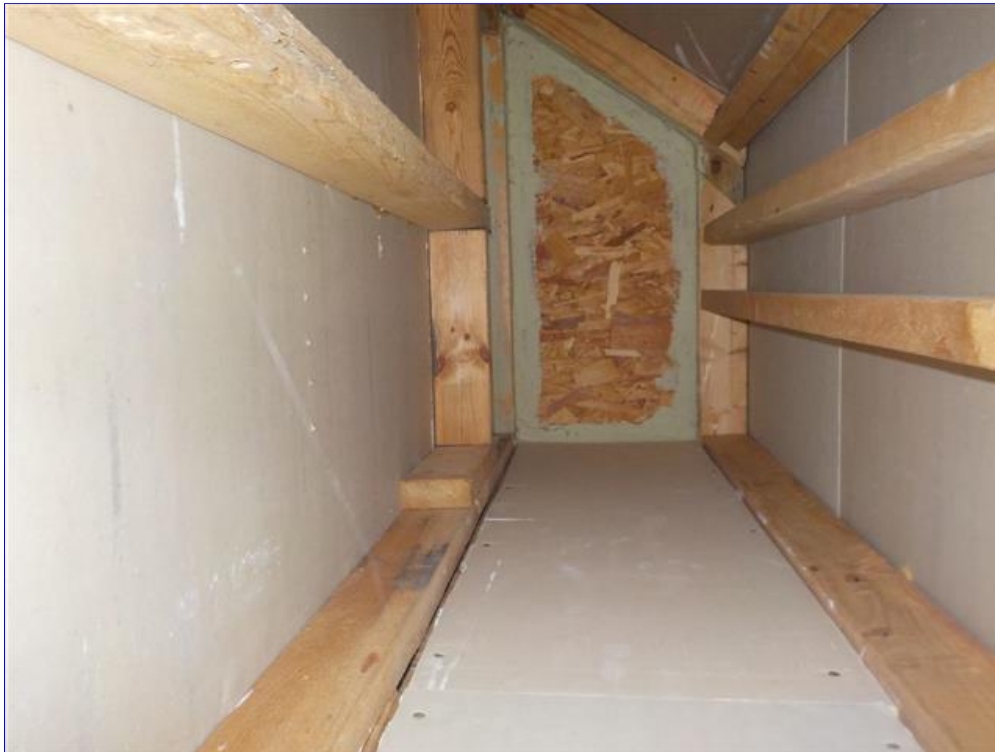
C. Item 7(Picture) Shoot should be free from debris

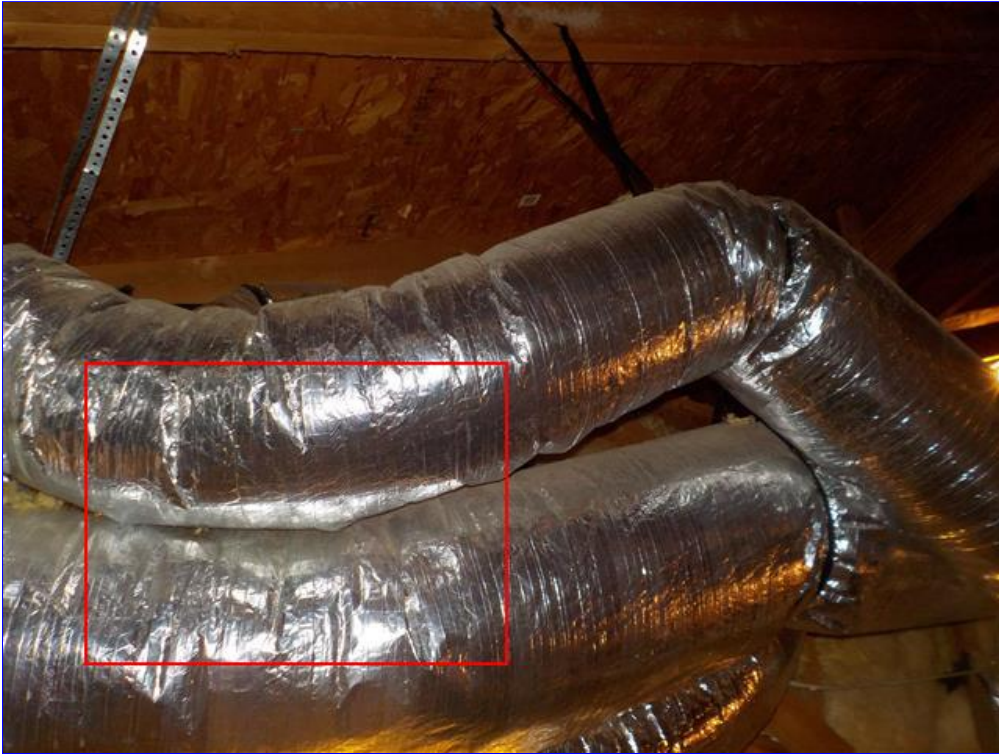
C. Item 13(Picture) Insulation can be put inbetween two ducts

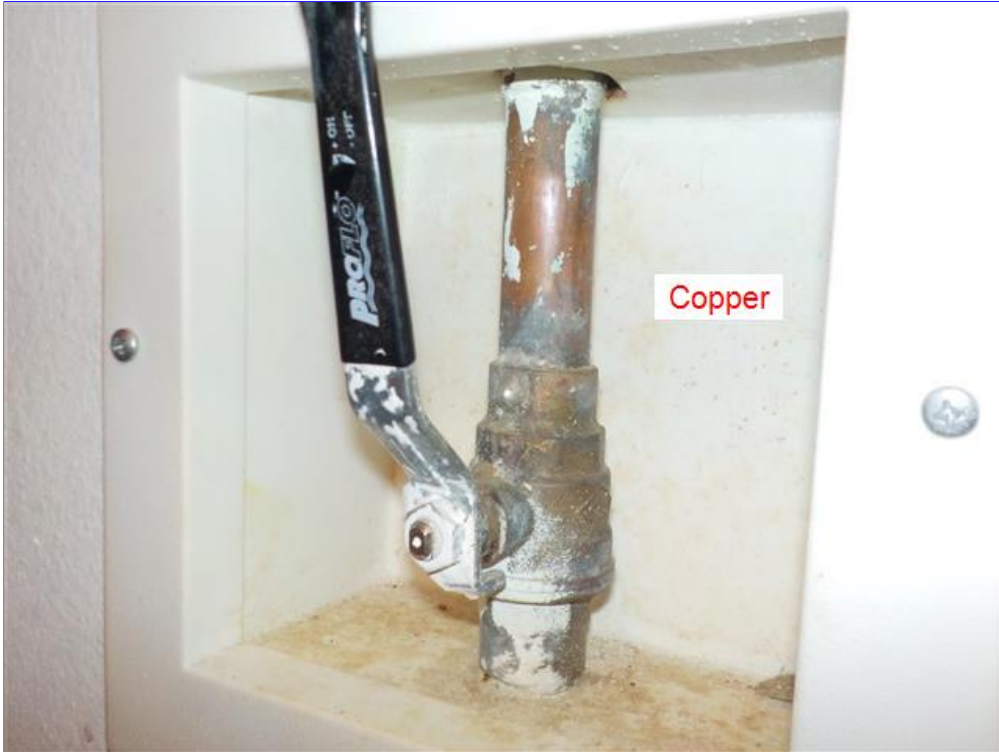
A. Item 7(Picture) Fixture

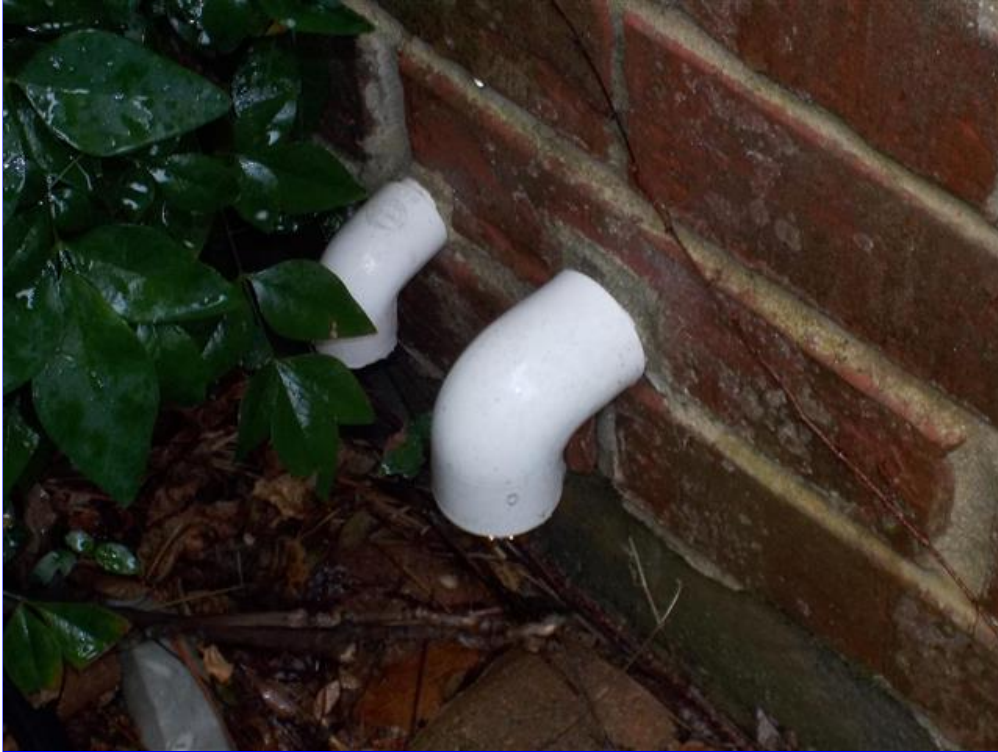
B. Item 1(Picture) Water heater drains add elbow

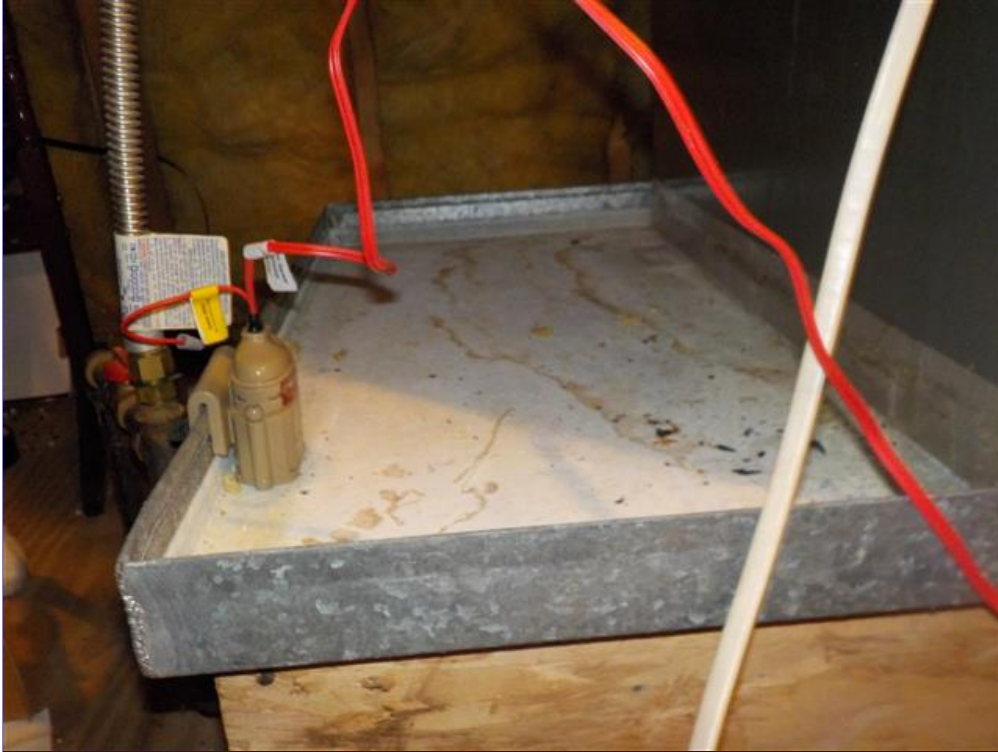
C. Item 11(Picture) debris in ac pan

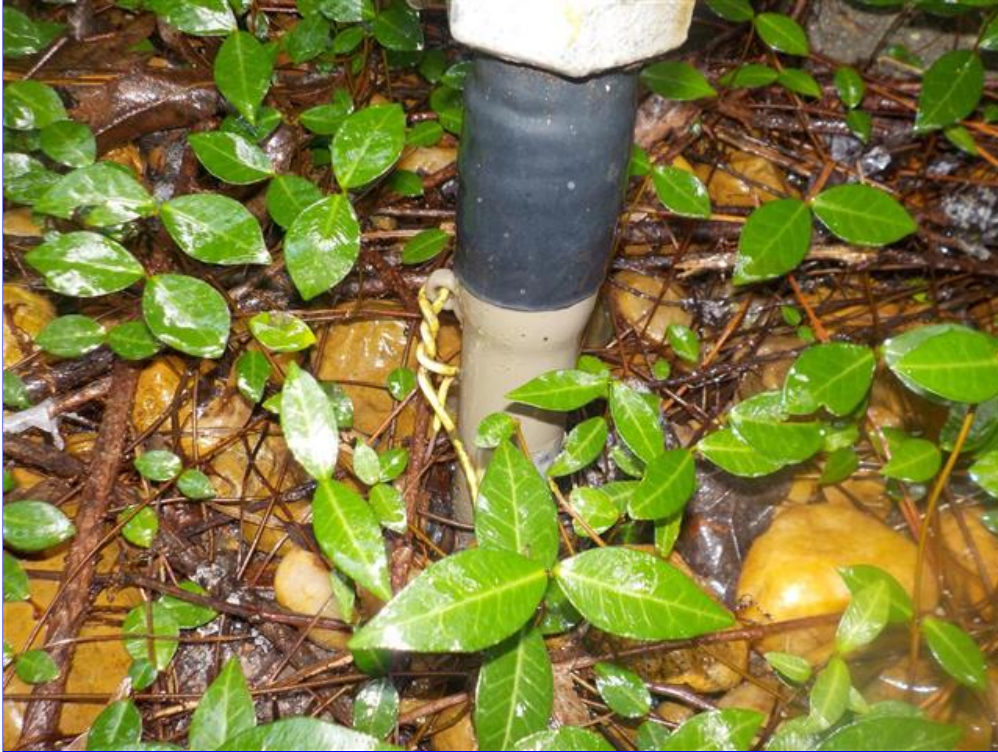
G. Item 1(Picture) Supply to gas in dense vegetation

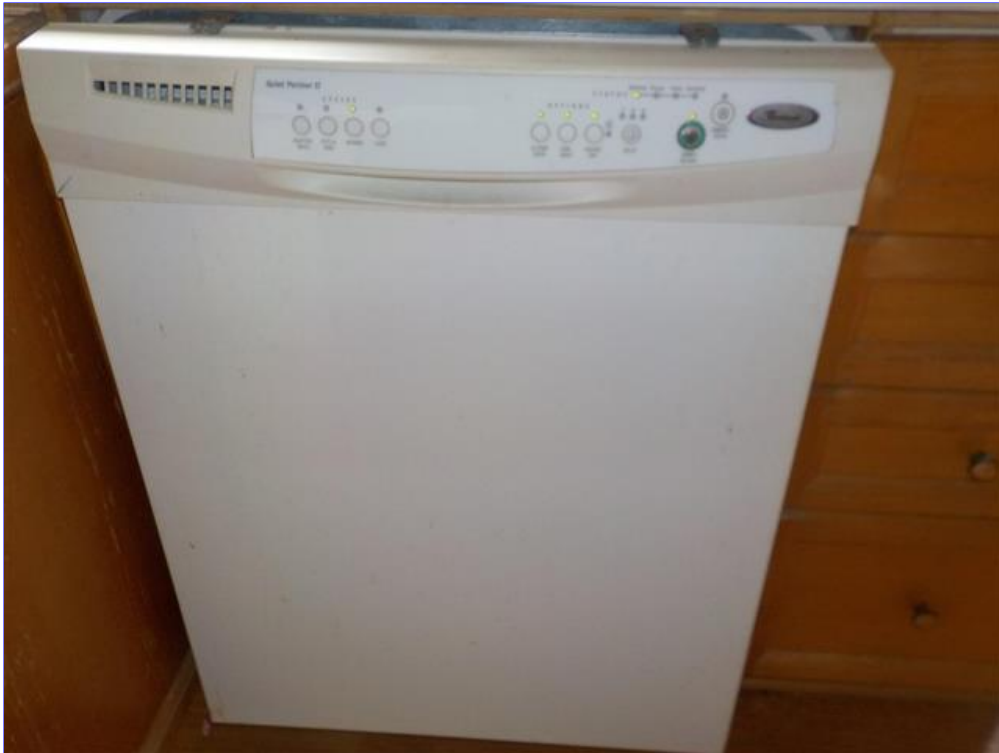
Dishwasher is draining properly

A. Item 1(Picture) Dishwasher works as intended.

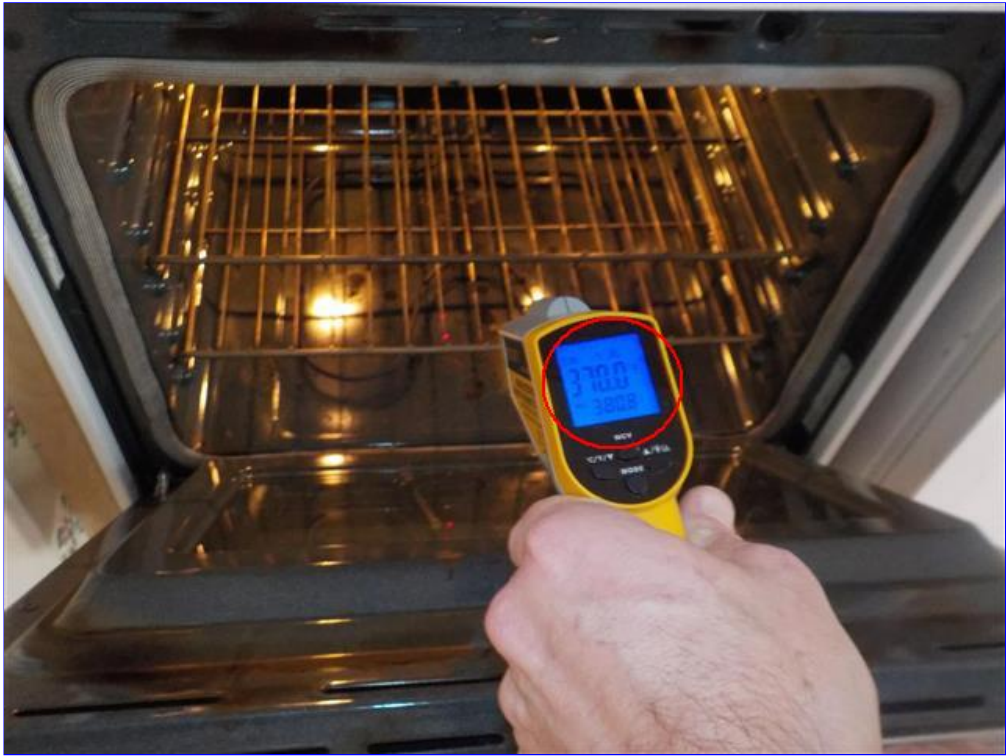
E. Item 2(Picture) Oven was set to 350F
