NationSpec Home Inspection

7027 Brockington Dr, Katy, TX 77494

PROPERTY INSPECTION REPORT

Concerning: 7027 Brockington Dr, Katy TX, 77494
 (Address or Other Identification of Inspected Property)

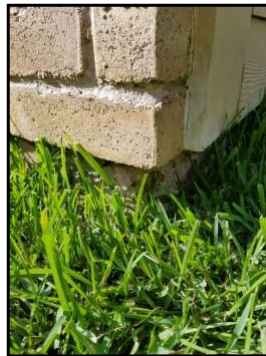
A.3. Corner Pop observed. This is not a structural issue. It is caused by the thermo-expansion of the brick and that expansion of the brick, cracks the corner of the foundation which is the weakest area. Recommend repairing this area with an approved material for this type of application (generally "epoxy based cement")

Right rear, corner pop

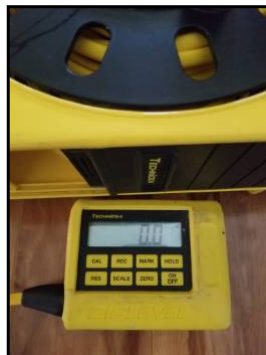
Zeroed in

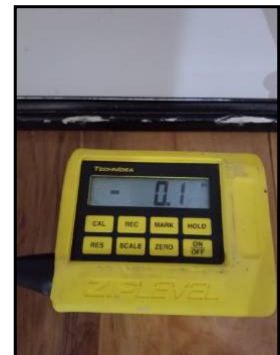
East wall (front door), -0.1

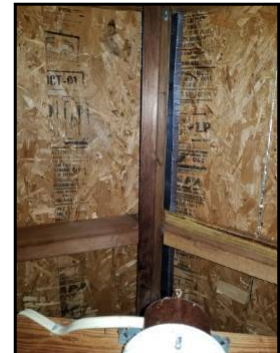
Ridge board is curved/split

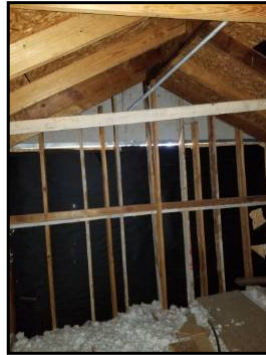
Daylight visible

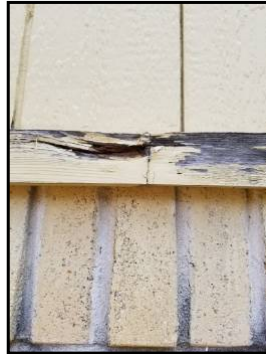
Left side, detail

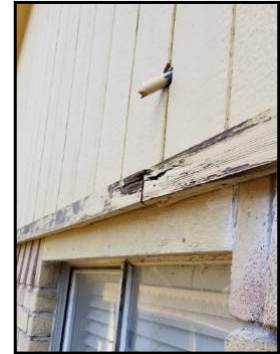
Left side, detail

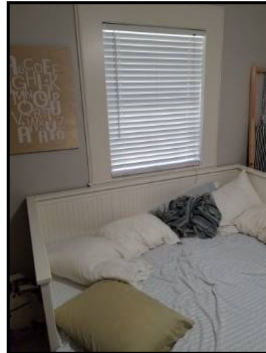
Back left bedroom, restriction

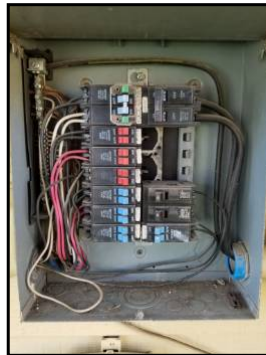
Aluminum 2 AWG for main service conductors, no antioxidant grease present

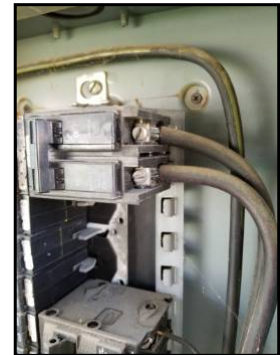
A.9. Undersized wiring for the circuit is considered a Safety Hazard and should be repaired by a licensed electrician

Undersized conductors for a 50 amp breaker. 10AWG

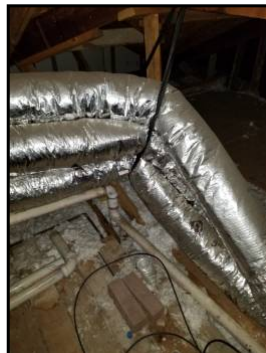
Ducts touching

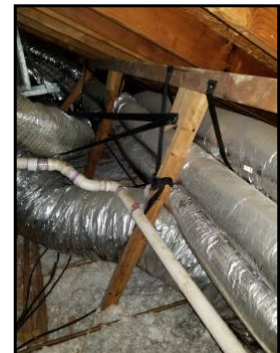
Ducts touching

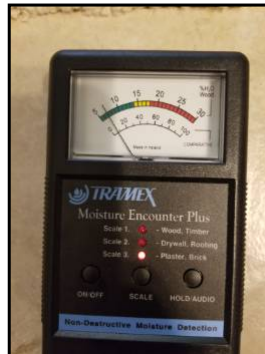
Master bathroom control, 7%

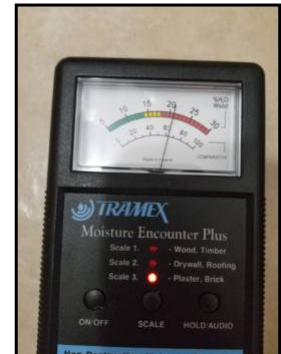
B.2. Subsurface moisture readings were observed to be high in the hall bath and master bathroom as the bathtub was draining. This could potentially be caused by a variety of influences including but not limited to high retained mc at the material, over watering of the grounds or possibly a subsurface leak. Recommend further review by a licensed plumber.

Master bathroom tub, 21%

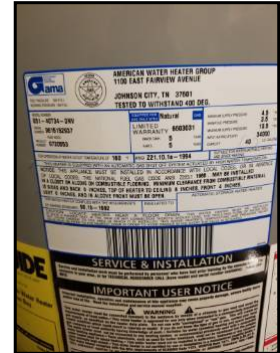
Data plate

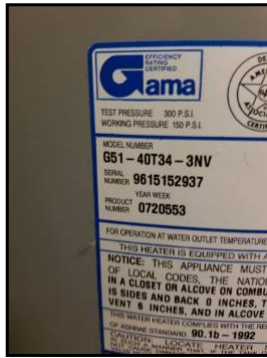
Manufactured in 1996

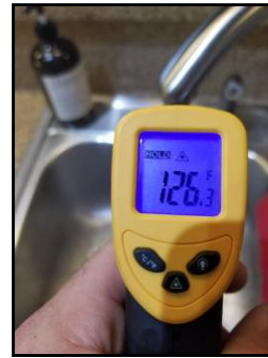
Kitchen, 126.3°

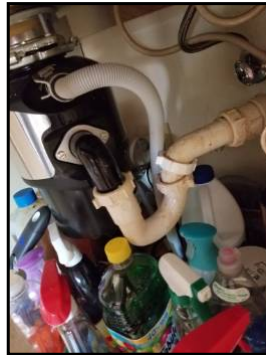
A.1. Lack of a proper air gap noted and/or high loop drain line at dishwasher. In the event of a sewer backup this device prevents sewer matter from entering into dishwasher. Recommend having a qualified plumber install a air gap to prevent possible contamination.

No high loop and/or air gap

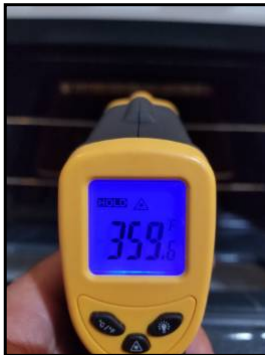
Oven set to 350, within acceptable range 359.6

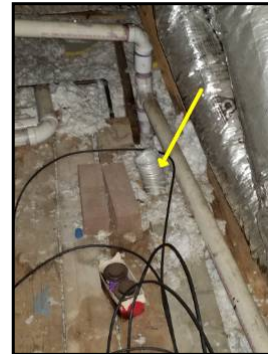
F.1. The vent fan terminated in the attic space and should be vented to the exterior as per current building standards

Exhaust vent terminates in attic

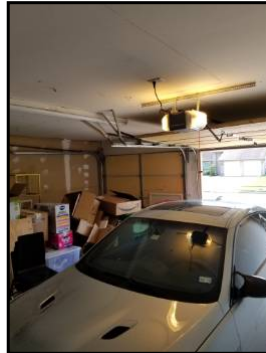
Only one garage door opener noted

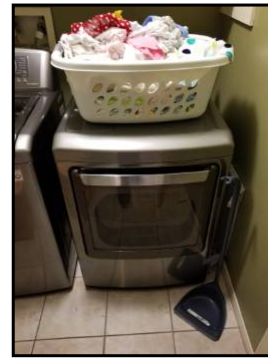
Dryer installed/restriction
